PROVO RIVER DIVERSION DAMS EVALUATION

Final Draft Report

Utah Reclamation Mitigation and Conservation Commission

October 2001

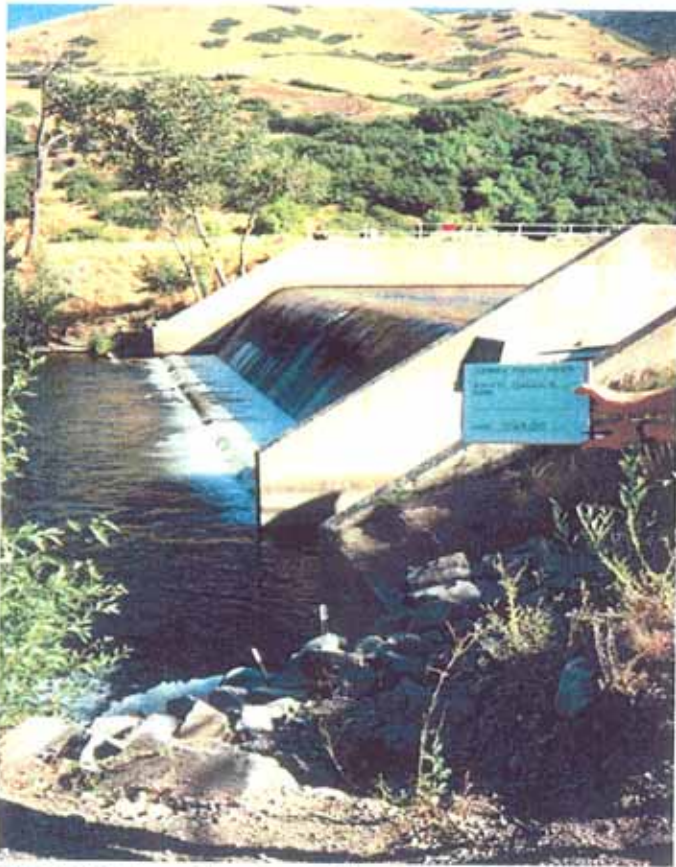
The existing diversion structure is in good condition and consists of a concrete dam with a radial gated sluiceway on the south (river left) side of the dam. The headworks to the Murdock Canal consist of a metal radial gate installed on the south (river left) side of the dam and sluiceway.

Photo 1-1. Murdock Diversion structure.

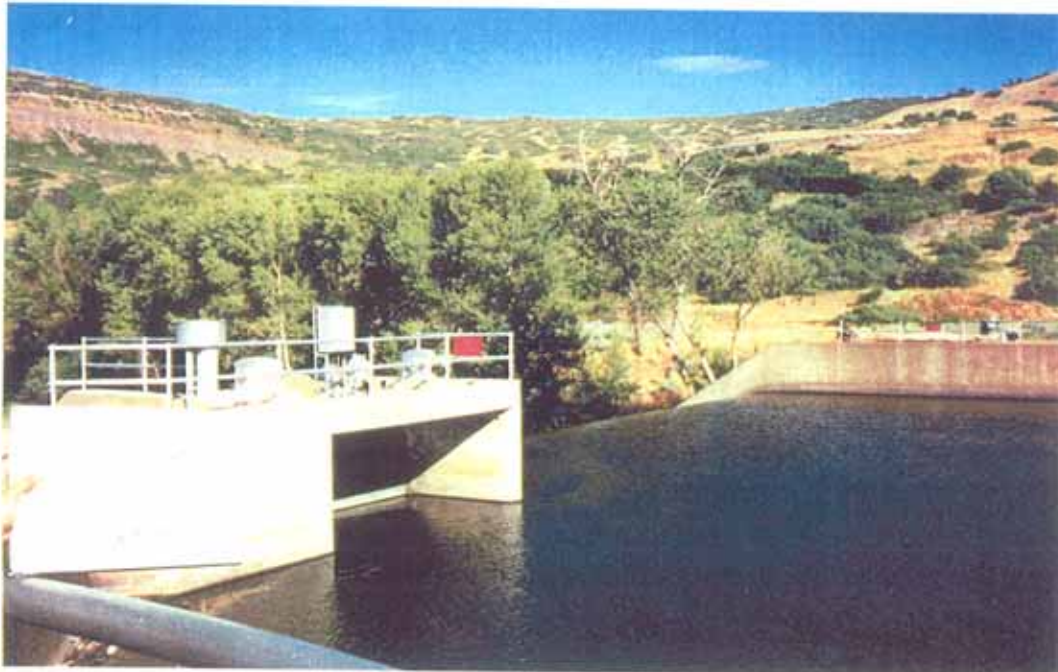
Photo 1-2. Murdock Diversion: view of structure and radial-gated sluiceway.

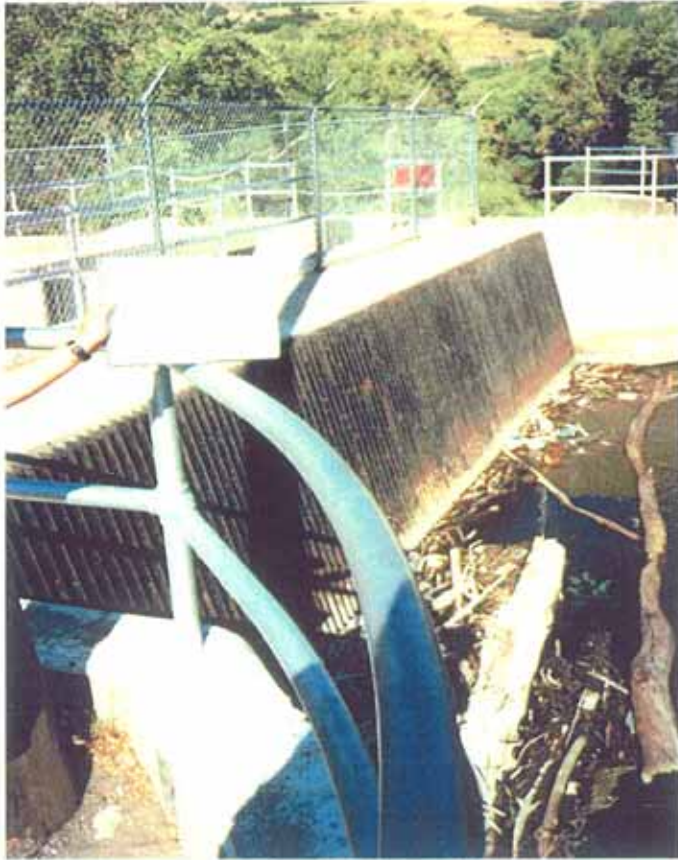
Murdock Dam creates a complete barrier to upstream fish migration at all flows, and the 3 inch spacing of the trash grate located at the canal entrance is inadequate to prevent fish from becoming entrained in the canal. The initial portion of Murdock Canal consists of a concrete-lined channel, but shortly downstream the canal enters a pipe and passes under the highway.

Photo 1-3. Murdock Diversion: grate at canal headworks.

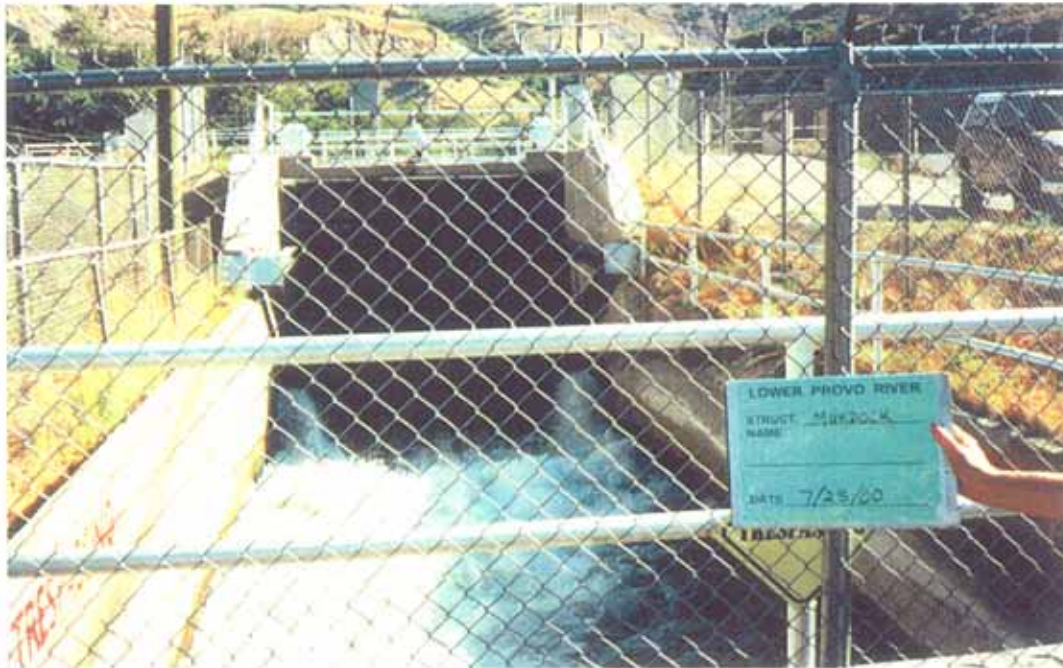
Photo 1-4. Murdock Diversion: upstream view of headworks canal.

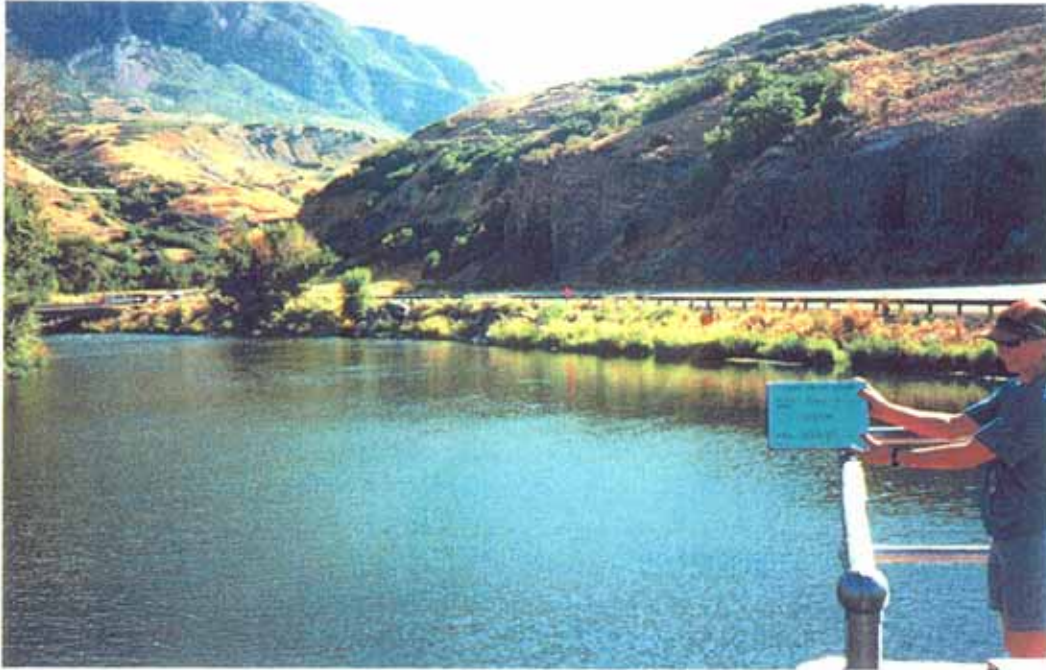
Photo 1-5. Murdock Diversion: channel upstream from structure.

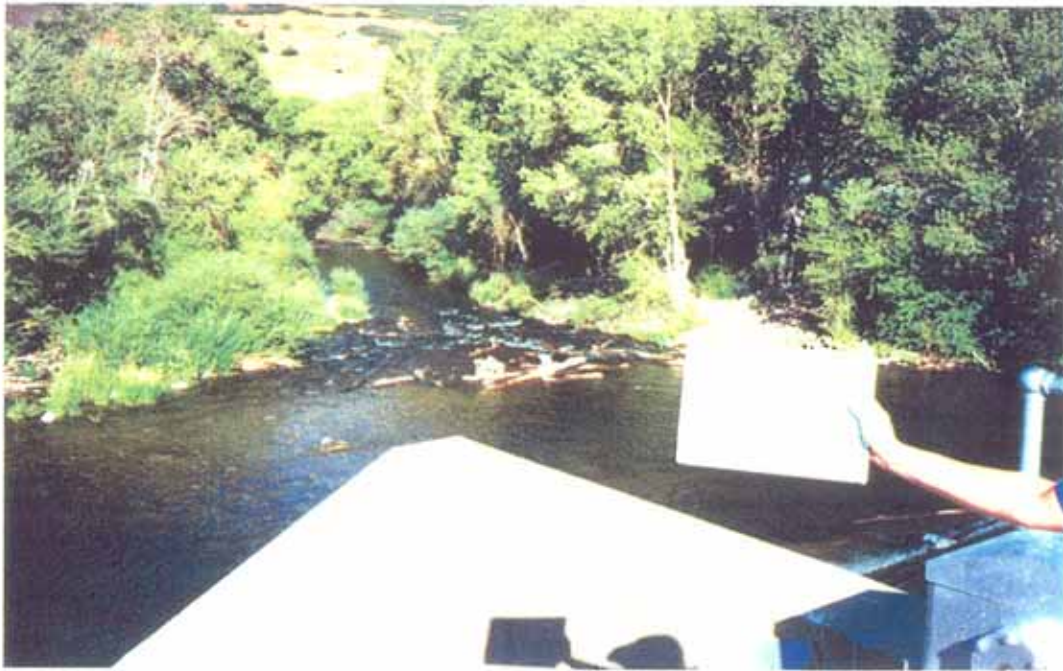
Photo 1-6. Murdock Diversion: channel downstream from structure.

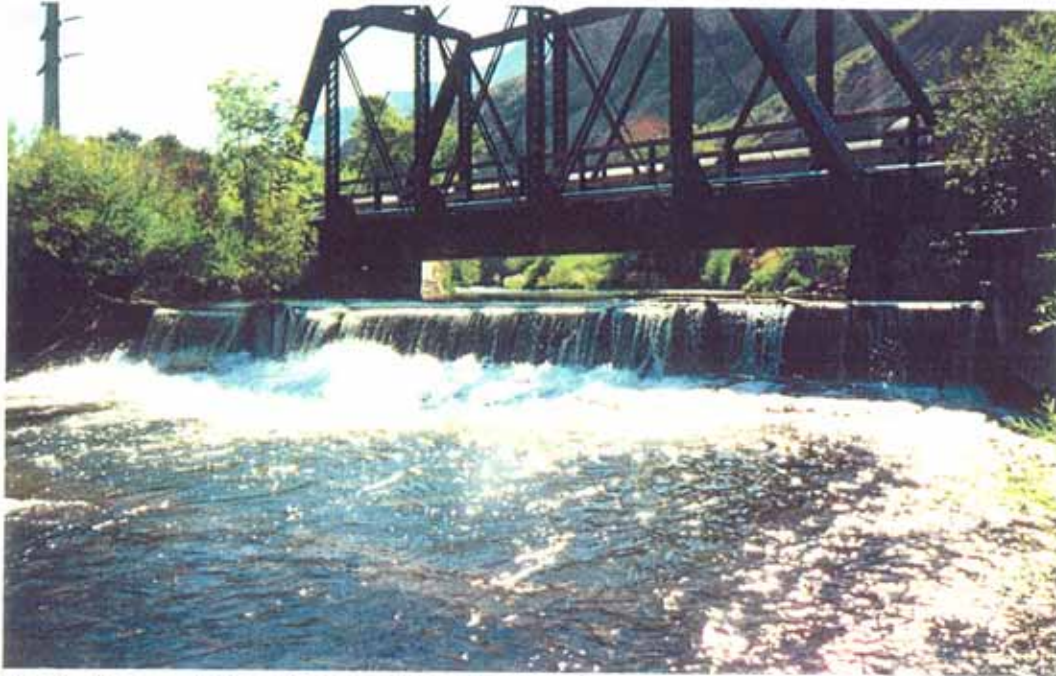
Photo 2-1. Timpanogos Diversion: upstream view.

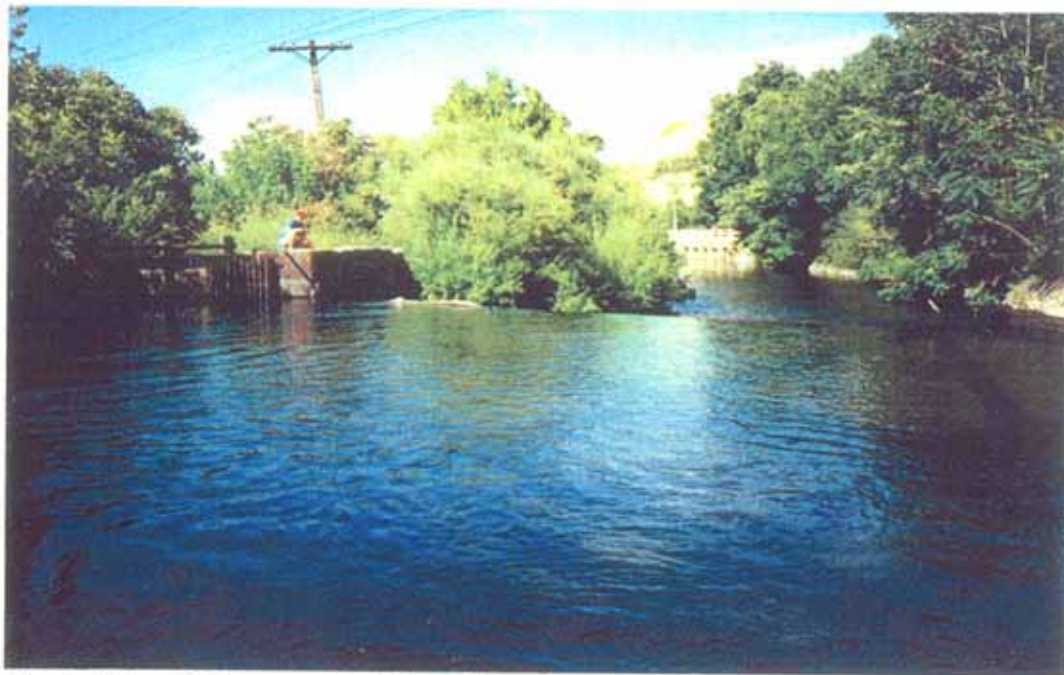
Photo 2-2. Timpanogos Diversion: downstream view.

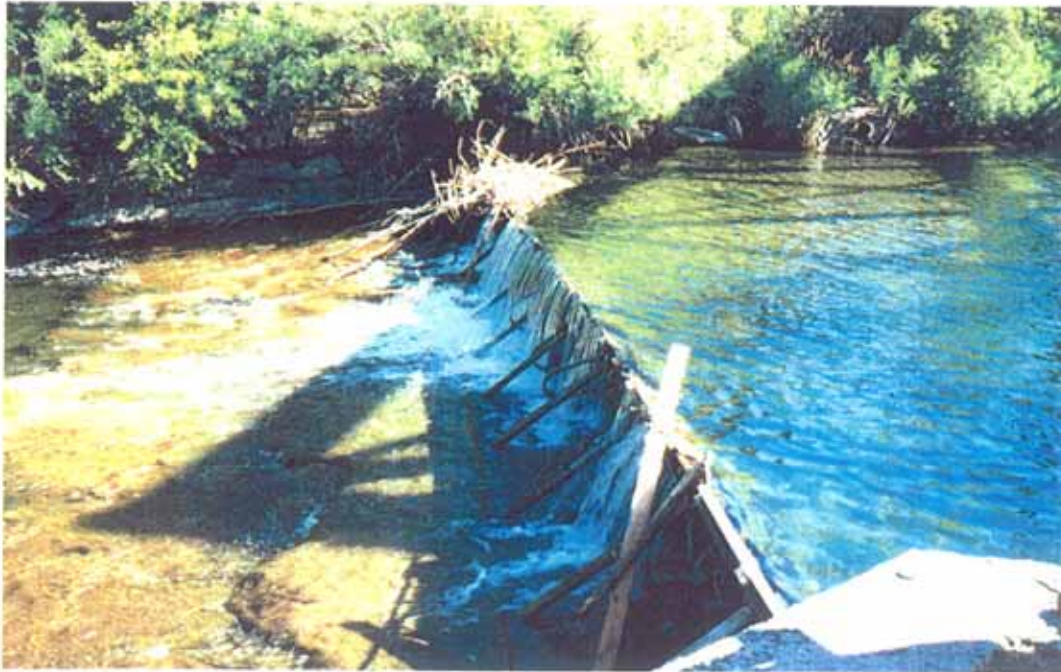
The existing diversion structure is in good condition and consists of a kick-leg dam installed with concrete sidewalls and a flat concrete sill that lies flush with the streambed. No flow bypass device is present. During high flow years, the dam is taken down so that it will not be damaged. The Provo River Commissioner estimated that the dam has been removed and re-assembled 3 or 4 times in the last 10 years (S. Roberts 2000, pers. comm.). The canal headworks consist of a metal radial gate set in concrete. The initial section of the canal is approximately 300 feet long and has bed and banks made of natural materials. After this initial section, the canal is piped. A mechanical moving screen has recently been installed at the entrance to the piped section of the canal. The CUWCD has recently purchased water shares associated with this canal, and in the future instream flows will be provided below this structure. Based on Division of Water Rights records, the average maximum canal flows during May, June, and July exceed the legal water right of 14.12 cfs (Table 3).

Photo 2-3. Timpanogos Diversion: kick-leg structure.

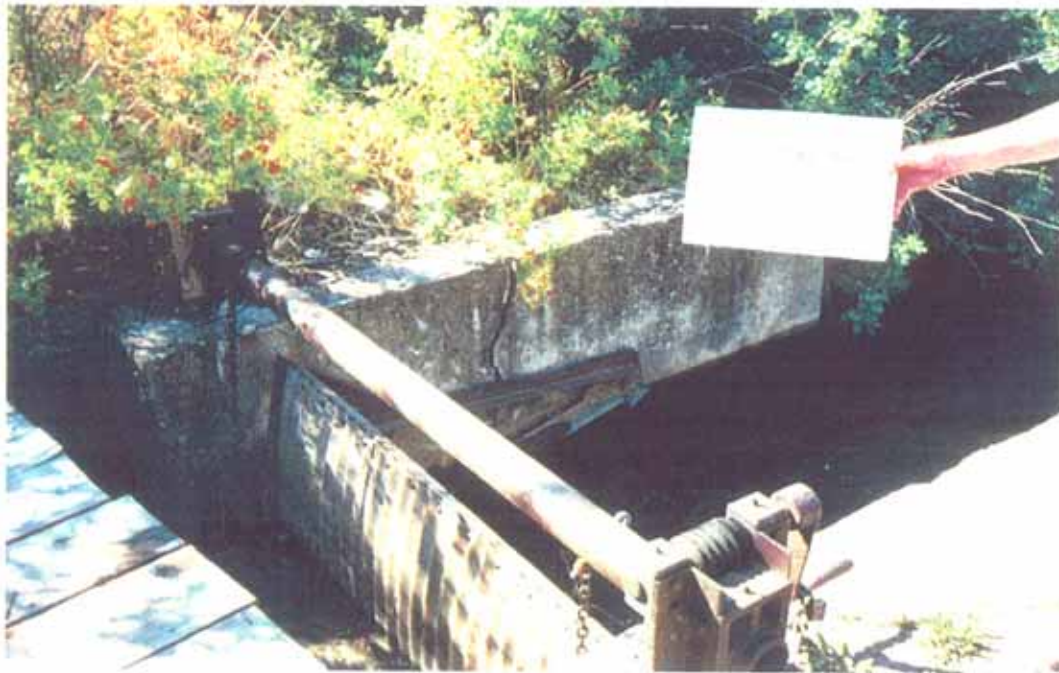
Photo 2-4. Timpanogos Diversion: canal headworks.

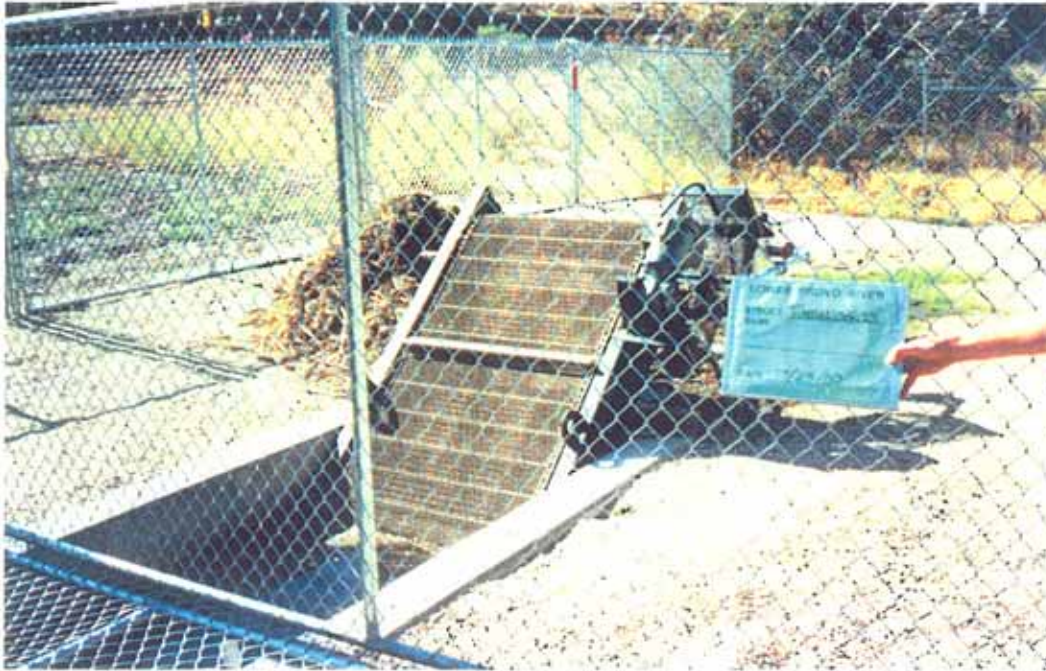
Photo 2-5. Timpanogos Diversion: mechanical moving fish screen at pipe entrance.

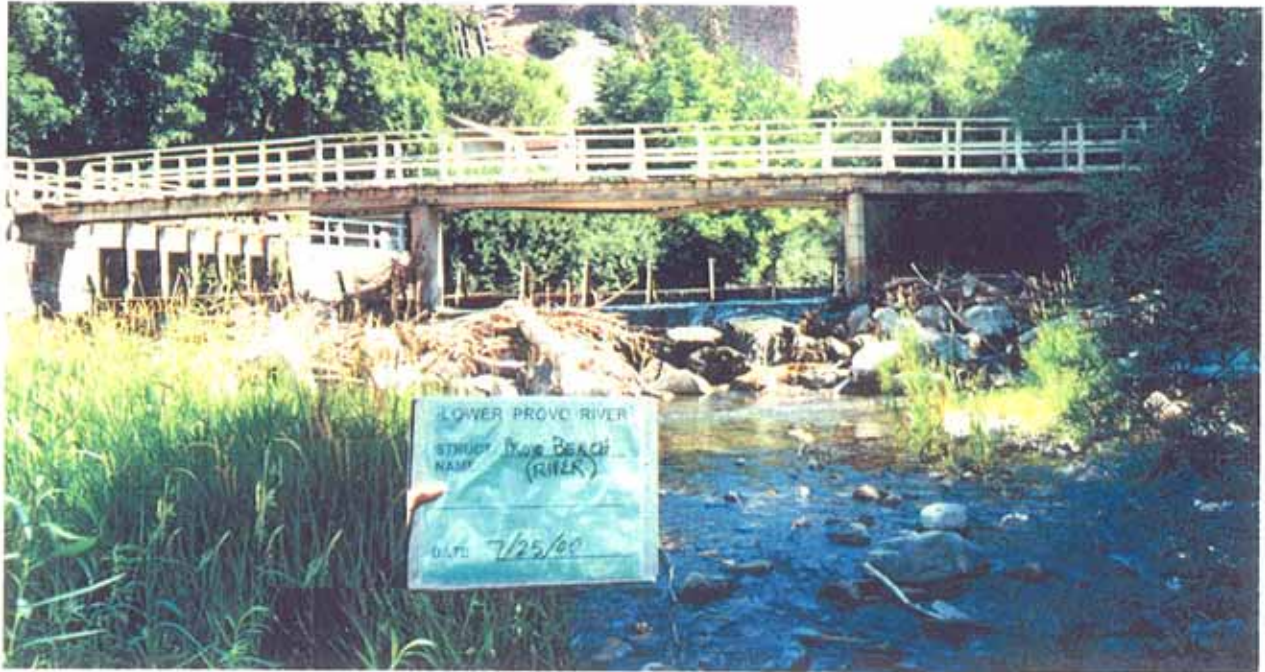
Photo 3-1. Provo Bench - diversion on river: upstream view of structure.

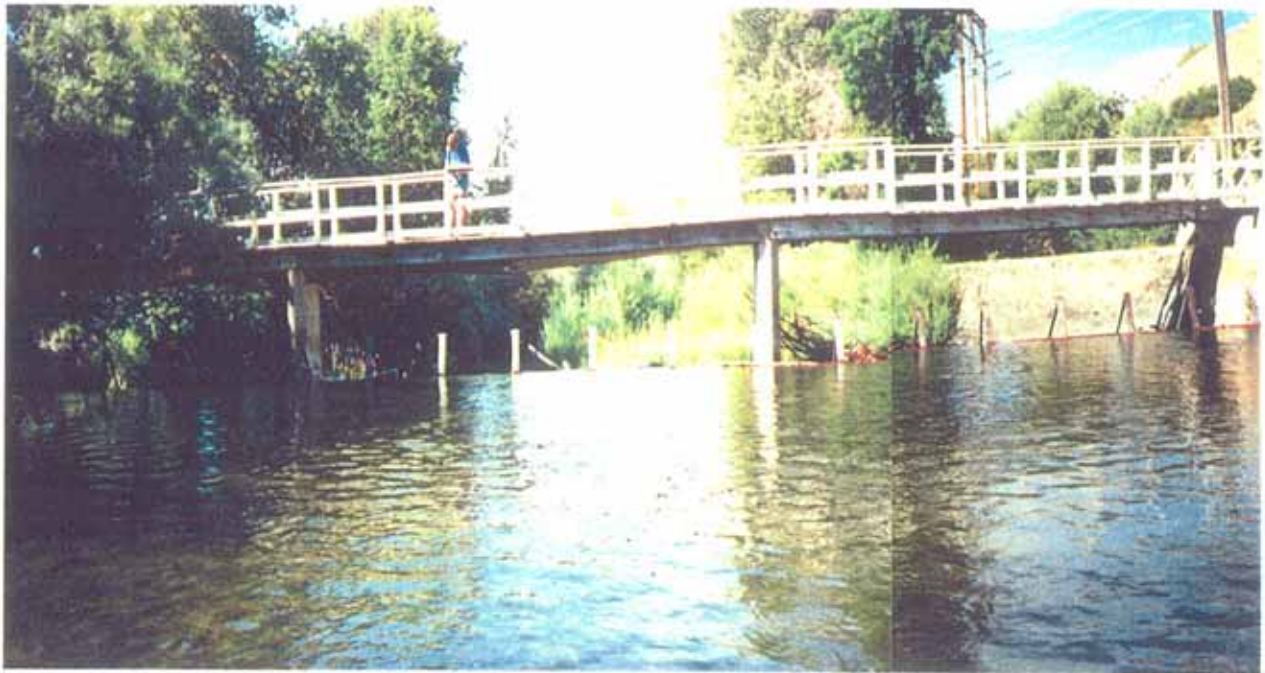
Photo 3-2. Provo Bench - diversion on river: downstream view of structure.

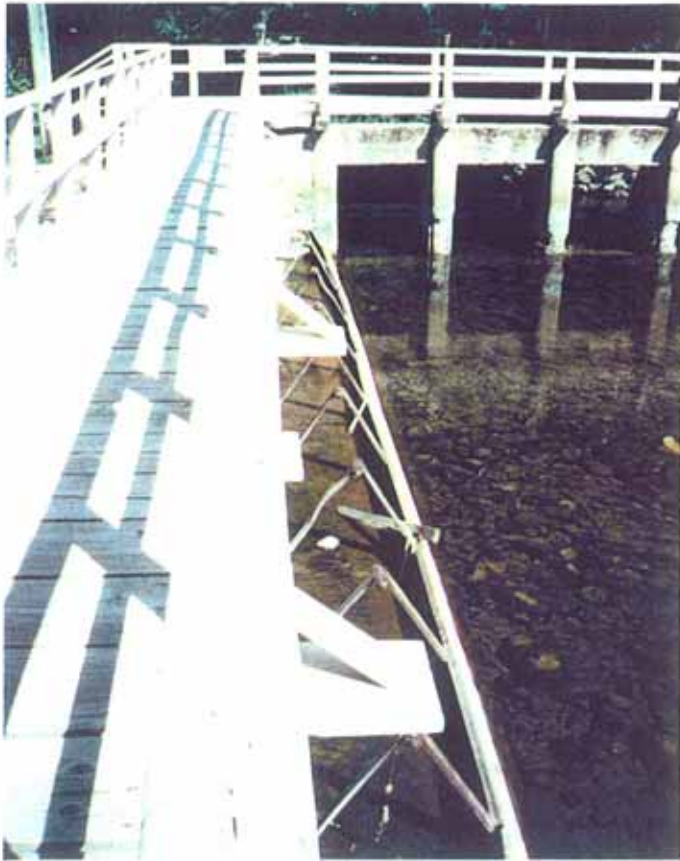
The existing diversion structure is in fair condition and consists of a kick-leg dam installed with concrete sidewalls and a flat concrete sill. This concrete sill lies flush with the streambed above the dam, but below the dam considerable scour has occurred at the base of the sill (Photo 3-1). Rip rap has been placed below the sill and this appears to have halted the scour/ undercutting process; however, the potential exists for further undercutting to occur during high flow events. No flow bypass device exists for this structure. The diversion feeds a short section of canal that connects to the Olmsted tailrace. The entrance to this canal consists of openings between concrete footbridge pillars. Although no defined headgate is present, the entrance to the canal could be blocked by placing flashboards in vertical slots between the pillars.

Photo 3-3. Provo Bench - diversion on river: kick-leg dam structure.

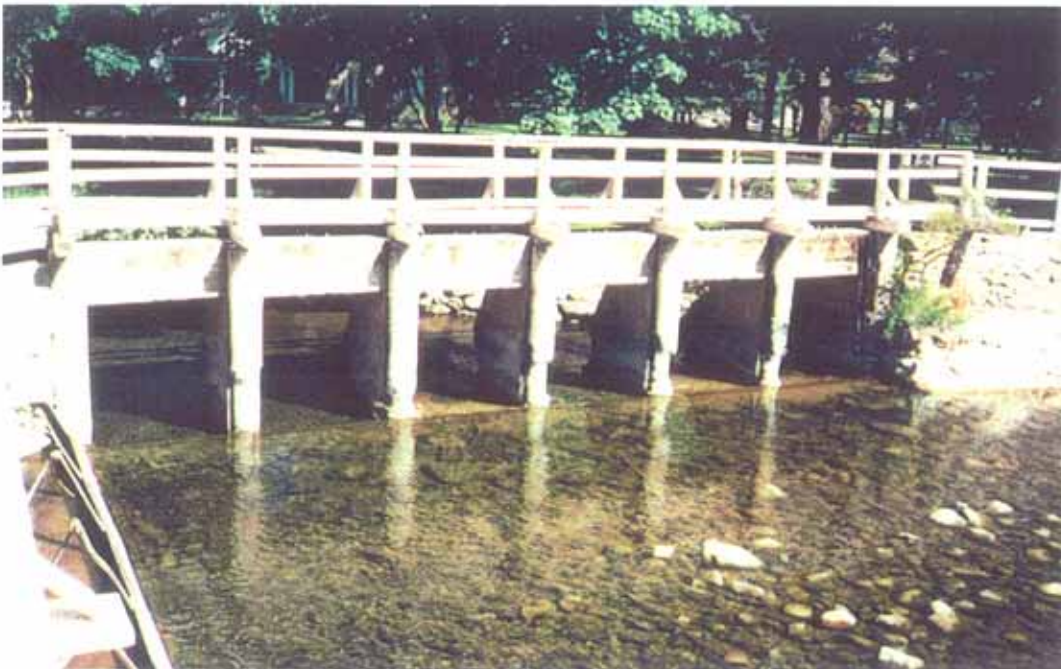
Photo 3-4. Provo Bench - diversion on river: canal head works.

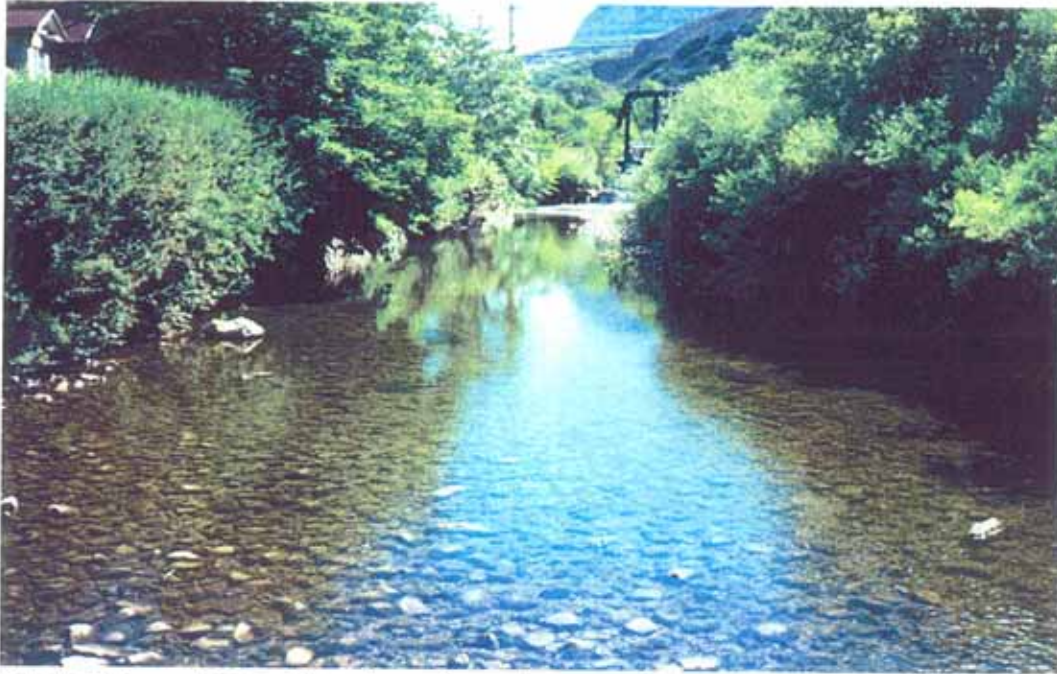
Photo 3-5. Provo Bench - diversion on river: channel upstream from structure.

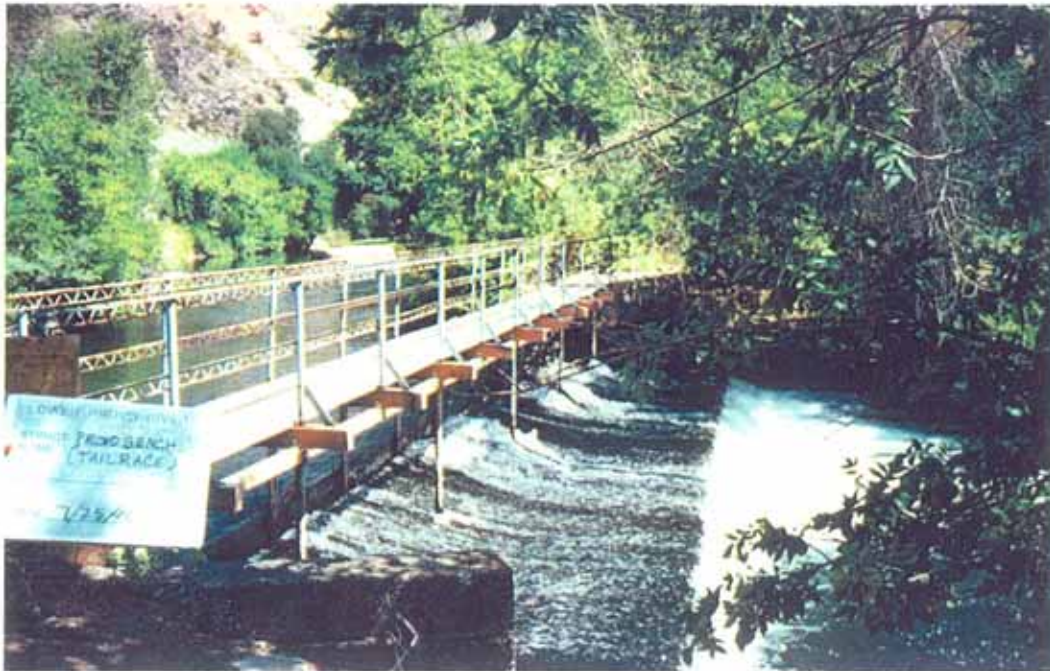
The existing diversion structure is in good condition, and consists of flashboards on top of a concrete dam. The flashboards are fitted in slots between metal footbridge supports (Photo 4-1). Some minor scour has occurred at the base of the concrete dam, but the stability of the structure remains good. No flow bypass device is present.

Photo 4-1. Provo Bench - diversion on tailrace: flashboard and concrete structure.

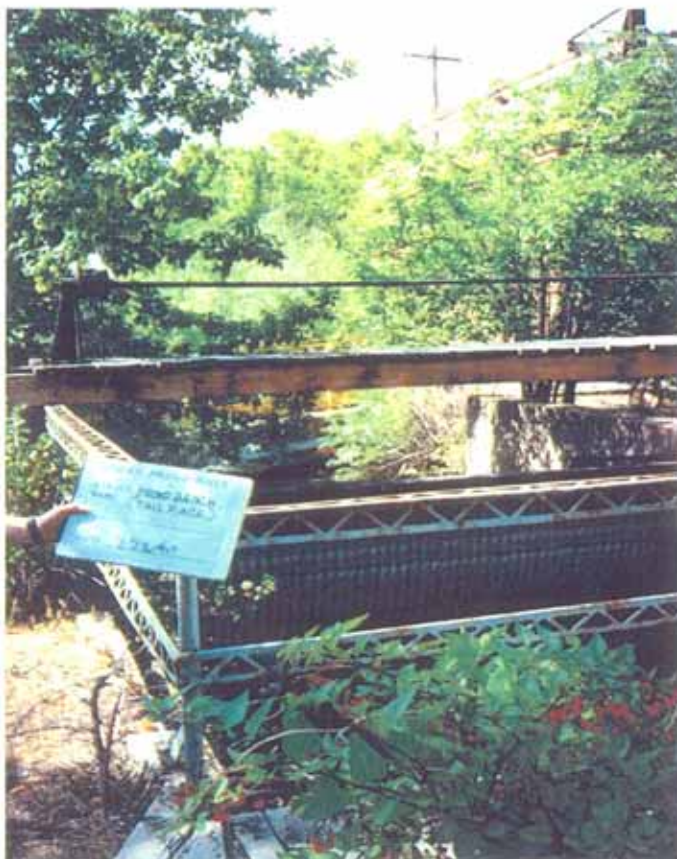
Photo 4-2. Provo Bench - diversion on tailrace: canal headworks.

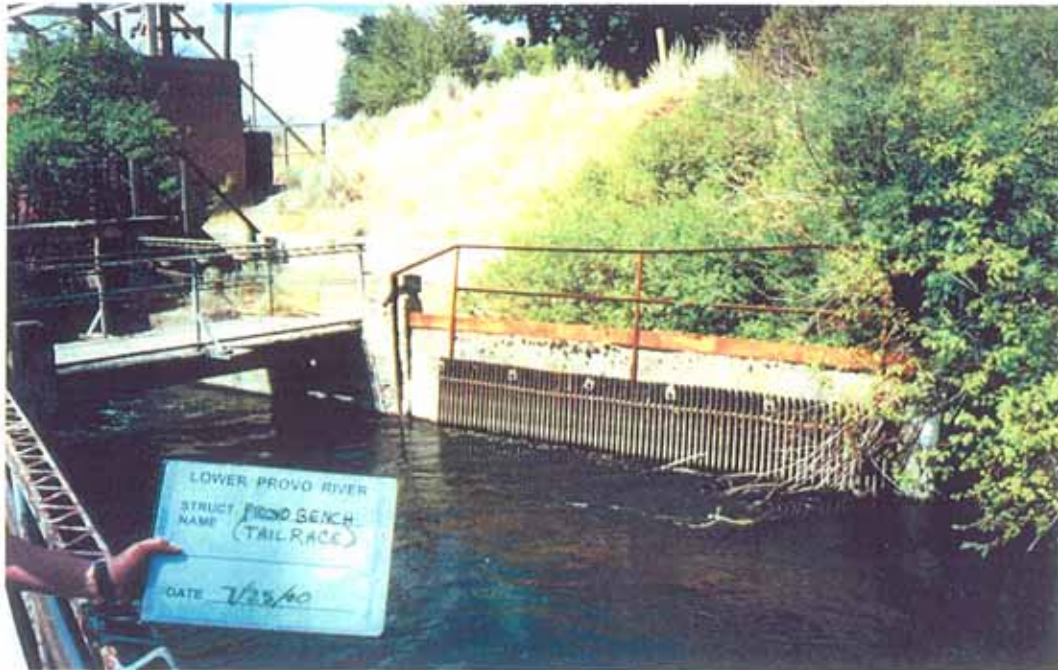
Photo 4-3. Provo Bench - diversion on tailrace: headworks to pumping station.

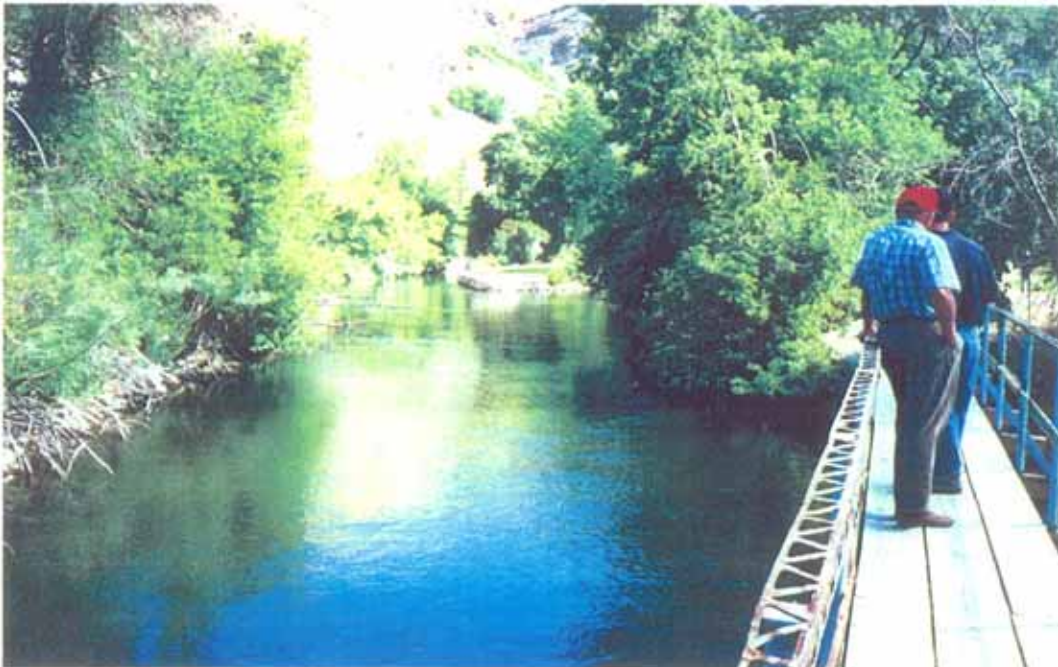
Photo 4-4. Provo Bench - diversion on tailrace: view of tailrace above structure.

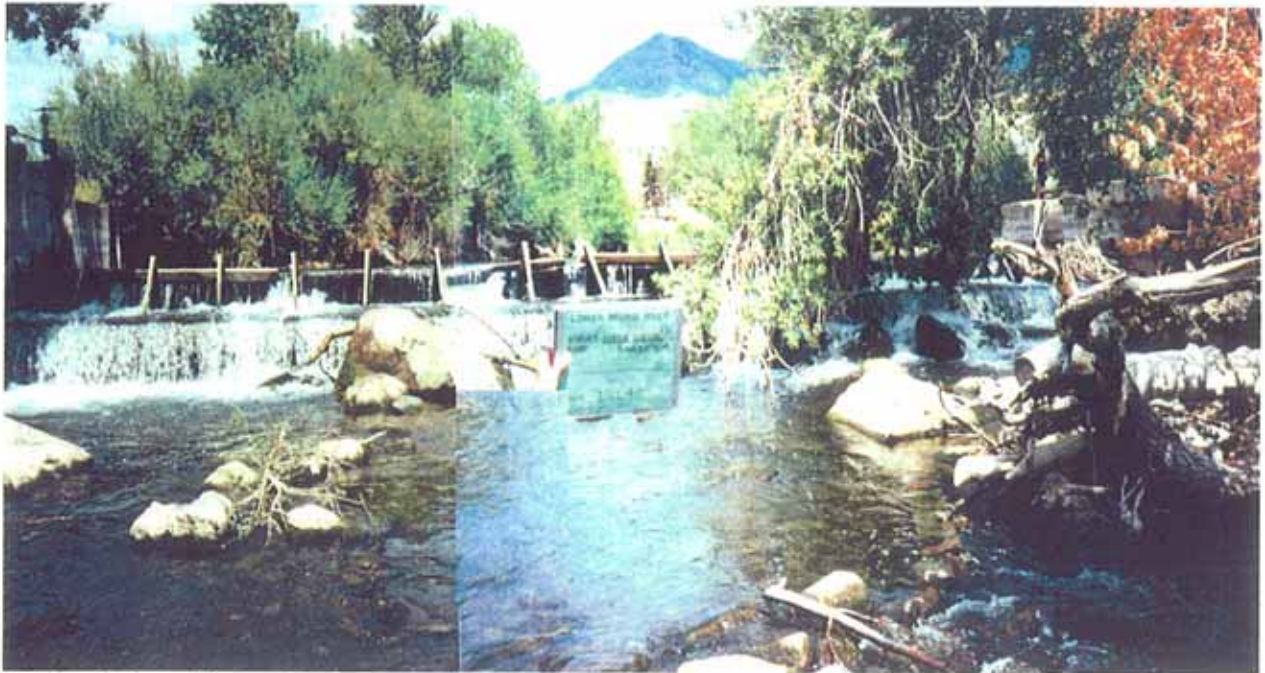
Photo 5-1. Upper Union Diversion: upstream view of structure.

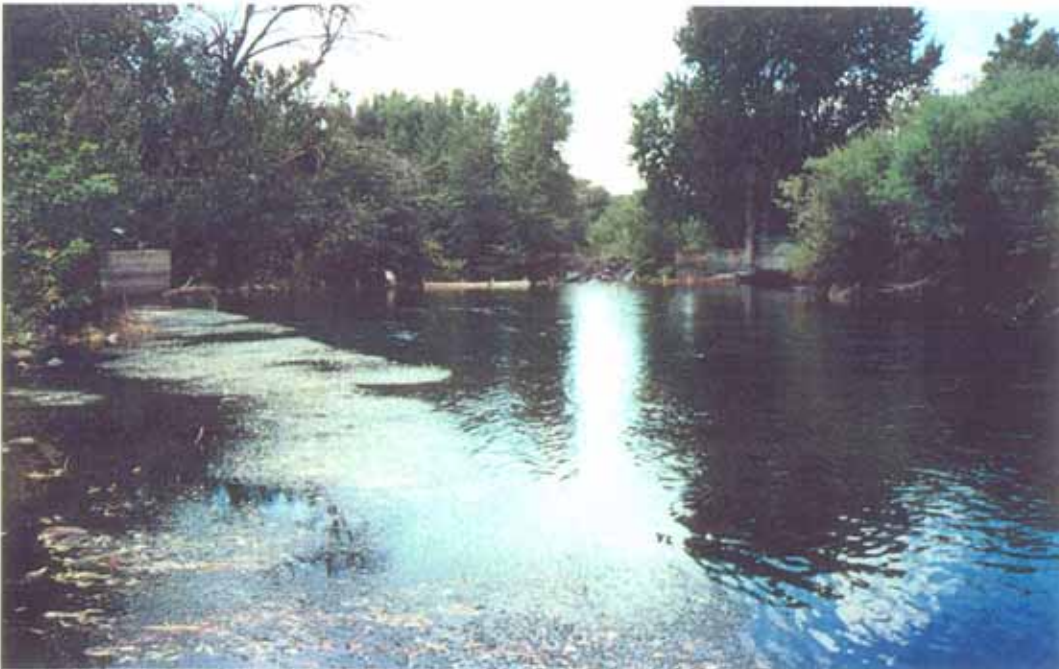
Photo 5-2. Upper Union Diversion: downstream view of structure.

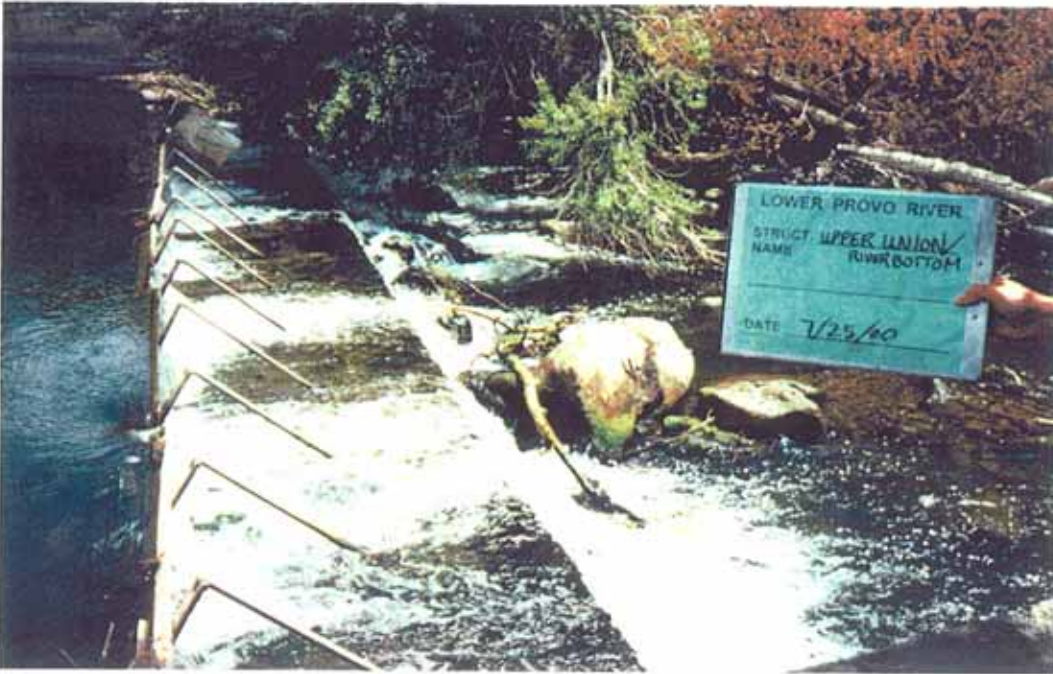
The existing Upper Union diversion structure is in fair condition and consists of a kick-leg dam installed with concrete sidewalls and a flat concrete sill. This concrete sill lies flush with the streambed above the dam, but below the dam considerable scour has occurred at the base of the sill (Photo 5-1). At the present time, this scour has not caused the structure to become unstable; however, the potential exists for further scour and undercutting to occur during high flow events. No flow bypass device is present. Three separate canal headgates are associated with this structure. A metal radial gate on the east (river left) side of the dam feeds the Upper East Union and East Riverbottom canals. A metal radial gate on the west (river right) side of the dam feeds the West Union canal. A third, smaller metal slide gate on the west (river right) side of the dam is the headworks to the Park Nuttal Canal/ Barton Young ditch. This canal system was discontinued in the 1970's and the headworks are now kept closed.

Photo 5-3. Upper Union Diversion: kick-leg dam structure.

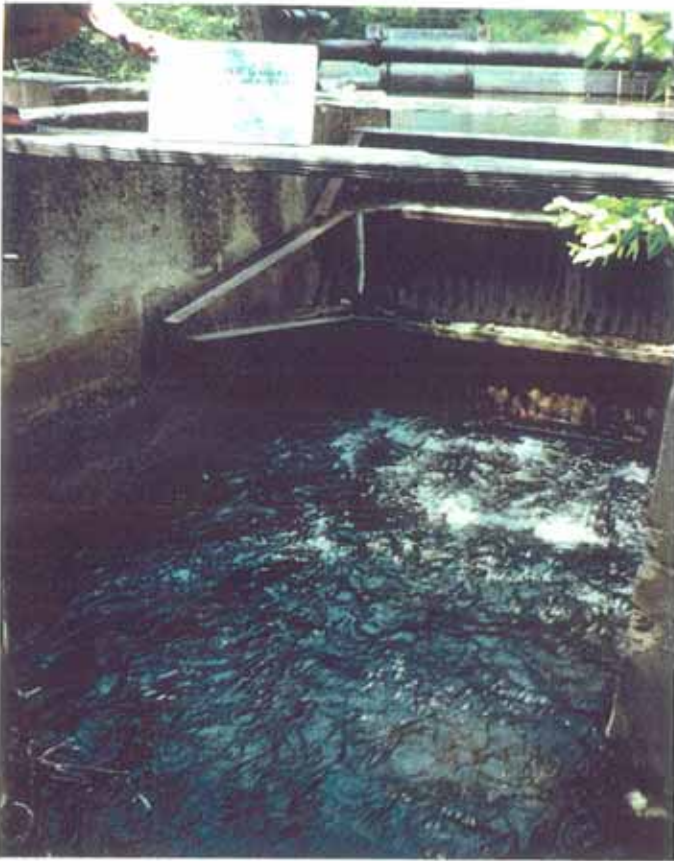
Photo 5-4. Upper Union Diversion: headworks to Upper East Union / East Riverbottom canals.

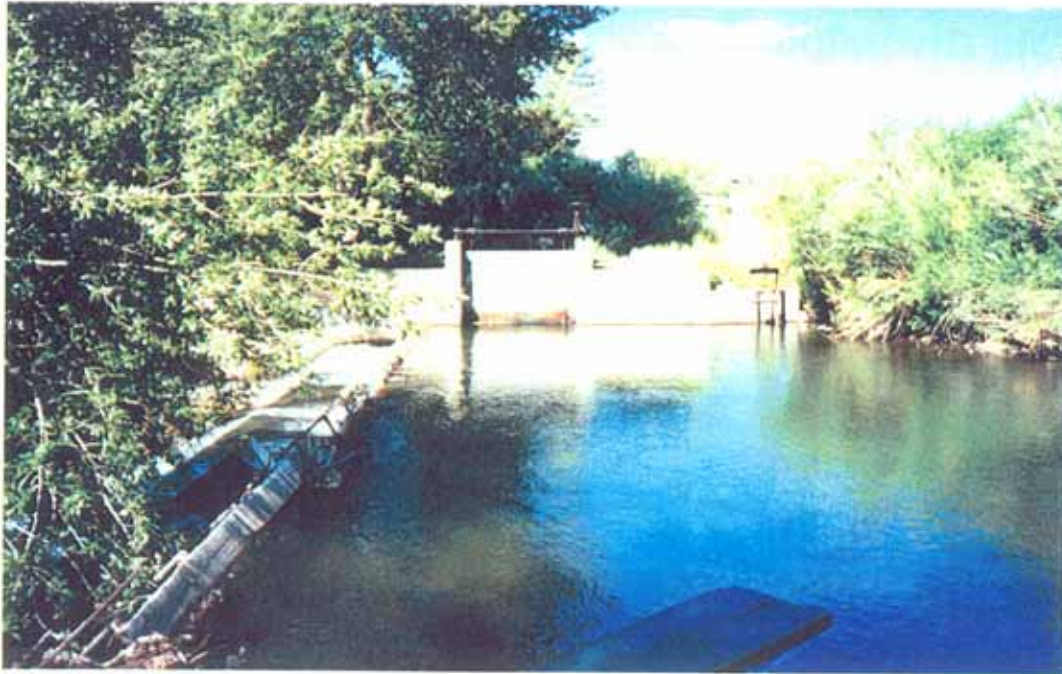
Photo 5-5. Upper Union Diversion: headworks to West Union Canal/West Smith Ditch (large headgate). Small headgate on right is no longer in use.

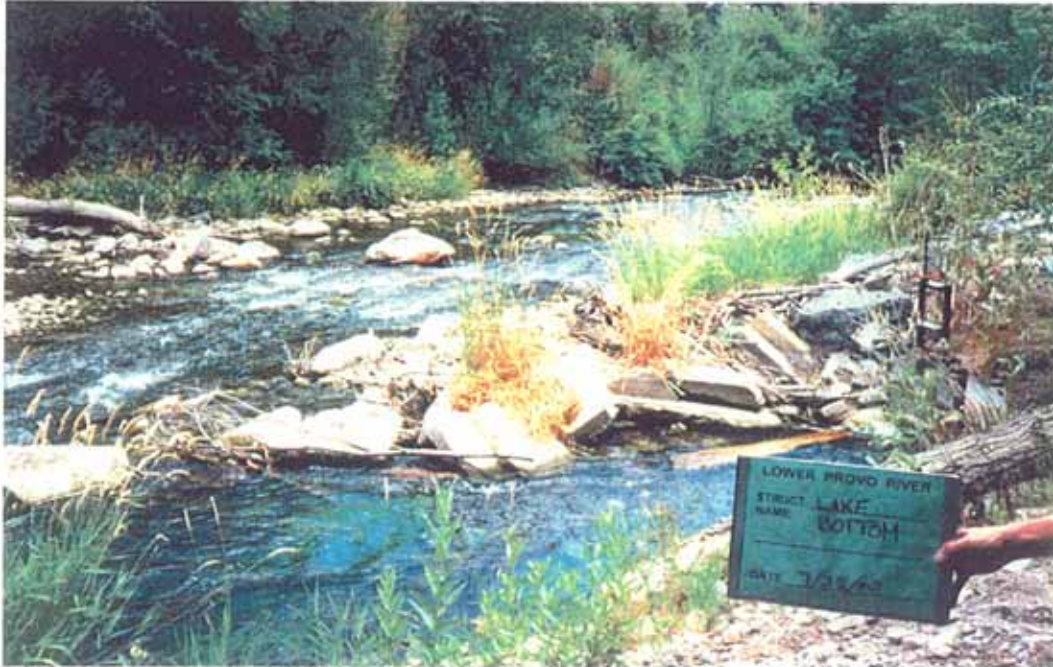
Photo 6-1. Lake Bottom Diversion: view of partial rock/rubble dam.

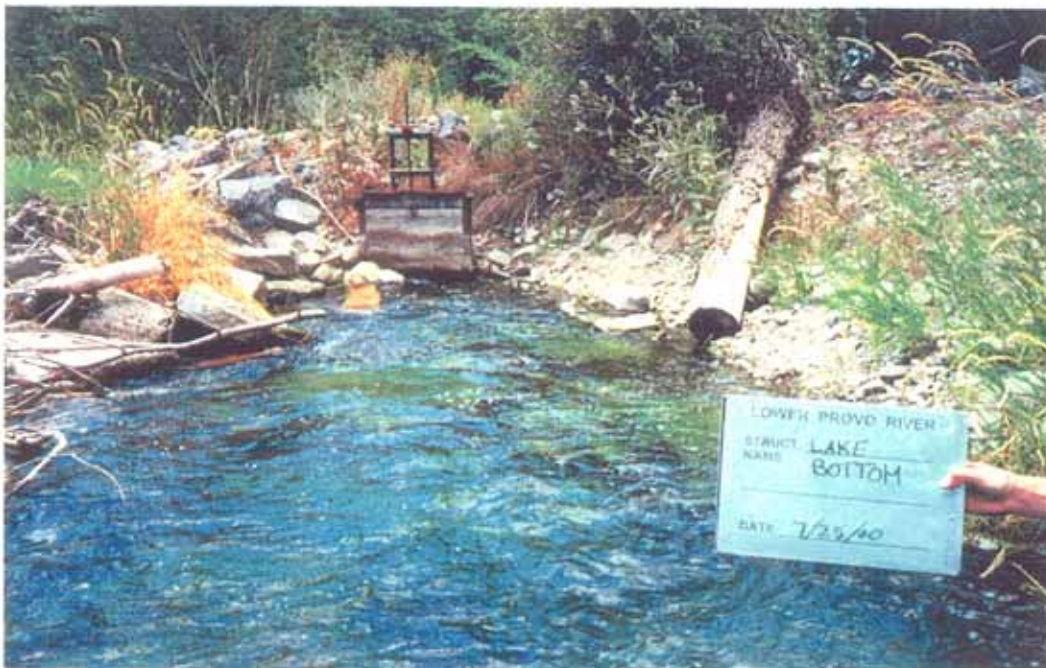
Photo 6-2. Lake Bottom Diversion: canal headworks.

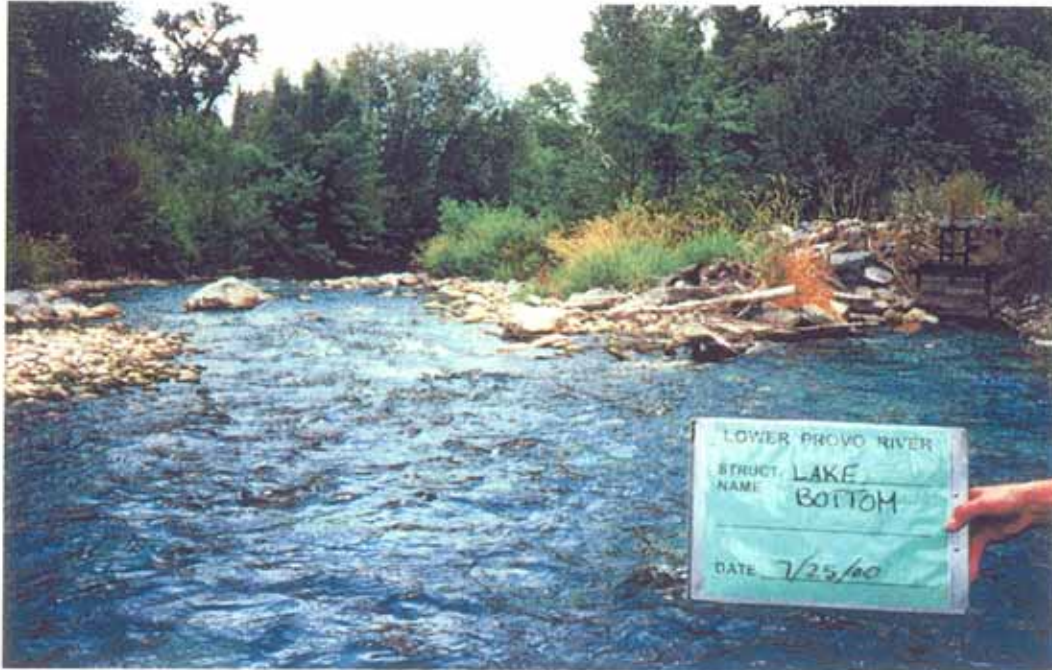
Photo 6-3. Lake Bottom Diversion: view of channel downstream from structure.

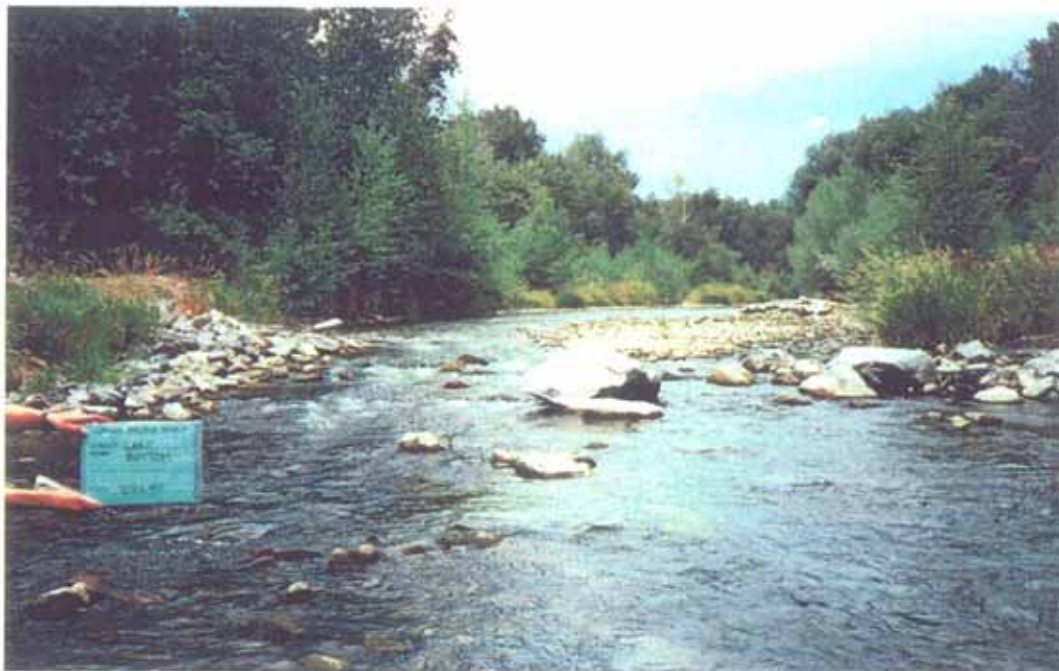
Photo 6-4. Lake Bottom Diversion: view of channel upstream from structure.

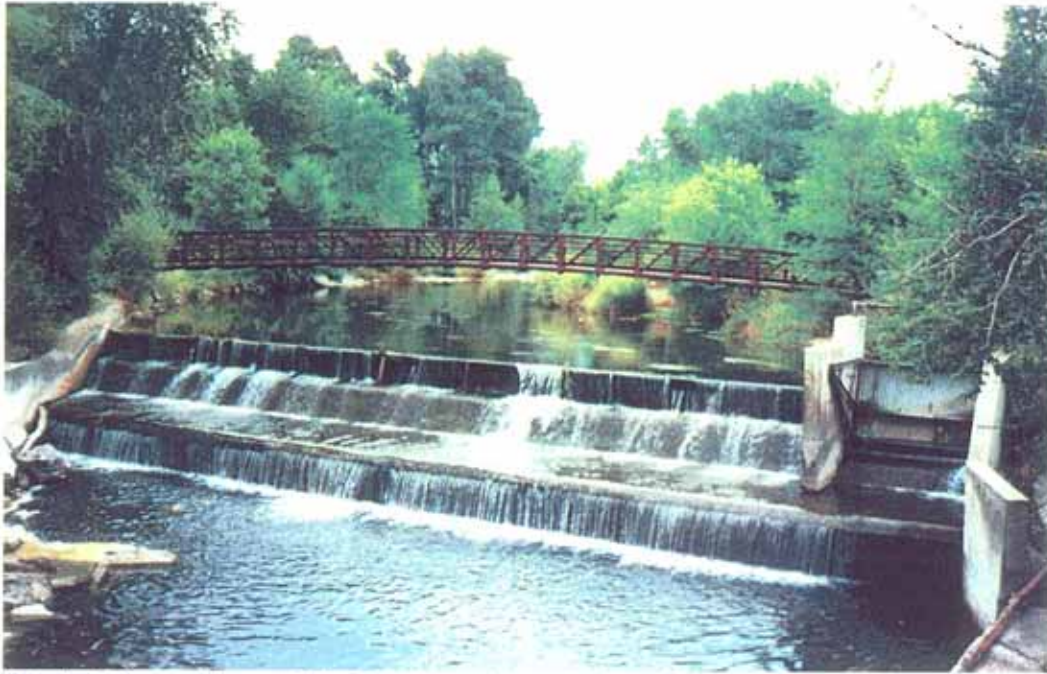
Photo 7-1. Upper City Dam: upstream view of structure.
