PROVO RIVER DIVERSION DAMS EVALUATION

Final Draft Report

Utah Reclamation Mitigation and Conservation Commission

October 2001

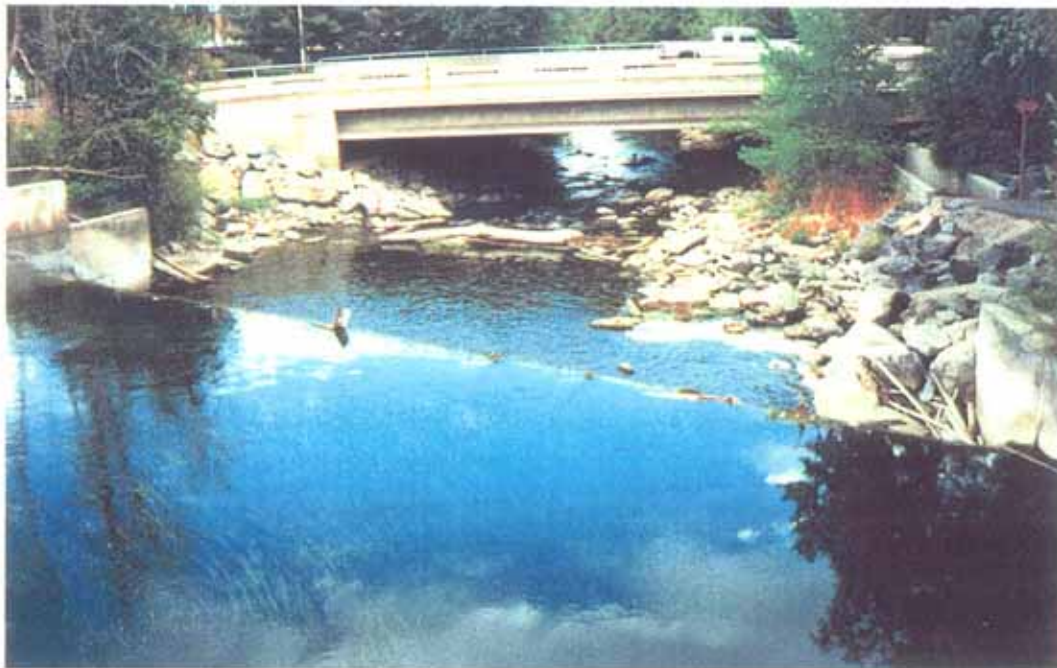
Photo 7-2. Upper City Dam: downstream view of structure.

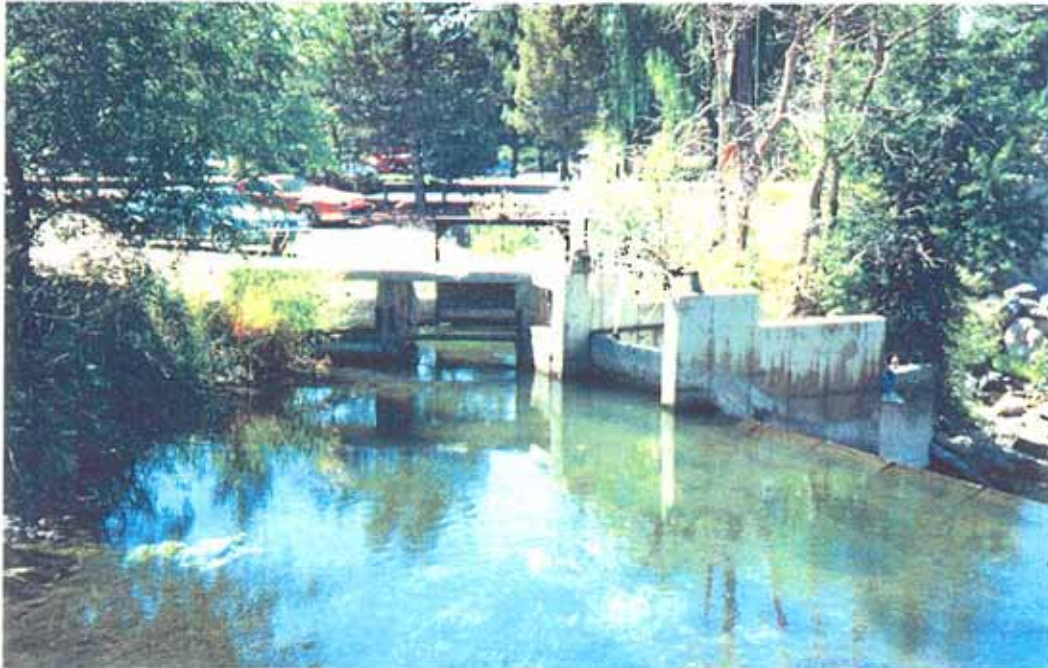
Photo 7-3. Upper City Dam: headworks to Lower East Union/Factory Race canals.

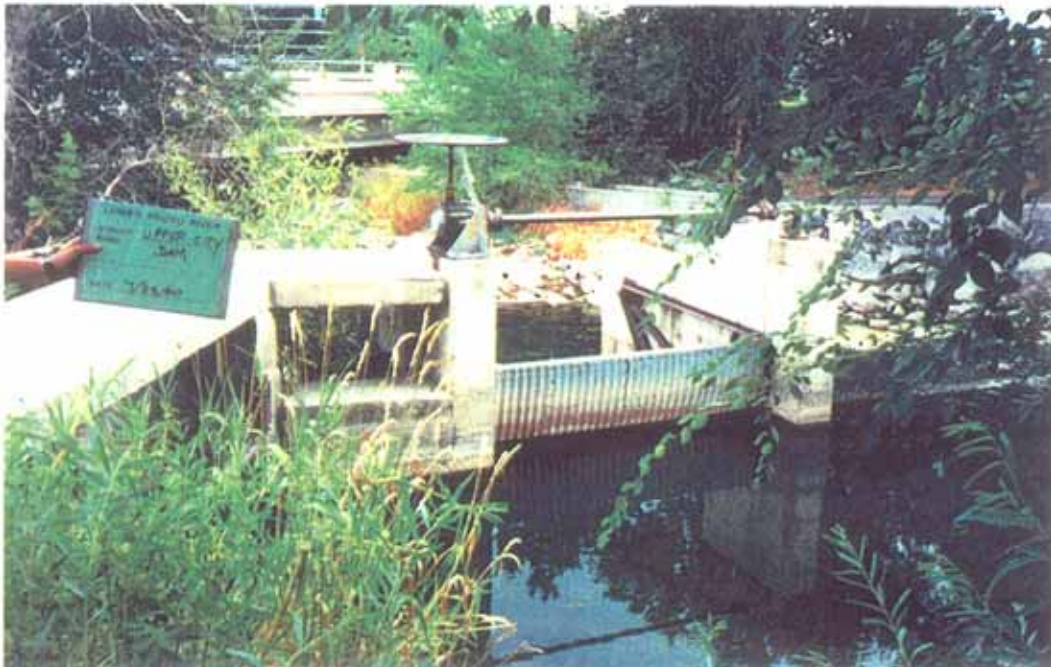
Photo 7-4. Upper City Dam: radial gated sluiceway.

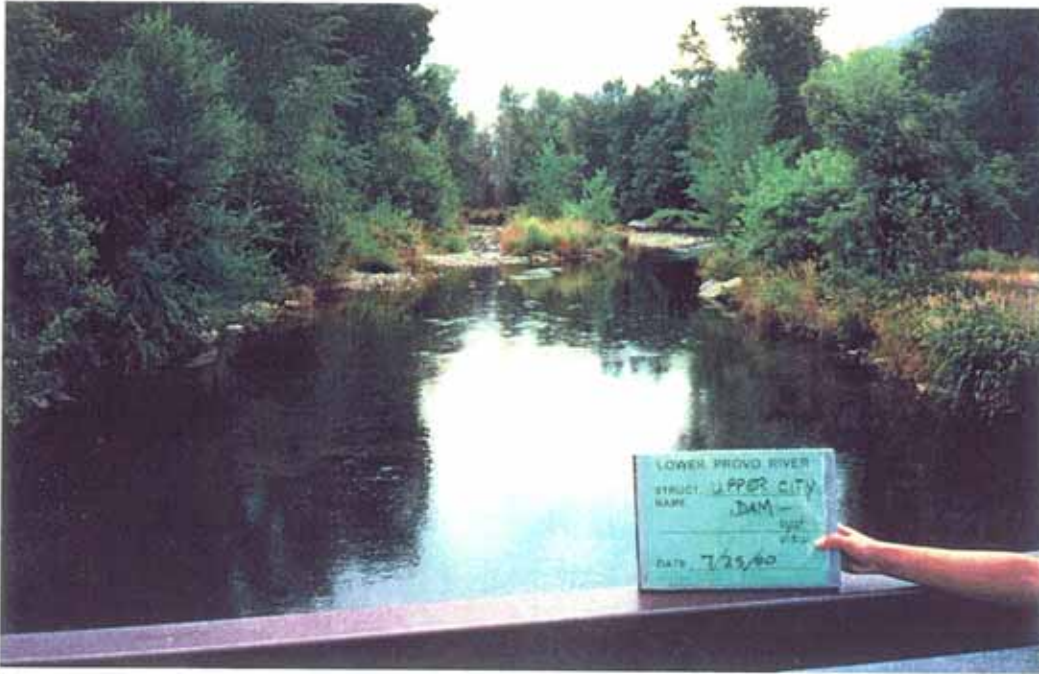
Photo 7-5. Upper City Dam: view of channel upstream from structure.

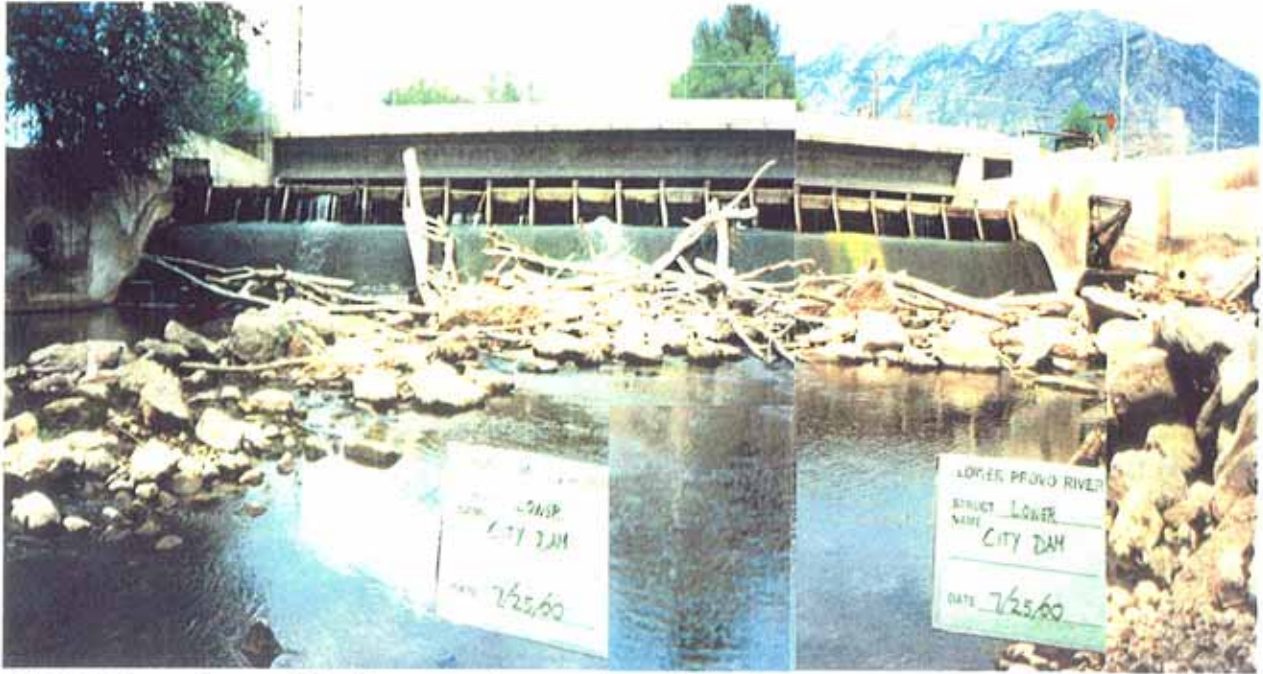
Photo 8-1. Lower City Dam: upstream view of structure.

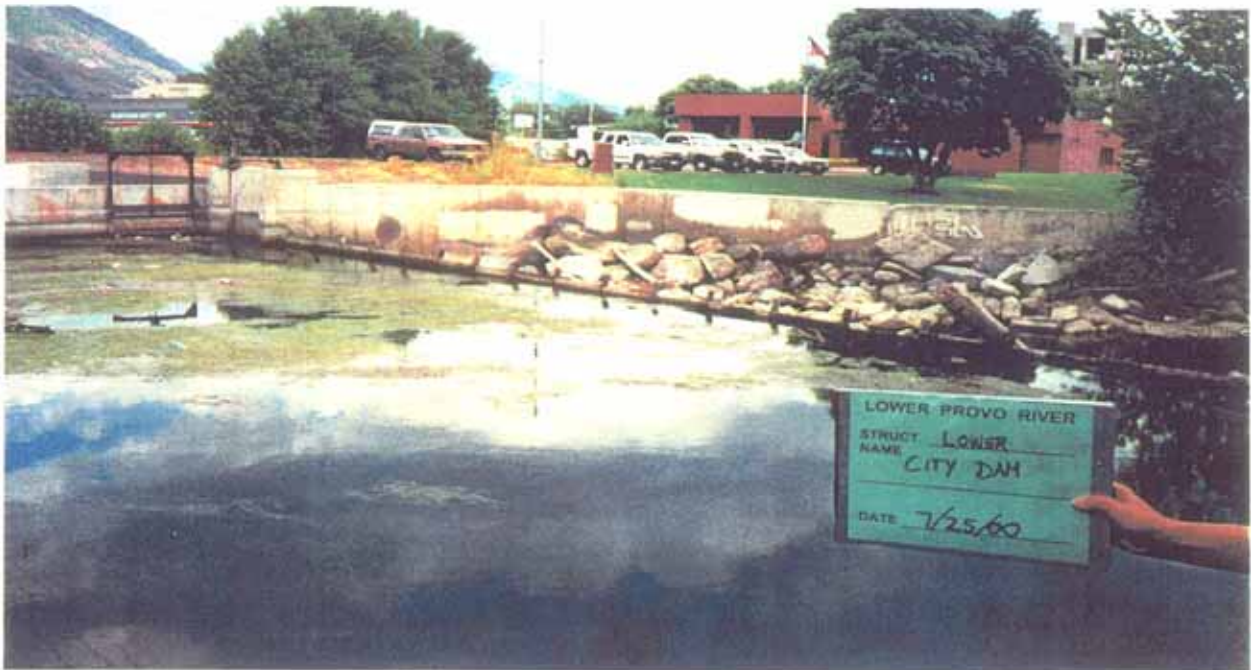
Photo 8-2. Lower City Dam: downstream view of structure.

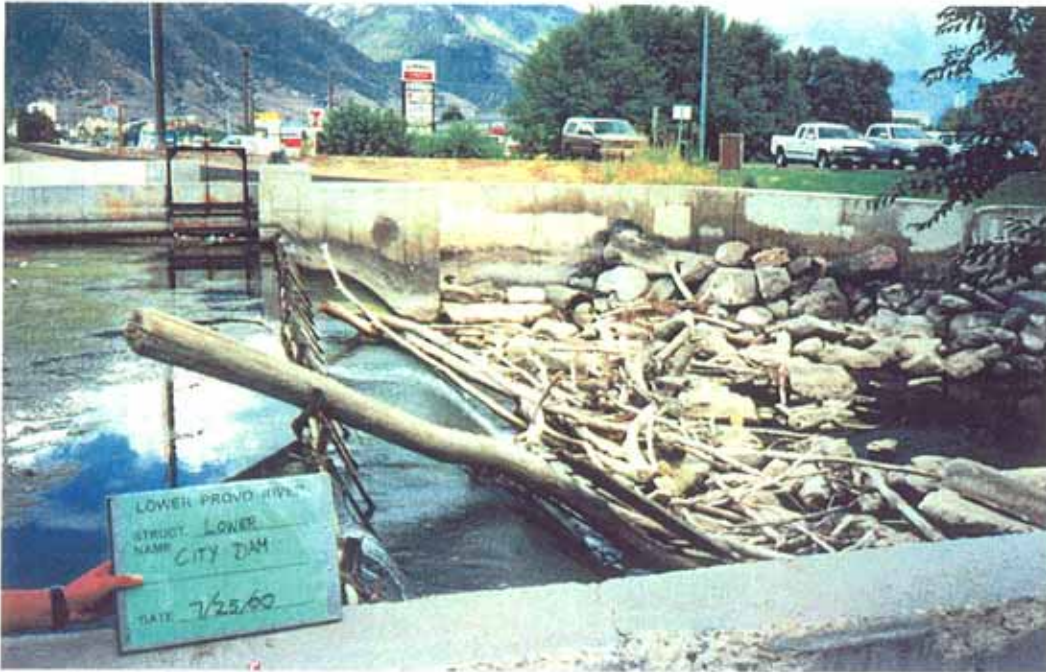
Photo 8-3. Lower City Dam: view of kick-leg structure and canal headworks.

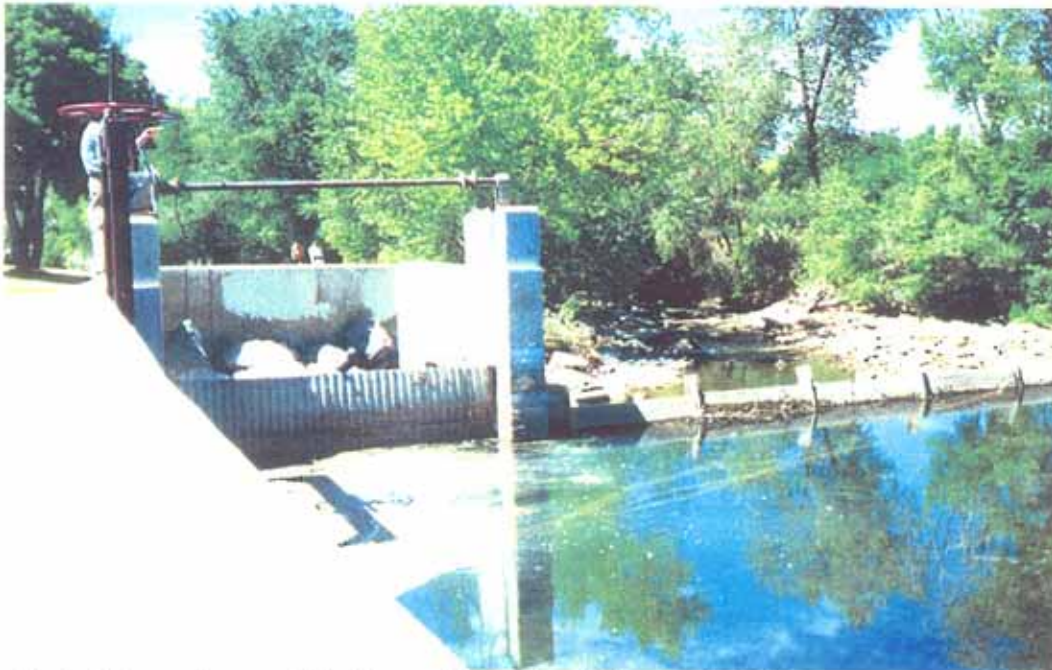
Photo 8-4. Lower City Dam: view of radial-gated sluiceway.

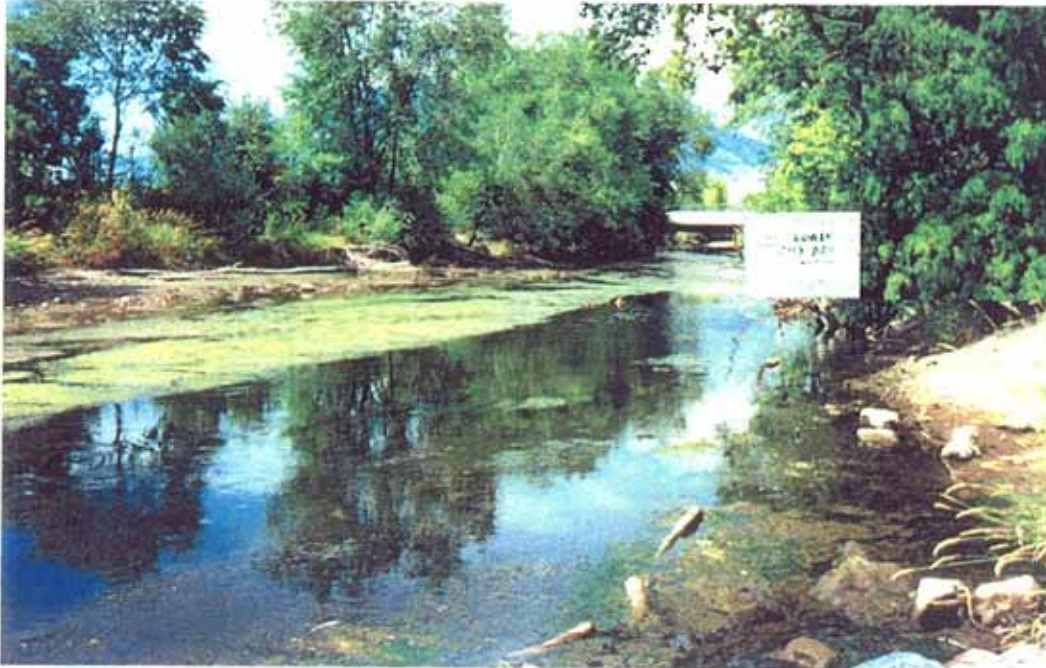
Photo 8-5. Lower City Dam: view of channel upstream from structure.

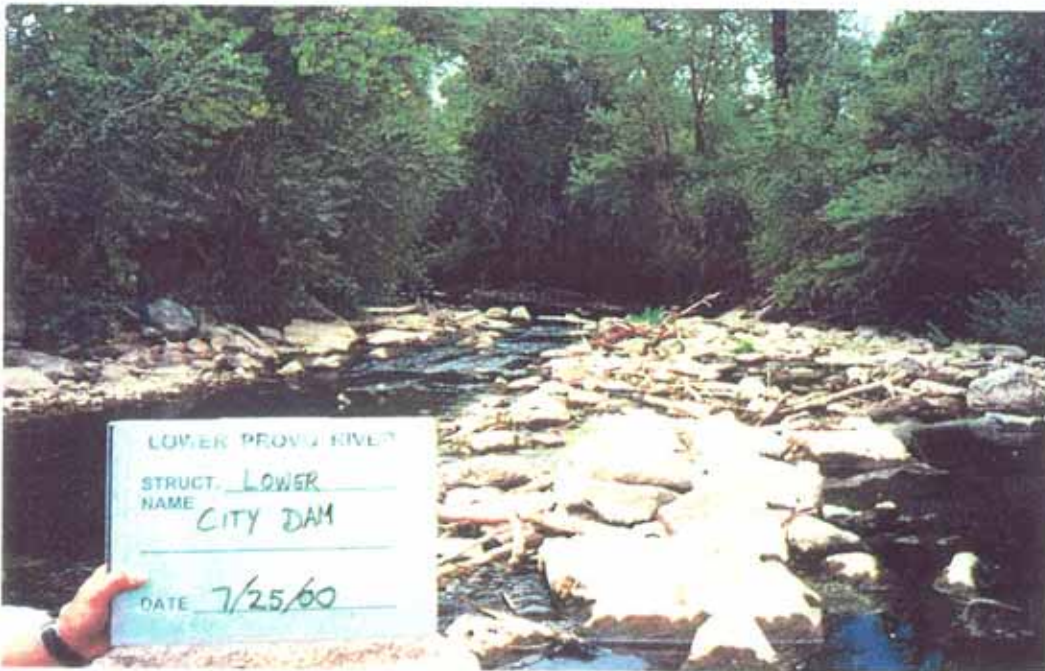
Photo 8-6. Lower City Dam: view of channel downstream from structure.

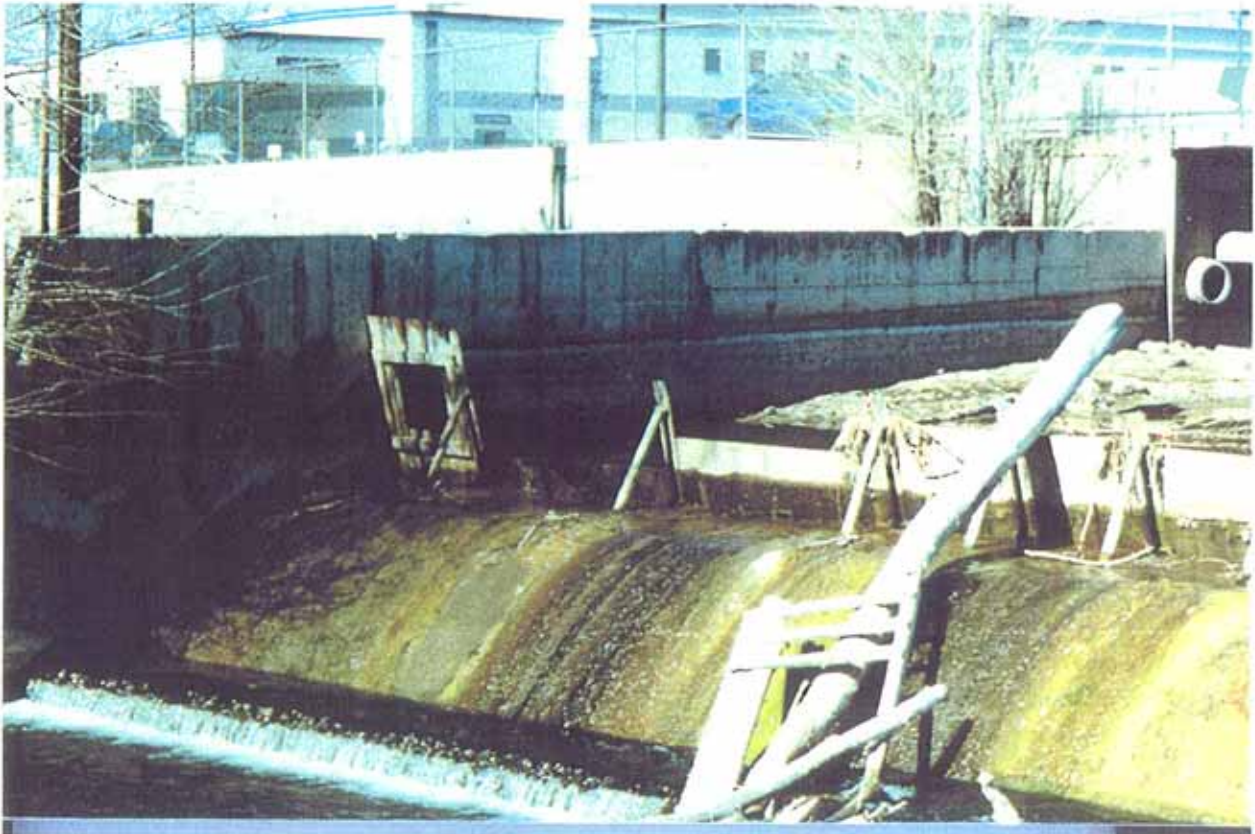
Photo 8-7. Upstream view of Lower City Dam. At the left side of the photo, note the 3-foot-wide metal slot designed to pass 25 cfs.

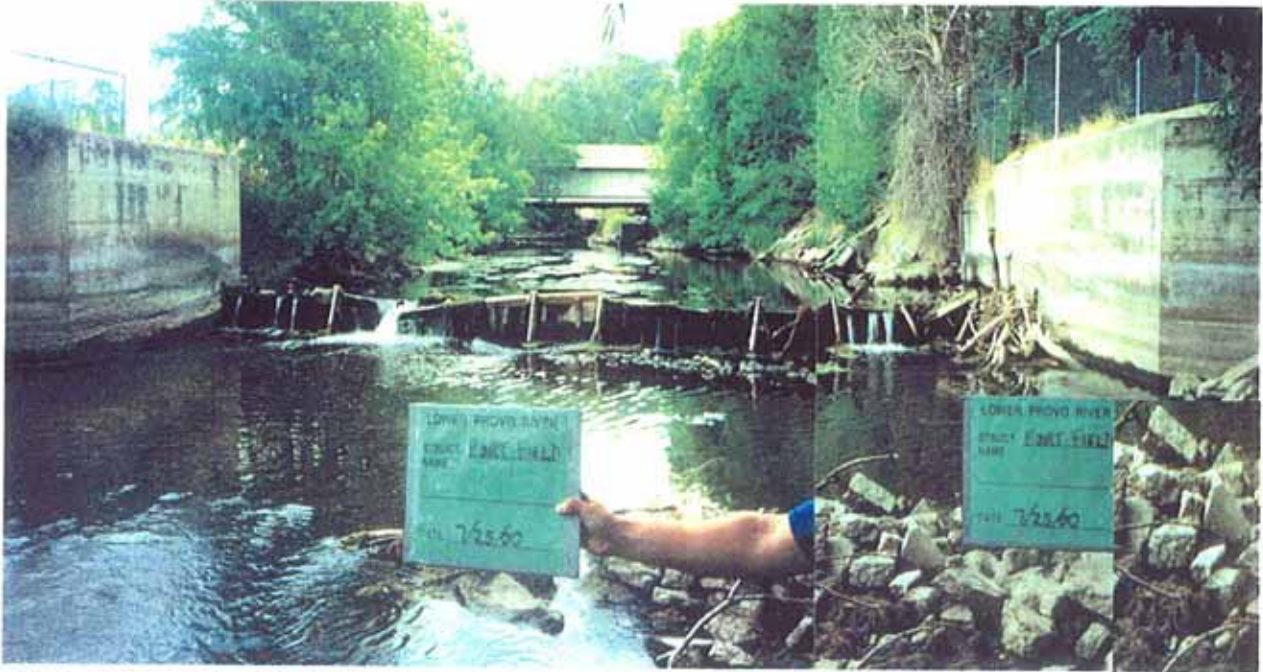
Photo 9-1. Fort Field Diversion: upstream view of structure.

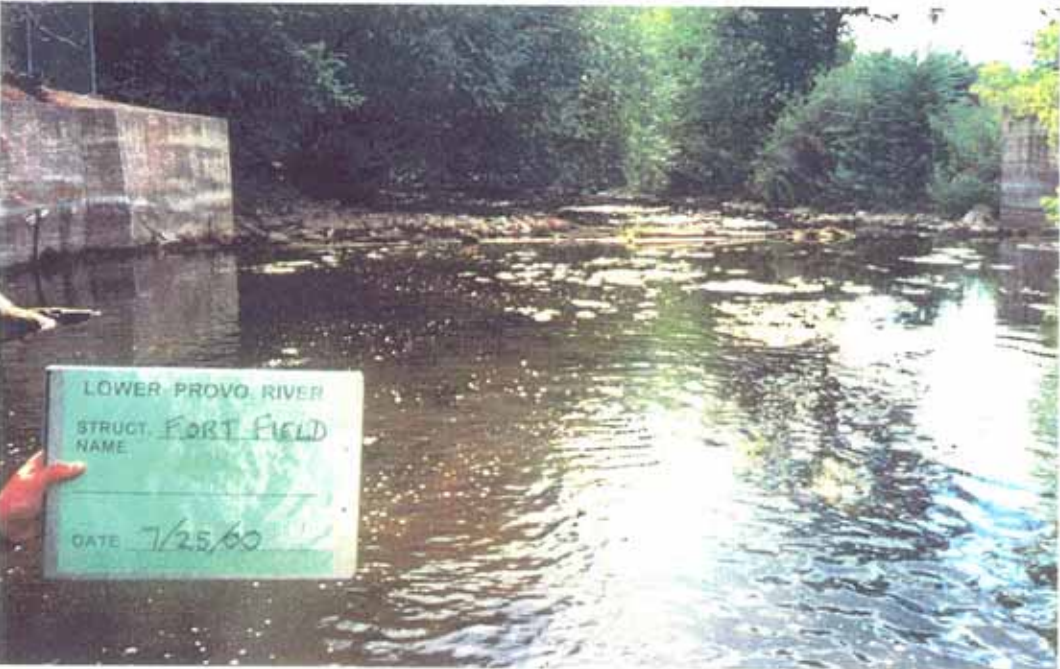
Photo 9-2. Fort Field Diversion: downstream view of structure.

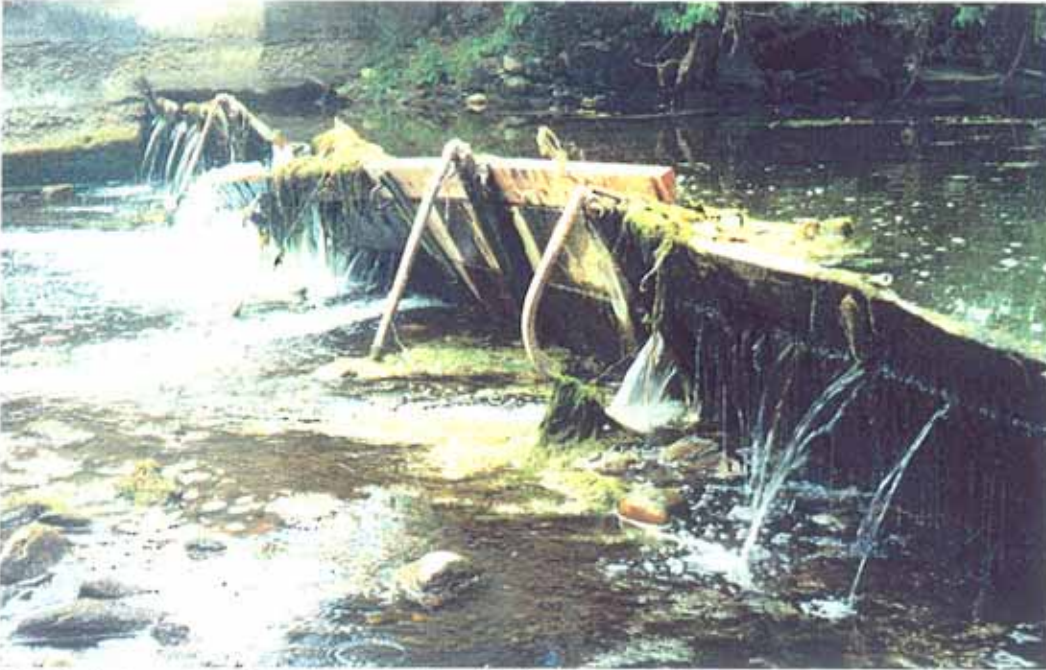
Photo 9-3. Fort Field Diversion: kick-leg structure.

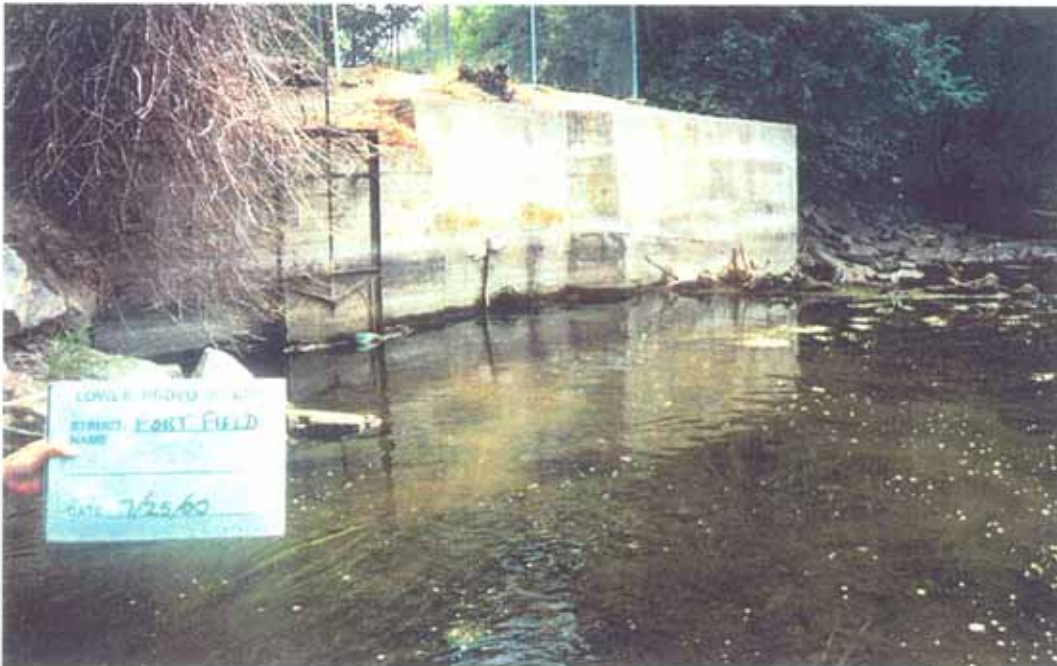
Photo 9-4. Fort Field Diversion: canal headworks.
