**Collision With Trees on Final Approach  
Federal Express Flight 1478  
Boeing 727-232, N497FE  
Tallahassee, Florida  
July 26, 2002**

**NTSB/AAR-04/02**

**NTSB/AAR-04/02  
PB2004-910402  
Notation 7501B  
Adopted June 8, 2004**

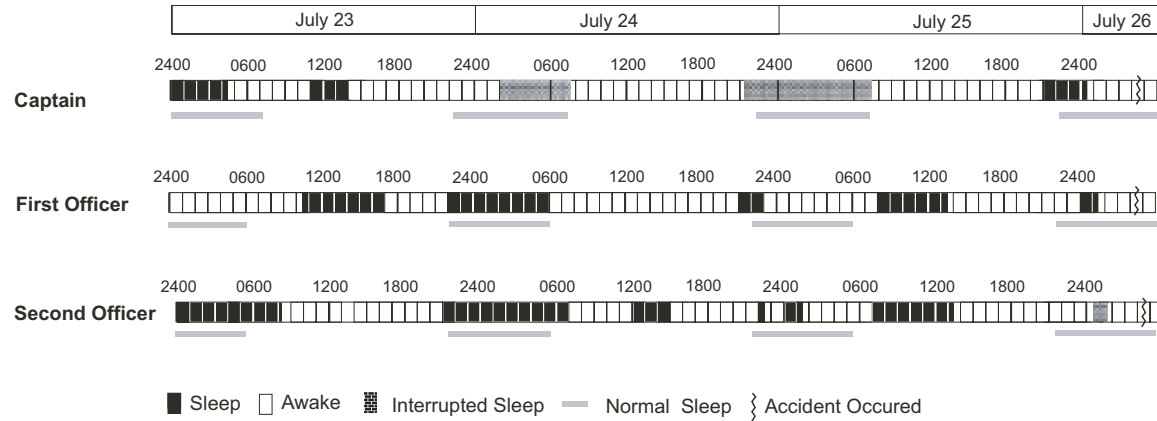
**Figure 4.** The three crewmembers' estimated sleep schedule during the 72 hours before the accident.

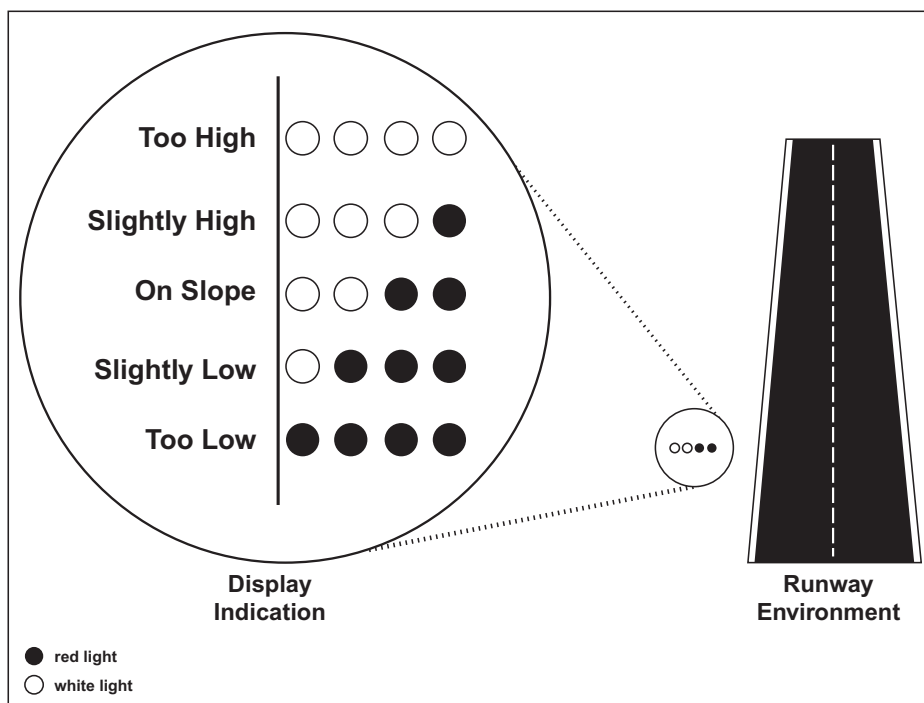
**Figure 6.** PAPI indications from various approach path angles.
