STATE FIRE MARSHAL'S OFFICE

Firefighter Fatality Investigation

Investigation Number 05-218-02

Captain Grady Burke

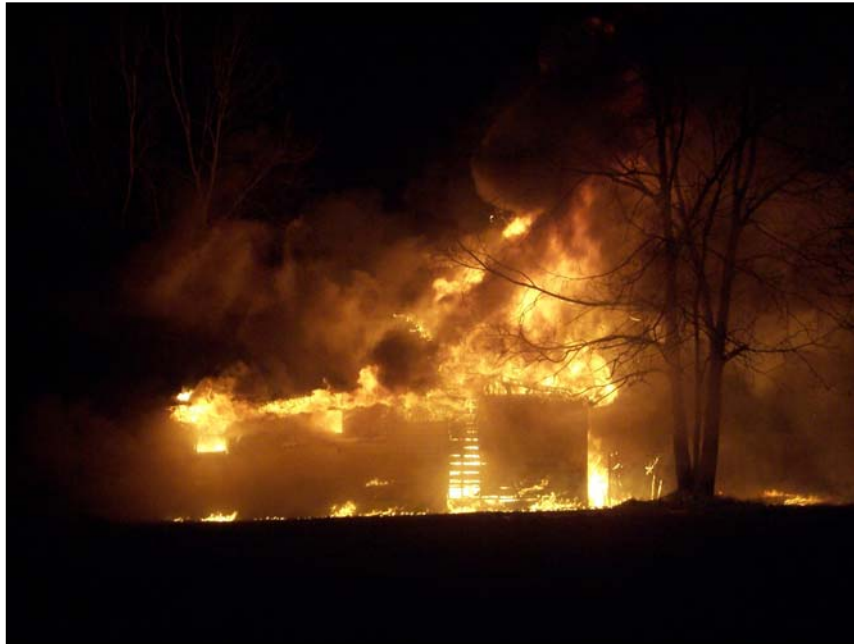
**North side of 8510 Brandon shortly after firefighters entered.
(Houston Fire Department Photo)**

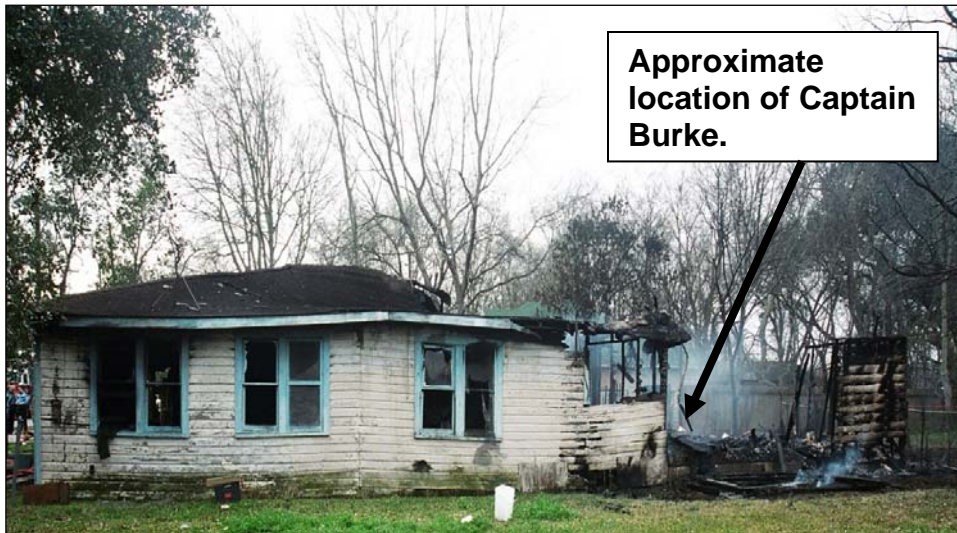
North side of 8510 Brandon (post-fire) (Houston Fire Department Photo)

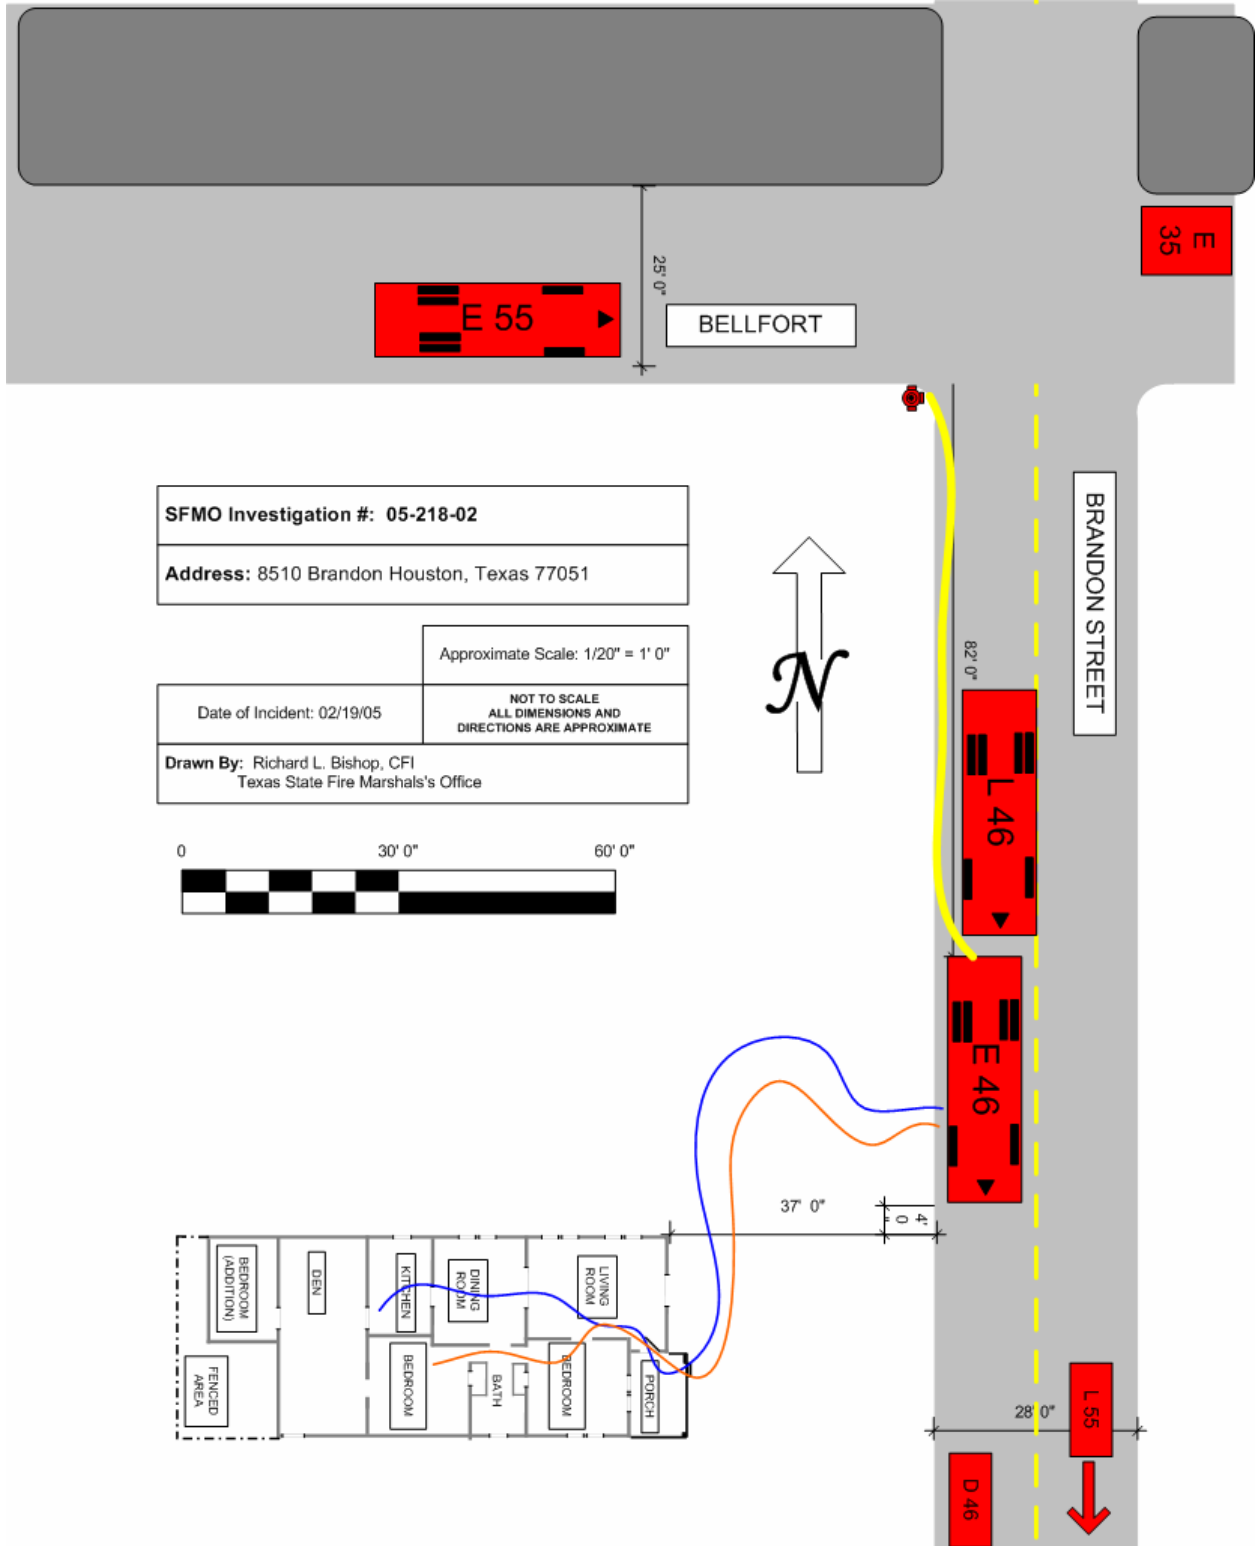
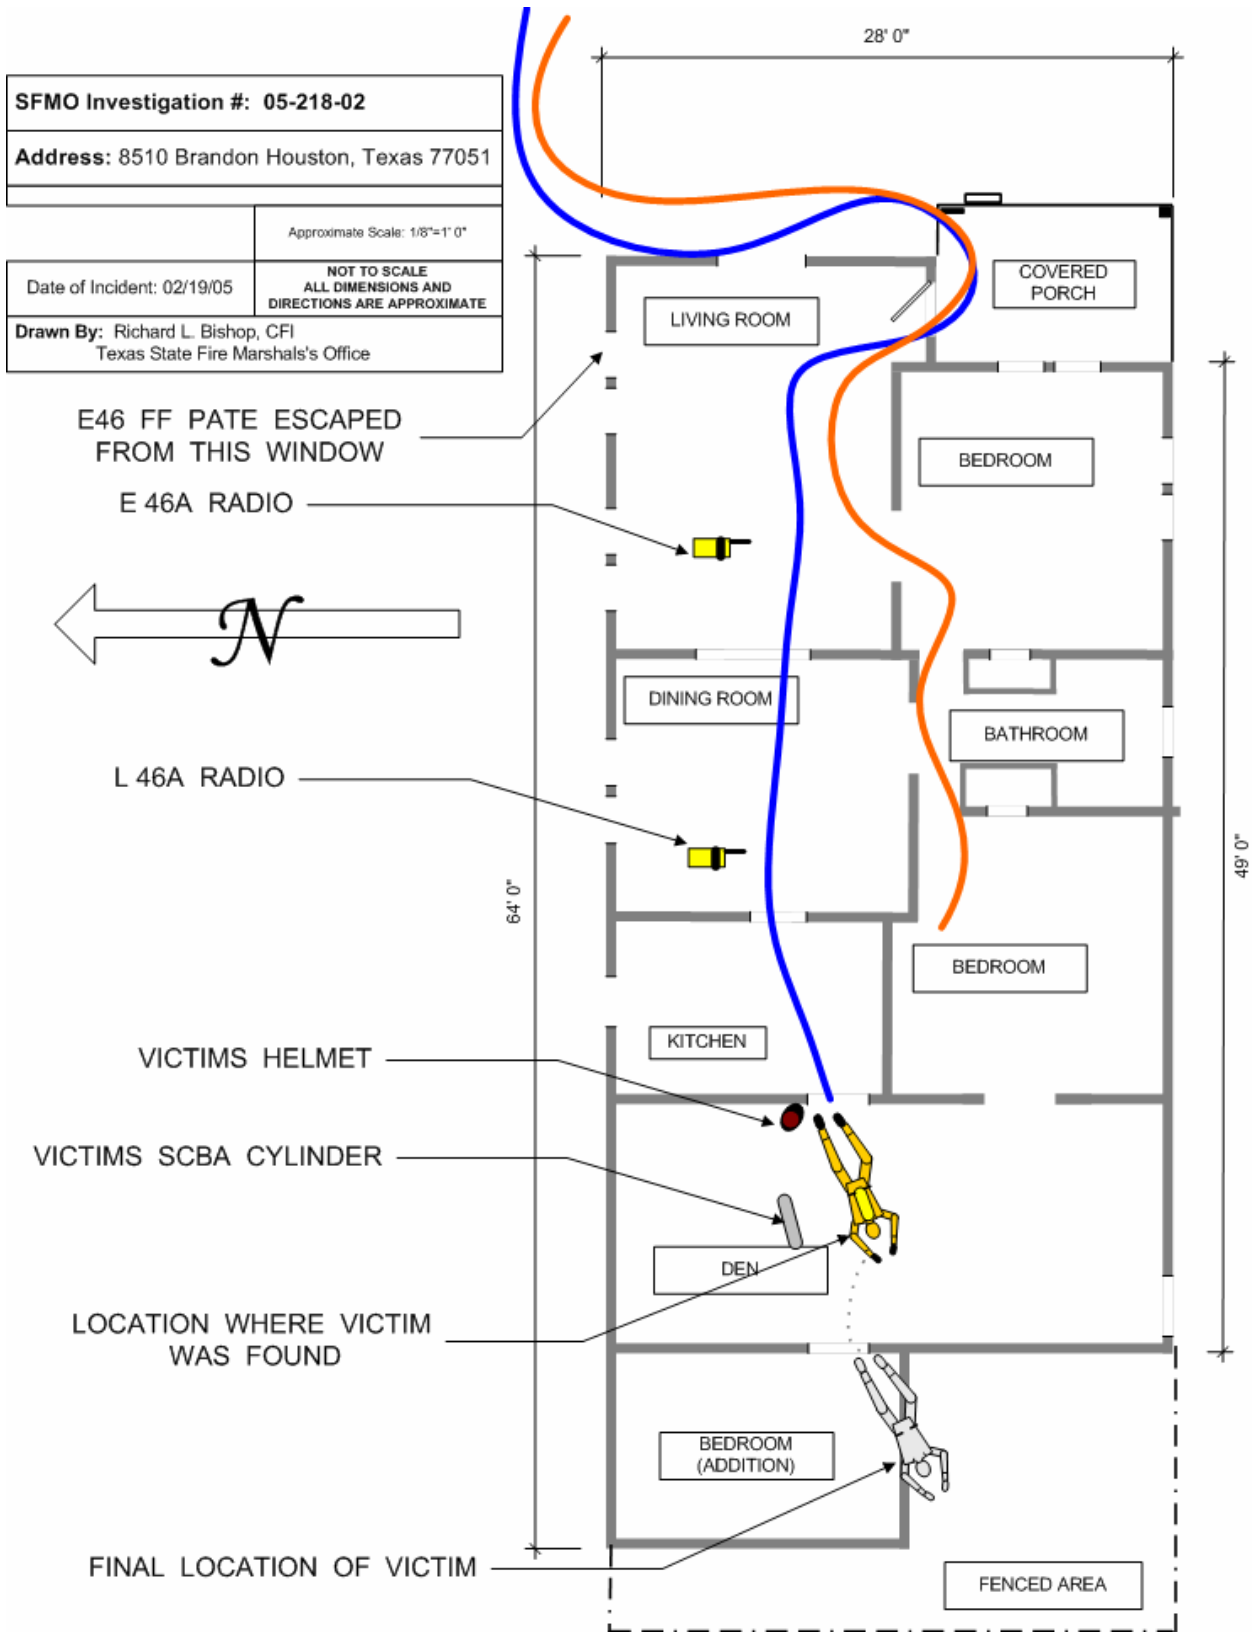
Captain Burke was found lying prone near the passageway from the kitchen area to the den area. Most of his protective equipment had burned away. Firefighters who found him attempted to remove him from the building but were stopped near the rear porch area when it became obvious that Captain Burke was deceased. (See diagrams at end of report)
