# STATE FIRE MARSHAL'S OFFICE

## Line of Duty Death Investigation

**Investigation Number 02-251-02**

**Fire-Rescue Officer Vincent Davis**

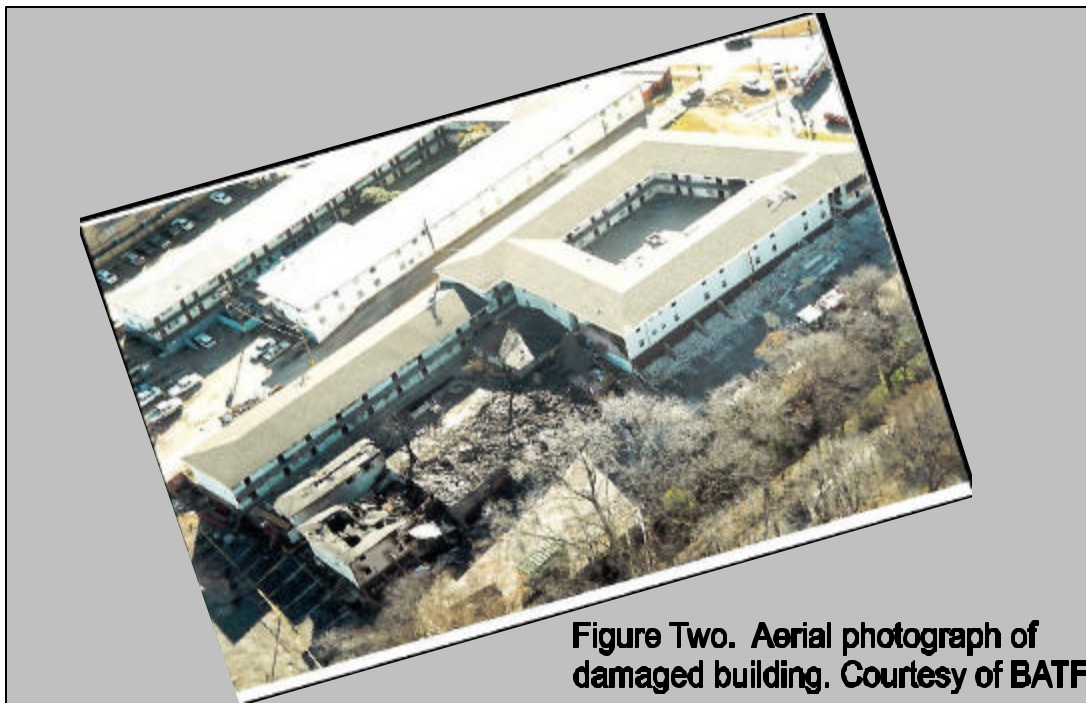
**Figure Two. Aerial photograph of  
damaged building. Courtesy of BATF**

Section 2, north of the breezeway had totally collapsed. A portion of Section 1, north of the grade change, was standing but was heavily damaged. **(Figure Two)** Sections 8 and 9, located north and south of the open courtyard/play area sustained extensive damage from radiant heat.

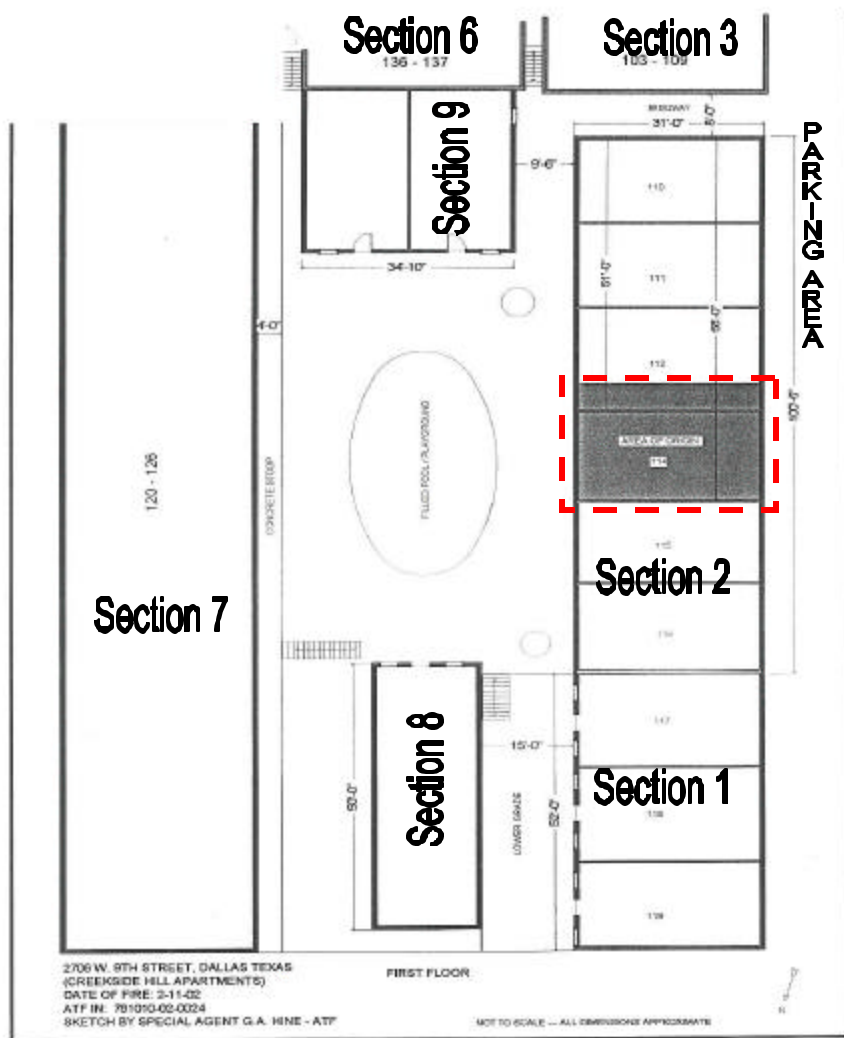
**Figure Three. Building Floor Plan**  
**Courtesy of BATF.**  
**Notations by SFMO.**

Investigators determined the fire originated in the area of apartment 114 in section 2 of building 2. **(Figure Three)** This building was undergoing extensive renovation. Cutting of metal guard rails with cutting torches and pipe soldering operations using open flame torches had been conducted in the building in the areas of apartments 114 and 214 on the afternoon of the day of the fire.

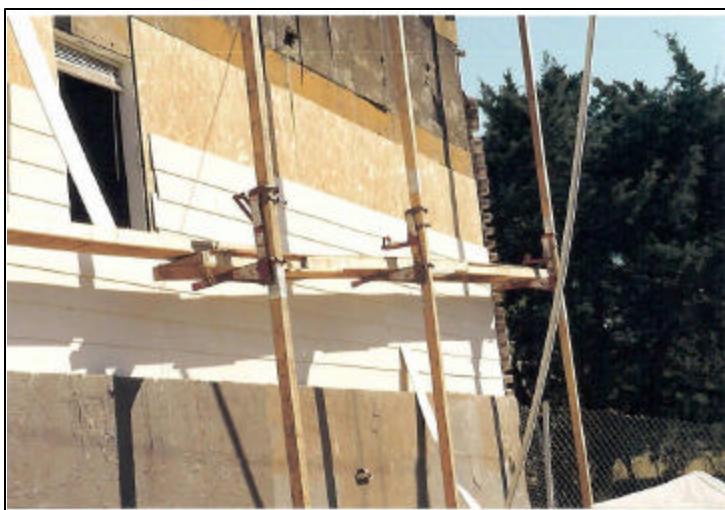
As part of the renovation project, all brick had been stripped from the west side of Section 3 and had been replaced by composition siding. **(Figure Eight)** This eliminated the tie-in between the double wythe brick veneer wall on the north end of Section 3 and the double wythe brick veneer on the west side of Section 3 that provided some structural stability. This created a freestanding double wythe wall over 15 feet tall that was separated from the structural members of Section 3 by a void of several inches.

**Figure Eight. Southeast end of Section 3 showing brick removal. Photo by BATF.**

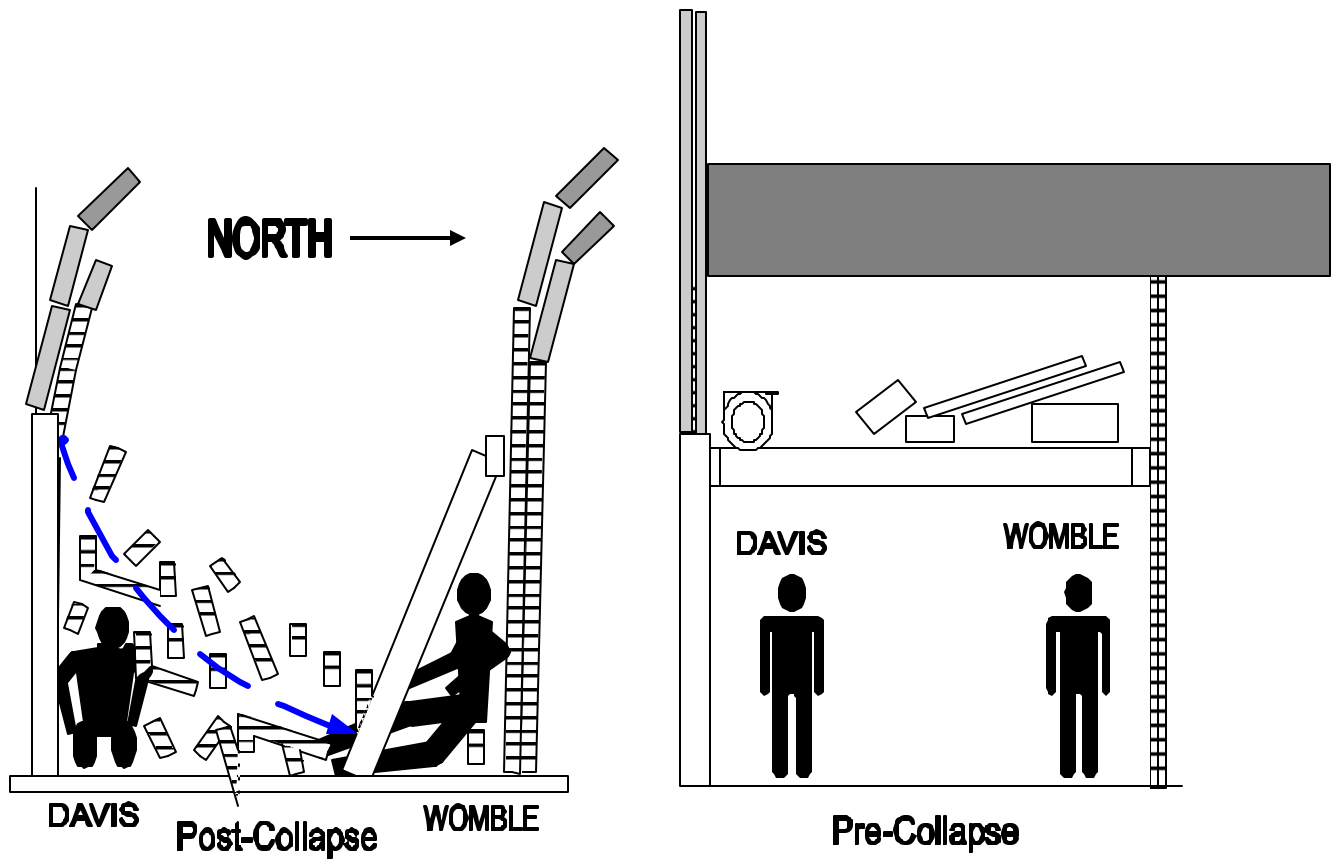
The falling bricks impacted upon the breezeway roof, shearing the ribbon board from the west end of the south wall causing a lean-to type collapse as the breezeway roof, still firmly attached on the north side, rotated downward. **(Figure Nine)** The falling breezeway roof impacted upon E 33's Vincent Davis' head and shoulders, driving him to a sitting position. Bricks continued to fall, completely covering Davis with bricks and wood. The falling breezeway roof knocked down E33's Chuck Womble and pinned his leg. Womble was located in the void space of the lean-to collapse and was shielded from most of the bricks. **(Figures Ten/Eleven)** E33 Captain Creager was grazed by the falling bricks and knocked down the breezeway steps, and onto his knees in the west parking area.

Figure Nine. Graphic depicting wall and breezeway roof collapse.

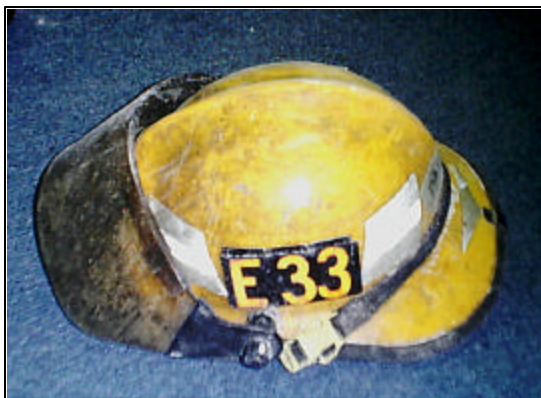
Davis' helmet was scratched and dirty, and when examined, was found with the chinstrap in the stowed position, wrapped around the back of the helmet. **(Figure 14)** Although not a factor in this incident, failure to wear the chinstrap may lead to loss of the helmet during firefighting operations, exposing the user to injury. There was no significant damage observed to the external shell or internal shock-absorbing cap assembly.

**Figure 14. Fire helmet with stowed chin strap.**

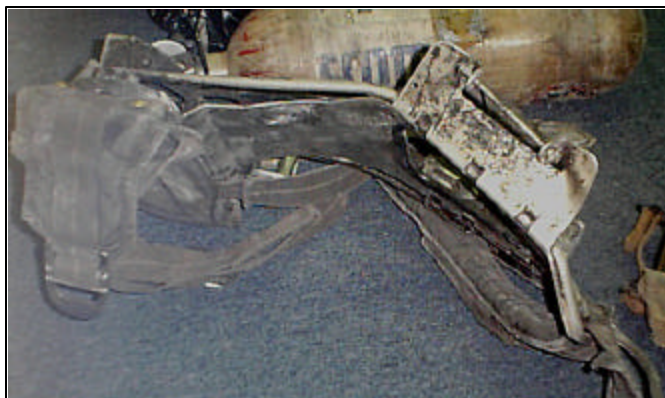
The SCBA backpack assembly was severely bent, probably by impact with falling bricks and structural members. **(Figure 15)** Firefighters that found Davis noted he was in a sitting position with outstretched legs and was bent over under the weight of the debris.

**Figure 15. Bent SCBA backpack assembly.**
