# STATE FIRE MARSHAL'S OFFICE

## Firefighter Fatality Investigation

**Investigation Number 05-127-12**

**Firefighter Nito R. Guajardo**

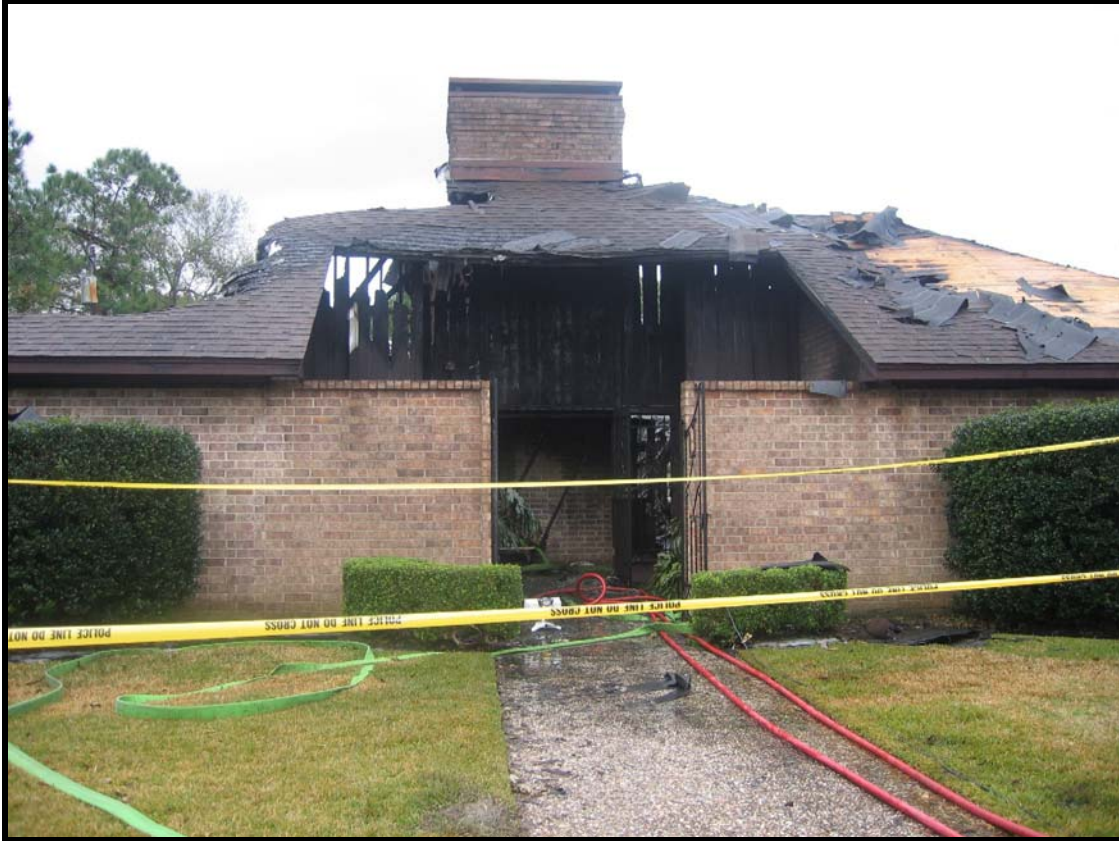
**North (main entrance) side of the building**

Command initially assigned EL1 to conduct a fast attack. Command observed the crew from EL1 having difficulty entering the building front entrance due to burglar bars and heavy doors. Command then ordered E2 to assist EL1 in forcing the doors and to bring forcible entry tools to the front.

***Recommendation:*** Fire departments should ensure that, whenever a building is known to be on fire and is occupied by firefighters, all exits are forced and blocked open. When fire fighters are in a building, all exits should be available, even if the doors or security gates must be torn down. The doorways should be clear and free of any debris, so fire fighters and any other occupants can exit if needed. Fire fighters should be aware of the building's exits and be trained how to force open different doors or security measures they may encounter in a building.

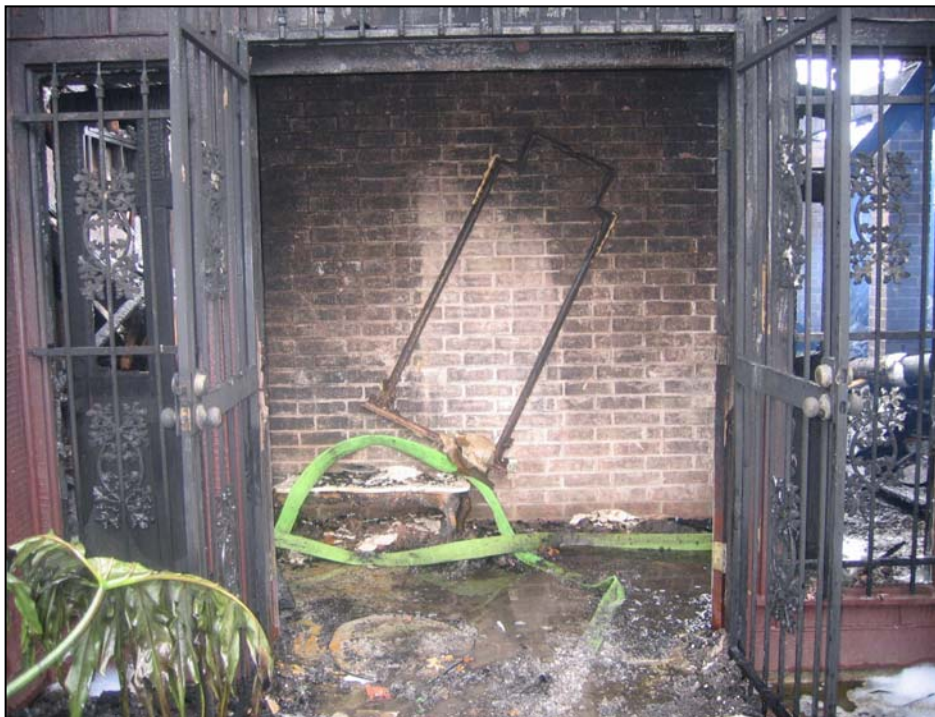
FF Lopez pulled a green 1 3/4" X 150' preconnect CAFS hose from EL1 and handed it to FF Guajardo. LT Lopez told FF Lopez to check the front door to see if it was locked. FF Lopez observed the wood front doors were locked as were the burglar bar gates covering the doors.

Window broken out before doors were forced.  
Front Entrance after doors were forced.

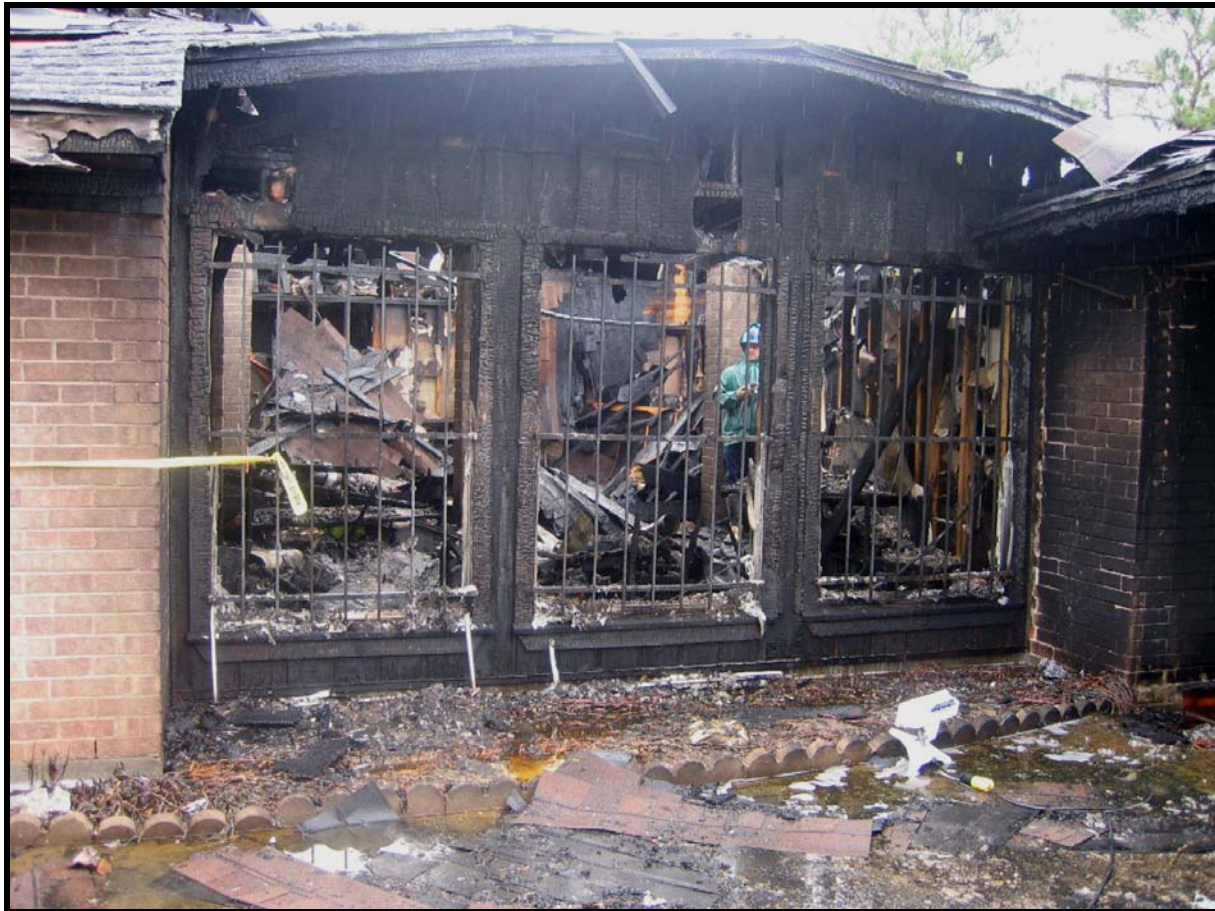
### **West windows looking into dining room**

EL1 then moved to the front door. FF Guajardo returned to EL1 for a circular power saw. LT Lopez instructed FF Lopez to break out a fixed window to the right of the door and to get some water on the fire because it would take some time to force entry. FF Guajardo returned from EL1 with a circular power saw and he and FF Lopez got it started. Engine 2's (E2) crew had obtained hand tools and forced open the burglar gates and wood entry doors and the power saw was not used.
