STATE FIRE MARSHAL'S OFFICE

Line of Duty Death Investigation

Investigation Number 02-50-10

Captain Jay Jahnke

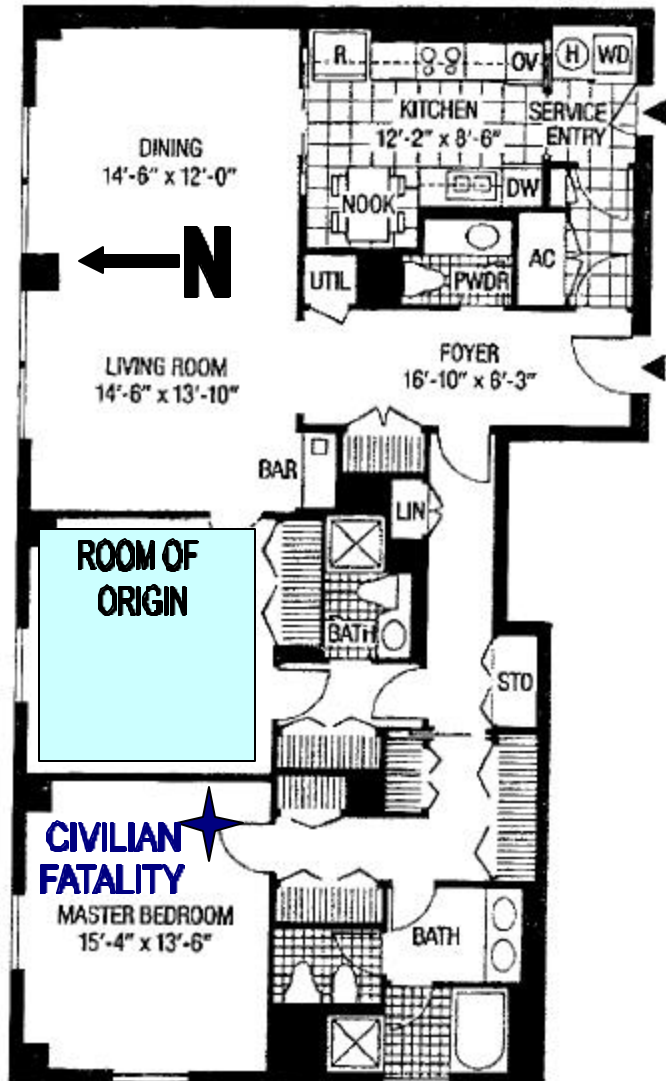
Figure 1-Unit 52

The HFD Arson Bureau had almost completed the scene excavation portion of their origin and cause investigation prior to the arrival of SFMO investigators. SFMO did not participate in the scene excavation or in the follow up phases of the investigation. HFD investigators determined the fire originated in a bedroom of Unit 52 used as a television and computer room. **(Figure 1)**

On April 2, 2002 the HFD Arson Bureau ruled the fire as accidental in origin, with the probable cause being carelessly discarded smoking materials ¹. The origin and cause report reported an ashtray was located near a sofa in the area of origin in the television room. Additional testing of electronic equipment in the room of origin may be conducted by an outside research firm at a later date.

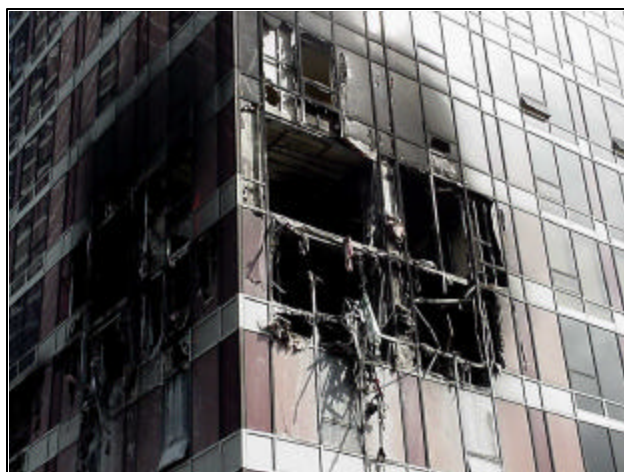
Four Leaf Towers-West is a 41-story high rise residential building. **(Figure 2)** The basement service area contains electrical, mechanical, and fire protection equipment. A parking garage is also located in the basement. The first floor contains a lobby, administrative offices, mailboxes, security office, and ancillary areas. The second floor contains self-storage units for residents. Floors 3-40 contain condominium apartments. Building mechanical equipment is located on the 41st floor.

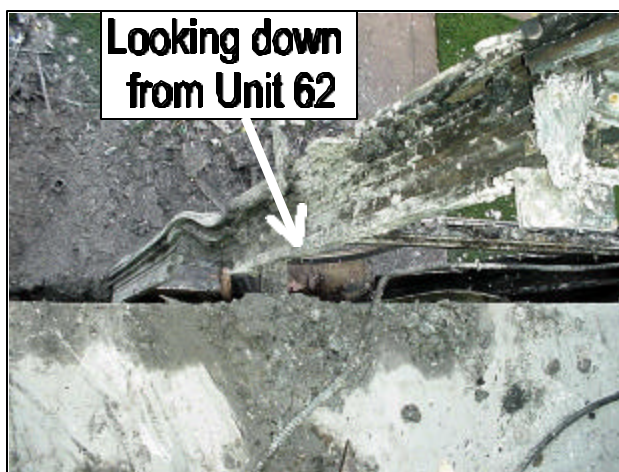
Figure 2-Northwest Corner of Building **Figure 3-Curtain Wall-Floor Slab Gap**

The fire and products of combustion began to spread vertically through openings between the concrete floor slabs and the glass curtain wall. In addition, some flame and smoke spread may have occurred through unsealed vertical floor openings between the fifth and sixth floor. The openings, which may have been made during initial construction, were located in the bathrooms, near heating and air conditioning units, and in other areas. The openings were exposed when the gypsum board ceilings of Unit 52 failed. **(Figure 9-unsealed vertical penetration from Unit 62 bathroom looking down into Unit 52 bathroom)** These unsealed penetrations were found in several areas of the building. Unsealed openings, in combination with the lack of sprinkler protection, can allow flames and products of combustion to spread rapidly, endangering residents above the fire.

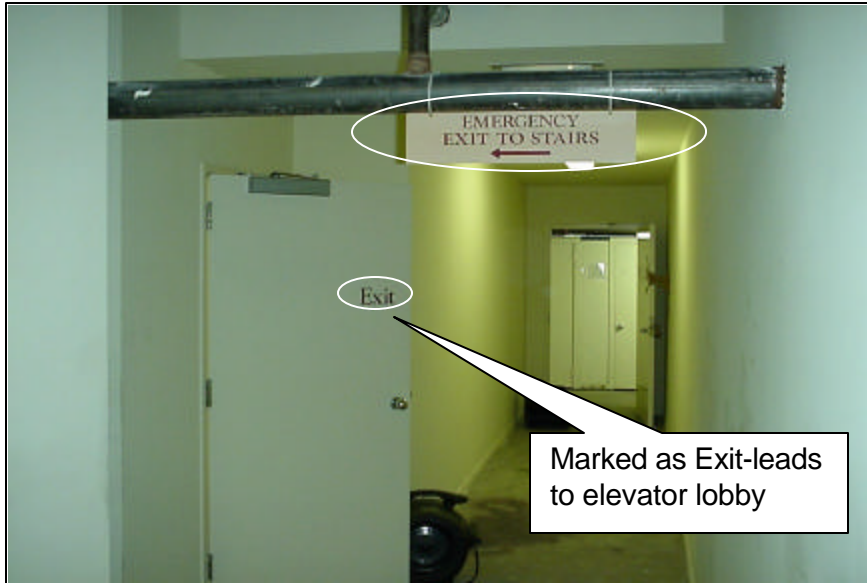
Users of Stair C must negotiate a winding path through an exit passageway to reach the exterior. The path begins at the end of stairway C on the second floor and travels through the second floor to reach the top of a straight run of stairs that discharges directly to the outside. This winding 100'+ path includes three 90-degree left turns and one 90-degree right turn combined with inadequate and confusing exit signage. (Figure 4)

Figure 4-Confusing and inadequate exit signage in Stair C exit pathway

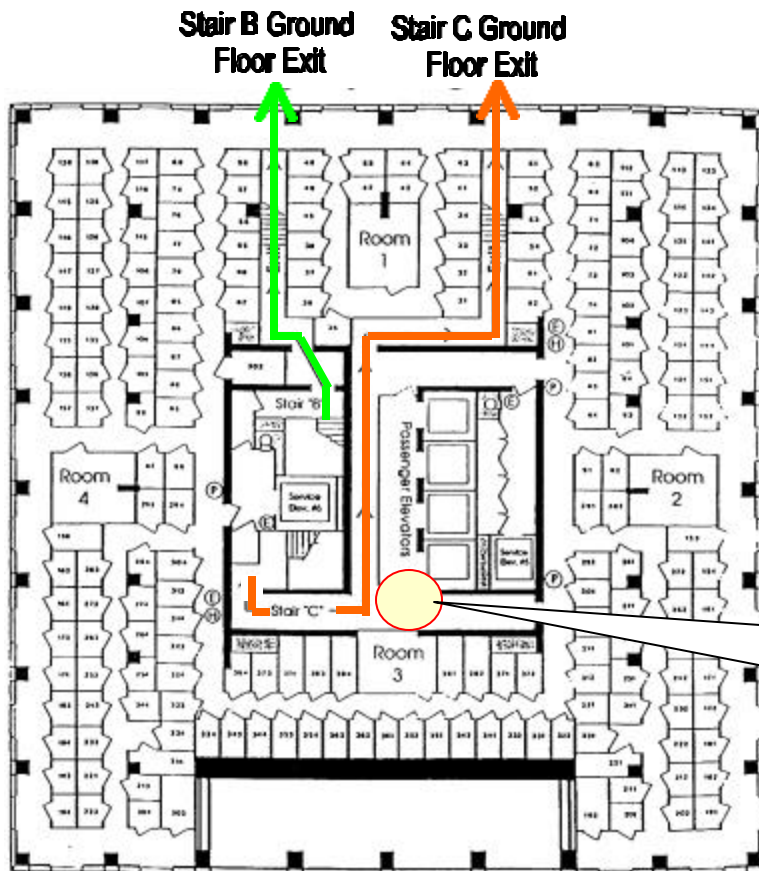
Both firefighters and residents reported confusion in traveling through this area, aggravated by smoke^{2,3,4}. (Figure 5)

Figure 5-Second Floor Exit Routes

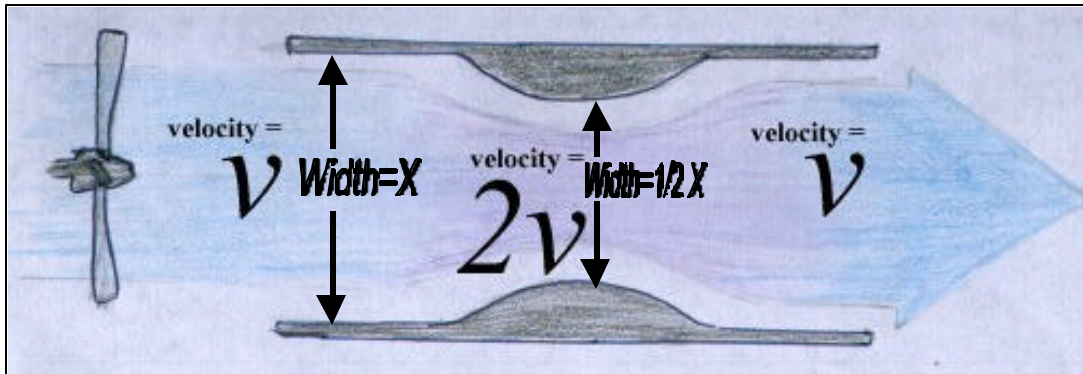
This intensification in heat may be due in part to the Venturi Effect. The gusty north winds entering the large opening created by the broken north and west windows would tend to accelerate as the air currents passed through the significantly smaller door opening into the corridor. The rate of wind acceleration is inversely proportional when comparing the speed of the wind passing through the large open windows to the speed of the wind passing through the small doorway opening. **(Figure 6)**

Figure 6-Illustration of Venturi Effect

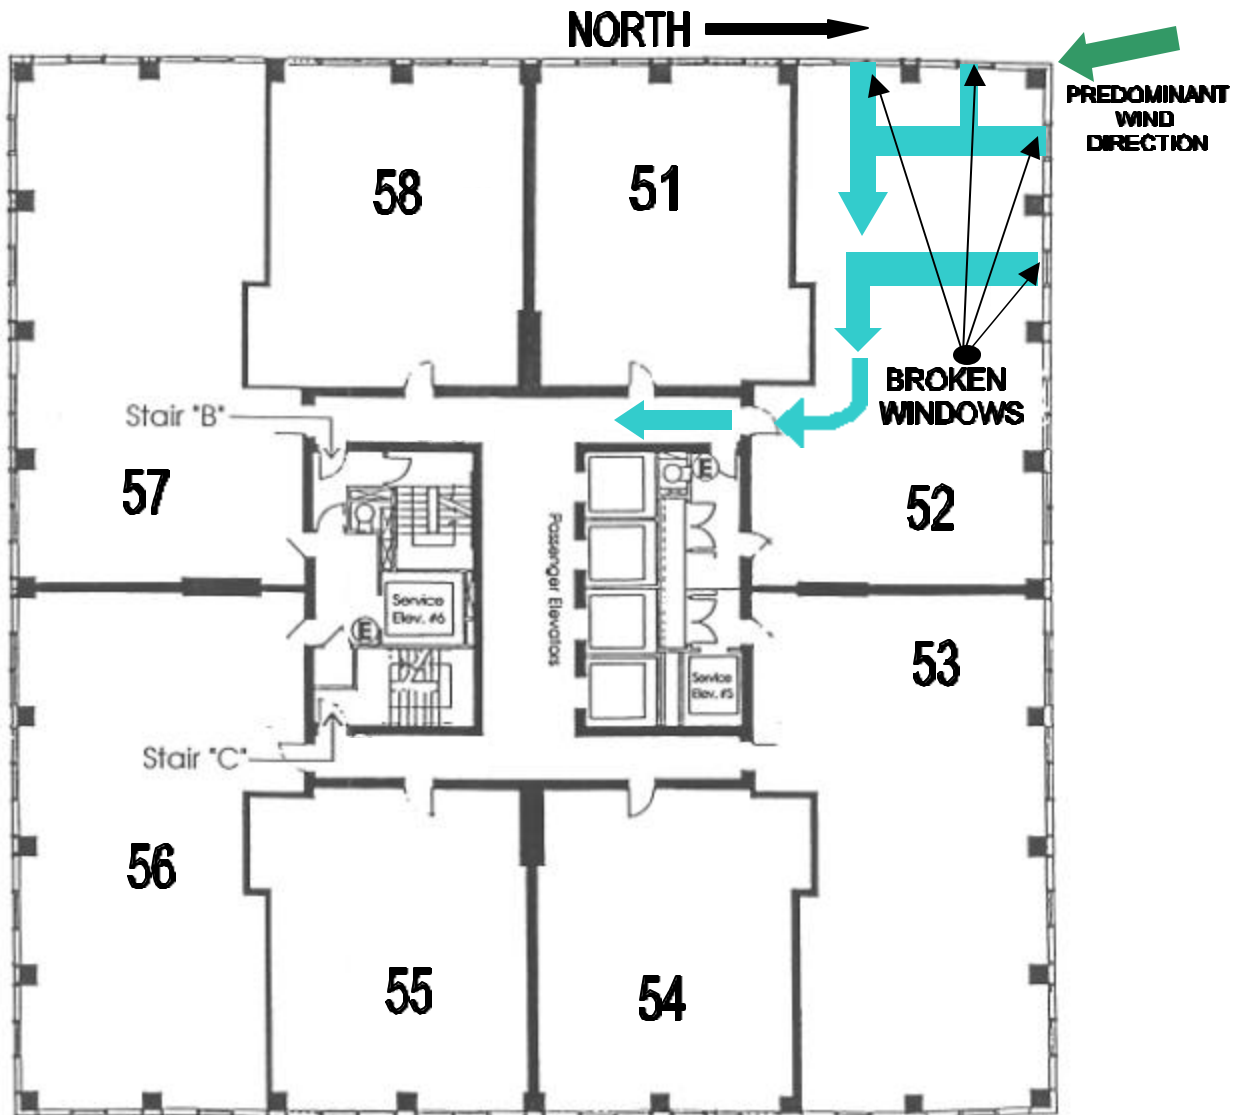
For example: Under laboratory conditions, a 30 mph wind passing through a 60 square foot opening into a confined area would tend to accelerate to 90 mph when passing through a 20 square foot opening at the other end of the confined area (30/60 → 90/20.) As the air moving through the doorway of Unit 52 into the corridor increased in velocity, the air at the doorway would decrease in pressure, causing even more heat, smoke, and fire gases to be pulled from the interior of the condominium and expelled into the corridor. **(Figure 7)**

Figure 7-Wind driven air currents in Unit 52 and corridor

The Venturi Effect may be partially responsible for the amount of smoke that quickly filled the main corridors of the fifth floor and entered the B stairway, overcoming the protection provided by the vestibule exhaust and stairway pressurization fans. News video footage shows pressurized smoke venting from the stairway exit at grade level ¹². Firefighters and residents reported they experienced near zero visibility inside stairway B.

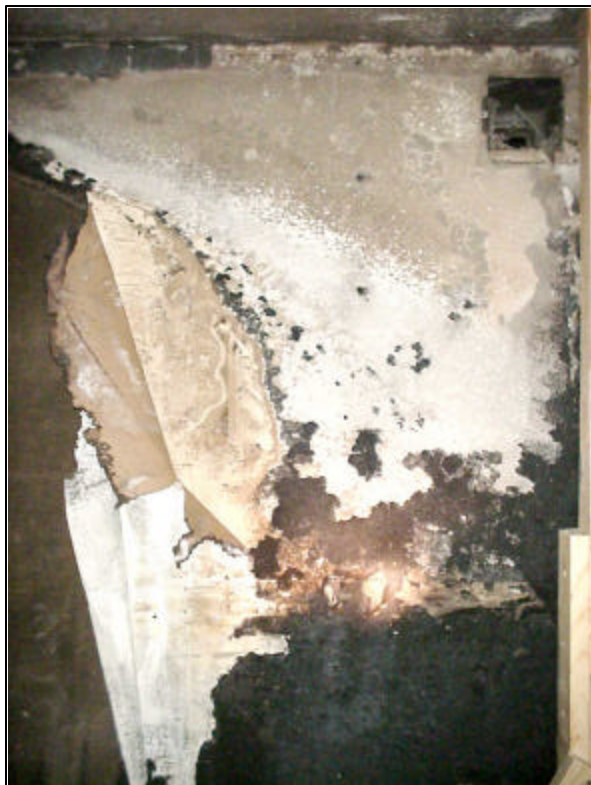
Figure 8

When the initial attack group withdrew from Unit 52, they left their hose line in place in the entry foyer¹⁴. This prevented the self-closing solid core door from closing, allowing flames and smoke to enter the corridor. A fire sprinkler head in the corridor, located approximately 88 inches from the door to Unit 52, fused and prevented any further flame damage in the corridor. There is a clear line of demarcation in damage to the vinyl wall covering in areas wetted by the sprinkler spray as compared to non-wetted areas. **(Figure 8)**

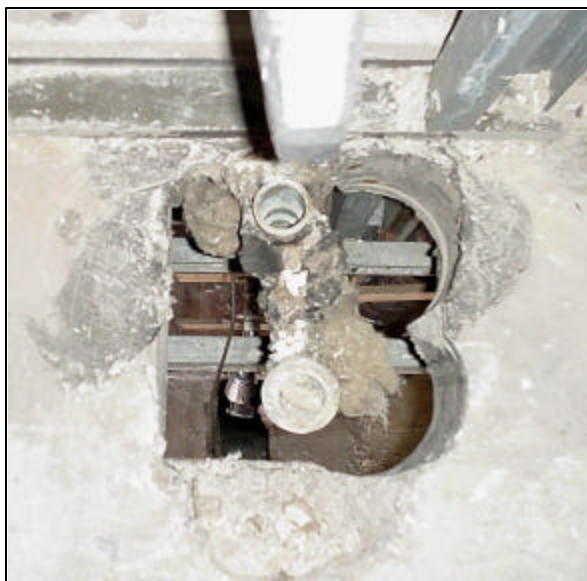
Figure 9

Every sprinkler head in the north-corridor from Stair B to Unit 52 opened. The sprinkler head in the service elevator lobby outside the kitchen of Unit 52 also opened. One sprinkler head on the west side of the elevator lobby that connected both main corridors opened also. The combination of the discharging sprinkler heads, closed solid core doors, and fire rated walls prevented any significant horizontal spread of fire damage outside of Unit 52.

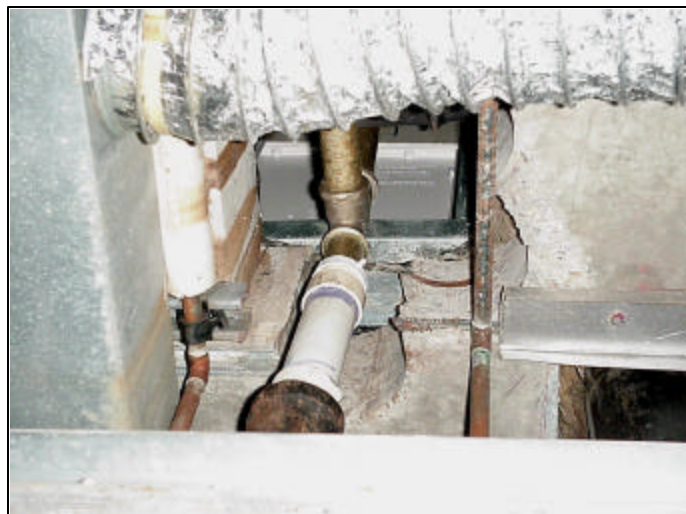
Figure 10

Unsealed vertical penetrations were observed in other condominiums, indicating that this was a common practice when the building was constructed. **(Figure 10-looking up into ceiling/floor penetration)**

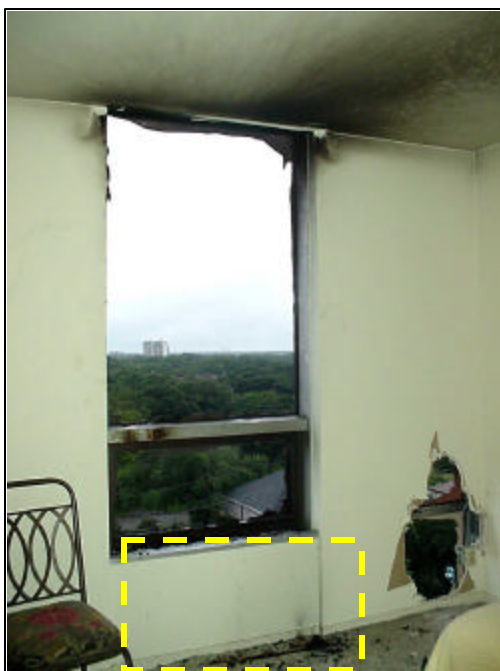
Figure 11

As fire and smoke spread vertically from Unit 52, contents of Unit 62 ignited, resulting in heavy damage to that unit. Flames continued to spread vertically and began to enter Unit 72, resulting in broken windows and scorching of carpet in areas where the curtain wall-floor slab gap was sealed with lightweight materials. **(Figures 11 and 12)** The vertical spread of fire was stopped at this level by both a master hose stream from an aerial platform and the use of a standpipe cabinet hose by firefighters checking for extension from the sixth floor.

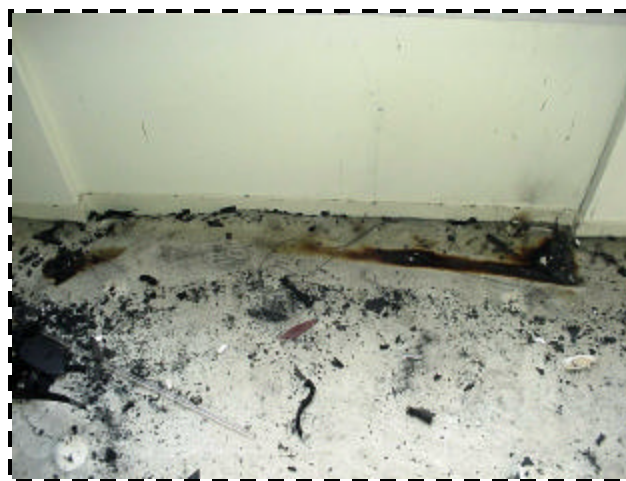
Figure 12-close-up of scorched carpet in dashed area from Figure 11

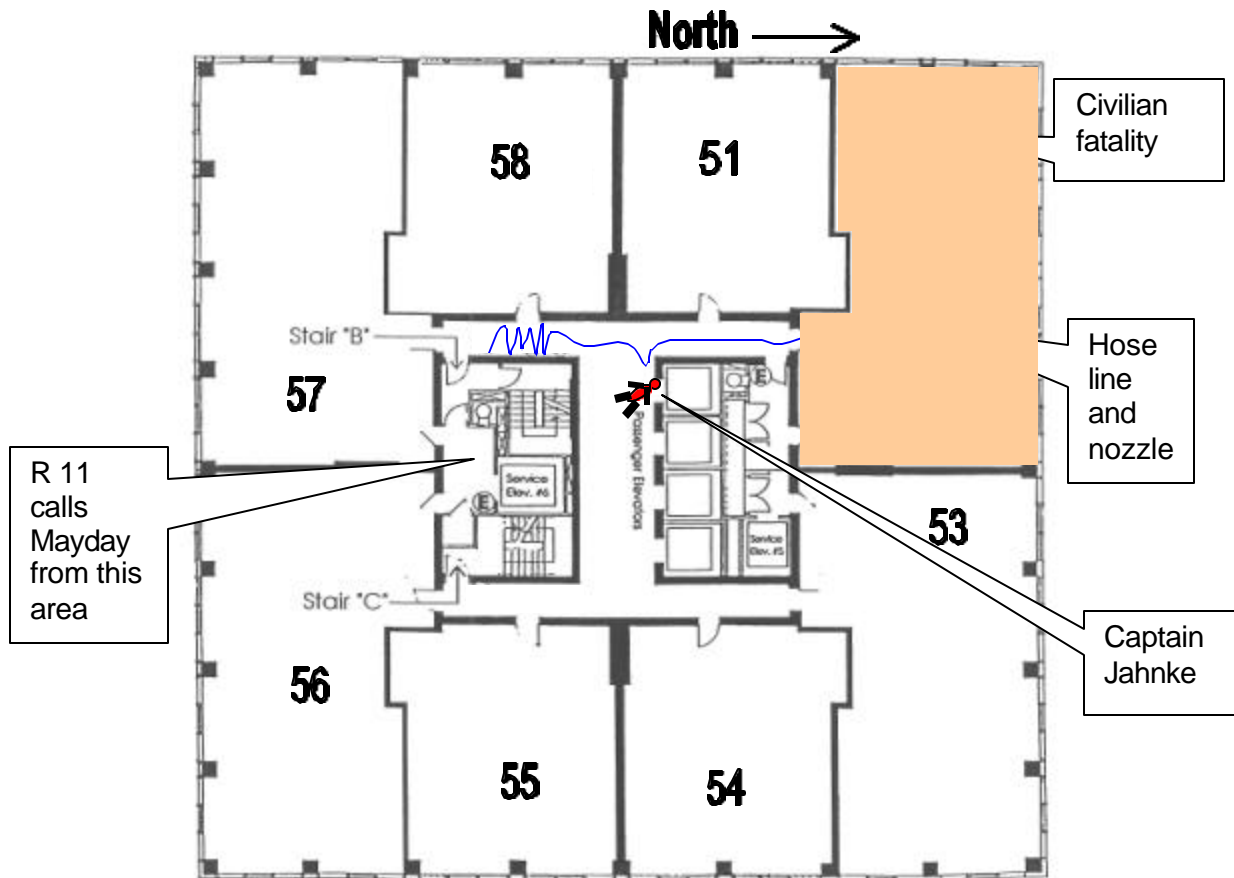
Figure 13-Fifth floor layout. Locations of civilian victim, Captain Jahnke, and fire hoseline are approximate and based on firefighter interviews.

Approximately 5:30 AM, Jahnke was located by the rescue team of Mathison, Kahney, and Parry in the elevator lobby, halfway between Unit 52 and the exit stair door. He was approximately 25 feet from the B stair vestibule door and 50 feet from the C stair door. (Figures 13 and 14)

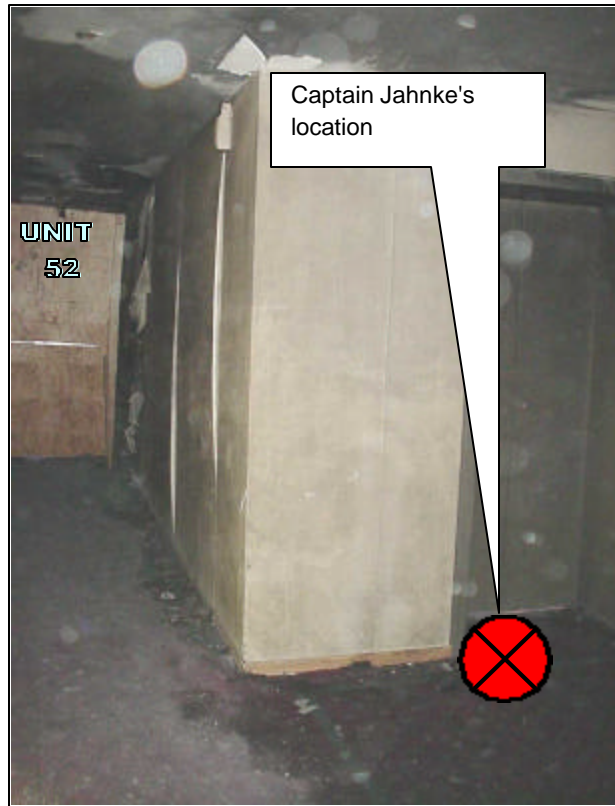
Figure 14-Approximate location where Captain Jahnke was found.

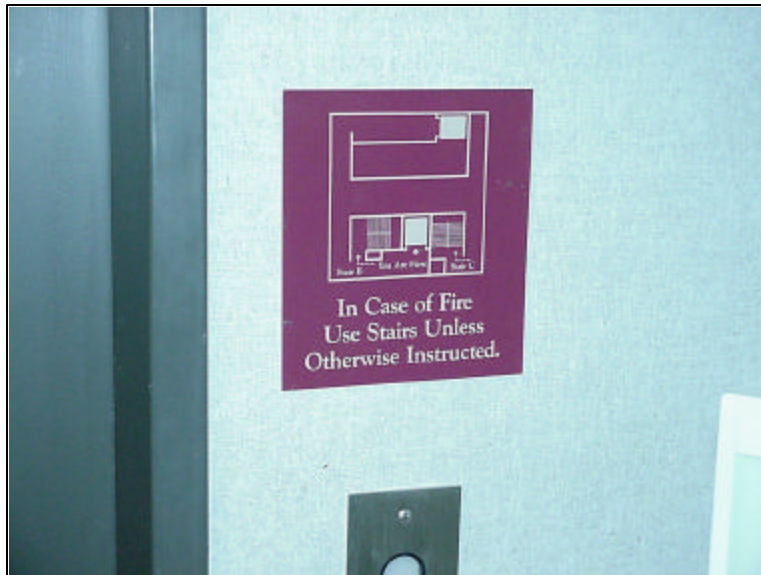
Figure 15-Floor plan sign located in all south service elevator lobbies.

AT 05:35:41 HFD Dispatch tried to call R11 on channels A2 and A4 and received no response. As he searched for the exit, Kahney found a building floor plan adjacent to the service elevator **(Figure 15)** and used it to reorient himself and he then led Mockler to the door from the service lobby to the vestibule. Kahney recalled that there was a large group of firefighters in the vestibule area and that he and Mocker were pushed into the stairway. Kahney and Mockler made their way to the outside of the building without assistance.
