# STATE FIRE MARSHAL'S OFFICE

## Line of Duty Death Investigation

**Investigation Number 03-262-03**

**Lieutenant Charles Lance Mathew**  
**LaBelle-Fannett Volunteer Fire Department**  
March 18, 2003

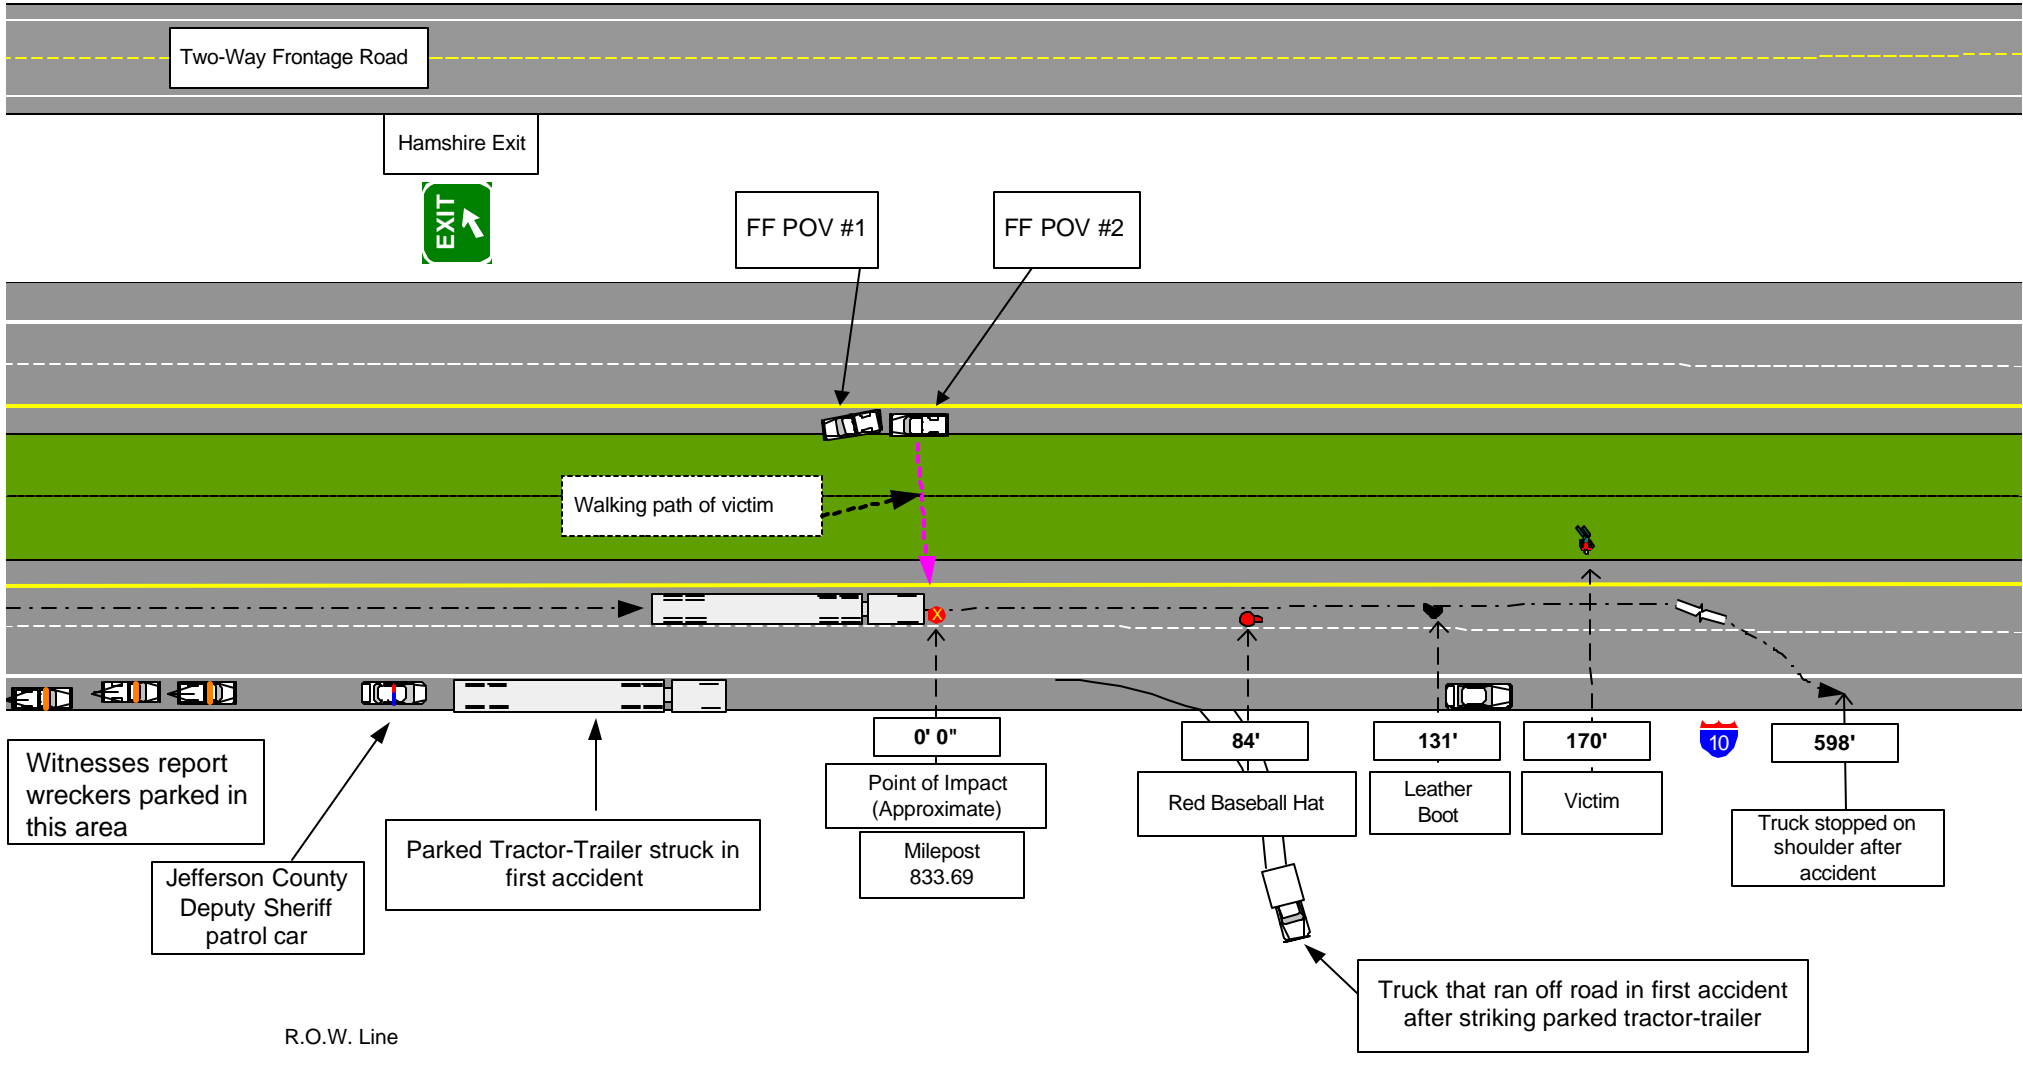
**Interstate 10 Eastbound Lanes, Mile Marker 833.69, Jefferson County, Texas**

Firefighter Dearborne parked on the inside westbound shoulder of Interstate 10 directly across from the original incident at approximately milepost 833.69 and walked across the highway to assess the situation. Dearborne's vehicle was approximately ¼ mile from the Hamshire exit ramp. Dearborne had turned his vehicle headlights off and left the four-way emergency flashers operating. Dearborne called his fire dispatcher on the department radio to advise all units that only one person had sustained hand injuries at the incident. LaBelle-Fannett VFD utilizes the Incident Command System, but Firefighter Dearborne did not announce he was taking command because the incident was in Hamshire VFD's area of responsibility.

Lieutenant Mathew arrived shortly after Dearborne at approximately 2:59 a.m., and he parked his personal vehicle directly behind Dearborne's, turning off the headlights and leaving the emergency flashers on. Mathew alighted from his dark grey truck and walked across the grassy median toward the original incident.

As he passed the incident scene, the truck driver checked his right mirror to see if he had cleared the scene and when he looked back to the front he saw Lieutenant Mathew step out into the eastbound lane of traffic. The driver of the tractor-trailer was unable to stop and struck Mathew with the right front part of the truck-tractor just to the left of the center divider line. The driver came to a controlled stop on the shoulder approximately 598 feet past the point of impact. There were no skid marks left during the stop.

Lieutenant Mathew was thrown by the impact to the grassy median approximately 170 feet east of the point of impact. Firefighter Dearborne and others on the scene checked Mathew, but he had sustained catastrophic injuries and was obviously deceased.

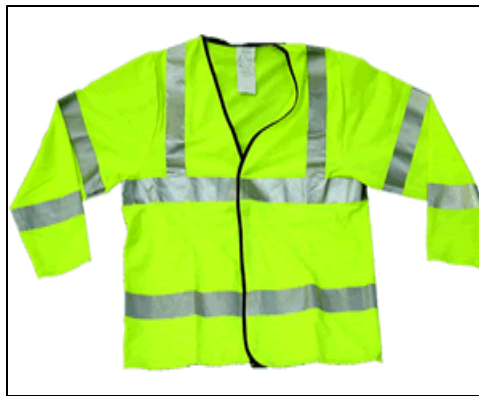
Typical ANSI Class 3 Garment

The need to wear personal protective clothing such as a reflective, brightly colored vest arises from the fact that personnel need to be highly visible while working on the scene of a motor-vehicle incident. American National Standard Institute 107 recommends that Class 3 high visibility garments be worn by personnel in high risk work activities that take place in or near traffic at speeds over 50 mph and participating in tasks that may distract motorists or divert the attention of the emergency worker from watching for traffic. These garments will help approaching motorists identify workers from over 1,280 feet.
