# STATE FIRE MARSHAL'S OFFICE

## Firefighter Fatality Investigation

### **Volunteer Firefighter James McMorries**

Howardwick Volunteer Fire Department

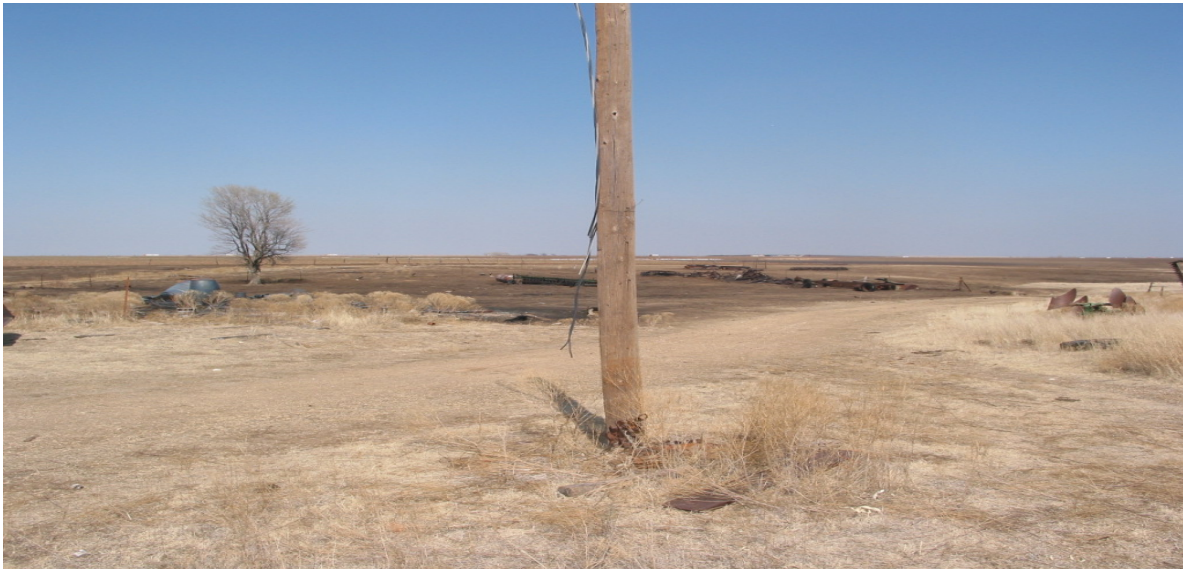
**Area of Origin**

Deputy State Fire Marshal Kelly Vandygriff conducted an origin and cause investigation on March 24, 2006. Vandygriff concluded that the fire originated on property owned by Dan Steed of Groom, Texas approximately six miles east of the city of Groom and one mile south of Interstate 40 in Donley County. Vandygriff concluded the fire was the result of electrical wires touching causing arcing in forty to fifty mph winds.

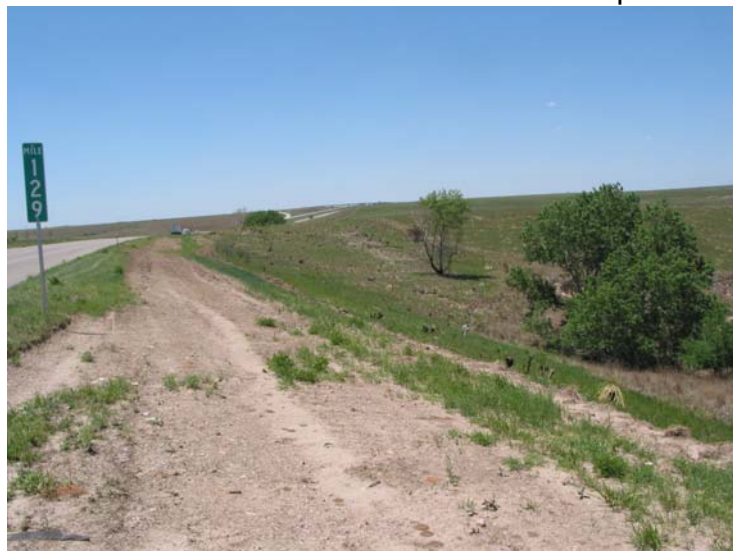
At approximately 1900 hours, after refilling at the rest area, Unit #417 was creeping east along the westbound shoulder in the soft sand between the paved shoulder and the drop-off into a ravine. The wind shifted and fire began approaching the truck. Garcia, riding the front bumper, motioned to McMorries to back up. As the truck reversed, the driver's side rear wheels lost traction in the sand and the truck loaded with water turned over and rolled down the side of the ravine.

**View of the location of the roll over**

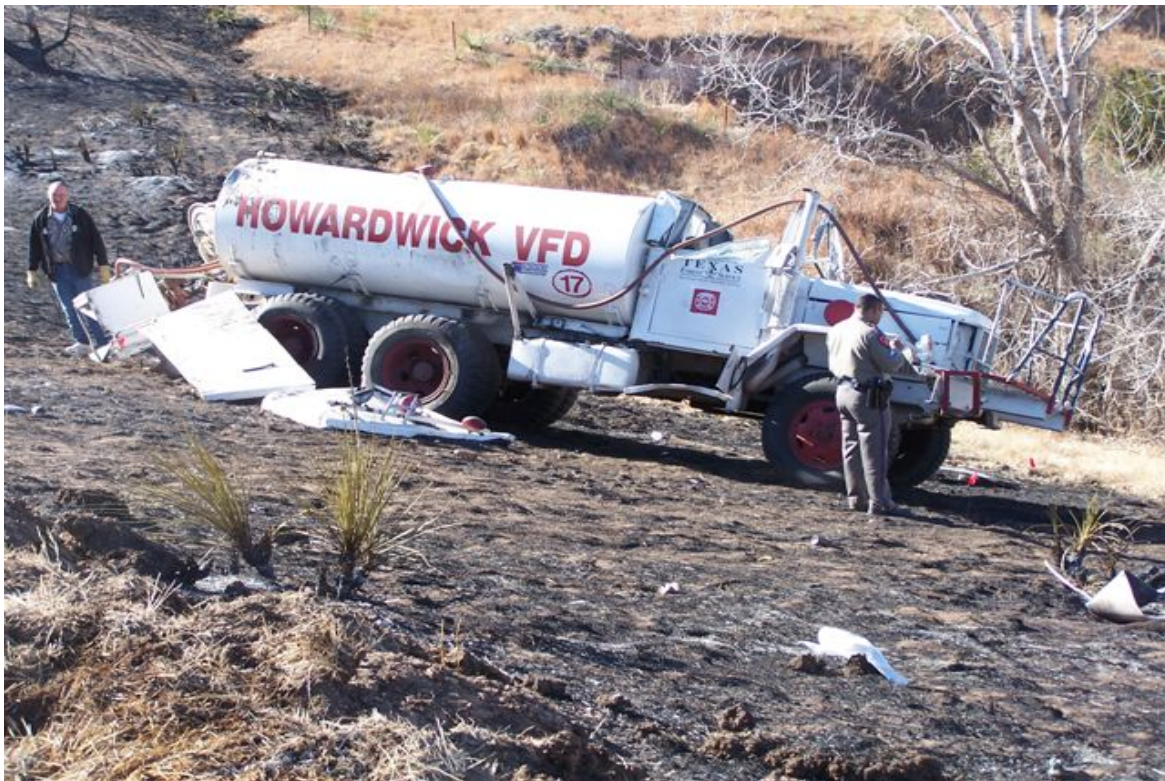
**Location of Unit #417 after roll over**

- The fully loaded cargo tank trailer exceeded the maximum gross weight listed on the data plate by at least 3500 pounds.
- The ground next to the roadway was newly graded and did not provide a stable base for a truck of this size and weight.
- There were no baffles in the water tank to control water movement and subsequent weight shifts.

The overloaded vehicle with inadequate water tank baffles presented an extreme challenge to the driver to maintain control.

**Recommendation:** All fire departments should consider safety and health as primary concerns in the specification, design, construction, acquisition, operation, maintenance, inspection, and repair of all fire department apparatus. Fire departments should utilize the resources discussed in this report to evaluate their water tender (tanker) policies.

**Recommendation:** Any fire department acquiring a vehicle, chassis, or trailer not originally designed as firefighting apparatus should proceed with caution when converting equipment for use in firefighting. Fire departments should take into account factors such as the weight of tank water and equipment, center of gravity, load distribution, capacity of the drivetrain, tires, steering, and braking systems during fire apparatus construction.

**Recommendation:** All fire departments acquiring vehicles, chassis, or trailers should refer to all available manuals or documentation prior to commencing conversion or modification operations. Water tanks should be clearly marked with the tank capacity and full gross weight. Fire departments should install positive physical safeguards, such as overflow vents, to prevent vehicles from exceeding maximum permissible gross weight when fully loaded.
