STATE FIRE MARSHAL'S OFFICE

Firefighter Fatality Investigation

Investigation Number 06-139-11

Firefighter Clint Dewayne Rice

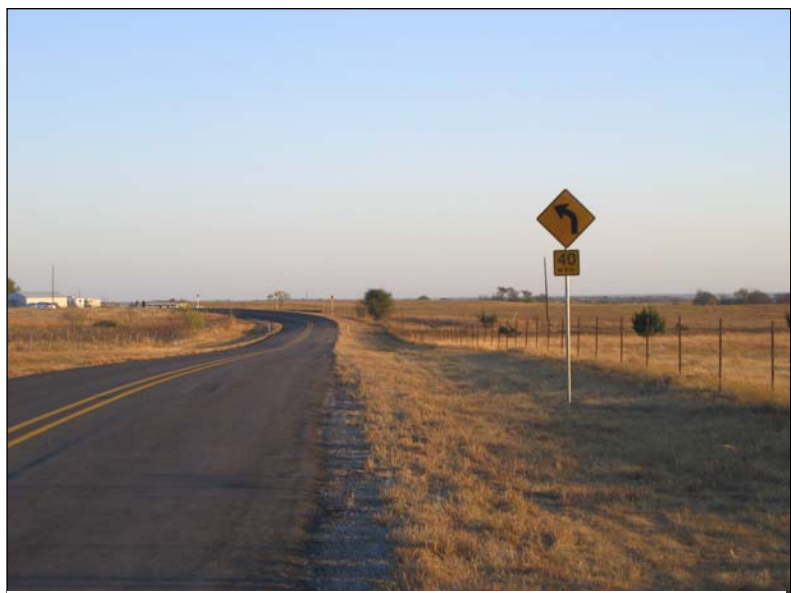
FM 219 approaching the incident scene in the direction of travel of Unit 610.

Warning chevrons delineated the curve. The asphalt roadway was dry, in good condition, and had a slight downhill grade continuing into a banked left curve. The incident occurred during daylight hours.

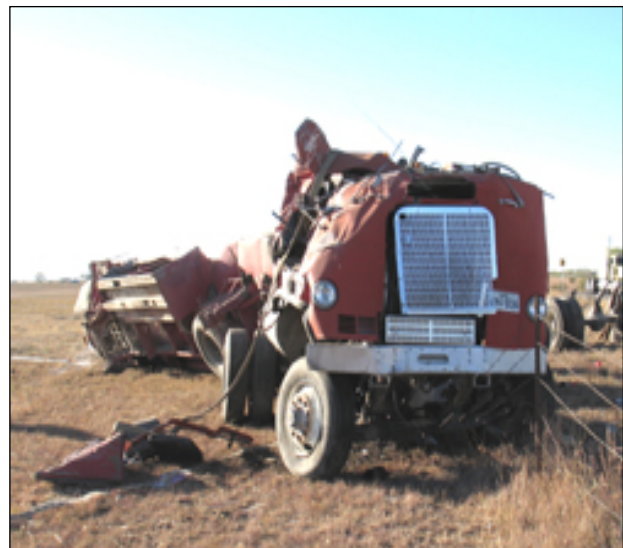
**Final resting position of tractor-trailer.
Photo by Hamilton County JP Lively .**

As the tractor-trailer combination came to rest in a field, the truck tractor rolled back upright onto its wheels. The cargo tank

came to rest on its left side. The force of the rollover separated several tire/axle assemblies from the tractor-trailer water tender. The vehicle traveled approximately 330 feet from the point the first tire left the roadway.
