STATE FIRE MARSHAL'S OFFICE

Line of Duty Death Investigation

Investigation Number 03-193-01

Firefighter Gary L. Staley

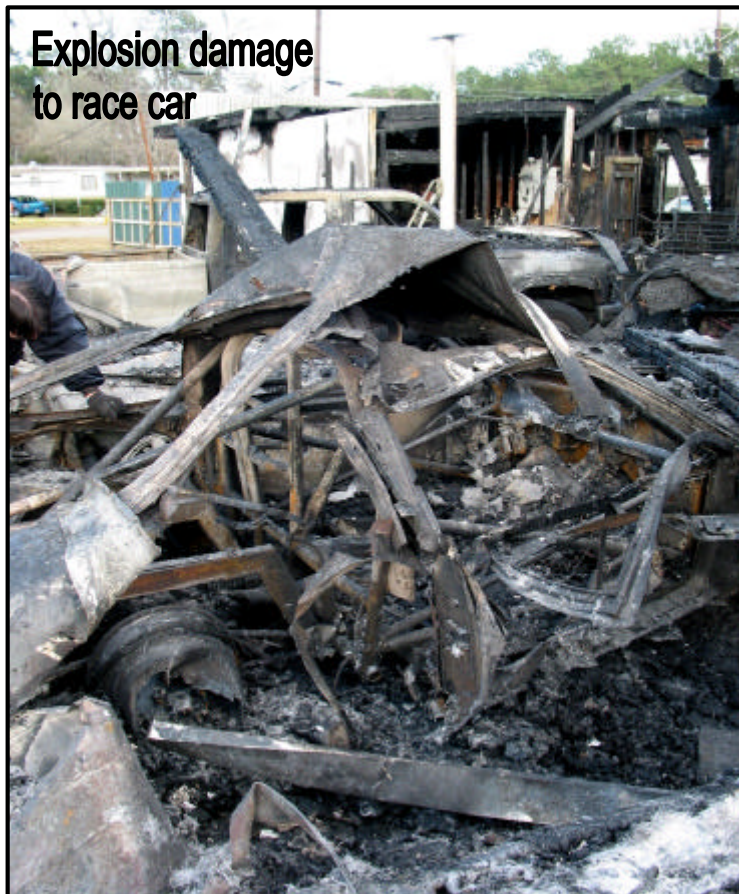
Investigators determined that approximately 5-10 gallons of flammable liquid (lacquer thinner) had been spread on the floor in the west end of the showroom area, allegedly to prepare the floor for applying ceramic tile. The tile worker claimed vapors from the liquid ignited when he plugged in a forced air space heater. The flaming liquid ignited the contents of the building, including boxes of auto parts, lubricating oil, classic and racing cars, personal watercraft, a boat and other vehicles. The building was destroyed by the fire.

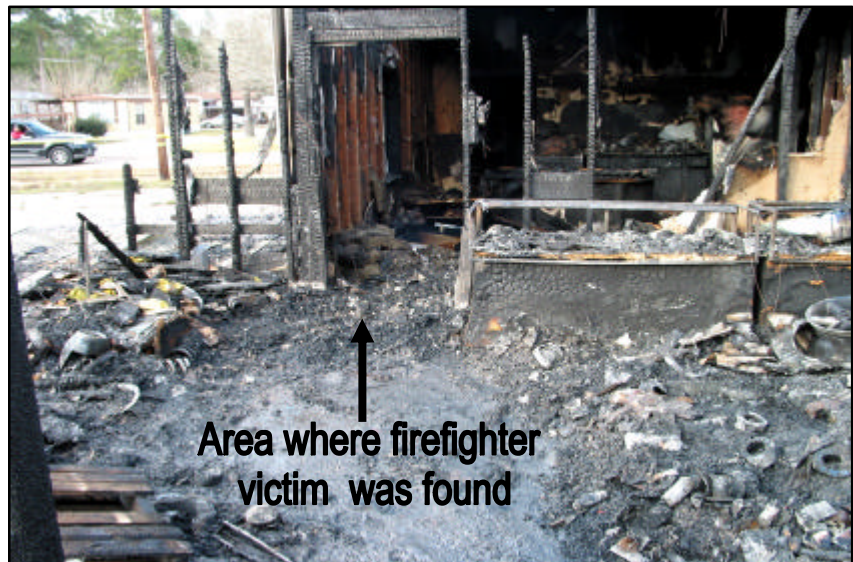
As the fire progressed, the metal roofing and wood rafters collapsed in the showroom area. None of the metal support posts failed. The area where the deceased firefighter was found had no significant structural failures.

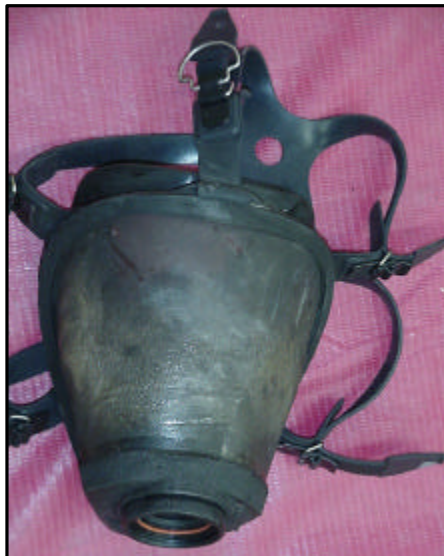
All SCBA masks were melted and opaque in some areas due to flame exposure. Some areas of the face pieces were undamaged because they were covered with portions of the firefighter

protective hood. Haynes sustained serious facial burns when he removed his face piece inside the building because he could not see. Haynes was the only injured firefighter that was wearing a "Reed Hood," a protective hood made of material similar to that used in bunker clothing and designed to be worn over a standard knit fabric fire resistant hood.
