STATE FIRE MARSHAL'S OFFICE

Line of Duty Death Investigation

Investigation Number 03-194-01

Firefighter James Taylor

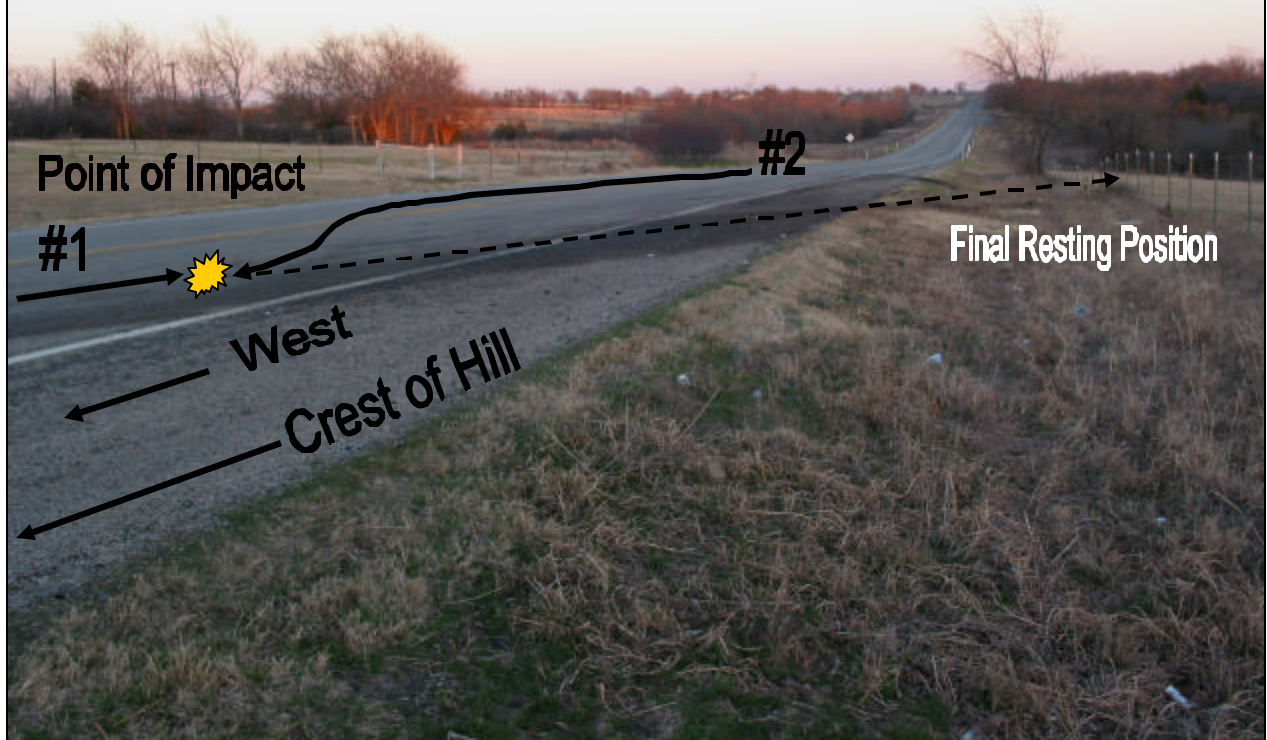
ACCIDENT SCENE-STATE HIGHWAY 56-FANNIN COUNTY, TX

After the collision, both vehicles came to rest on the grassy shoulder on the south side of SH 56. Vehicle #1 had damaged a barbed wire fence and came to rest facing southwest. Vehicle #2 came to rest approximately 75 feet from the rear of Vehicle #1 facing northeast. Both vehicles caught fire a short time after the impact. The fires were primarily concentrated in the engine compartment and front passenger areas.

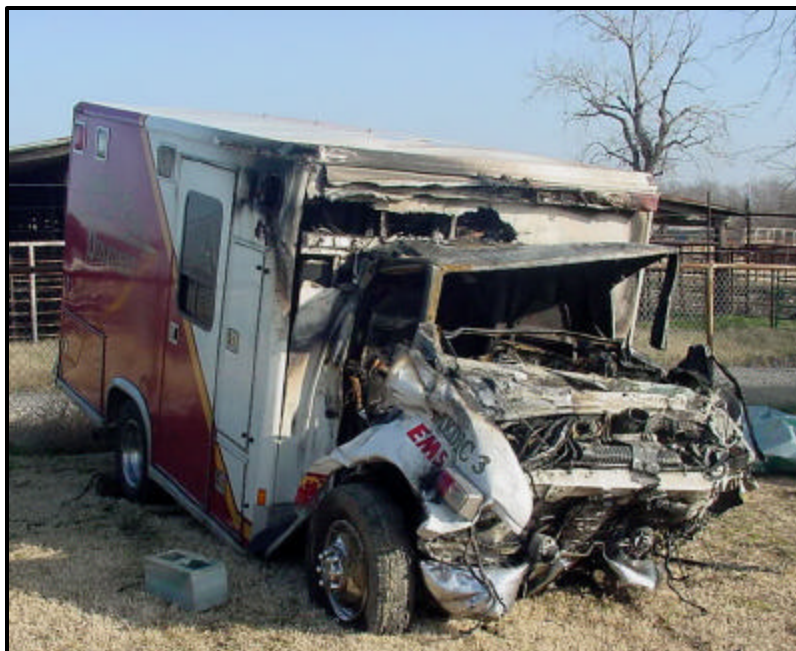
The gross vehicle weight listed for the vehicle was 10,500 pounds. The Texas Department of Public Safety weighed the vehicle after the accident and found that it weighed 11,800 pounds without crew or patients. It was not possible to determine the total mileage on the vehicle because of fire damage, but fire department records show Medic 3 had 312,657 total miles shortly before the accident in January 2003.

Recommendation: Fire departments should weigh all vehicles and compare weights to the Gross Vehicle Weight (GVW) listed on the federally required label. Equipment loads should be adjusted to bring weights to a level at or below GVW. Allowances should be made for the weight of the largest foreseeable number of crew and passengers aboard and a full fuel tank.

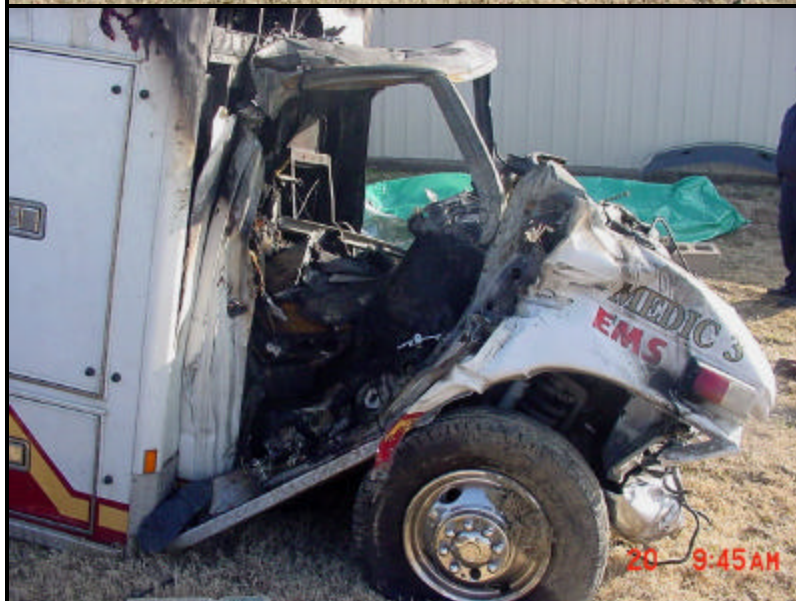
There was significant deformation of the vehicle and intrusion into the passenger space caused by the collision. The cab doors were removed with rescue tools when Taylor's body was removed from the vehicle. Other than fire damage, there was not significant damage to the ambulance box assembly.
