STATE FIRE MARSHAL'S OFFICE

Firefighter Fatality Investigation

Investigation Number 06-166-12

Firefighter Chad Ernest Wessels

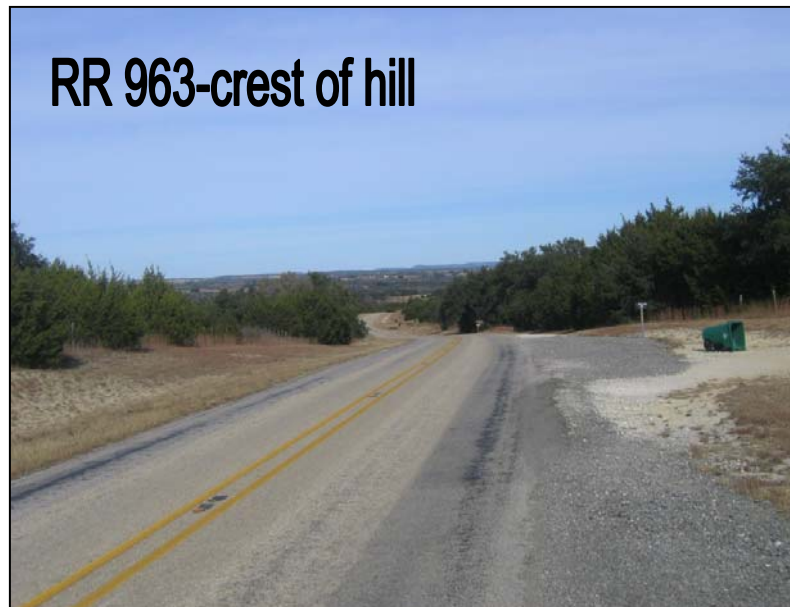
No warning chevrons delineated the curve. The asphalt roadway was dry, in good condition, and had a slight downhill grade transitioning from a slight left curve into a straight section. The roadway was marked with a double yellow centerline. The edges of the roadway are not marked with a white line, and loose asphalt and rock material is present at the edges of the roadway. The terrain of the shoulders and adjacent land is rocky and uneven.

The incident occurred during the hours of darkness and the only illumination of the roadway in that area was from moonlight. The US Naval Observatory lists the phase of the moon on that date as 84% of a full moon. Moonrise was 2:07 PM on the previous day and moonset was 3:21 AM on the morning of 12/11/05.

After cresting the hill, the right front tire of Unit 4240 left the right hand side of the roadway at the exit of the left curve to the downhill straight section, after passing the curve warning sign. The Texas Department of Public Safety (DPS) report stated no tire marks were present that would have indicated that Firefighter Wessels applied heavy braking action.

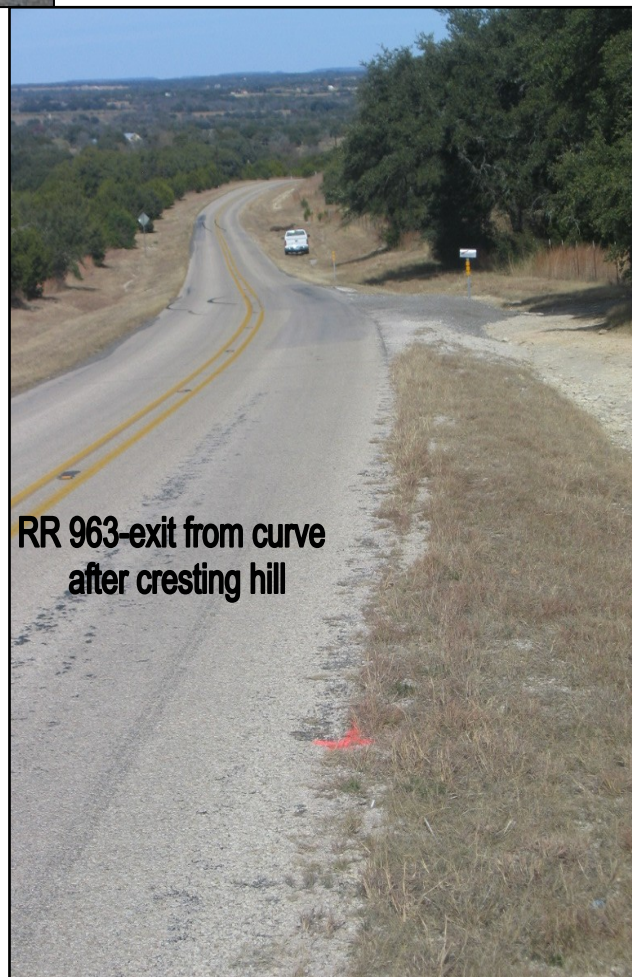
Unit 4240 reentered the highway and veered left across the roadway at an angle and left the roadway on the left side. The water tender passed through a barbed wire fence and traveled parallel to the roadway approximately 600 feet before reentering the roadway, crossing it an angle and crashing through a barbed wire fence on the right side of the road. After traveling approximately 112 feet off road, Unit 4240 came to rest in a grove of cedar trees and brush.

A post-crash fire ignited and consumed the front and cab interior of Unit 4240. The investigating DPS trooper surmised that the movement of the truck through fences and across rocky terrain disrupted the fuel system of the Unit 4240, leading to the fire. The DPS report stated that it was believed that Firefighter Wessels, who was not wearing a safety belt, was thrown about and possibly rendered unconscious during the off-road excursion of the truck and was not able to respond and escape the burning truck. There was collision damage to the front bumper area of the truck, but none to the cab area.

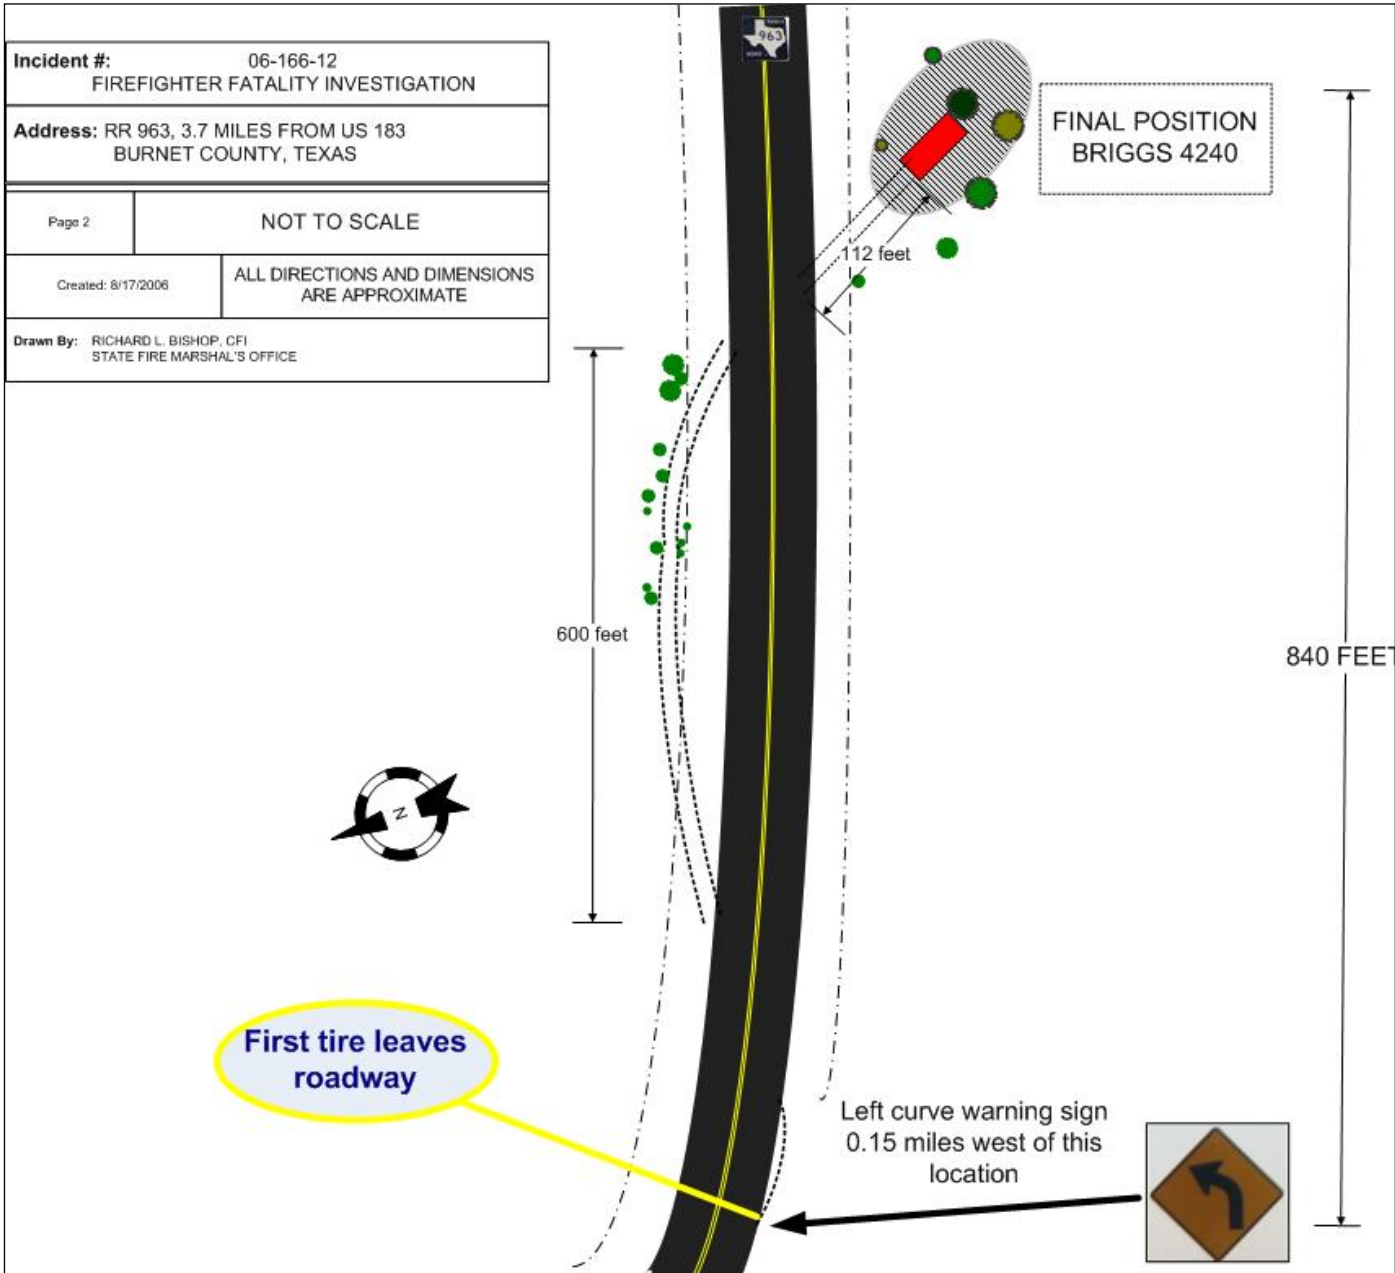
Incident #: 06-166-12 FIREFIGHTER FATALITY INVESTIGATION	
Address: RR 963, 3.7 MILES FROM US 183 BURNET COUNTY, TEXAS	
Page 2	NOT TO SCALE
Created: 8/17/2006	ALL DIRECTIONS AND DIMENSIONS ARE APPROXIMATE
Drawn By: RICHARD L. BISHOP, CFI STATE FIRE MARSHAL'S OFFICE

Approximately 5 miles from the Wessels residence eastbound on Ranch Road 963, Briggs Unit 4240 passed a diamond left curve sign. No speed advisory sign is attached. (See attached diagram)
