# STATE FIRE MARSHAL'S OFFICE

## Line of Duty Death Investigation

**Investigation Number 02-524-08**

### **Firefighter Travis Wiens**

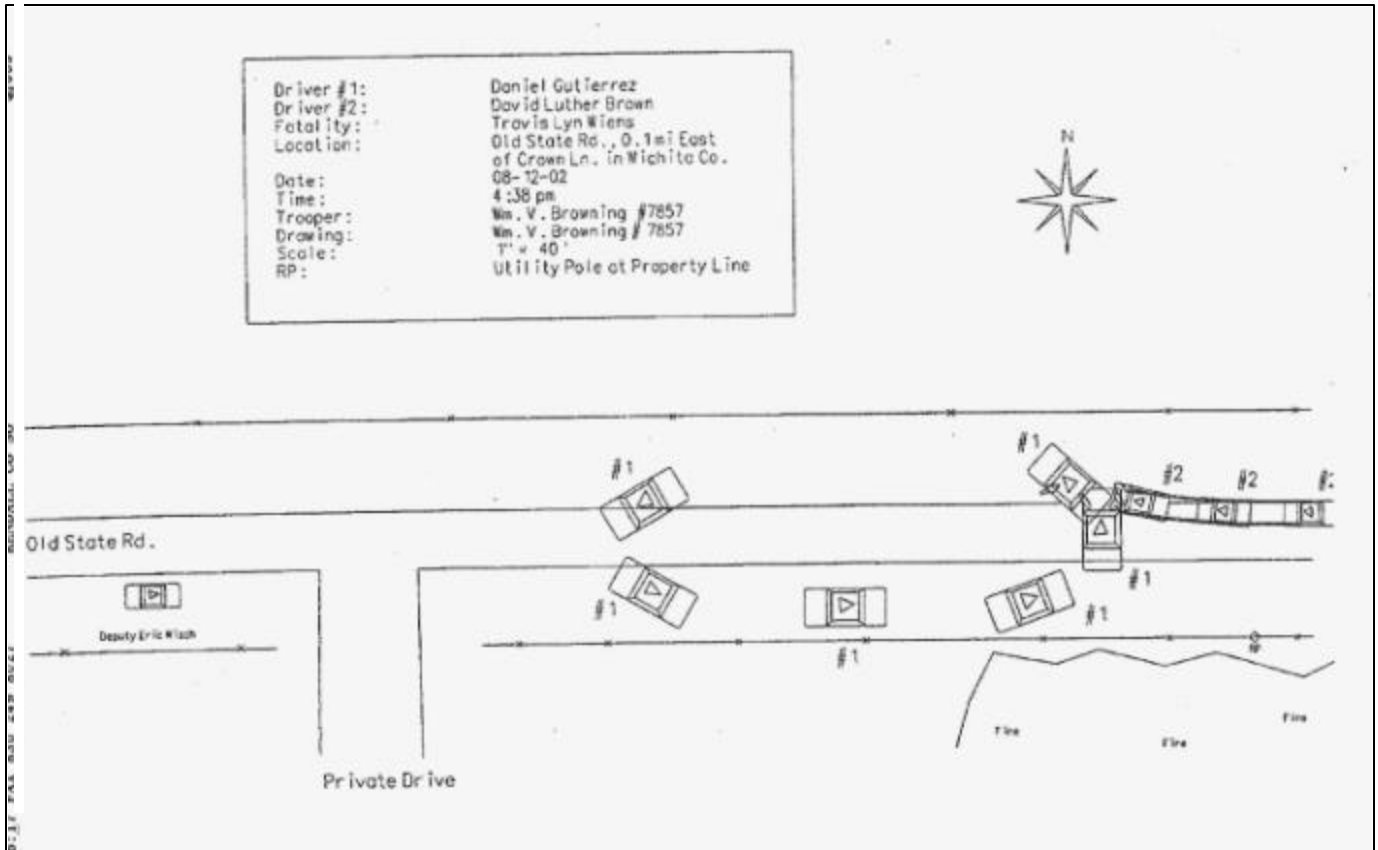
### DPS Diagram-NOT TO SCALE

The speed limit on Old State Road is 55 mph. A ¾ ton pickup truck driven by David L. Brown was westbound on Old State Road when it entered the cloud of smoke. Brown estimated visibility at 30 to 40 feet. Brown stated he had moved far to the right to give room for any eastbound vehicles that were over the center of the unmarked blacktop roadway. As Brown proceeded through the cloud of smoke at 30-40 mph (Brown's estimate) he encountered the fire truck blocking the roadway. The driver applied the brakes, but was unable to stop and skidded 56 feet into the fire truck. Brown's truck collided with the right front tire and wheel of the fire truck.

The impact threw Engine 720 driver Gutierrez across the interior of the truck towards the passenger seat. Gutierrez was not wearing the safety belt installed in the truck. The impact also threw firefighter Wiens over the top of protective screen and bar on the front platform. Wiens lost his firefighters helmet during the fall from the platform and landed on the ground in front of the left front wheel of the fire truck. There was no safety strap or harness on the front bumper platform.

The truck, which was still in low gear with no one behind the wheel, lurched forward and rolled over Wiens' head and then continued to lurch forward approximately 24 feet from the point of impact. Wiens sustained massive crushing head injuries.

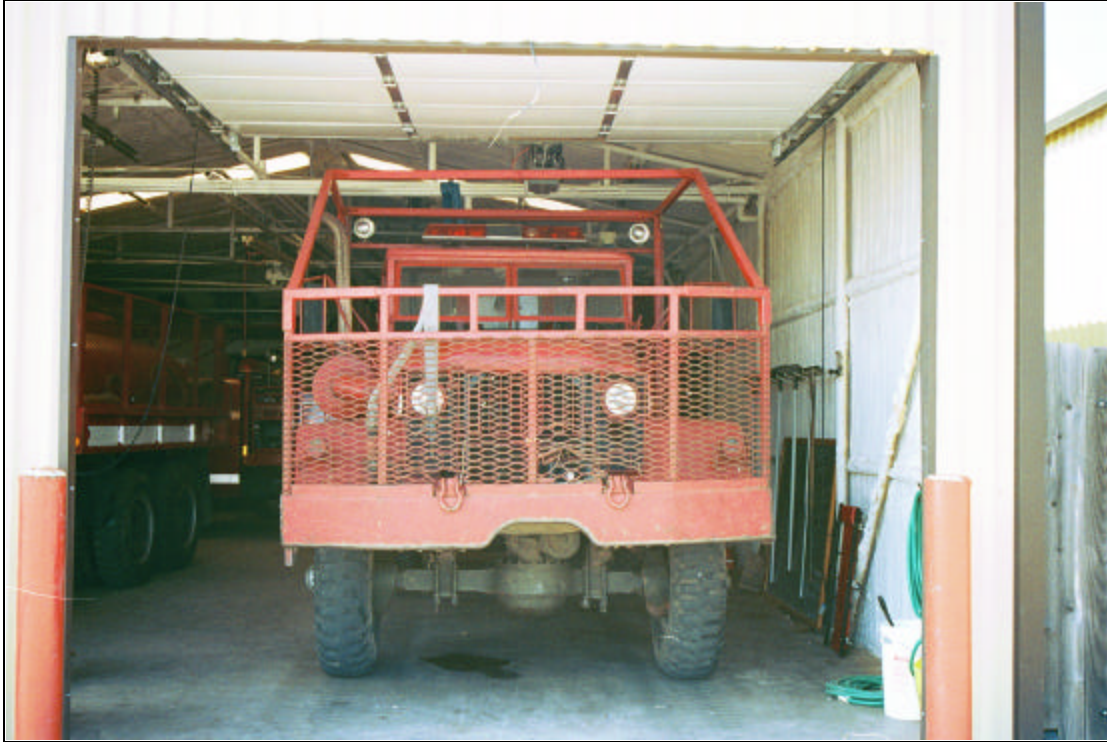
### **Wichita West Engine 720**

The front bumper platform extended out approximately 36 inches. The bumper had an open frame that extended up to the cab and then down to the sides of the bumper. The lower front portion of the frame had mesh wire, which extended 39 inches from the top of the bumper to the cross member. The rest of the frame was completely open allowing uninhibited access from either side. There were no safety type harnesses or other safety devices for the front bumper platform.

The truck has been painted red. Four-inch-wide white reflective tape and reflective 911 emblems had been applied to both sides of the cargo bed. Red and white alternating reflective tape has been applied across the rear of the truck. The only warning lights on the vehicle are a full width red light bar mounted on top of the cab. The truck is also equipped with an electronic siren with the speaker mounted on the front bumper platform. Two high-mount white lights were installed for extra night visibility. There are no low-mounted or side-mounted warning lights.

There were no safety straps or harnesses installed on the front firefighting platform of the 5-ton brush truck.

- Personnel should not be allowed to ride on the front of wildfire firefighting apparatus at any time.

Accident prevention signs should be located on the vehicle at the rear step areas, and at front bumper extensions and cross walkways, if they exist. The signs should warn personnel that standing on these areas while the vehicle is in motion is prohibited.

- Firefighting should be limited to protected positions on the sides and rear of vehicles.

Firefighters in these positions should be protected by safety cages or belts that will prevent falls from vehicles. Rollover protection equipment should be considered for these types of vehicles.

Automatic nozzles may be installed on front bumpers to avoid placing firefighters at risk on an exposed position.
