Loss of Backfill in Mechanically Stabilized Earth Retaining Walls

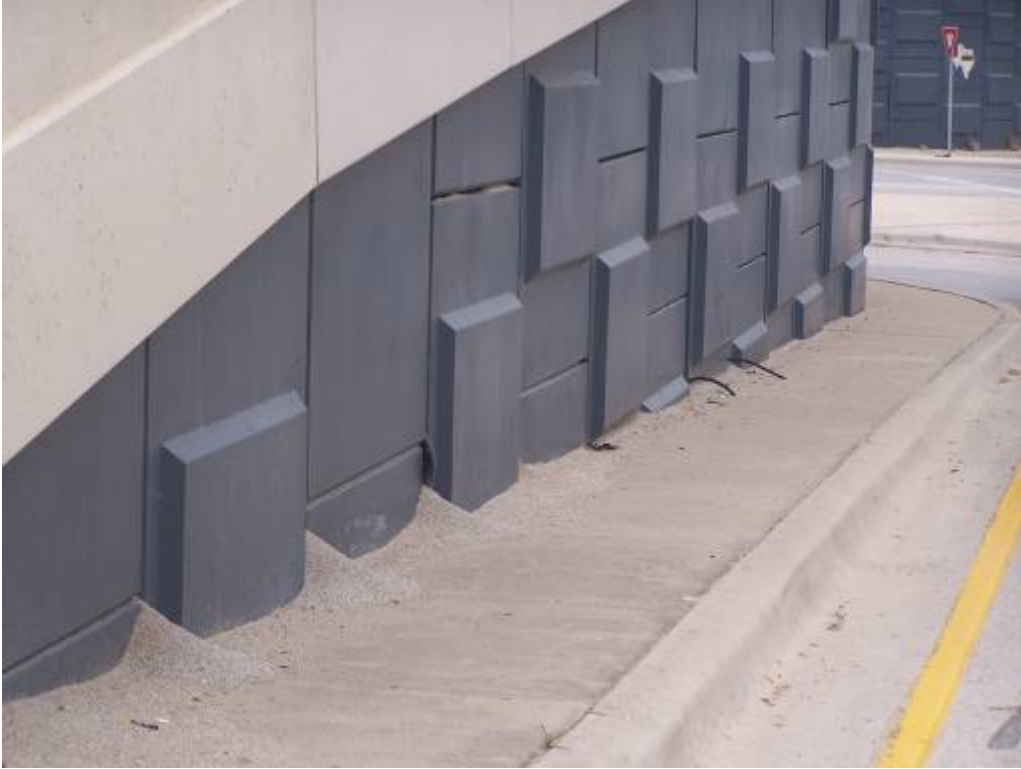
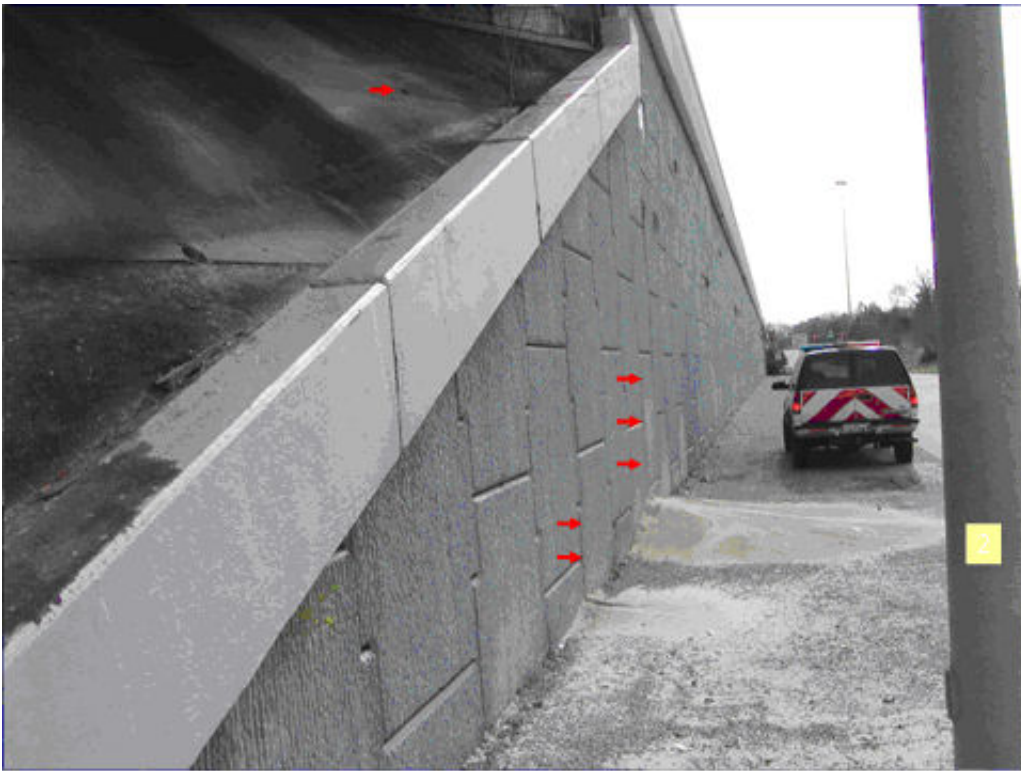
The problem is caused by surface water entering the top of the wall and then transporting select material out through joints or other openings in the wall. Incidence of backfill loss is most commonly associated with very fine, uniform "sugar sands" that were allowed in past specifications, although some more recent cases have involved coarser backfills.

Mounds of select backfill appearing at the base of a wall after heavy rains are likely to signal backfill loss. As the problem becomes more advanced, voids form behind the wall face, sometimes causing precast panels to shift outward due to loss of anchorage, and causing roadways above the wall to settle due to loss of support. In extreme cases, portions of roadways and concrete riprap have ultimately collapsed into voids up to several cubic yards in size.

Examples of MSE retaining walls exhibiting loss of select backfill

The solution to the problem is to identify all areas where water is entering a wall and then seal those locations to prevent further infiltration. The site of infiltration can often be above the area where backfill is being found at the base of the wall. Sealing these areas may require regrading of the ground behind the wall, repair of flumes, or extensive sealing of flume and coping joints. As a rule, use either silicone or hot rubber sealers to seal joints.

Fill any identified voids to restore structural integrity and stop further loss of material. TxDOT recommends Flowable Backfill (Item 401) for filling these voids, although some districts have used expandable foam (Uretek) for the same purpose. Locate voids by probing from the surface and from the face of the wall. For more detailed mapping, use Ground Penetrating Radar or coring and visual inspection.
