NATIONAL TRANSPORTATION SAFETY BOARD

MARINE INCIDENT SUMMARY REPORT

NEAR GROUNDING OF THE LIBERIAN TANK SHIP *PATRIOT*
BAY OF CAMPECHE, MEXICO
OCTOBER 15, 1995

Vessel: Tank ship *Patriot*, Liberian registry, LR9006904, 798 feet long, 53,772 gross registered tons, built 1992

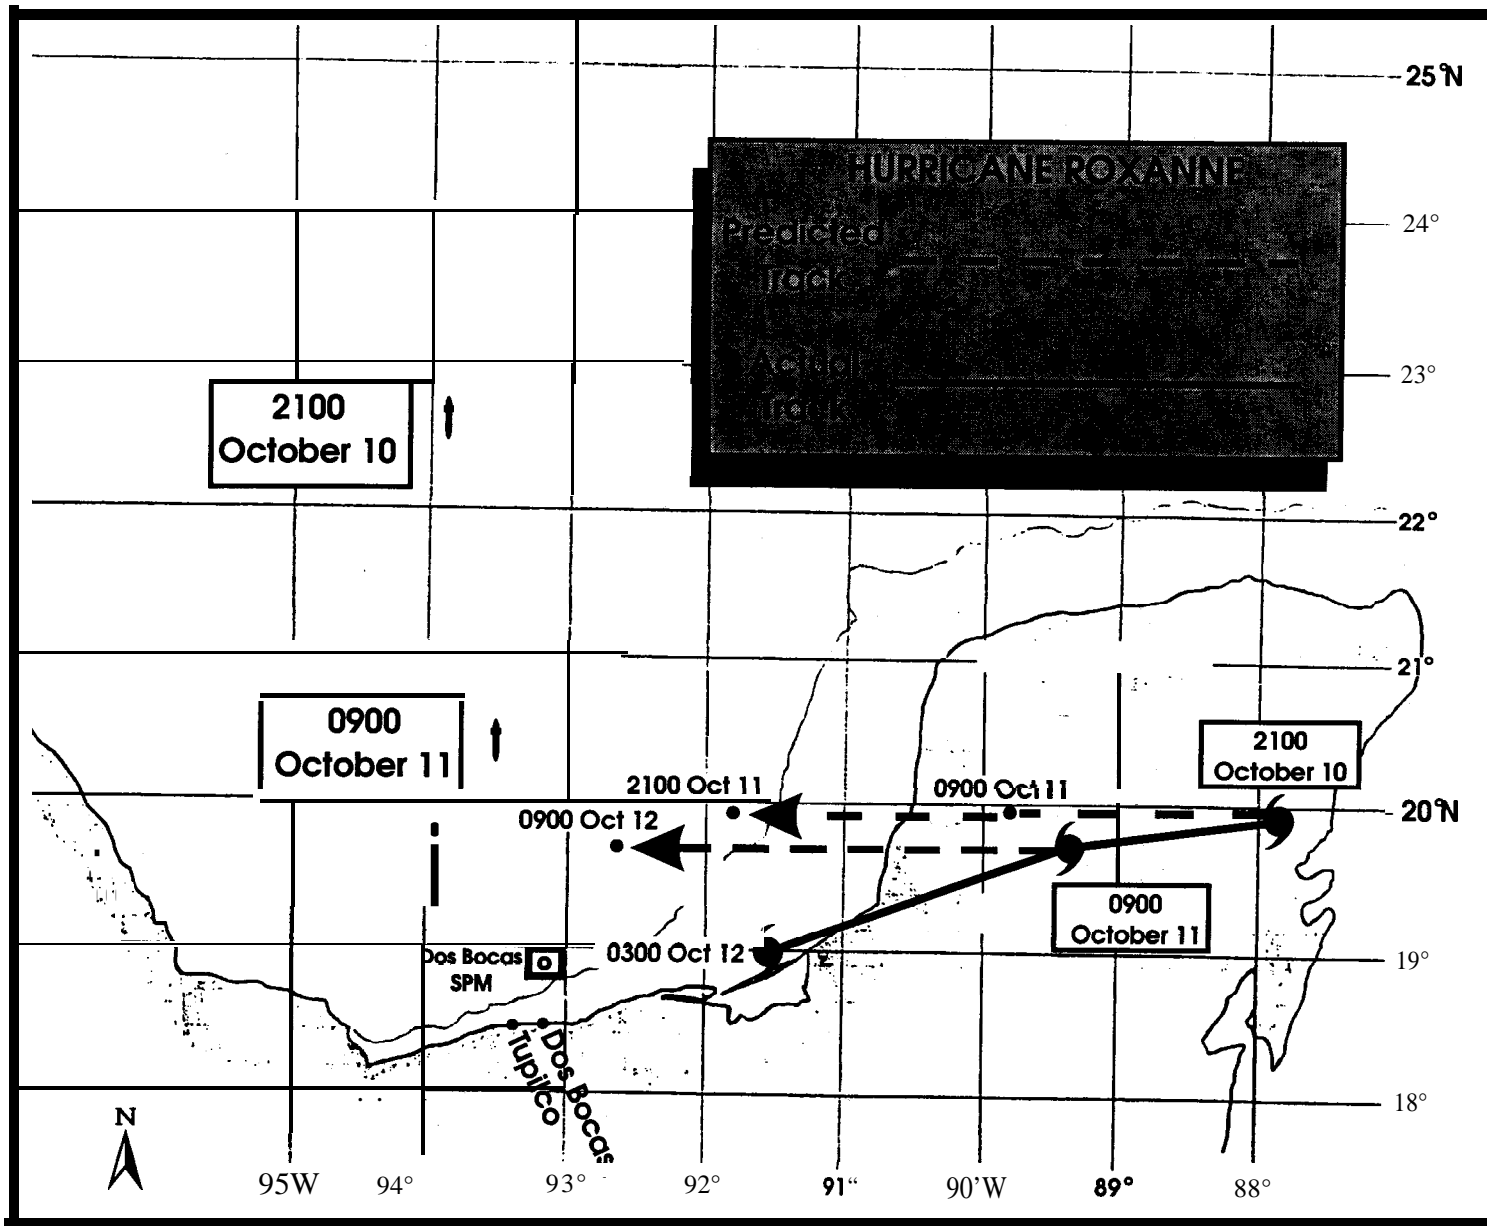
At 0853 on October 11, the agent⁴ at Dos Bocas sent telexes to Conoco Shipping Company's main office in Houston and to the master of the *Patriot*, informing them that the port was closed because of gale-force winds⁵ from Roxanne and that weather forecasts were predicting even stronger winds later that day. The message to company headquarters was received by the company's vessel coordinator, who passed it on to his supervisor, the director of chartering and traffic. The director of chartering and traffic passed the information to members of the company's tanker operations optimization team (TOOT).⁶ The company took no further action. The message to the master asked that he provide the agent with the vessel's position, as well as his intentions. After checking the latest NWS forecasts, the master notified the agent that he intended to continue the voyage to Dos Bocas. (See figure 5.)

Figure 5- Relative positions of *Patriot* and Hurricane Roxanne when hurricane made landfall (2100 on October 10) and when *Patriot's* master made the decision to continue voyage toward Dos Bocas (0900 October 11)

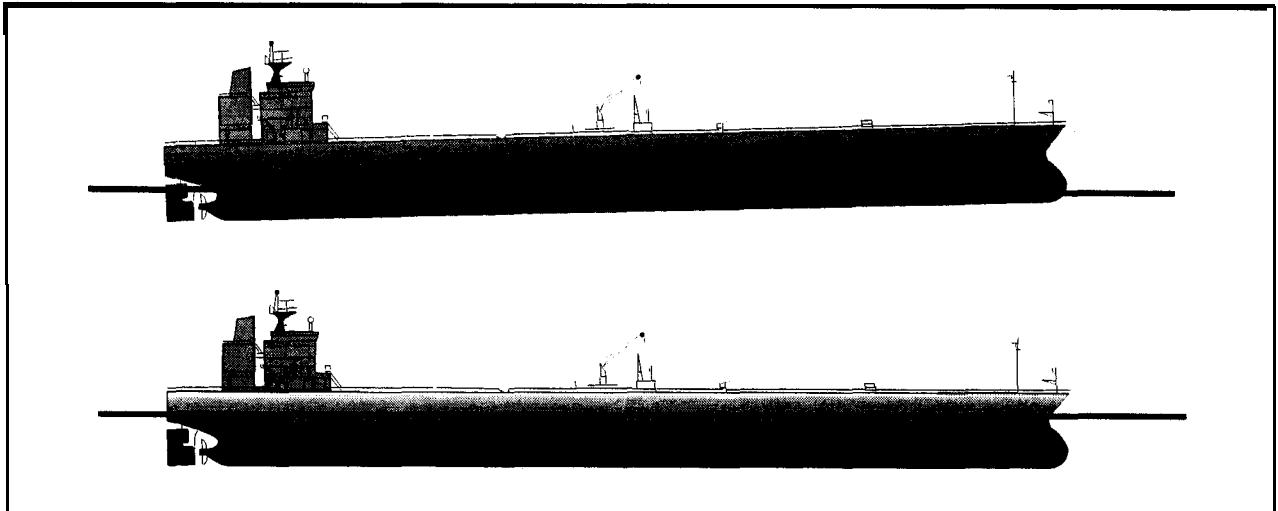
The master was aware that one alternative for dealing with the overspeed condition was to load storm ballast into one or more of the vessel's cargo tanks.⁹ Additional ballast would increase the vessel's draft and reduce the magnitude of rolling and pitching, thereby allowing engine rpm to be increased without creating an overspeed condition. (See figure 6.) At 0715 on October 12, the master ordered his

Figure 6- Approximate draft of Patriot-class tank ships when operating in light ballast condition (top) and when fully loaded (bottom)

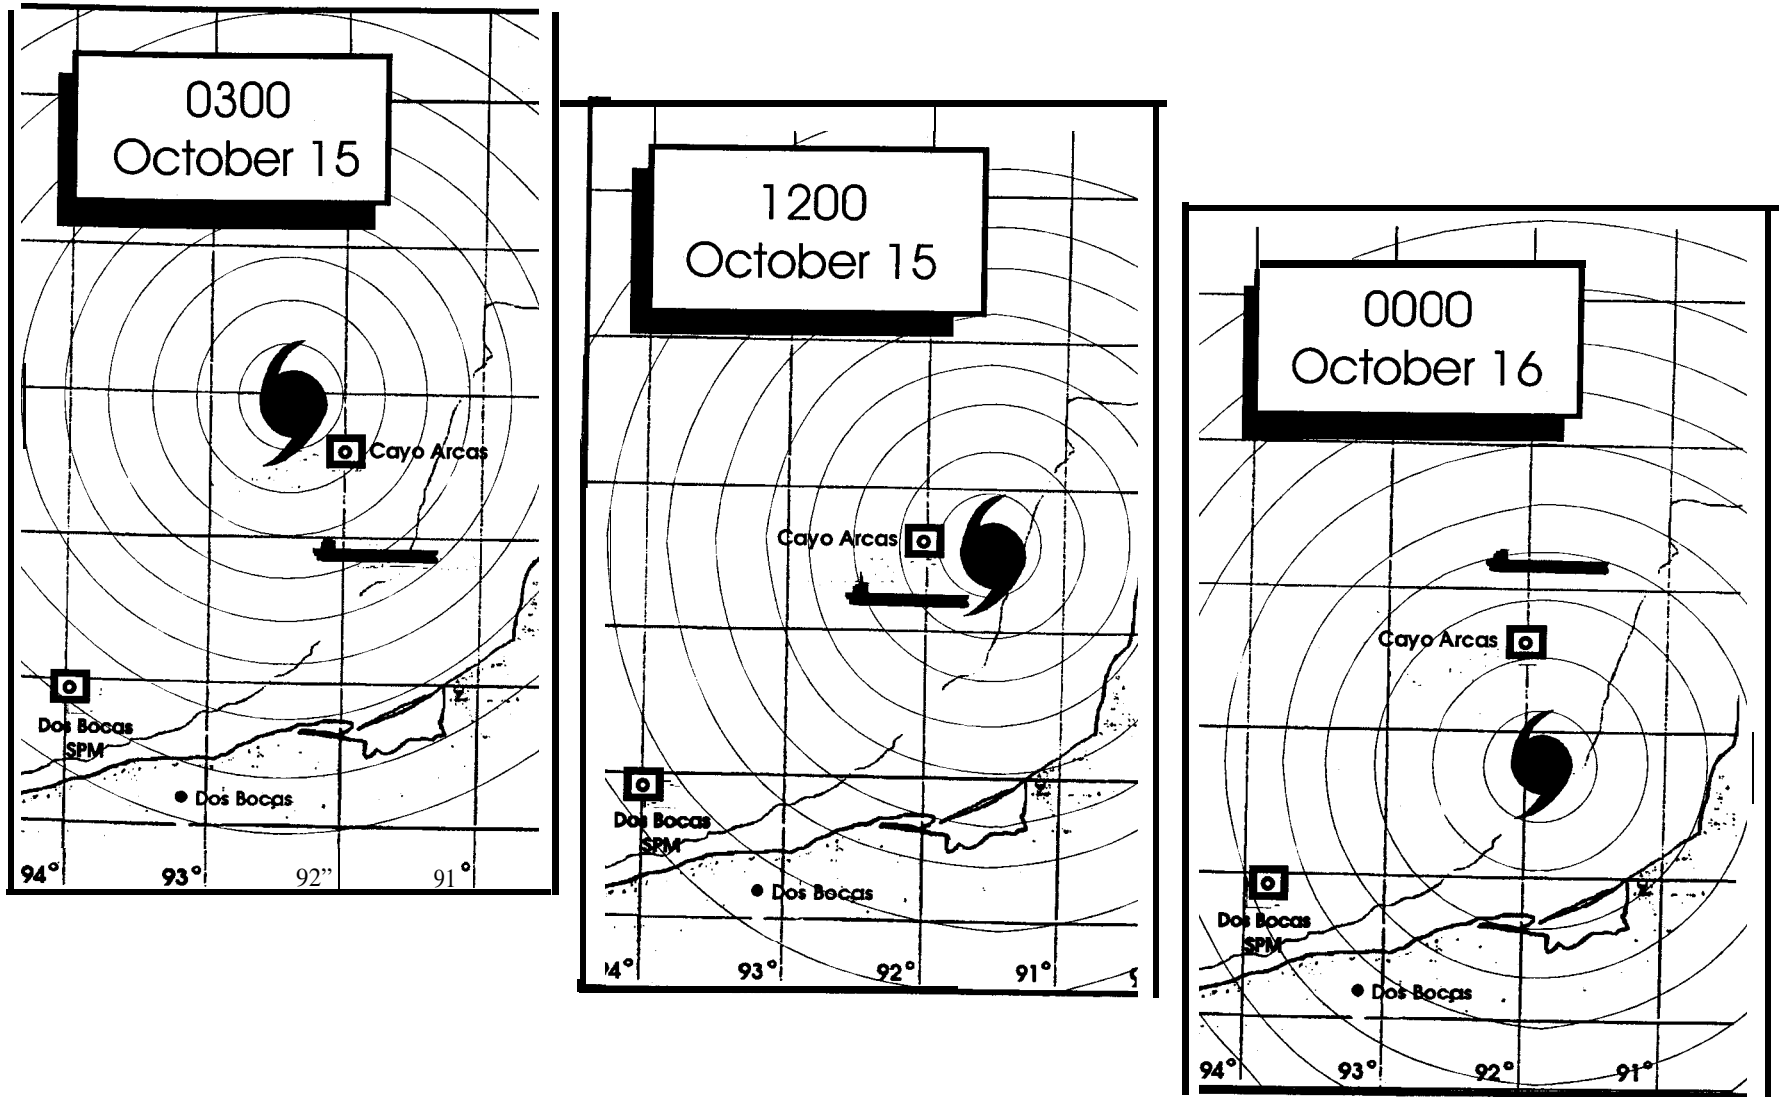
because the *Patriot* was essentially hemmed in between the storm and the shore with no easy avenue of escape (see figures 7 and 8), the master turned the vessel into the wind and waited for conditions to improve. During the early morning of October 15, watchstanders reported winds in excess of 130 knots and rough seas that caused the vessel to roll and pitch heavily. At 0421, the main engine once again went into an overspeed condition and shut down. Although the engine was quickly restarted, engine speed had to be limited to about 50 rpm.

Figure 7- Relative positions of *Patriot* and Hurricane Roxanne during the tank ship's most serious encounter with the storm
