# NATIONAL TRANSPORTATION SAFETY BOARD

## MARINE ACCIDENT REPORT

**GROUNDING OF THE LIBERIAN PASSENGER SHIP *STAR PRINCESS* ON POUNDSTONE ROCK, LYNN CANAL, ALASKA, JUNE 23, 1995**

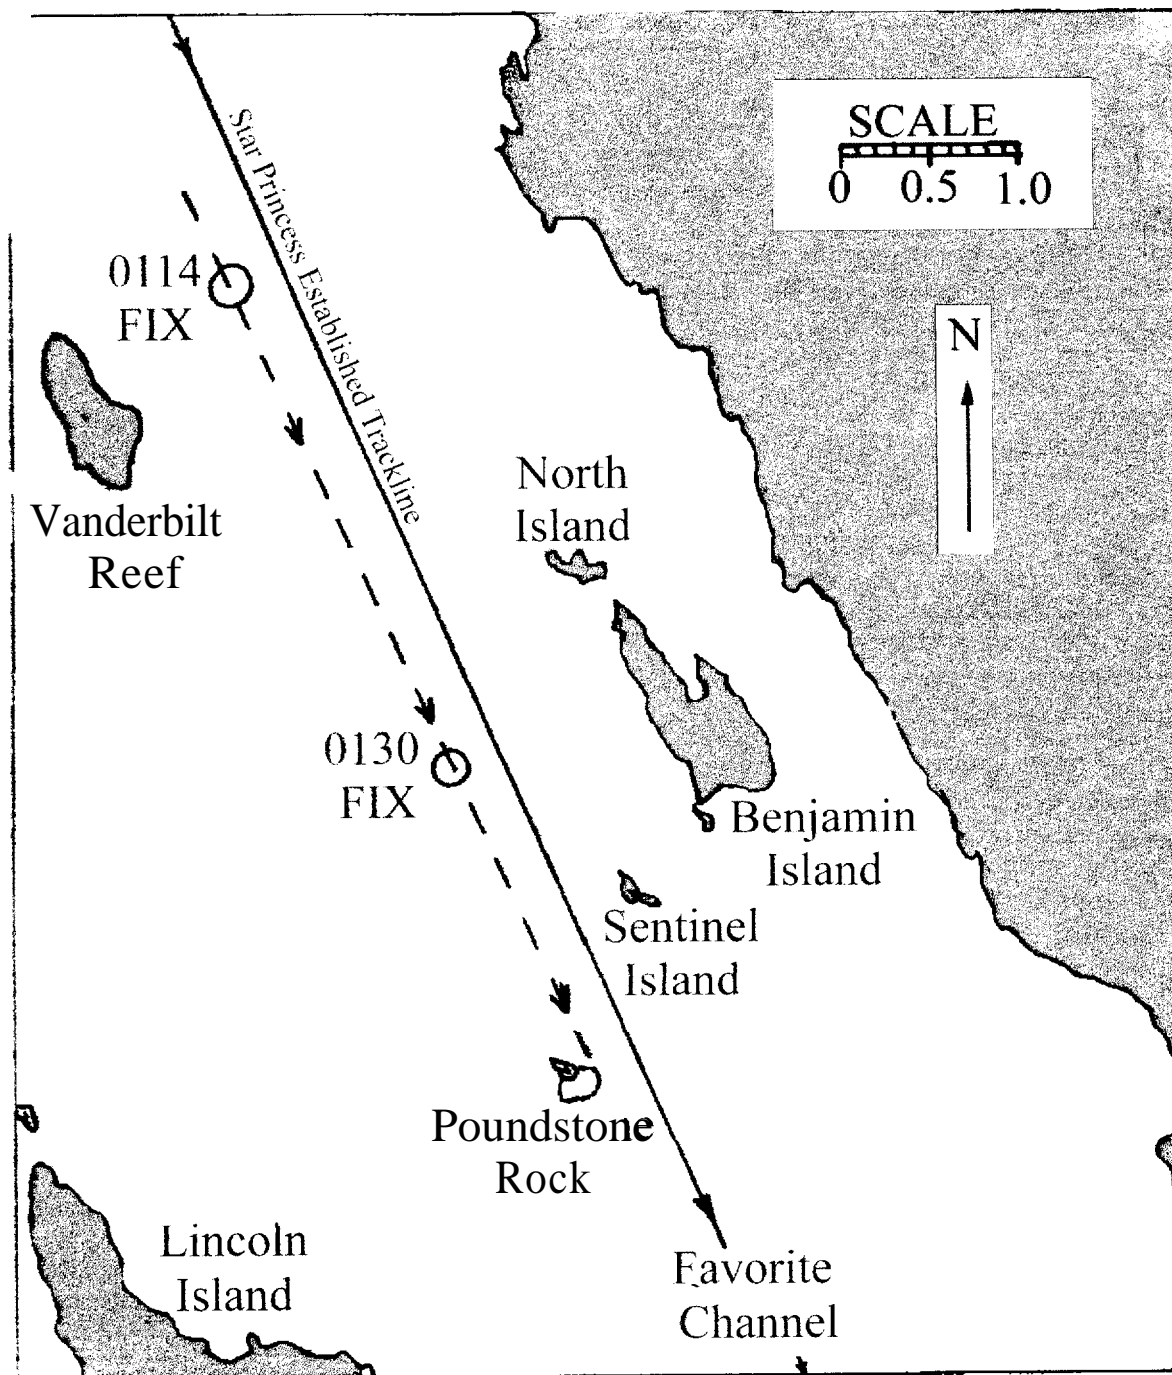
Figure 5. – Established trackline of the *Star Princess* compared with the actual trackline of the *Star Princess* (scale in miles)

A cross current (a combination of water current from the tide ebbing and the light winds) probably did move the vessel to the west during the 26 minutes before the accident, as indicated by the comparison of the course steered and the course made good. The plot of the track shows that the *Star Princess* remained on a steady heading toward Poundstone Rock, rather than being offset from the buoy as the pilot had intended when he turned to course 155°T at 0116. Although the vessel was steering a course of 155°T, the effects of the current caused the vessel to actually make a course of about 158°T. Consequently, the 3° difference between the course steered and the trackline indicates that the vessel did encounter a cross current along its track. The current setting the ship westerly toward the rock, however, calculates only to about 1/2 knot, not the strong current that the pilot later speculated might have occurred. Such a weak current acting on the vessel before the grounding might have set the ship somewhat toward the rock, which an effective pilot would have taken steps to counteract.

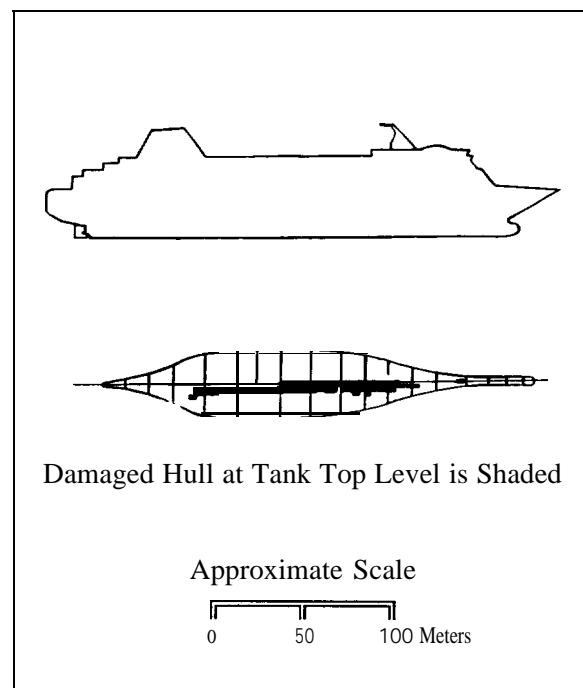
Figure 7. – Approximate areas of damaged hull plate replaced or repaired

The vessel sustained damage to the keel and the starboard hull bottom. The hull had two 8-inch-wide tears — one 40 feet long and the other 100 feet long — amidships on the starboard side. Altogether, 22 fuel tanks, ballast (water) tanks, and cofferdams<sup>16</sup> were damaged. The starboard propeller blades sustained damage and required repair. (See figure 7, showing damaged hull plate areas.)
