NATIONAL TRANSPORTATION SAFETY BOARD

MARINE ACCIDENT REPORT

**ALLISION OF THE LIBERIAN FREIGHTER
BRIGHT FIELD WITH THE POYDRAS STREET
WHARF, RIVERWALK MARKETPLACE, AND
NEW ORLEANS HILTON HOTEL IN
NEW ORLEANS, LOUISIANA
DECEMBER 14, 1996**

**Adopted: January 13, 1998
Notation 6885A**

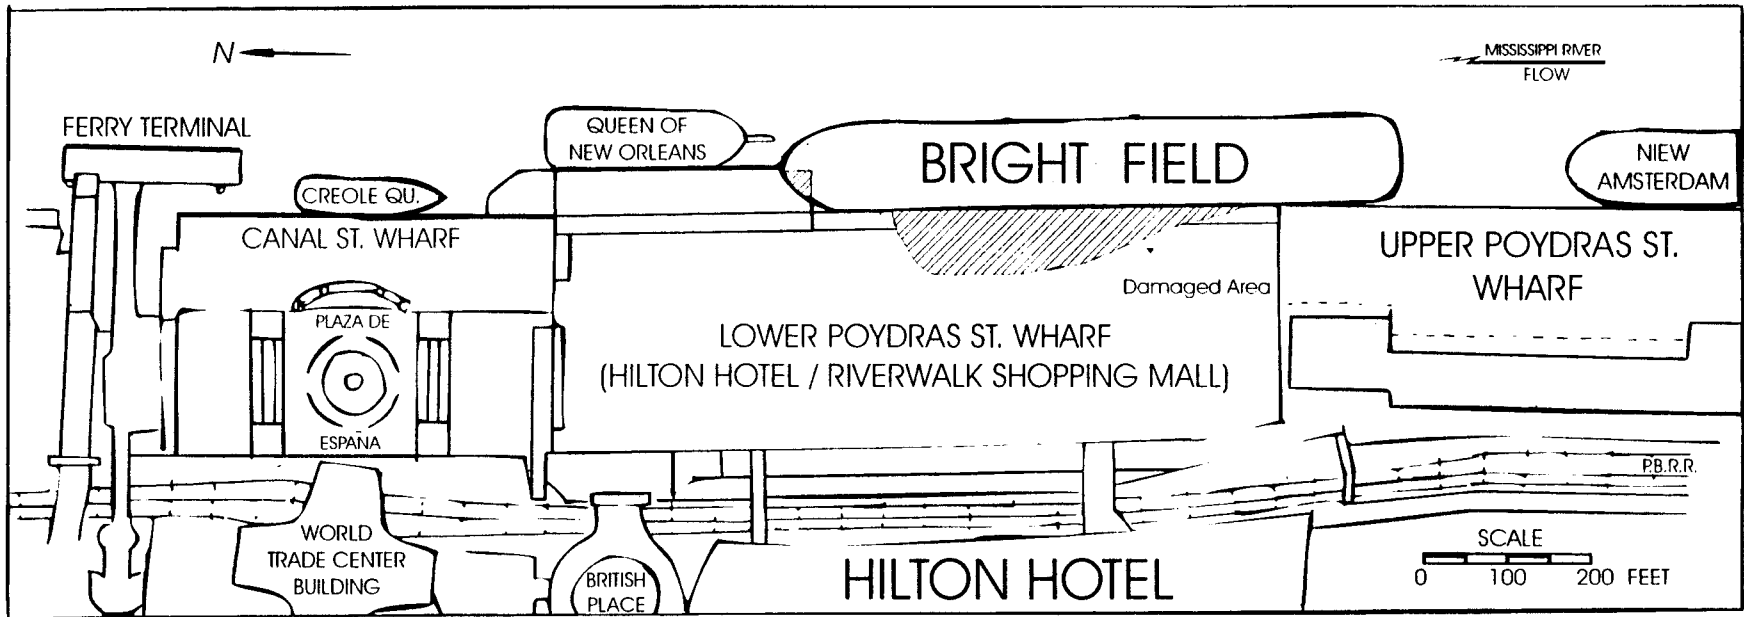
Figure 6 -- Final rest position of *Bright Field*

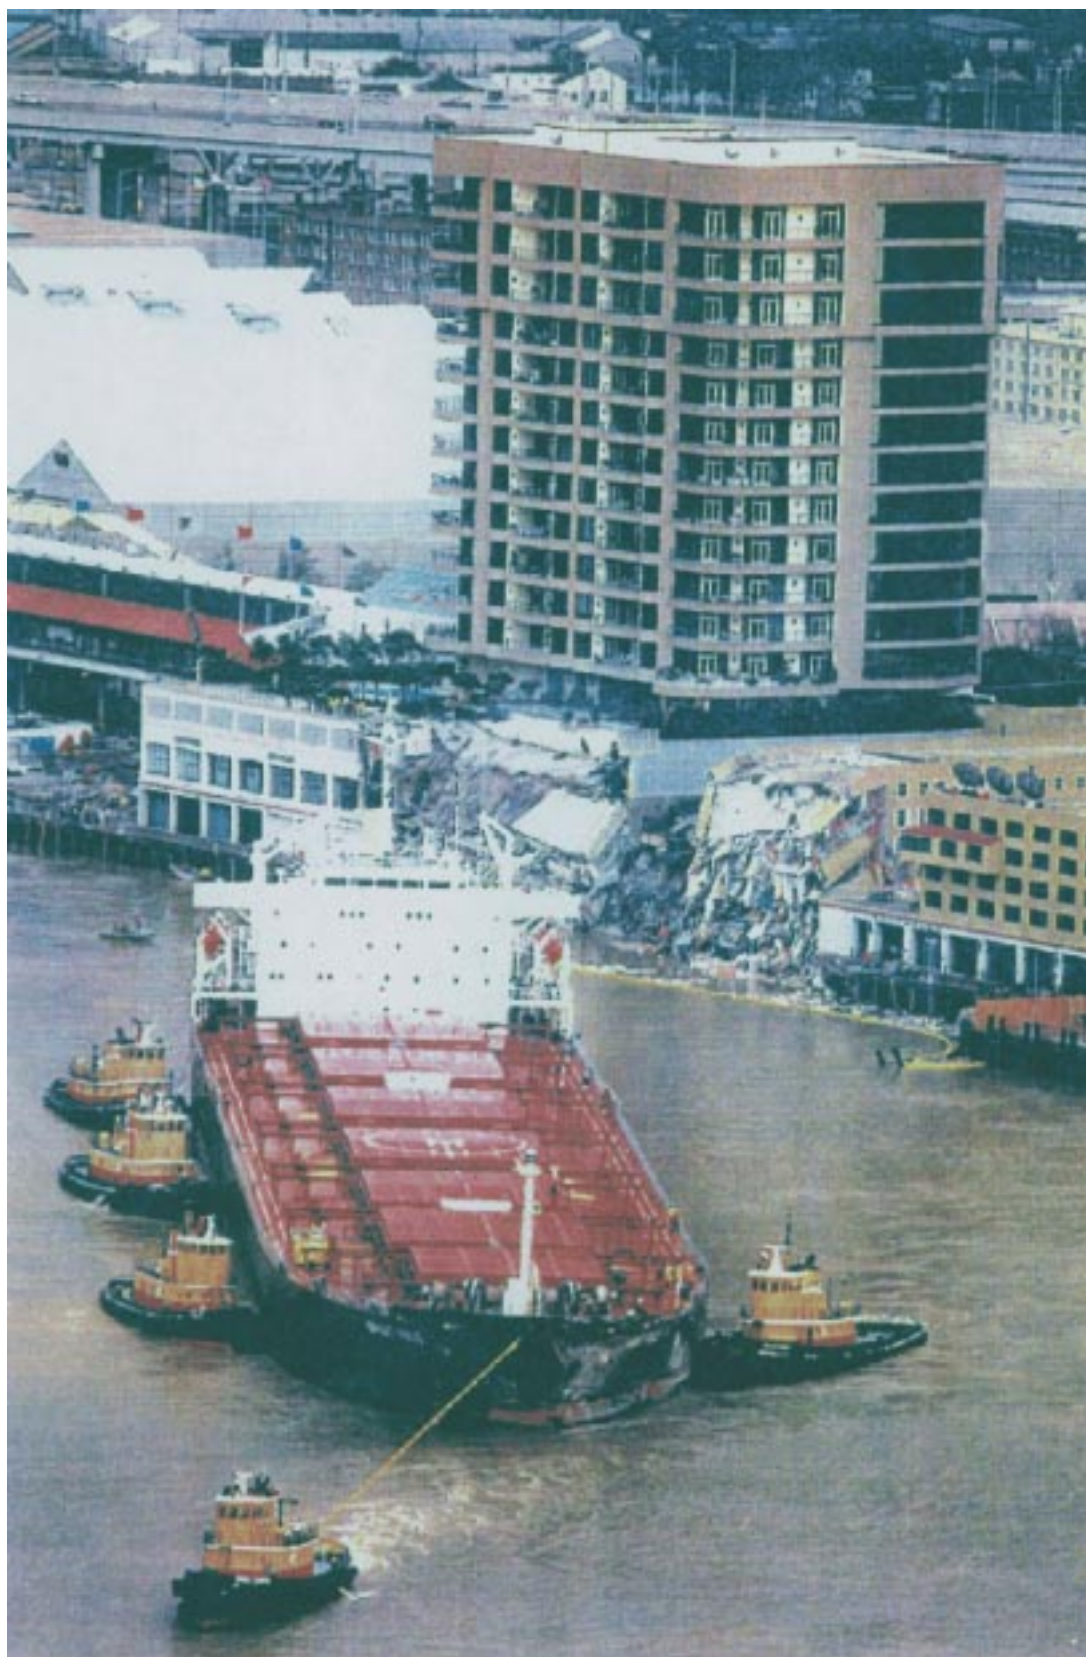
After striking the wharf, the bow of the *Bright Field* grated along the concrete and steel wharf structure for a distance of about 600 feet. The allision damaged the port side of the bow. The hull of the vessel sustained two horizontal gashes about 100 feet long that penetrated the port side of the ship and extended down the port side from the fore peak (bow) ballast tank and into the No. 1 cargo hold. Both the breached fore peak tank and the No. 1 cargo hold flooded. A diver found a 100-foot section of the forward hull resting on the river bottom adjacent to the Poydras Street wharf. Total damages to the *Bright Field* were estimated to be about \$2 million. (See figure 7.) The vessels that had been docked in the allision area did not sustain significant damage.

Figure 7 -- Damaged Bright Field being towed away from Poydras Street wharf en route to repair facility, January 6, 1997

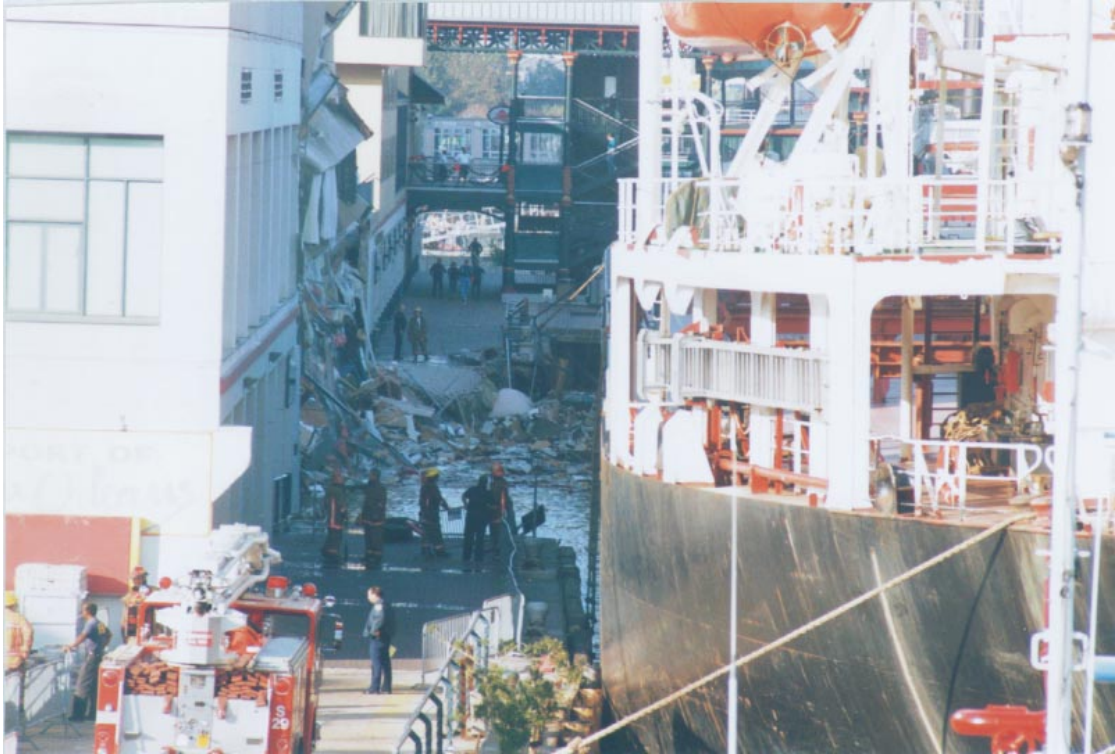
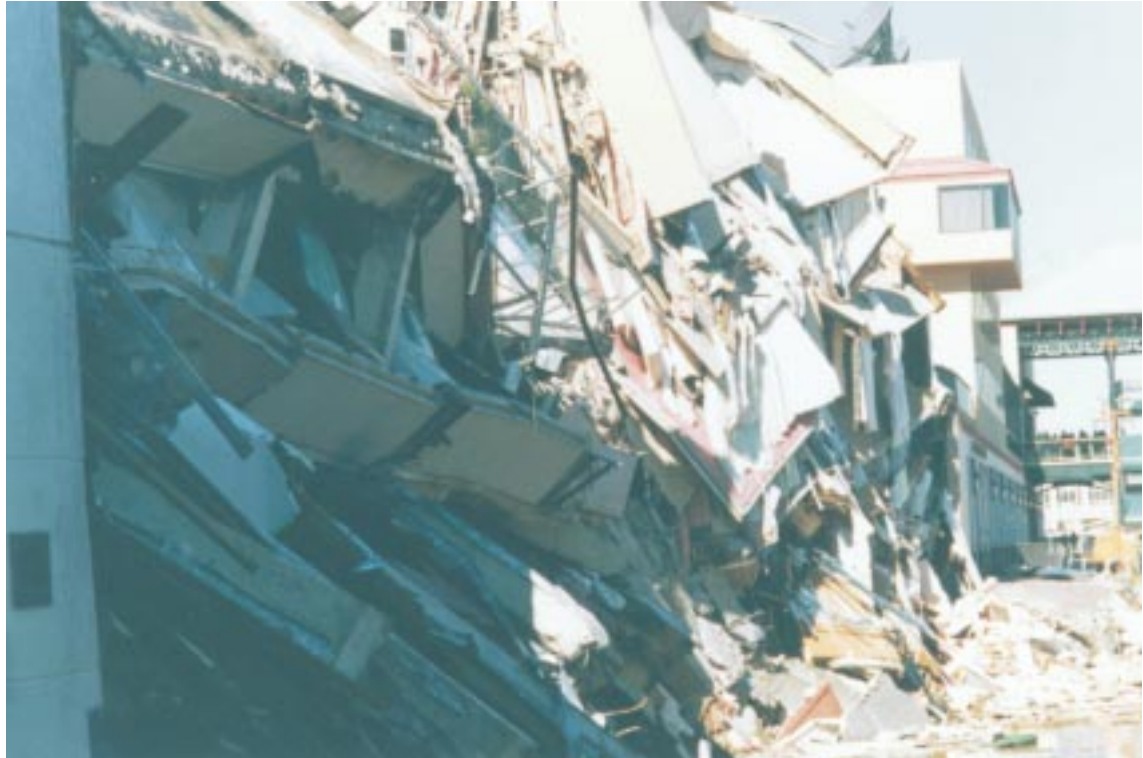
The One River Place condominium building, located on the Poydras Street wharf, sustained damage to its valet parking garage. Residents of the building were evacuated because of a loss of power and water. The Riverwalk Marketplace, a mall with 100 stores, 3 restaurants with outdoor seating, and a large wharf walkway, sustained damage to more than 350 feet of its wharf frontage. About 10 percent of the mall shops and restaurants were affected. The New Orleans Hilton Riverside Hotel, part of which was situated on the Poydras Street

wharf, sustained damage to 40 of its 1,600 rooms. Total damages to all facilities were estimated to be about \$18 million. (See figures 8 and 9.)

Figures 8 and 9 -- Postaccident scenes

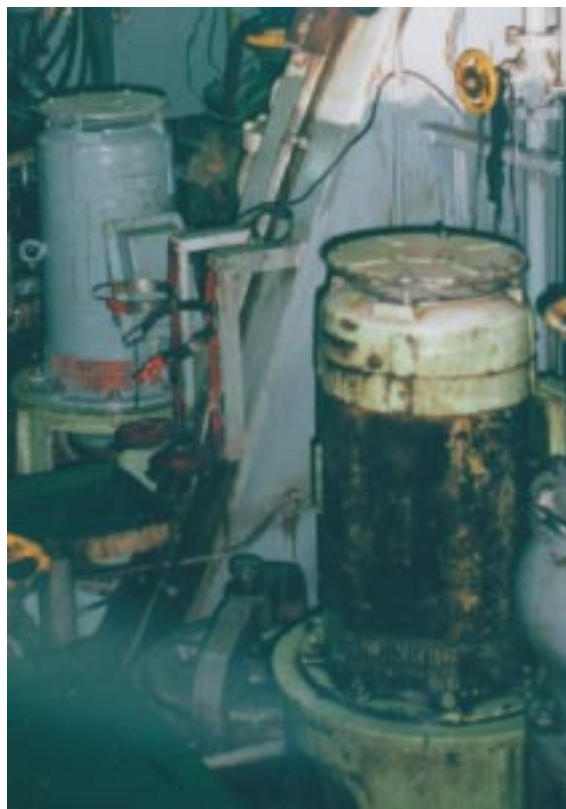
The chief engineer told the second mate that he did not know the reason for the sudden drop in the No. 1 oil pump pressure, but since the No. 2 pump had already come on line, the pressurization problem was solved. Neither the master nor the second mate attempted to clear the trip condition and restart the engine, and thus restore rpm, from the bridge controls. The chief engineer and the second mate mutually agreed to transfer engine control to the engine control room, and the chief engineer began the process of restoring engine power. He said that engine rpm quickly reached about 52 rpm, after which rpm continued to increase to about 60. According to alarm logs, main engine power was restored to the vessel at 1408, about 2 minutes after the logs indicated that the main engine had tripped.

Figure 10 -- *Bright Field* No. 1 (left) and No. 2 lubricating oil pumps

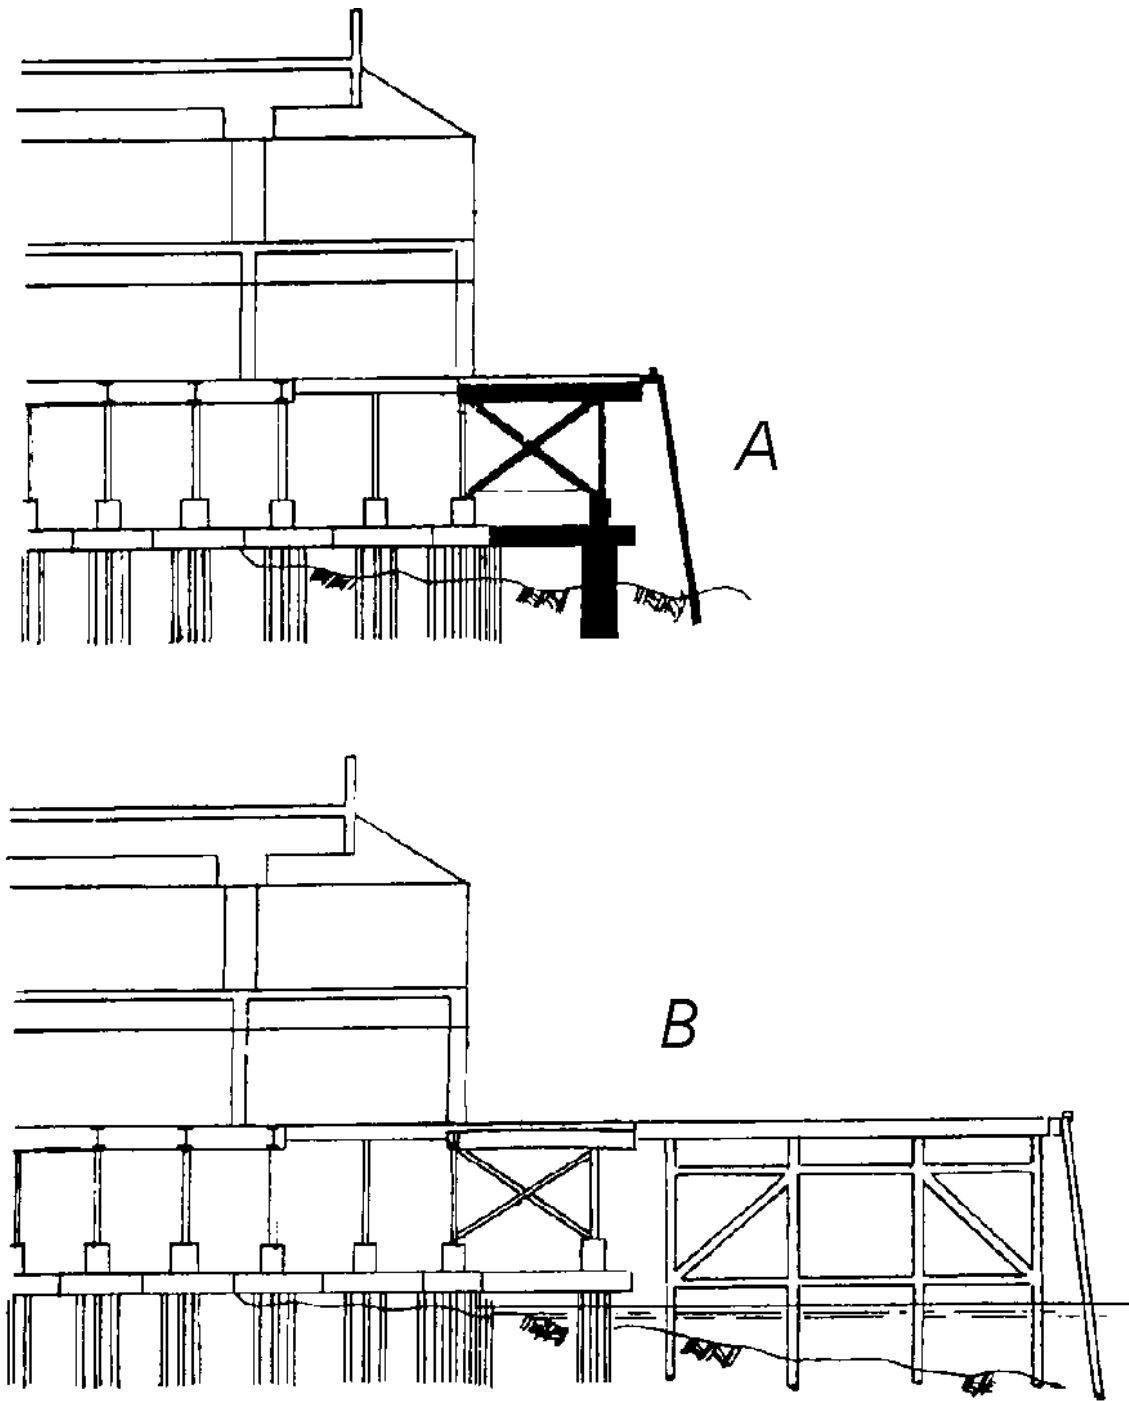
Figure 11 -- (A) Profile of wharf at impact location
(B) Wharf extension to accommodate gaming vessel
