Ramming of the Eads Bridge by  
Barges In Tow of the *M/V Anne Holly* With  
Subsequent Ramming and Near Breakaway  
of the *President Casino on the Admiral*  
St. Louis Harbor, Missouri  
April 4, 1998

**NTSB/MAR-00/01  
DCA98MM027  
PB2000-916401  
Notation 7009B  
Adopted September 8, 2000**

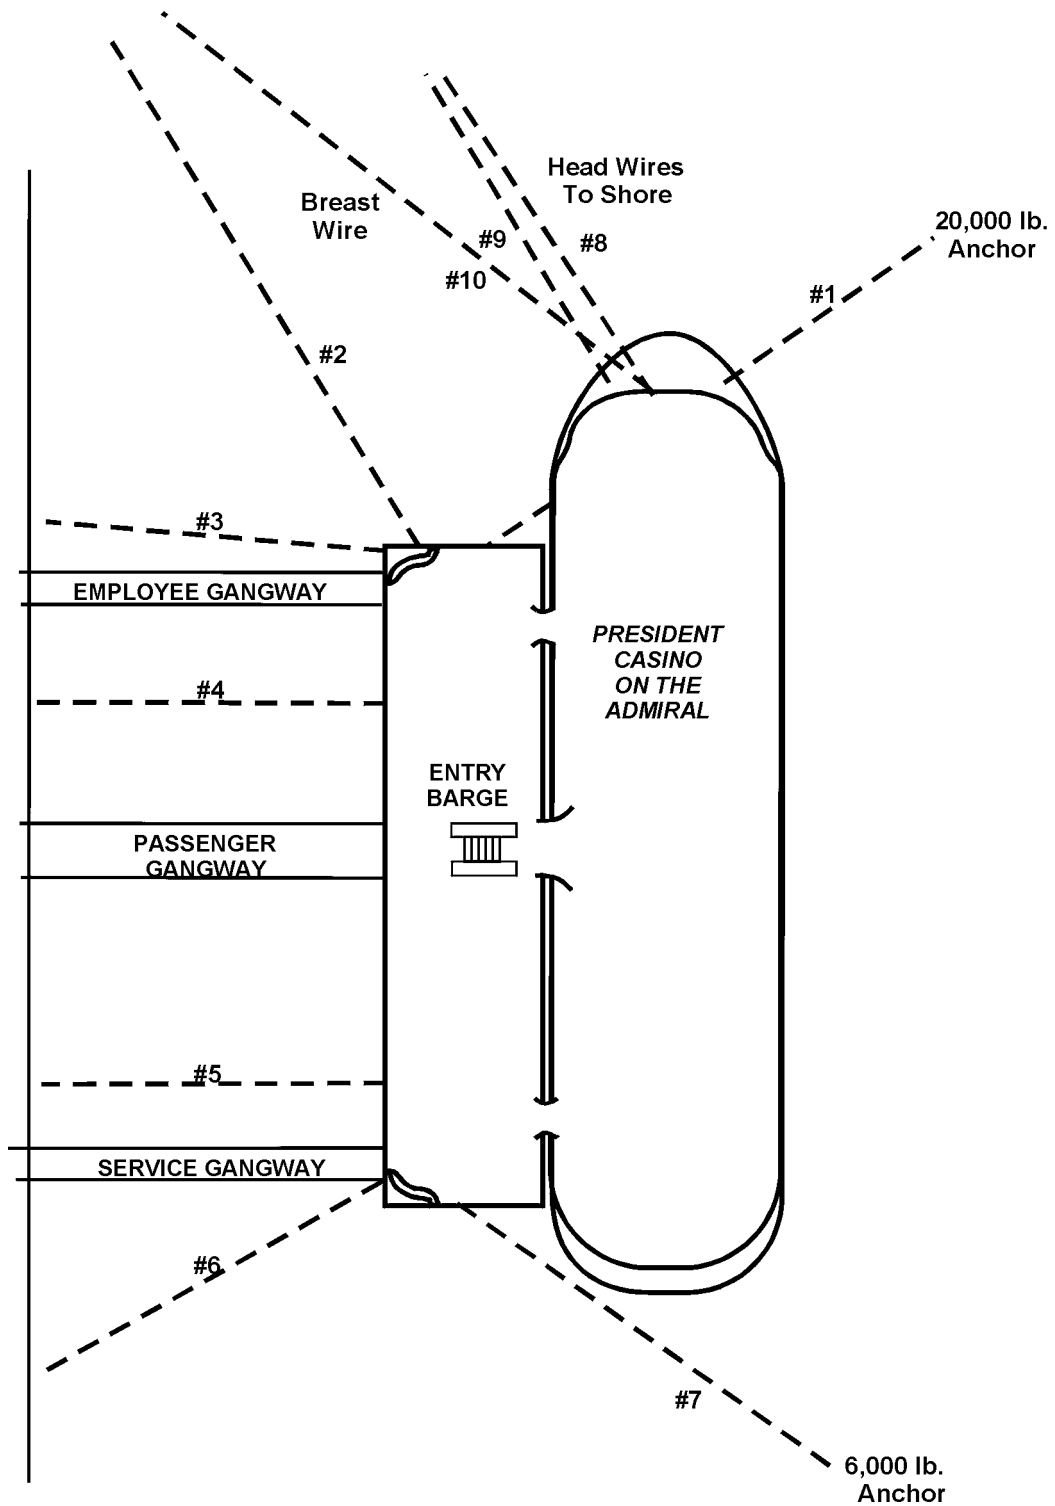
Figure 5. Schematic of the *Admiral* mooring arrangement

Shortly thereafter, the three barges from the *Anne Holly* drifted toward the *Admiral* and severed or severely damaged mooring line numbers 8, 9, and 10 at the *Admiral*'s bow, before colliding with the *Admiral*. At least two of the three barges struck the *Admiral*, and two barges drifted downriver. The third barge drifted toward shore and struck the sidewalk protection guards and the north gangway between the shore and the entry barge. The impact to the *Admiral* caused wire rope numbers 1, 2, 3, 4, and 5 to break. (Figure 5 details the mooring arrangement. Figure 6 shows two views of the complex.)

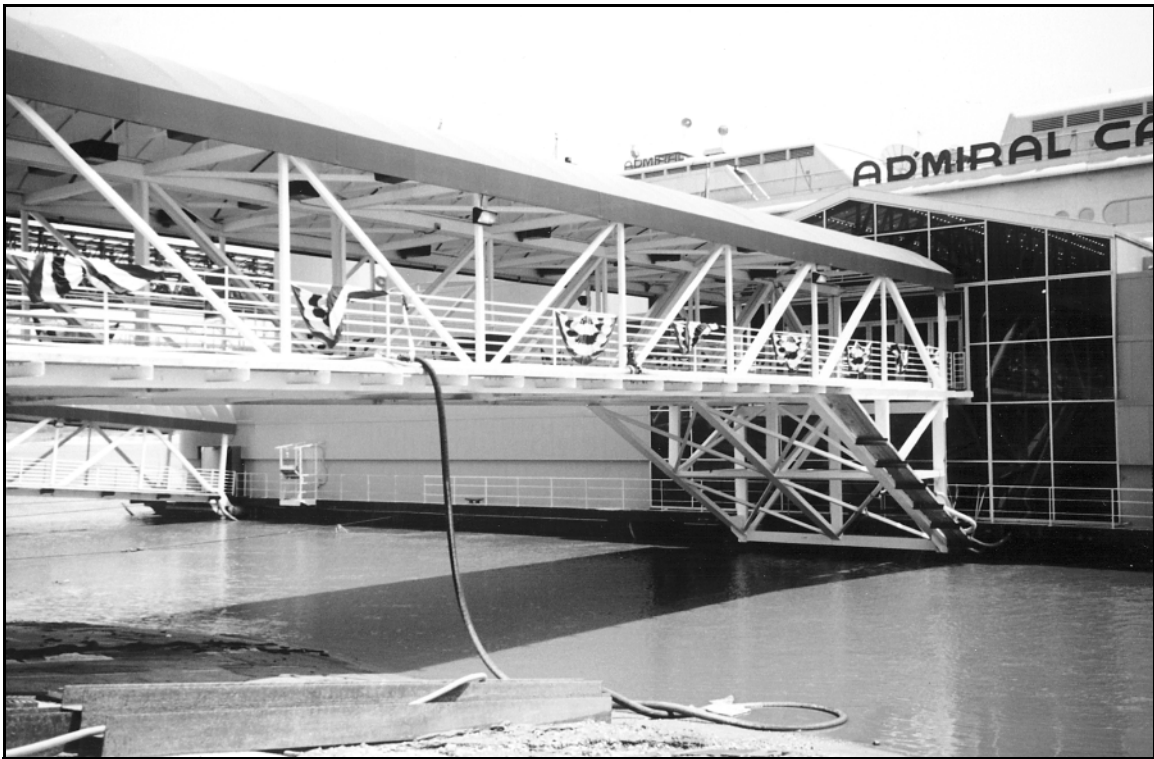
**Figure 8.** Center (passenger) gangway to the *Admiral*

Almost immediately, the *Admiral* began moving offshore and slowly rotated with the current clockwise downriver, away from the Missouri shoreline. The three gangways (which remained attached to the entry barge) were damaged, and the *Admiral*'s electrical, natural gas, telephone, and water service lines parted about 1954.<sup>13</sup>

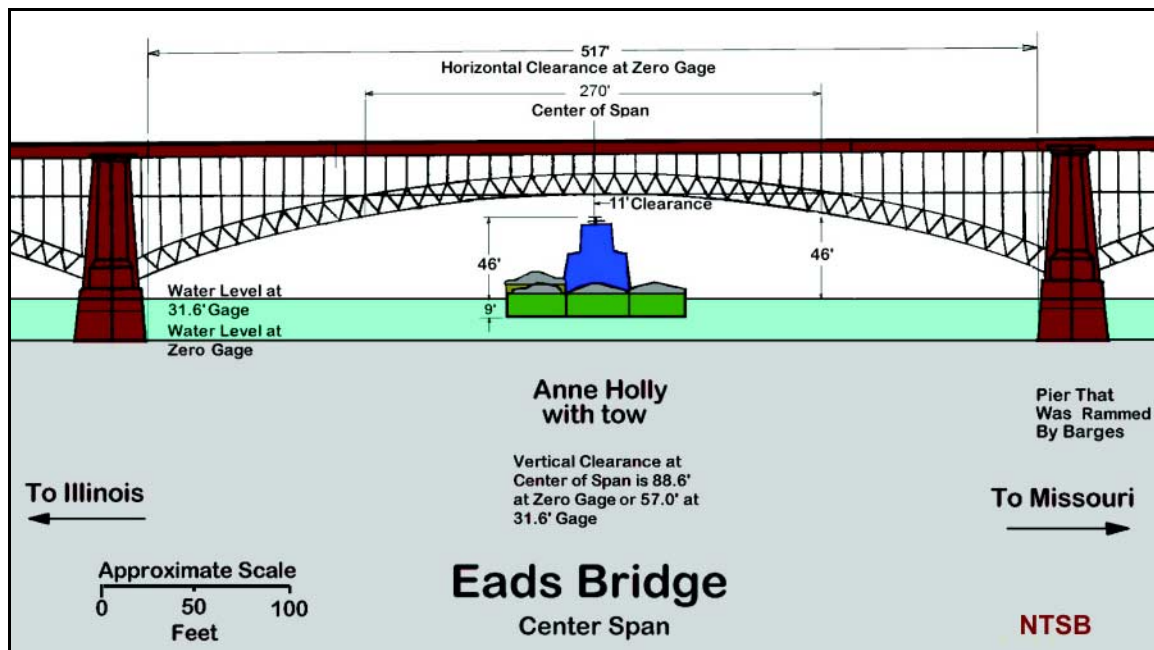
**Figure 10.** Schematic view of the *Anne Holly* tow under the Eads Bridge. (This figure is not representative of the actual path taken by the *Anne Holly*. The figure is used for illustrative purposes only, to show the heights of the bridge and the *Anne Holly*.)

down proportionately on each side of the arch. The bridge’s red day markers were each 150 feet from the center of the bridge, leaving a horizontal space of 300 feet between them. At the time of the accident, 42.2 feet was between each marker and the river surface. Given its air draft, the *Anne Holly* required a minimum of 46 feet of vertical clearance. The flood conditions reduced the vertical clearance under the side portions of the Eads Bridge main arch so that a center navigation area of about 270 feet had 46 feet or more of vertical clearance. (See figure 10.)
