MARINE ACCIDENT REPORT

FIRE ON BOARD THE
U.S. PASSENGER FERRY *COLUMBIA*
CHATHAM STRAIT
NEAR JUNEAU, ALASKA
JUNE 6, 2000

**NTSB/MAR-01/02
PB2001-916403
Notation 7292A
Adopted September 18, 2001**

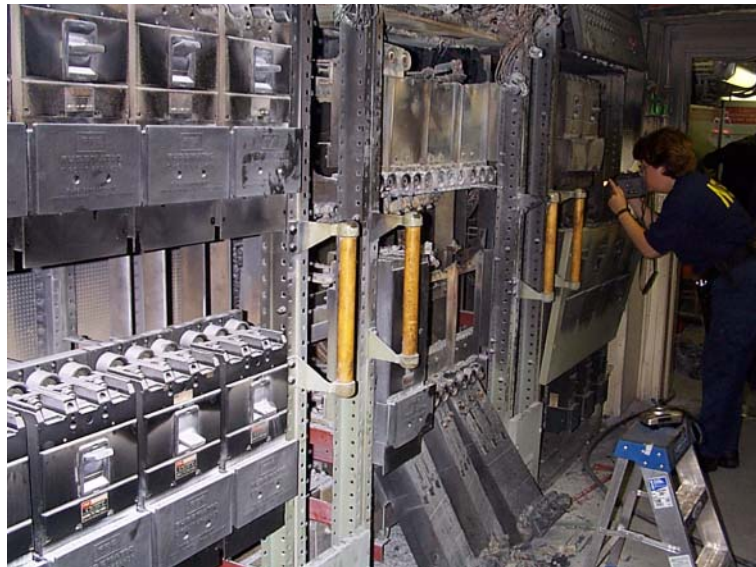
Damage to the *Columbia* was limited to the control room. A thin film of soot covered nearly all the surfaces within the room, and a video monitor used for surveillance was partially melted, as was a plastic light diffuser on one of the fluorescent light fixtures above unit 10 of the main switchboard. The main switchboard itself suffered the most serious and extensive damage. Most of the damage occurred in units 9, 10, 11, and 12 (all closest to the starboard end of the switchboard). (See figure 6.) Units 1 through 8 did not exhibit any evidence of electrical arcing and had minimal fire damage other than the sooting mentioned above.

Figure 6. Units 8, 9, 10, 11, and 12 of the main switchboard. The Safety Board investigator is examining unit 12.

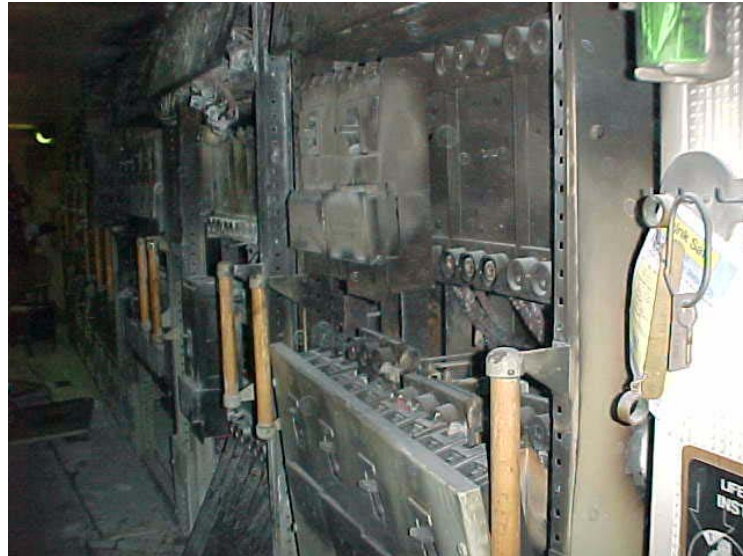
The interior side of the unit was covered with soot, heavy at the top and moderate toward the bottom. (See figure 7.) The top two-thirds of the interior had burned and blistered paint on the framing and the sides.

Figure 7. Unit 12. Photograph courtesy of the AMHS.

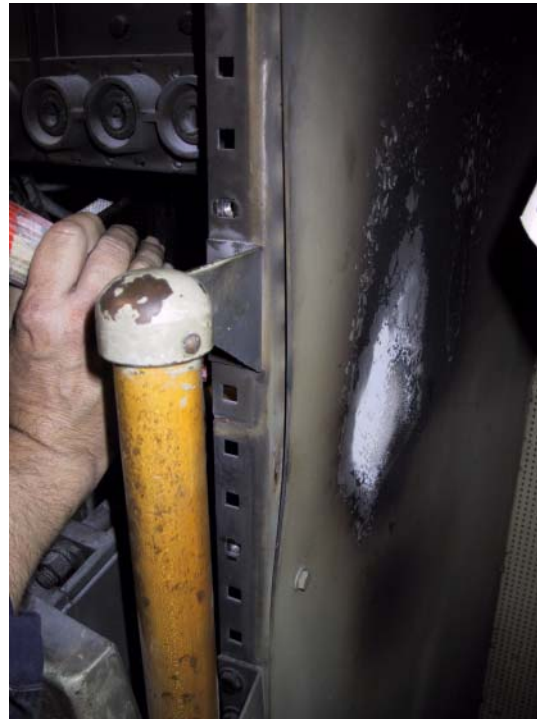
In addition, there was a 9-inch-high by 4-inch-wide spot of localized heating, where the paint was missing. (See figure 8.) On the exterior right side of the unit, a spot of localized heating measured 6 inches by 6 inches, and the paint was white and powdery. The feed and load wires for the entire unit were intact, with only heat damage to the insulation. The insulation on the wires that went to the lower row of breakers was sooted and showed no evidence of heat damage. The unit's cover was burned and paint was missing in places on the interior. The exterior of the cover had no significant damage.

Figure 8. Closeup of heat damage to unit 12.
Photograph courtesy of the U.S. Coast Guard.

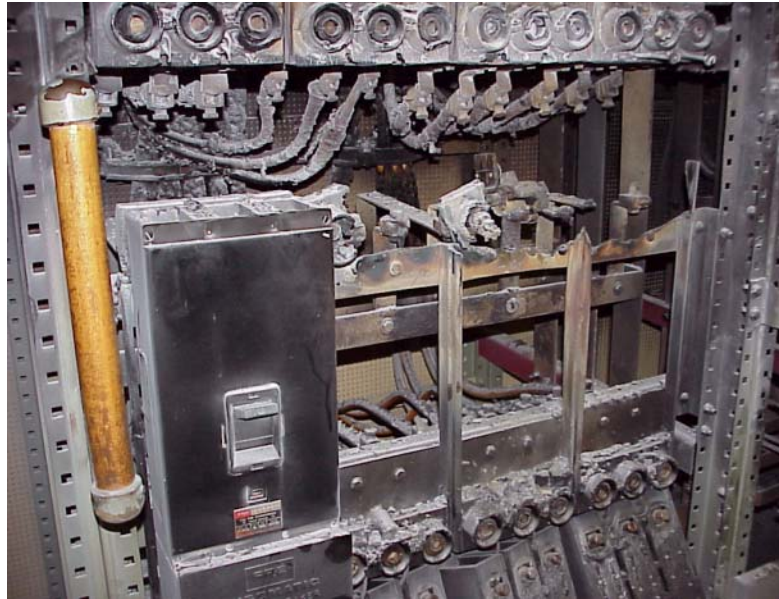
The top two-thirds of the unit framing was burned and heavily sooted; the paint was missing. (See figure 9.) The lower third was sooted but otherwise undamaged. The compartment above the unit was warped.

Figure 9. Unit 10. Photograph courtesy of the U.S. Coast Guard.

At the top of the unit was a light indicator board with 40 lights, each of which was serviced by 110-volt wires. All of the light bulbs were melted out of the panel. The insulation on the wires was melted, but the wires were intact. There was no evidence of arcing on the wires. There was a 34-inch long by 3.5-inch wide hole in the 1/8-inch steel plate that separated this area from the breaker area of the unit. (See figure 10.) The edges were smooth. Investigators found no evidence of material drip-down on the components below. The steel was discolored from tan to gray in some areas and to black in others.

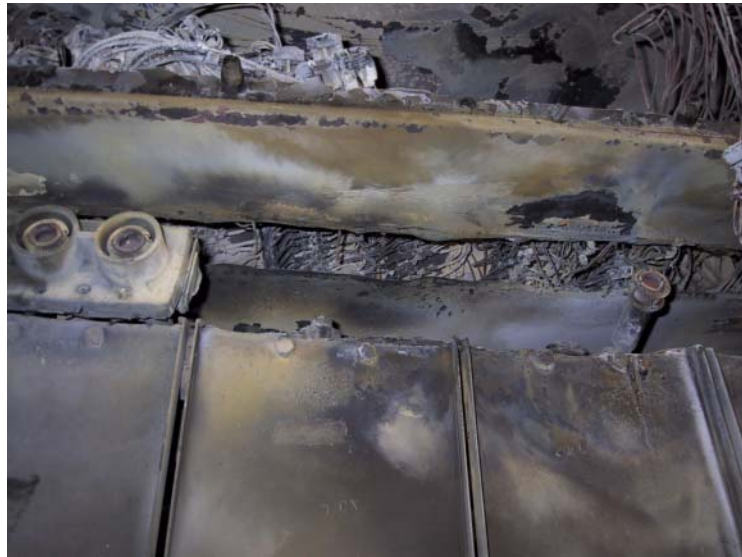
Figure 10. Closeup of hole in steel plate in unit 10.
Photograph courtesy of the U.S. Coast Guard.

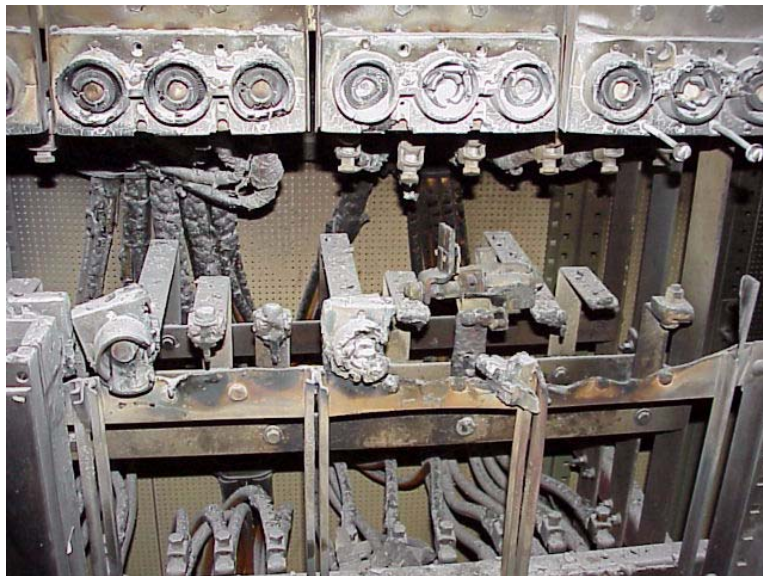
The unit was made up of two rows of breakers. The top row had four breakers. Four tulip-clip connectors were intact—three on the left and one fourth from the right. The rest of the bus bars were melted; both bus bar supports were delaminated in the front, and the breakers were not intact. (See figure 11.) The wires servicing this row were intact, but heat had heavily damaged the insulation.¹⁷

Figure 11. Damage to bus bars in unit 10.

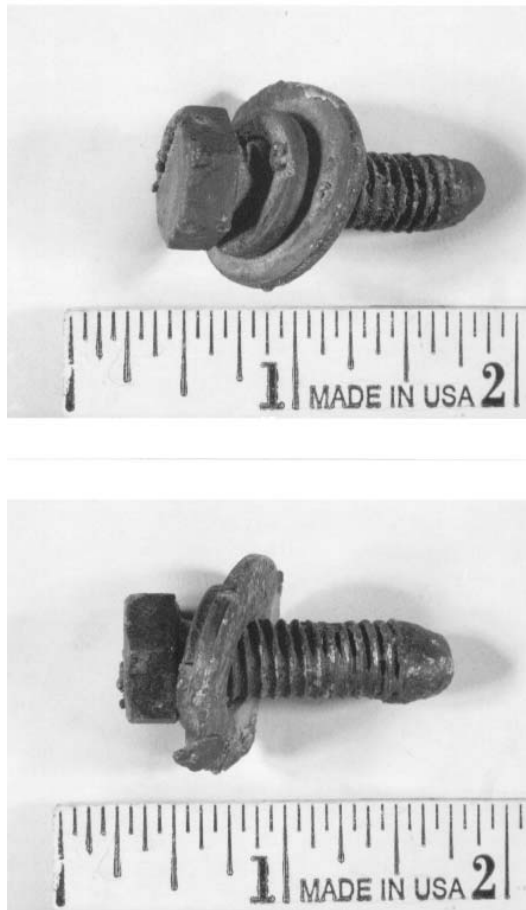
Investigators found a 3/8-inch diameter by 1 1/4-inch long steel bolt with an oversized flat washer and a lock washer lying on an angle support bracket on the lower portion of the unit. Arcing, melting, or spatter marks were present on the bolt and on both washers, and the bolt and washers appeared to have melted together.

The contractor, with the assistance of party representatives, thoroughly examined the switchboard and all of its components. During the investigation a steel bolt was found in unit 12 that was fused to two washers (mentioned earlier in the section on fire damage). (See figure 12.)

Figure 12. Bolt found on front (aft side) framework of switchboard.

For the bolt found in the switchboard, the copper that accumulated in the threads and between the washers and the bolt had little porosity and appeared to be consistent with molten flow. The edges of the washer and the threads were intact where the copper had accumulated. In contrast, the beaded areas in the intentionally arced bolt were porous and composed of molten steel. Also, the edges of the washer and the bolt's thread peaks were missing in locations where the molten material had accumulated, and there was an area of contact between the washer and the bolt. Because the damage to the subject bolt and washers was consistent with exposure to molten material, primarily copper, and did not appear consistent with arc damage, the Safety Board concludes that the bolt found in the switchboard was probably not the cause of the fire.
