**Capsizing of U.S. Small Passenger Vessel  
*Taki-Too*, Tillamook Bay Inlet, Oregon  
June 14, 2003**

**NTSB/MAR-05/02**

**Abstract:** This report discusses the June 14, 2003, accident in which the U.S. small passenger vessel *Taki-Tooo* capsized while attempting to cross the bar at Tillamook Bay, Oregon. A master, deckhand, and 17 passengers were on board the charter fishing vessel when it was struck broadside by a wave and overturned. The master and 10 passengers died in the capsizing; the deckhand and 7 passengers sustained minor injuries. The *Taki-Tooo*, with a replacement value of \$180,000, was a total loss.

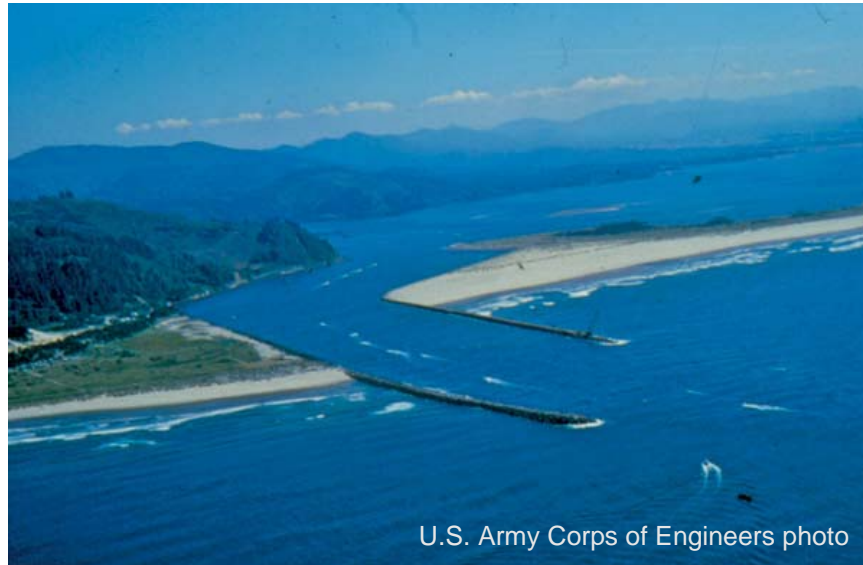
**Figure 2.** Looking southeast from Pacific Ocean toward Tillamook Bay, with inlet between north jetty (left) and south jetty (right). The Tillamook bar, not shown, is west of the jetty tips. The *Taki-Too* capsized outside the tip of the north jetty and washed up on the sandy beach on the left of the photo.

As noted earlier, the entrance to Tillamook Bay is protected by jetties on the north and south (see figure 2). According to the *U.S. Coast Pilot*, the north jetty is 1,900 yards long and extends 800 yards offshore, with the last 80 yards submerged.<sup>21</sup> A lighted whistle buoy sits in water over 100 feet deep about 1 mile west of the north jetty. The bar, a curved shoal where the water is less than 30 feet deep, lies between the jetty tips and the whistle buoy. Waves break over the bar on the ebbing tide, and the area is considered unpredictable and hazardous. The Oregon State Marine Board cautions boaters trying to cross the bar not to turn around if waves are breaking over it.<sup>22</sup>

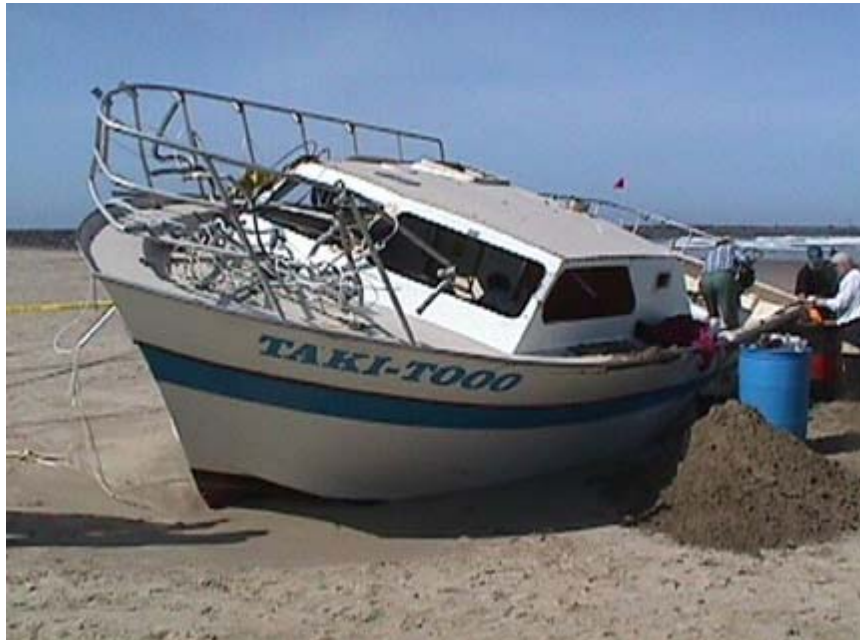
On Sunday, June 15, 2003, the day after the accident, an investigative group comprising a Safety Board investigator, a chief warrant officer from the Coast Guard, and a deputy from the Tillamook County sheriff's office conducted an on-site examination of the wreckage of the *Taki-Too*, which had been pulled onto the beach 3 hours after the accident (see figure 4). The flying bridge operating console was missing and never recovered. The deck railings on the bow were loose from their mountings.

**Figure 4.** *Taki-Tooo* on beach after capsizing.

In examining the vessel's propulsion and steering components, investigators found that the rudder and rudder post were solidly mounted and undamaged. The propeller shaft was straight and unremarkable; however, the propeller's four blades had minor nicks and scratches consistent with normal operation, given the age of the propellers. Investigators noted that the propeller blades were curled at the tips, so they had the propeller removed and sent to the Safety Board's materials laboratory in Washington, D.C., for detailed examination and documentation of damage. The results are described below, in the "Tests and Research" section.

The diesel engine was intact, with no signs of oil leaks or obvious signs of catastrophic failure. All fuel lines, fittings, and linkages were intact and attached. When manipulated at the lower helm station, the throttle and transmission control moved the throttle linkage throughout its range. The lower helm station wheel turned freely in both directions.

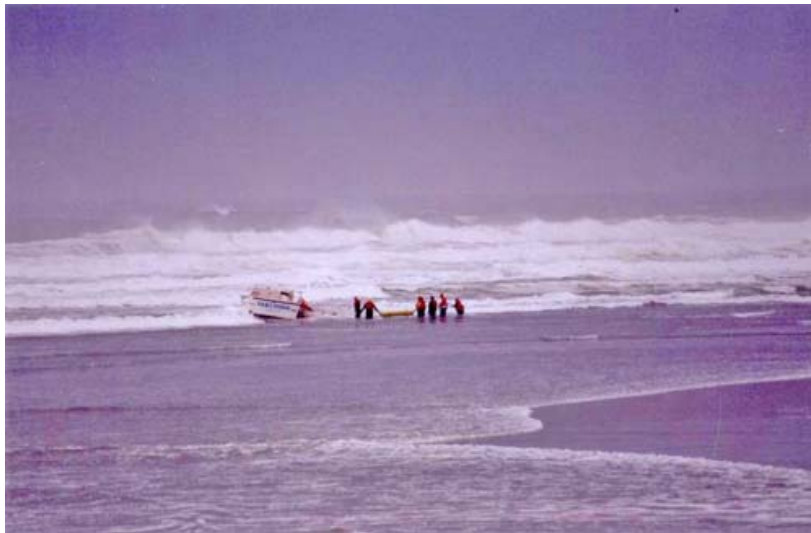
**Figure 5.** Rescue personnel near *Taki-Too* in surf after capsizing.

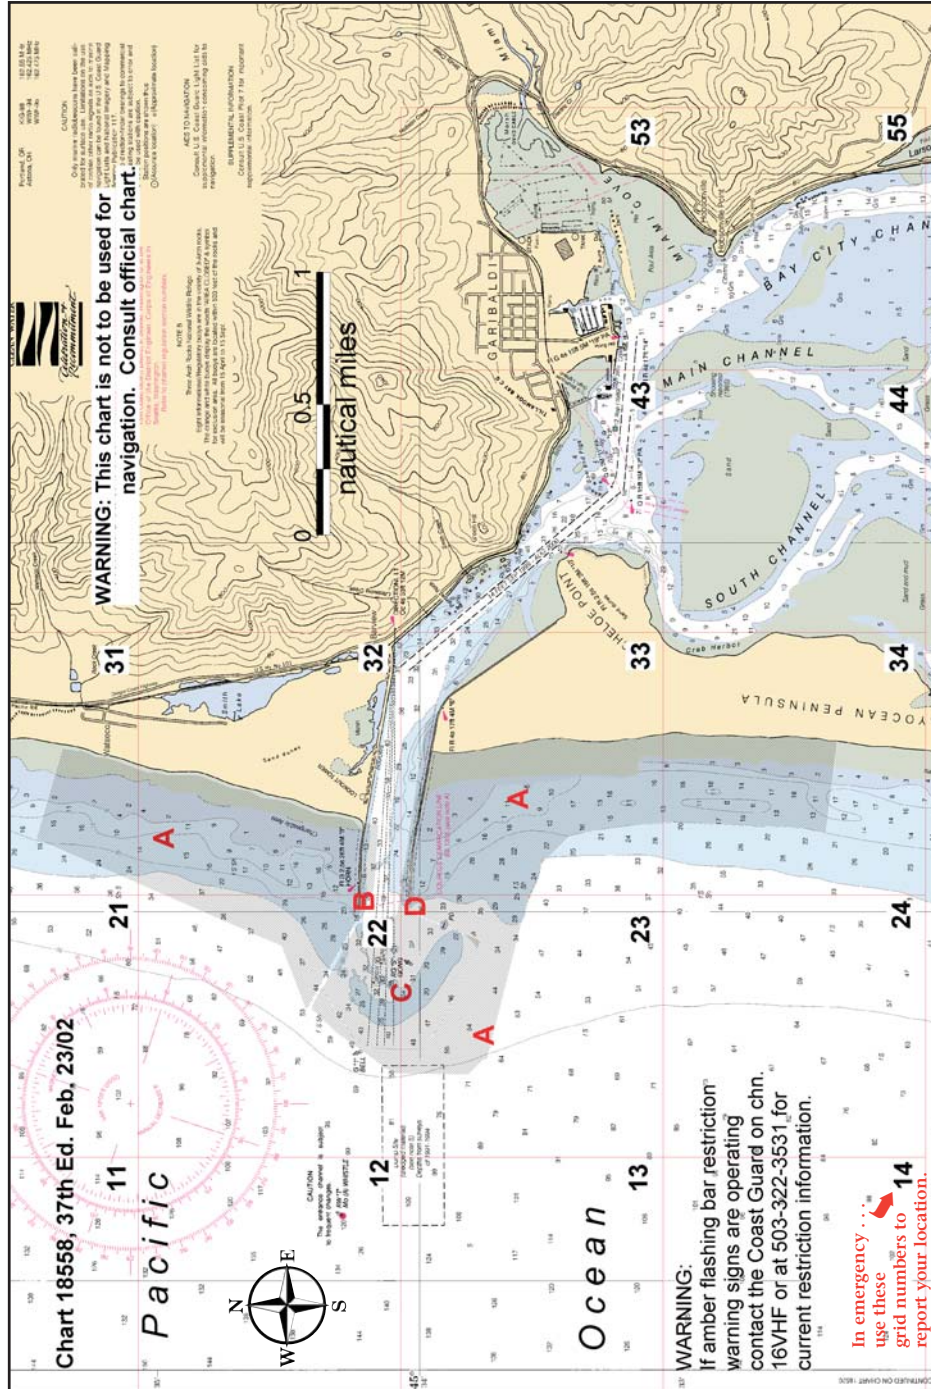
# TILLAMOOK BAY BAR DANGER AREAS

**A. Bar area.** The entire area between the beach and the 20-foot curve is bar area and breaks on the ebbing tide. The water runs out from four to six knots on the average and is very strong. Proceed on and stop in the channel and carefully evaluate the bar between November and April all vessels should avoid the area around Bell Buoy 1. This is extremely hazardous. The bar area is consistently changing.

**B. North jetty.** Approximately 100 yards of the seaward end of the north jetty is submerged. This, and all areas immediately adjacent to the jetty are extremely dangerous and should be avoided. About the last 150 yards of the outer tip of the North jetty is curving towards the Tillamook Bay Channel. Do not proceed north or south until you are well clear of the submerged jetty (approximately 200 yards seaward of the jetty tips).
