Fire Aboard Construction Barge *Athena 106*  
West Cote Blanche Bay, Louisiana  
October 12, 2006

ACCIDENT REPORT

NTSB/MAR-07/01  
PB2007-916401

# Marine Accident Report

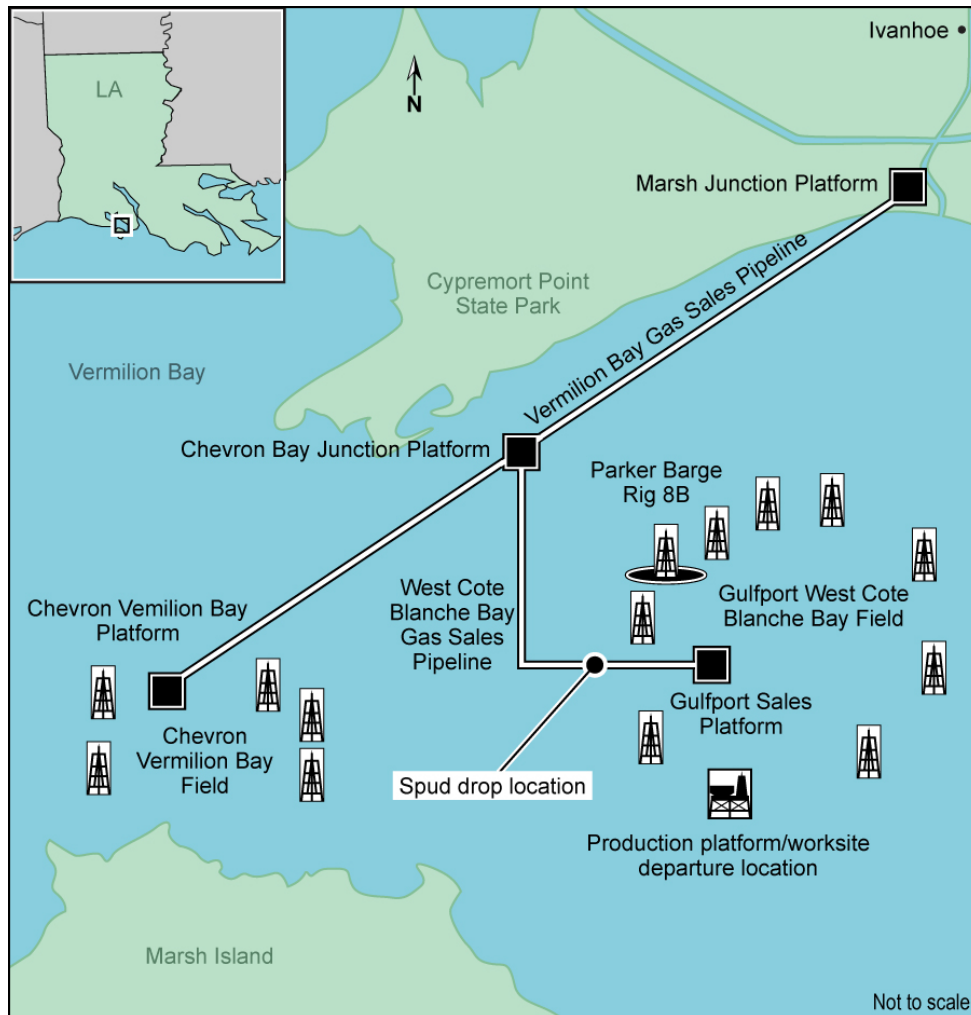
**Figure 1.** Site where construction barge *Athena 106* dropped a 5-ton mooring spud on the West Cote Blanche Bay natural gas sales pipeline. The pipeline carried excess natural gas from the Gulfport sales platform (where extracted natural gas was processed and injected back into oil-producing wells to aid in oil production) to a junction with Chevron’s Vermilion Bay gas sales pipeline. The pipeline between the Gulfport sales platform and the Chevron bay junction platform was about 19,650 feet long. The pipeline between the Vermilion Bay platform and the bay junction platform was about 32,300 feet long.

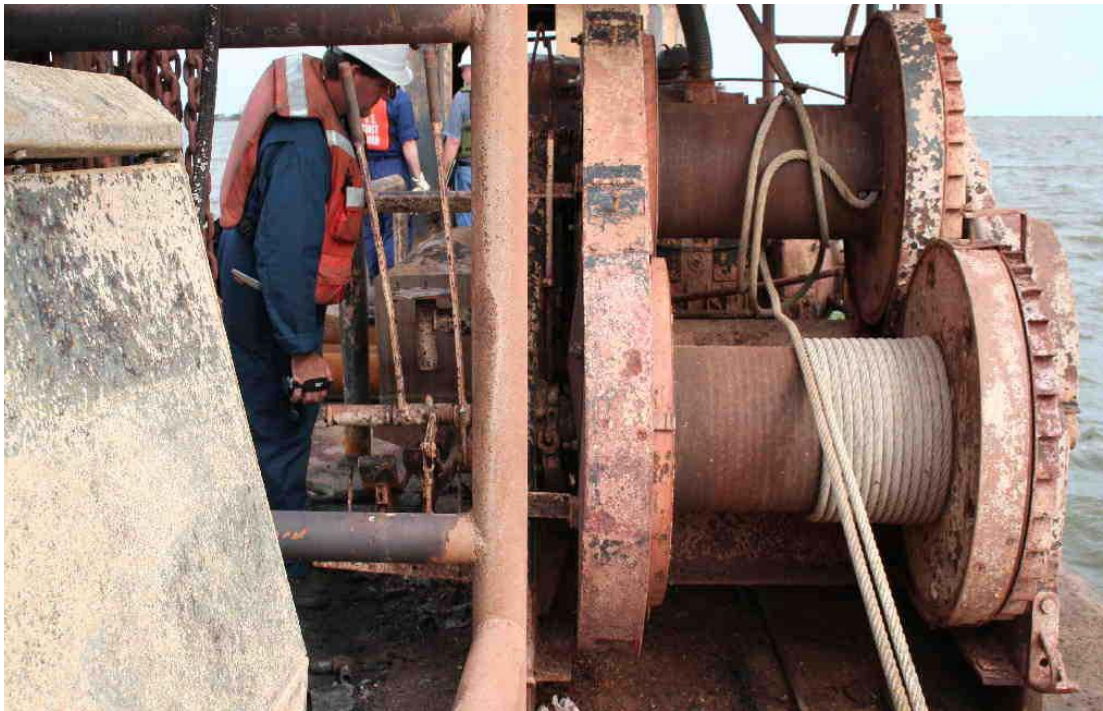
**Figure 6.** Photo showing cable “birdnested” on the winch drum (upper rear) that led to the *Athena 106*’s aft spud. The cable on the lower winch, which led to the forward spud, is properly wound.

**Athena 106.** Investigators found both the forward and aft spuds on the *Athena 106* in the lowered position (as noted below, they were informed by the recovery crew that the forward spud had been in the raised position until it fell during the recovery effort). The 7/8-inch steel cables connecting the spuds to the barge's winch were examined for signs of preexisting damage and found to be free of any fraying or other visible defects. The cable leading from the winch to the forward spud exhibited a light strain condition, with its remaining turns wrapped uniformly around the lower winch drum. The cable connecting the aft spud to the winch was found completely fouled on the upper winch drum, or "birdnested," with none of its remaining cable turns on the drum still wrapped on the inner drum surface (figure 6).

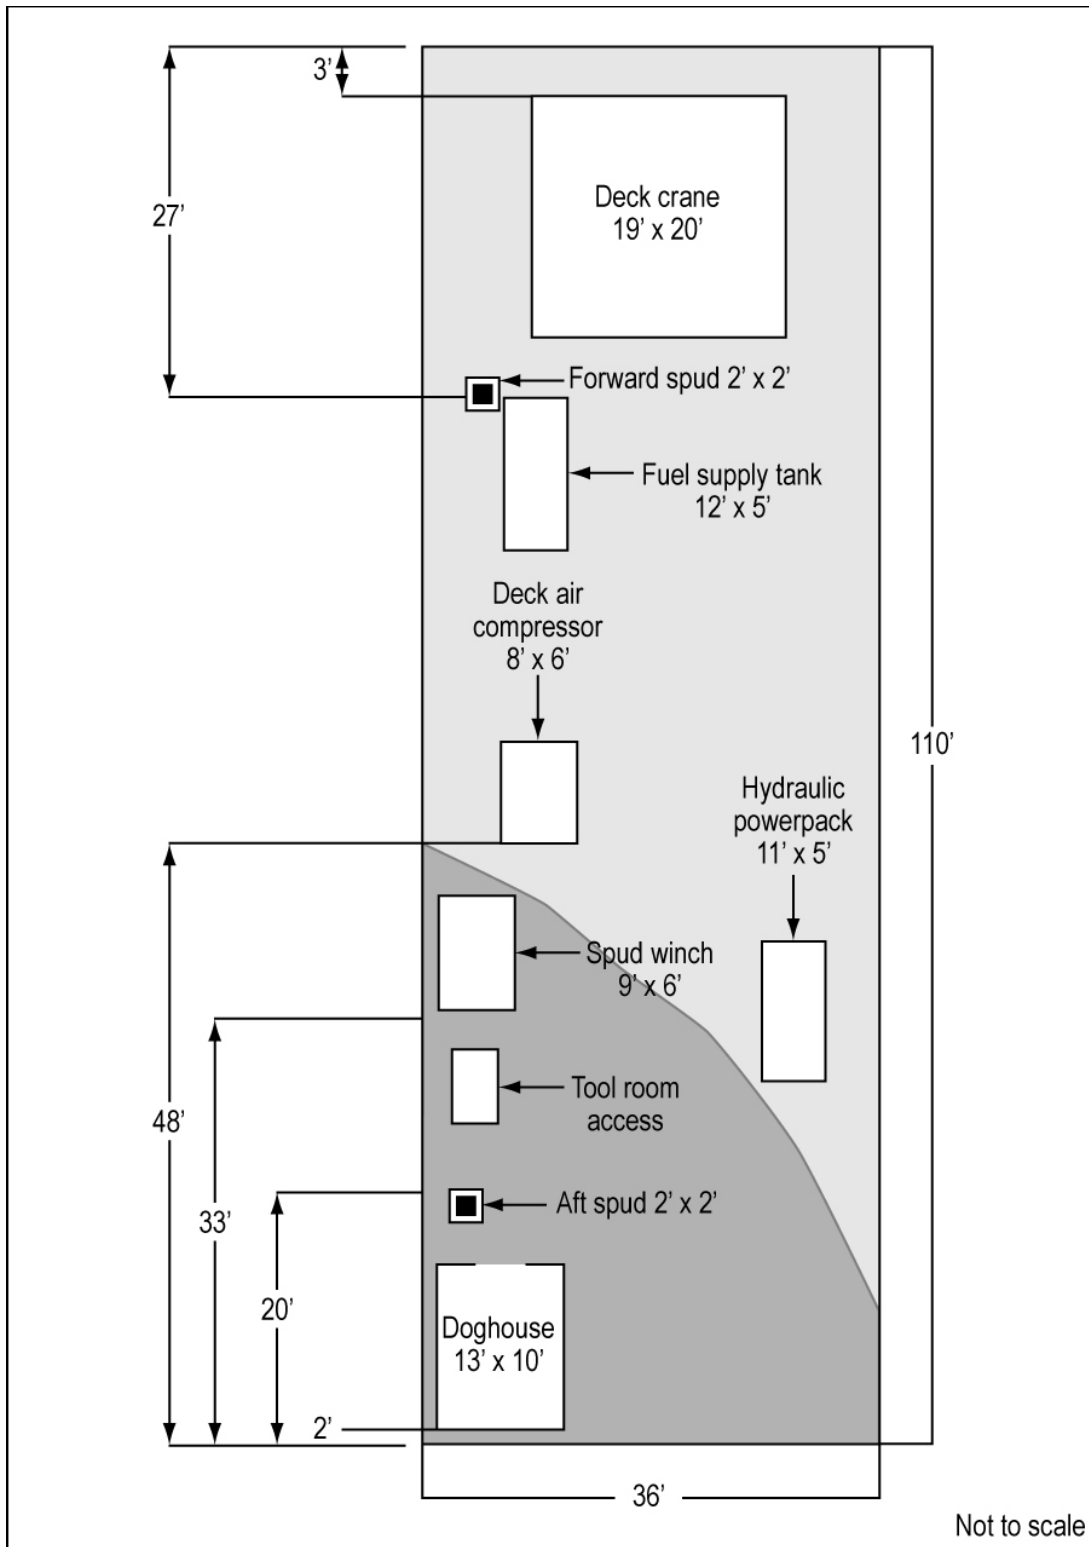
**Figure 7.** General layout of the *Athena 106* construction barge. Fire damage to equipment on the barge deck was greatest in the dark-shaded area.

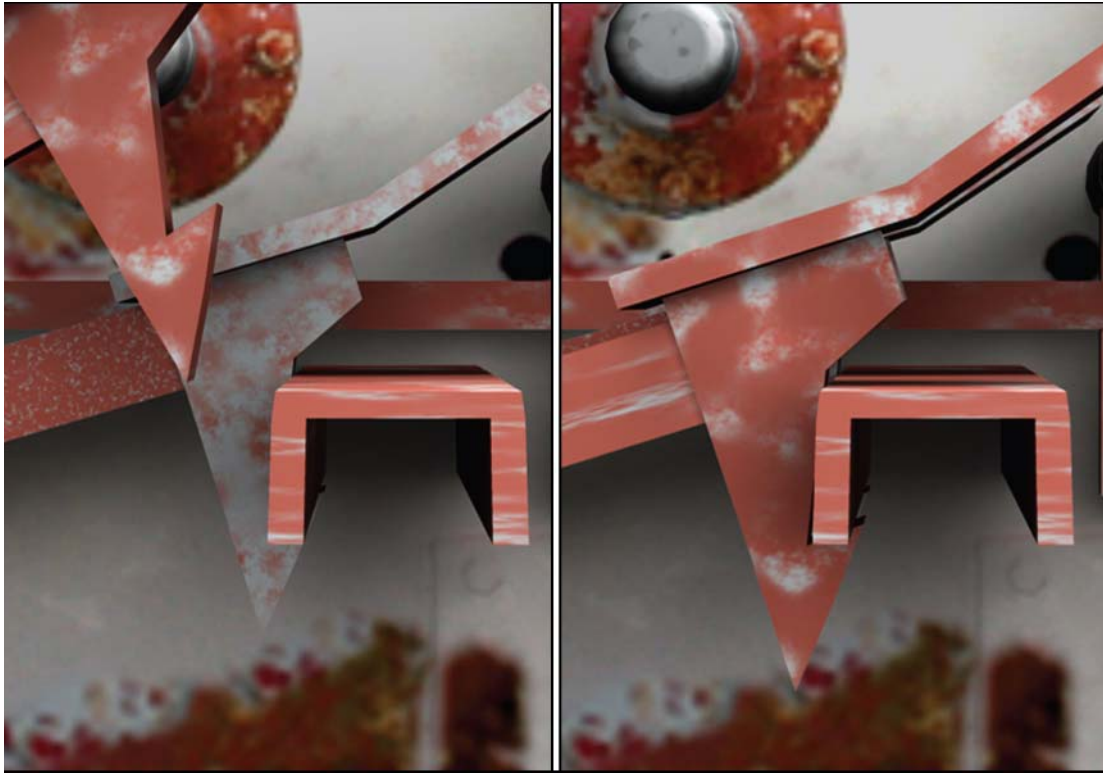
**Figure 9.** Operation of *Athena 106* foot brake pedals On the right, both pedals are engaged (depressed) and latched in place by the fixed steel piece shown pressing on a triangular section at the bottom of the pedals. On the left, the front pedal is released and the back pedal is still engaged. To release the pedal, the operator would push down on the pedal and twist the latch out of place, allowing a spring to raise the pedal.

The brake pedal for the aft spud was found elevated in relation to that of the brake pedal for the forward spud. Investigators noted a 3/32-inch indentation on the leading edge of the fixed steel piece to which the brake pedal latched. No further wear was found on the underside of the fixed piece. On the brake pedal, the latching mechanism displayed no wear.

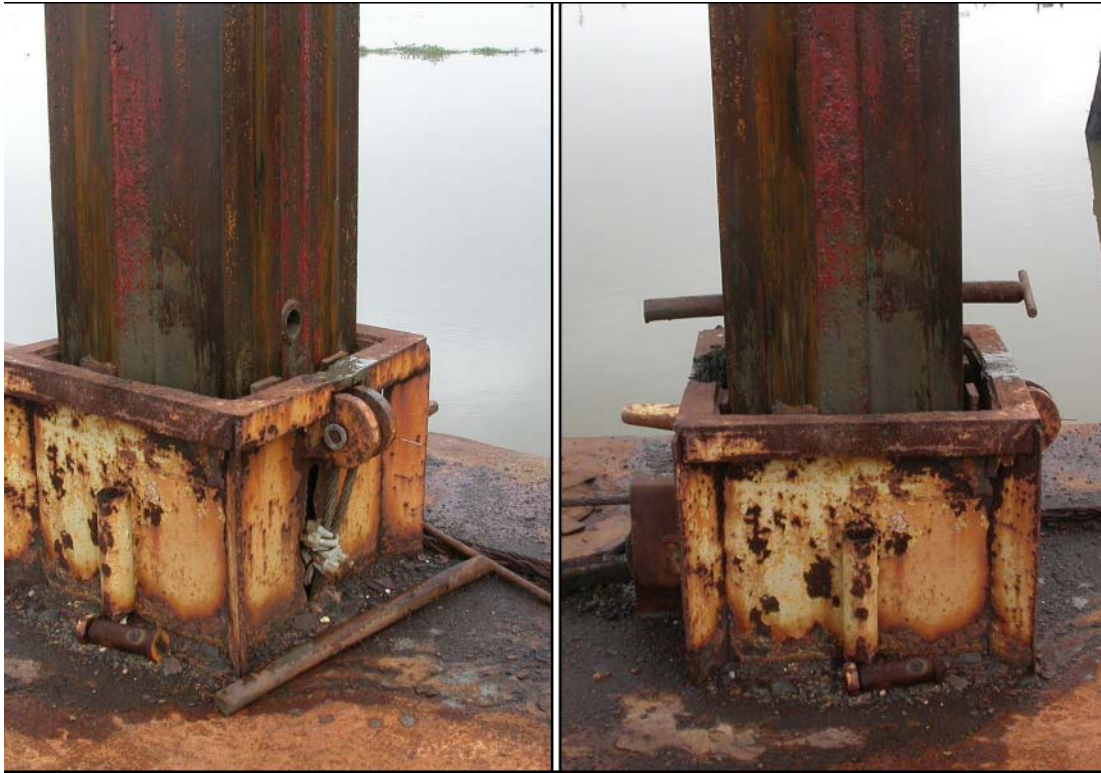
- A 36-inch-long by 2-inch-diameter steel securing pin (figure 11) that could be inserted directly through the spud once it was fully retracted to prevent it from freefalling in the event of a winch or cable failure.

We never put pins in a spud . . . we never had to. We stayed in the field, you know. Usually when you're going a short destination [distance] . . . a couple of hundred yards away, you really don't put a pin through the spud. I mean I'm sure it's a lot safer to do it, but we don't. I don't know why.

**Figure 11.** Photos showing spud with securing pin lying alongside (left) and with securing pin inserted (right).

Both the upper and lower winch drum hand friction control levers were found disengaged. Both spud winch drum pawls were found in the disengaged position. The spud winch's fuel tank, integral with the winch frame, was split open and deformed by the fire's heat. The 36-inch-by-2-inch spud securing pins were found lying next to their respective spud bases, not inserted into the spuds.

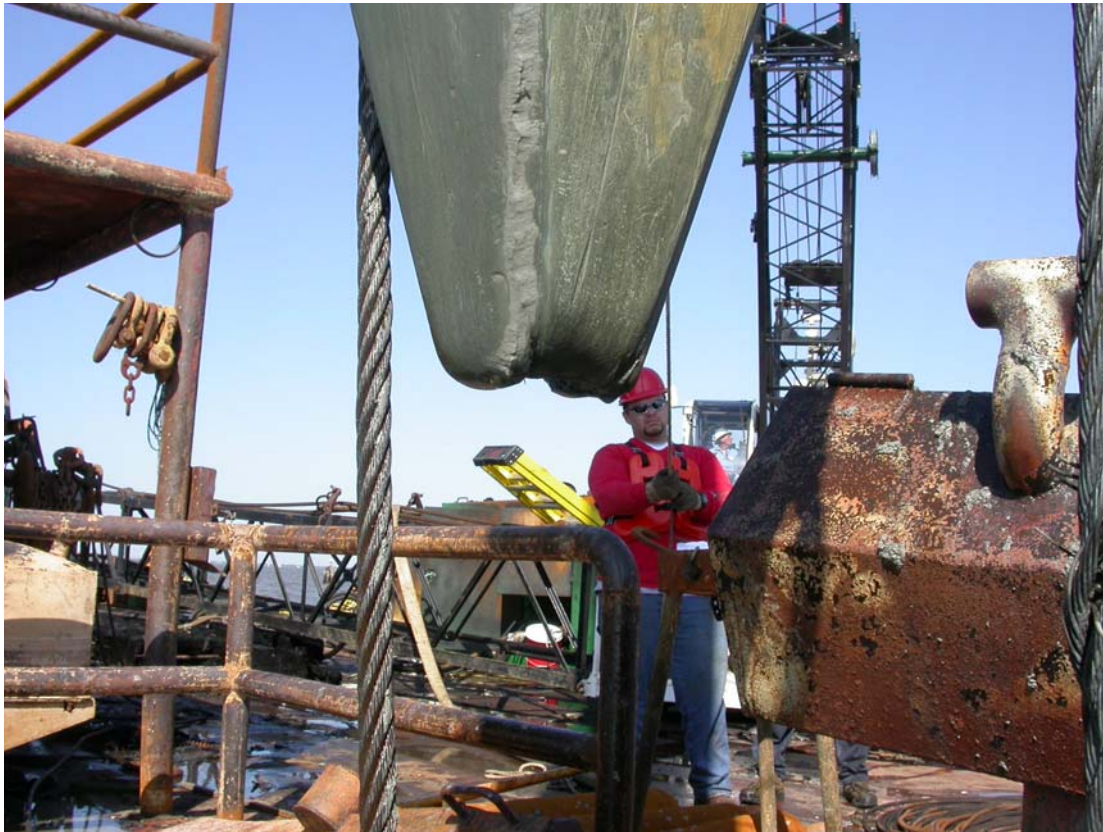
The deck end of the aft spud cable was cut and marked. The crane on the salvage barge pulled the *Athena 106* aft spud out of the water for examination. According to markings on the spud and measurements taken at the scene, the lower end of the spud had been submerged in the mud an estimated 17 feet. The cable, sheave, and deck pulleys were found to be in good working order during the recovery. The 4-inch tip of the aft spud displayed a slight concavity (figure 12).

**Figure 12.** Aft spud of the *Athena 106* when raised after it had released from its fully raised position and hit a submerged, buried high-pressure natural gas pipeline.

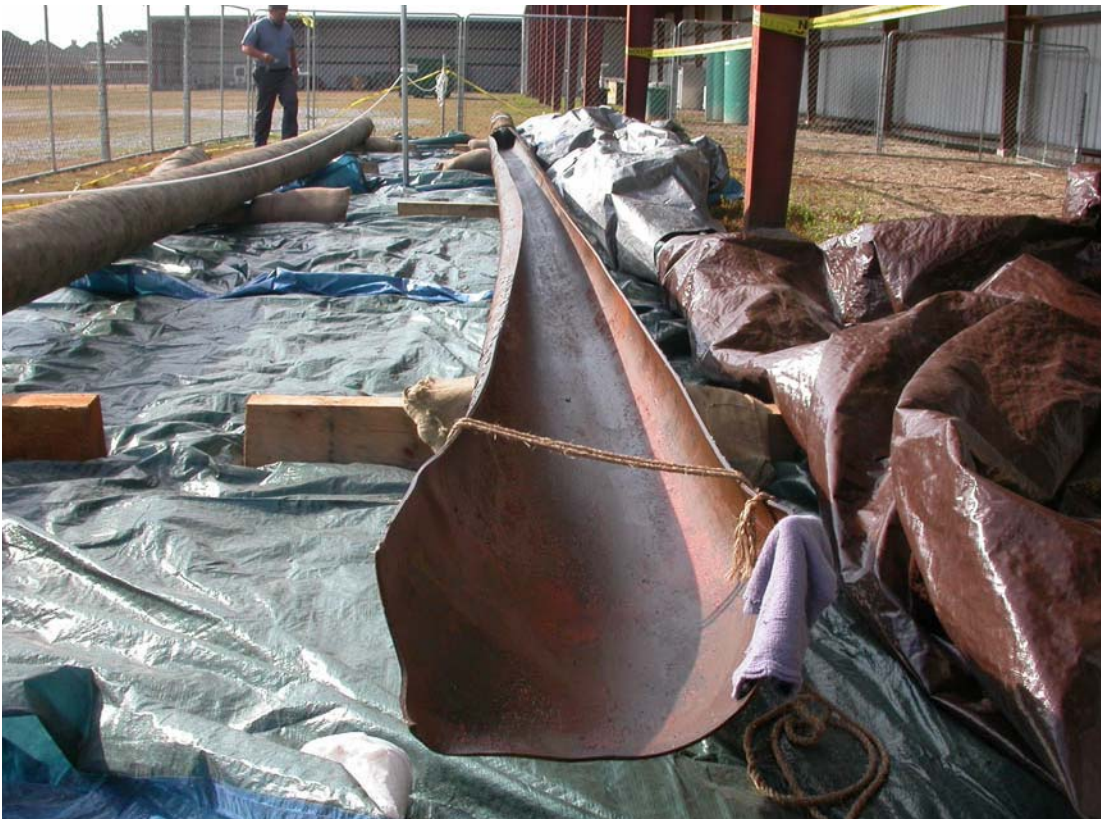
**Figure 13.** Fracture on the east piece of the ruptured pipeline.

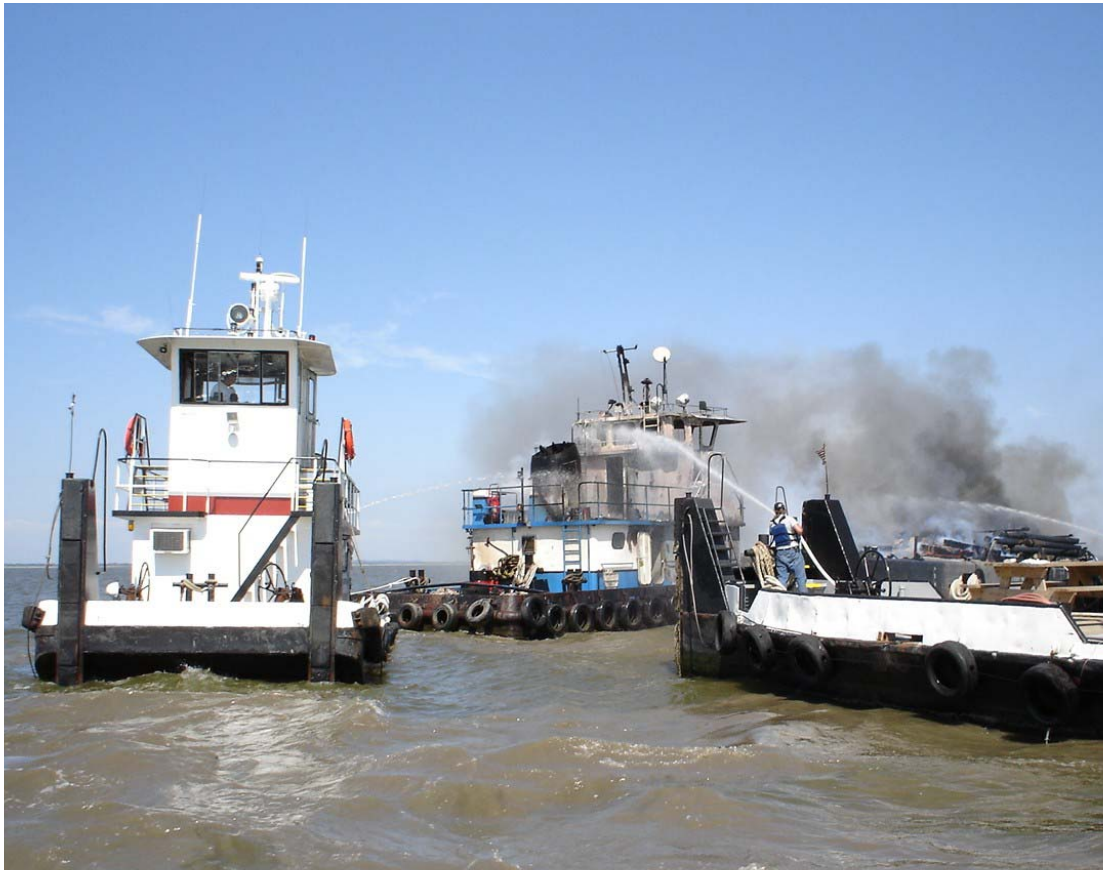
**Figure 15.** Towboats *Miss Joann* and *Yancy O* fighting the fire on the *Miss Megan* and the deck barge *IBR 234*. (Photo courtesy Louisiana Department of Wildlife and Fisheries)
