NATIONAL TRANSPORTATION SAFETY BOARD

HIGHWAY ACCIDENT REPORT

**COLLISION OF AMTRAK TRAIN NO. 88 WITH
ROUNTREE TRANSPORT AND RIGGING VEHICLE
ON CSX TRANSPORTATION, INC., RAILROAD
NEAR INTERCESSION CITY, FLORIDA
NOVEMBER 30, 1993**

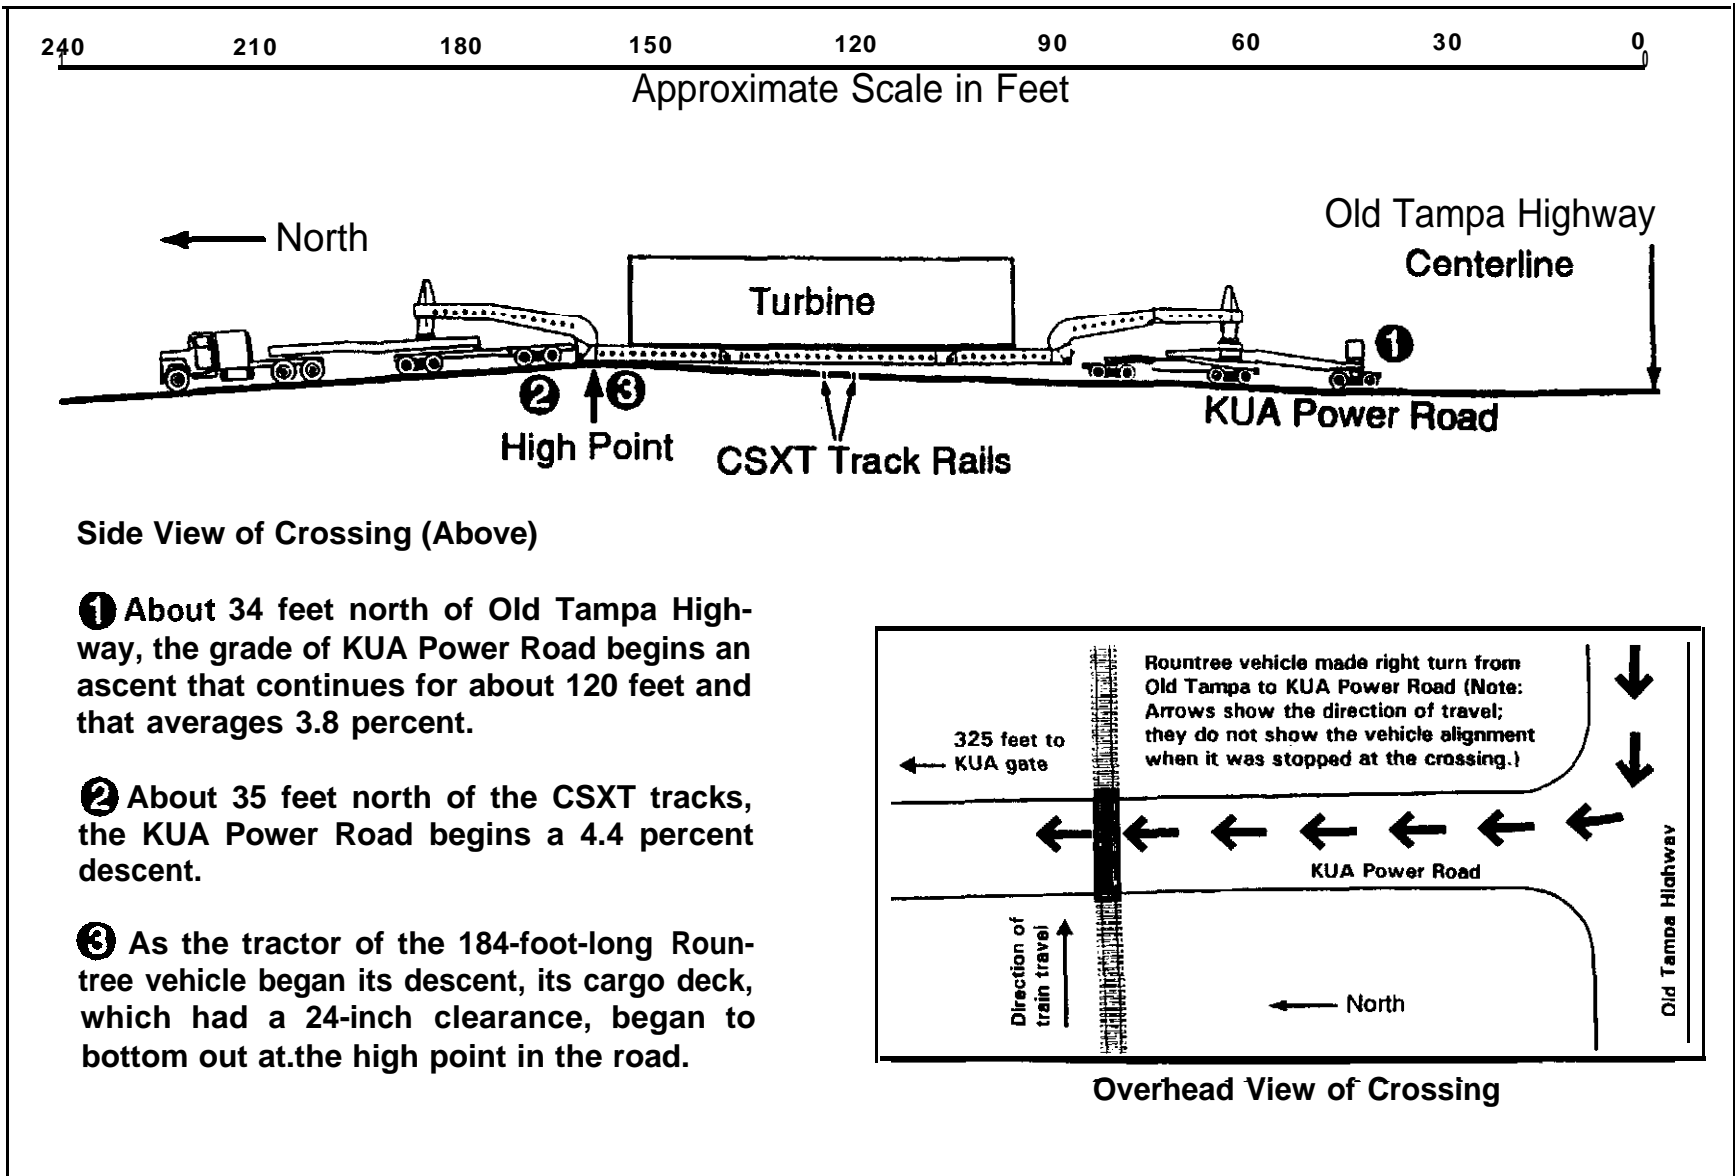
Figure 1.--Rountree vehicle on KUA Power Road grade crossing.

Because Rountree did not arrange for a flagman at the KUA crossing, their vehicle and load were not protected. The Safety Board concludes that Rountree failed to ensure that it was safe to proceed over the KUA Power Road grade crossing before doing so.

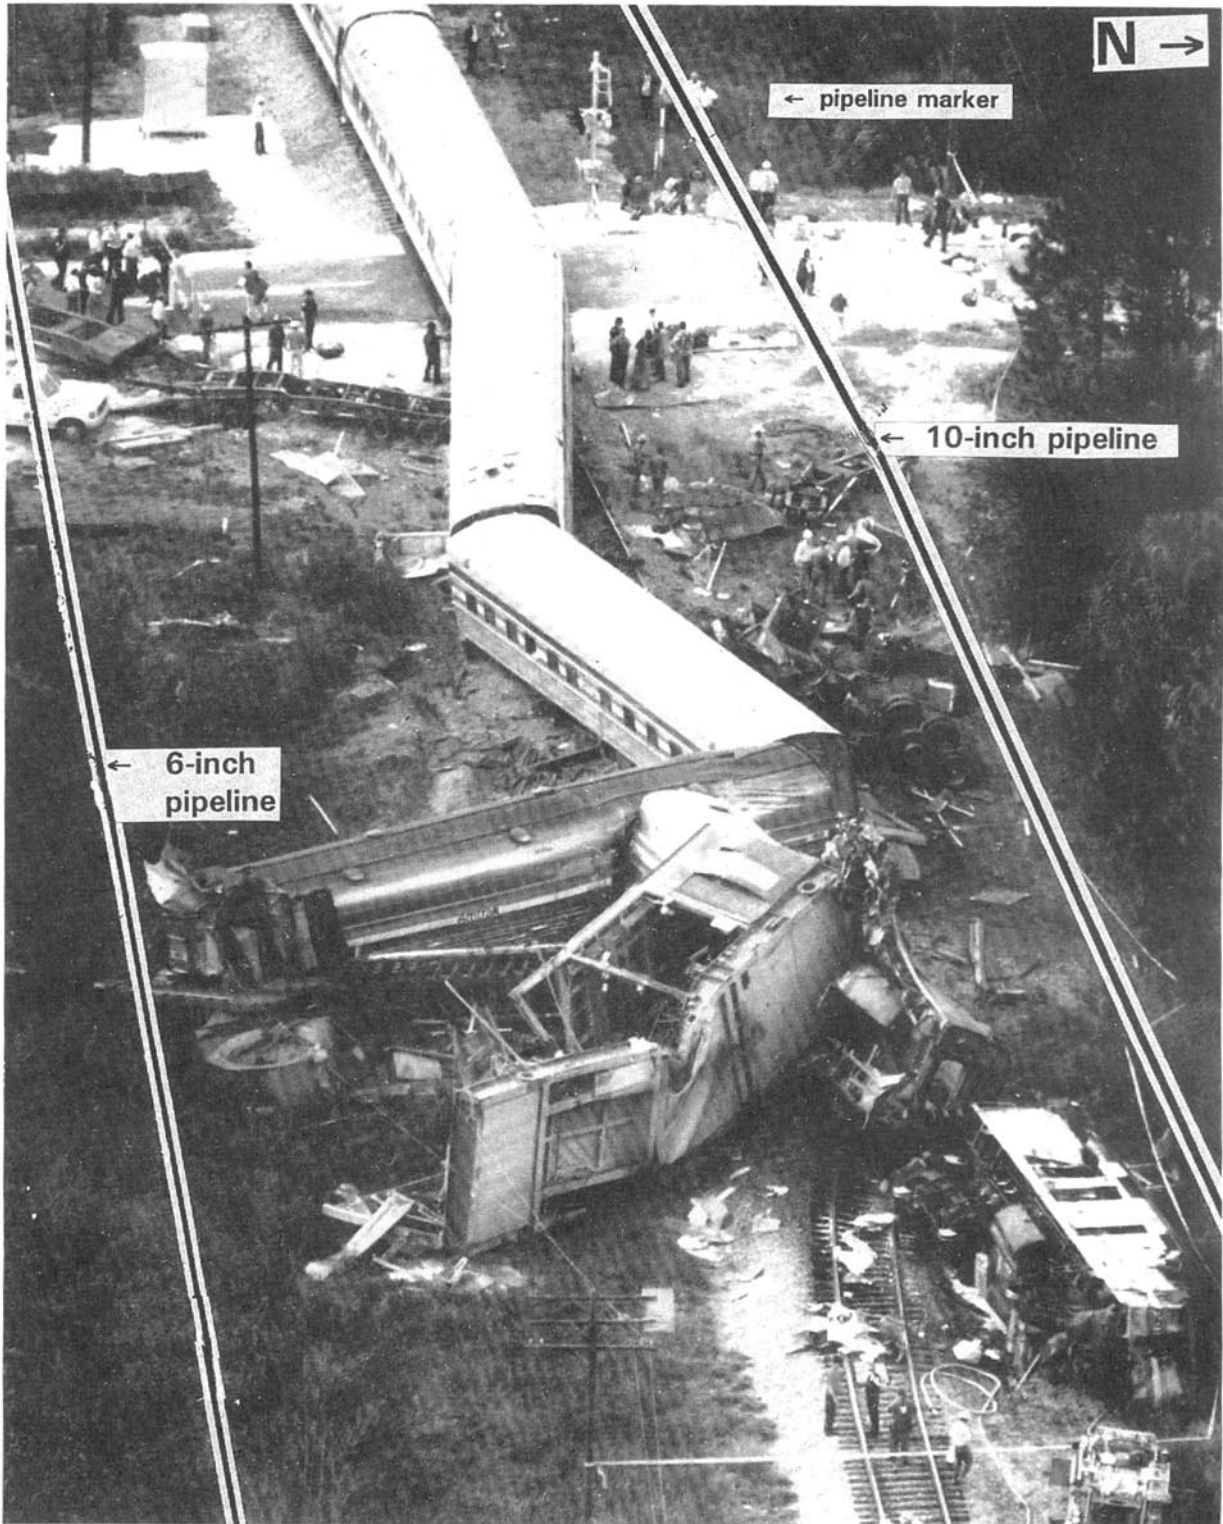
Figure 4.--Aerial shot taken by *Orlando-Sentinel* photographer about 2 p.m. Routes of pipelines are superimposed. Arrow points to CFPL pipeline marker.

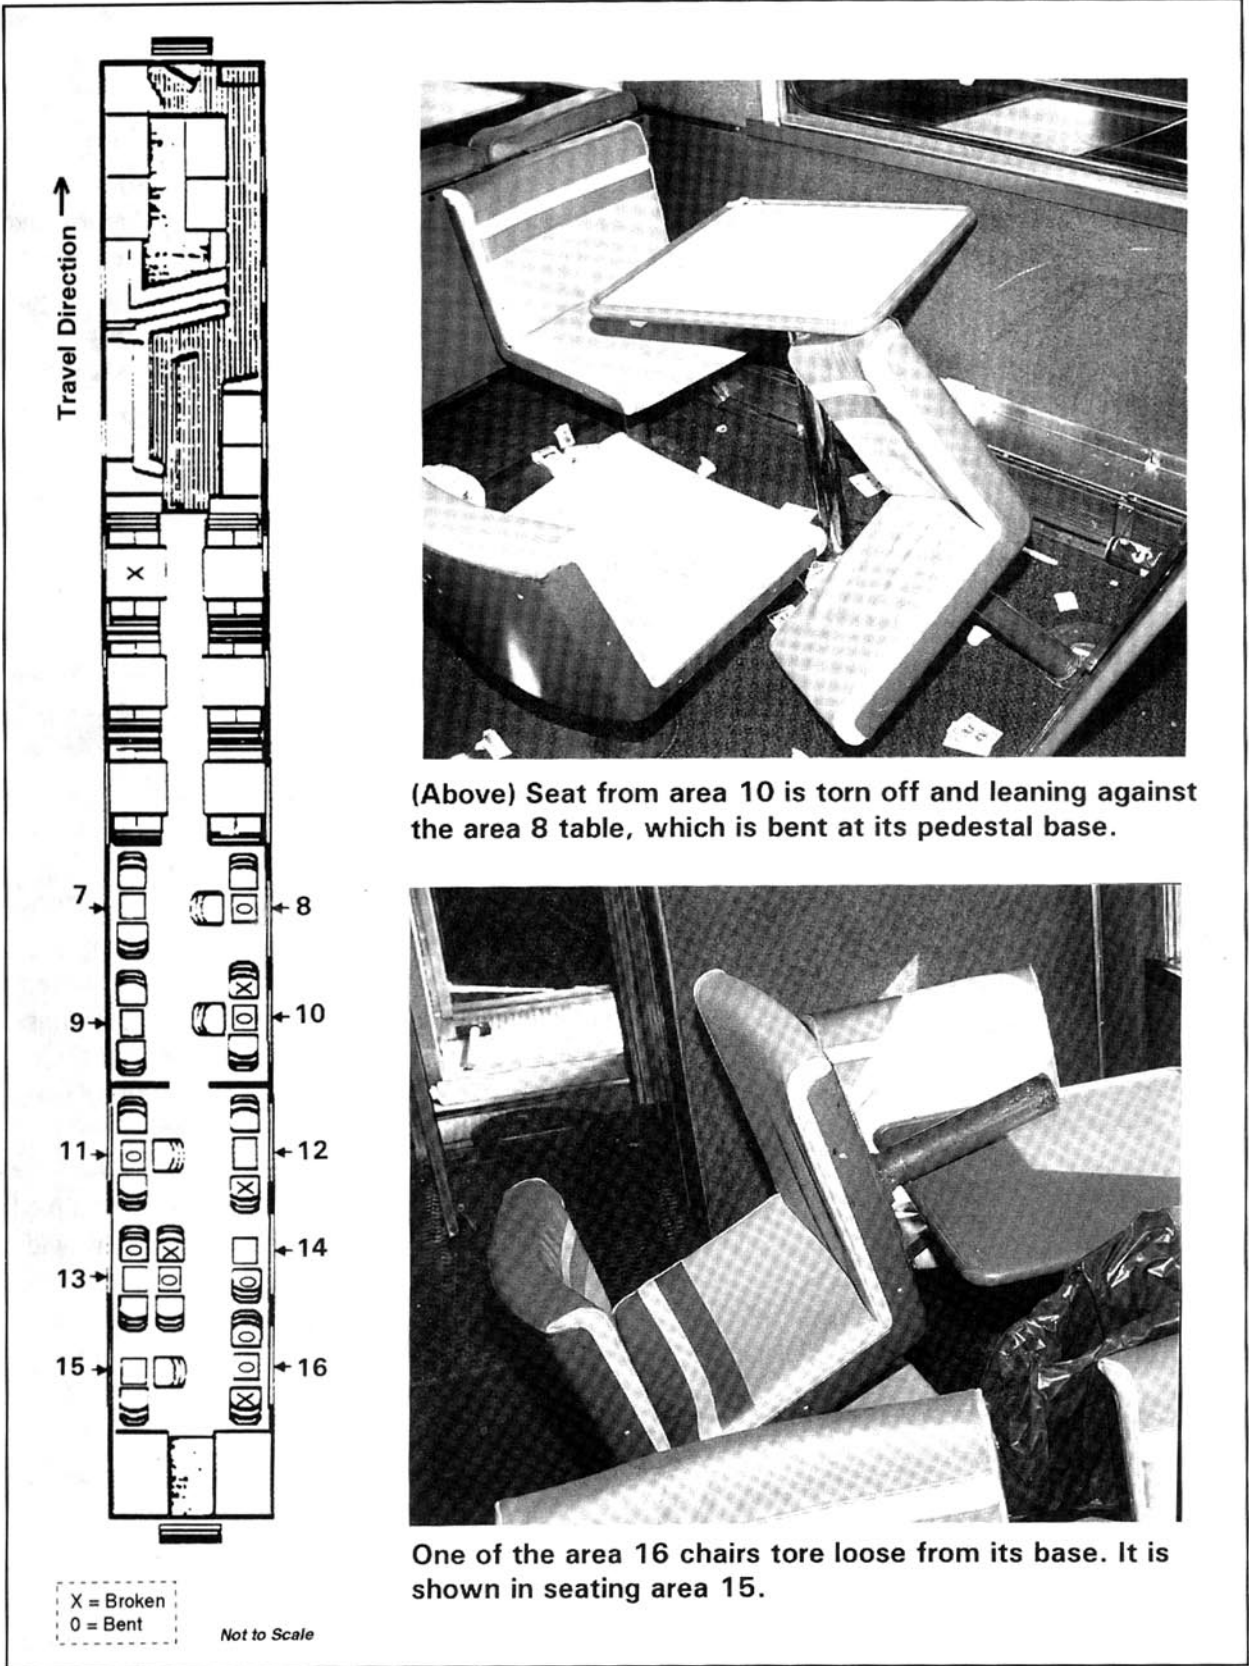
Train.--Upon striking the turbine, the locomotive nose, which contained a toilet and the event recorder, was crushed 12 inches. The locomotive came to rest on its left side about 28 feet north of the track line and about 364 feet east of the point of initial impact. Investigators found the automatic brake handle in the emergency position. The locomotive fuel tanks were breached, and diesel fuel was leaking. In the lounge car, investigators found four pedestal seats broken from their bases and five tables bent toward the front of the train. Safety Board investigators found that the pedestal seats had separated at the weld area where the pedestal was connected to the base. Amtrak's General Manager of Mechanical Standards and Compliances later stated that the pedestal seat should have collapsed or buckled along the pedestal support rather than separating from the base.

Lounge Car Injuries.--At the time of the accident, 12:40 p.m., 18 to 20 people were in the lounge (figure 10). In addition to the two injured OBS attendants noted above, an OBS attendant complained of minor injuries after being thrown against a lounge table and a lounge attendant received minor burns after being splashed with hot coffee. One passenger sustained chest trauma from striking tables, and another passenger received a head contusion after striking his head on a lounge partition wall. A passenger in a pedestal seat at table 11 received spinal trauma after she reportedly was thrown against and over the table. She said a broken chair also struck her right leg. Another passenger at table 11 was thrown more than 8 feet, striking table 10 with his left temple.

Figure 10.--Lounge car interior. Graphic shows location of damaged pedestal seats and tables.
