# 15-Passenger Van Single-Vehicle Rollover Accidents, Henrietta, Texas, May 8, 2001, and Randleman, North Carolina, July 1, 2001

**Highway Accident Report**  
**NTSB/HAR-03/03**

**15-Passenger Van Single-Vehicle  
Rollover Accidents,  
Henrietta, Texas, May 8, 2001,  
and Randleman, North Carolina,  
July 1, 2001**

**NTSB/HAR-03/03  
PB2003-916203  
Notation 7567  
Adopted July 15, 2003**

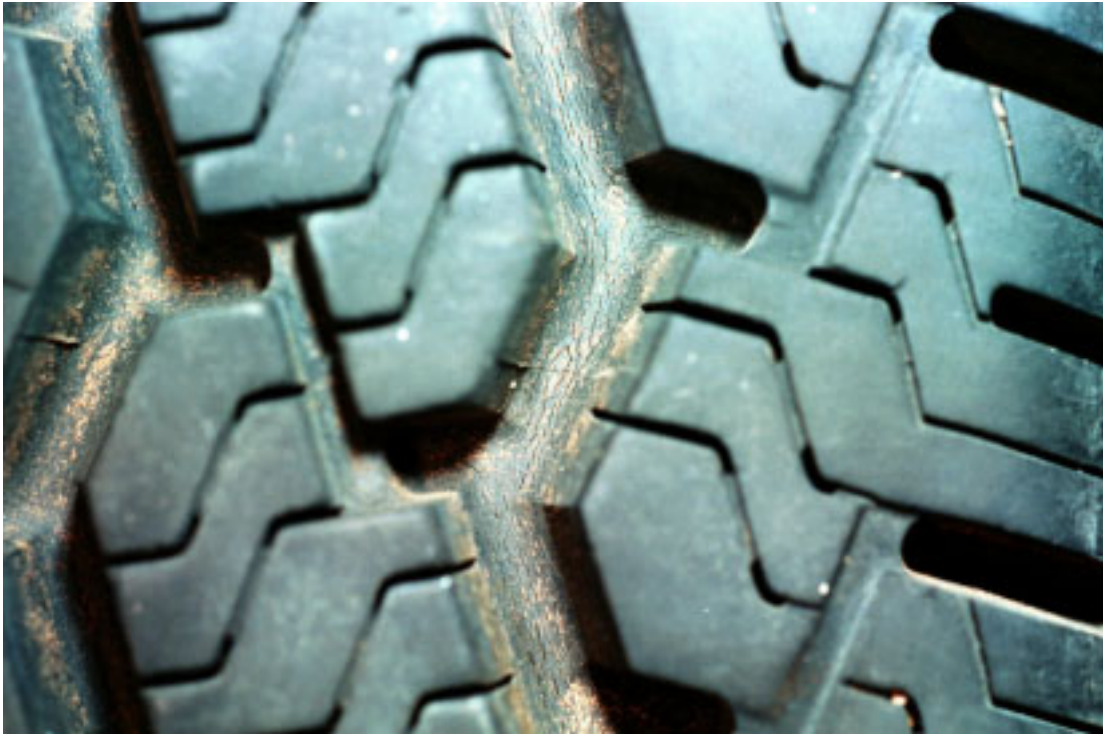
**Figure 5.** Left front tire tread groove cracking.

The left front tire exhibited extensive circumferential sidewall (see figure 4) and tread groove cracking (see figure 5). According to the manufacturer, the cracking was due to weather and is commonly referred to as weather checking, that is, surface cracks in the exterior tire rubber. Written in yellow crayon on the sidewall were the words "RE-

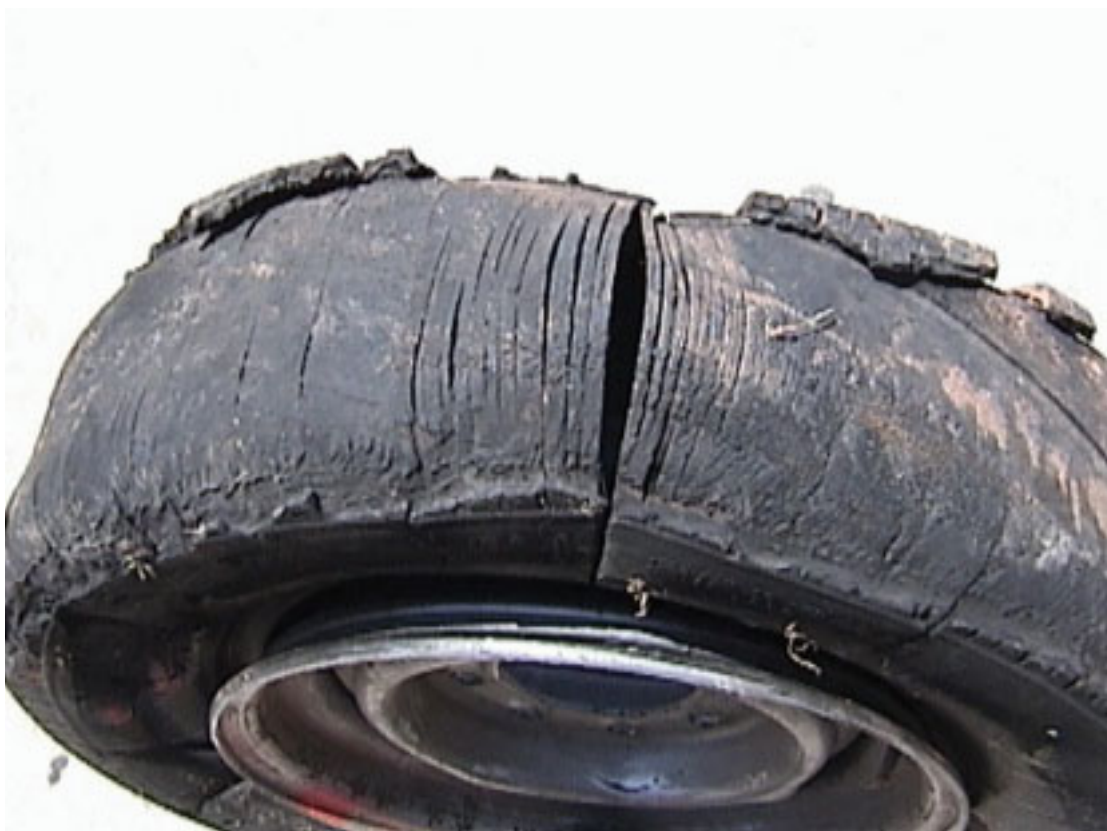
Figure 6. Left rear tire.

The left rear tire (see figure 6) sustained extensive damage to the inner and outer sidewalls and tread, exposing the body plies<sup>10</sup> and inner liner (see figure 7). The tire exhibited extensive circumferential cracking and deterioration of the sidewall and bead areas, which the manufacturer attributed to weather. Radial splits and abrasions were noted on the sidewalls, as was severe weather checking. The tread and belt components were partially detached from the tire. Where the bottom belt remained attached, it was separated from the body ply along the interior edge. A nail found embedded in the detached tread and top belt piece had not penetrated all components. Another puncture hole, extending through all components, was found. The inner liner was split radially.

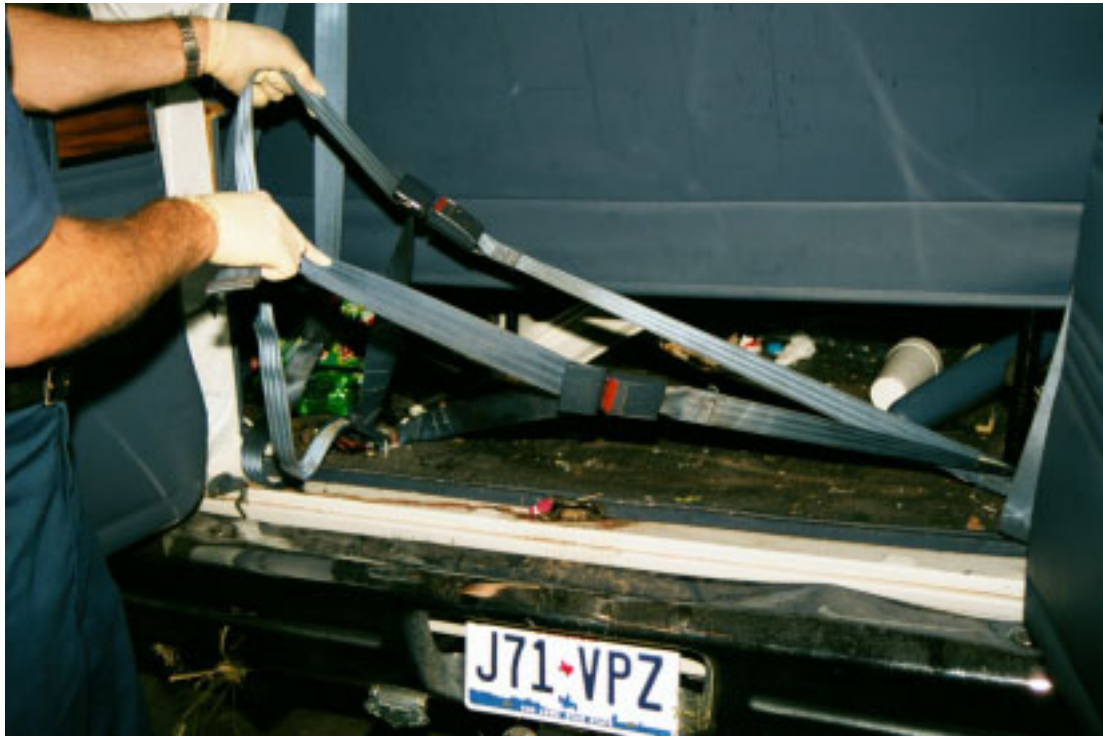
**Figure 8.** Fourth row lap belt attachments.

Lap belts were attached to the seat frame for passengers in the middle and right aisle seats of the first three rows. Lap belts for two middle seats in the fourth row were attached to the floor behind the seat frame (see figure 8). A single bolt near the right seat frame pedestal base secured the two webbing straps with buckles to the floor for these two middle seats; the two webbing straps with latch plates were bolted to the floor near the left seat frame pedestal base. DaimlerChrysler Corporation (DaimlerChrysler) engineers stated that they were unable to determine why the anchorages had been designed in such a manner. As a result of this configuration for the fourth row lap belts, the two buckles were on the right side of the seat, and the two latch plates were on the left side of the seat (see figure 9); they had to cross one another in order to buckle the belts (see figure 10).

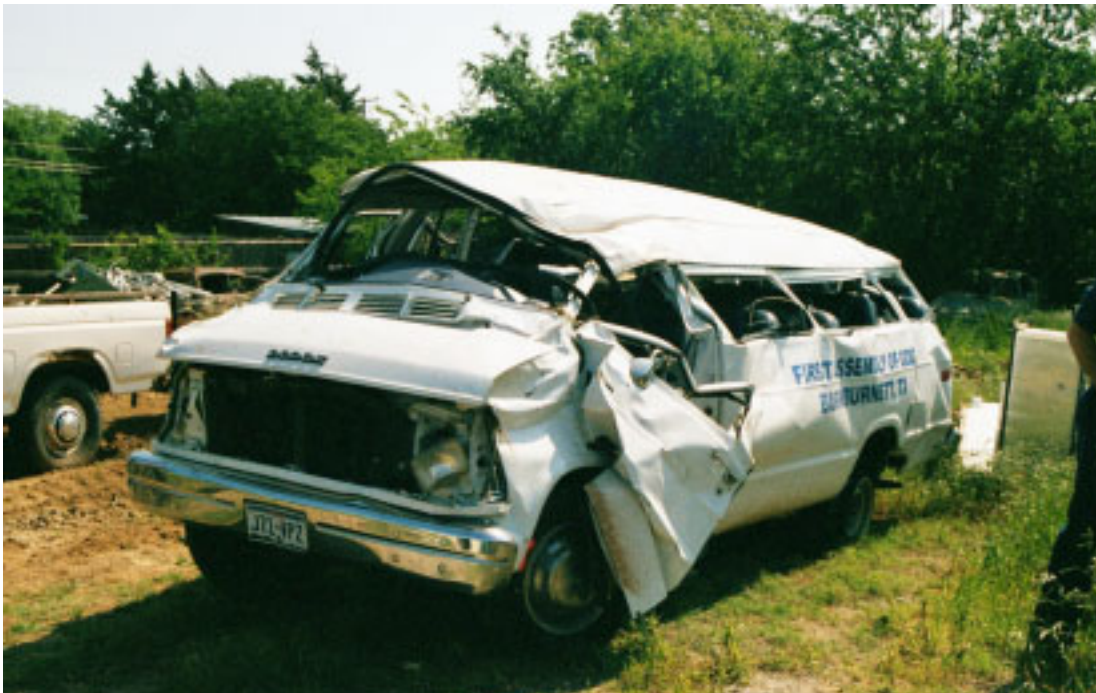
The roof of the van was deflected to the right and downward (see figures 11 and 12), damaging all the pillars that supported the roof. The pillar behind the driver was in contact with the headrest of the driver's seat and protruded 17 inches into the passenger compartment over the second row of seats. The roof shifted to the extent that the first and second rows of seats extended 16 inches beyond the edge of the roof, the third row extended 15 inches, and the fourth row extended 8 inches. The distance between the top of the seat and the roof at the point of maximum crush was 5.5 inches in the first row, 6 inches in the second row, 4 inches in the third row, and 5 inches in the fourth row. Investigators compared these measurements to those for an undamaged, exemplar 1999 Dodge Ram van, which had a distance between the seatback and the roof of 22 inches in the first row, 20 inches in the second row, 18 inches in the third row, and 18.5 inches in the fourth row.

**Figure 11.** Henrietta van roof crush.

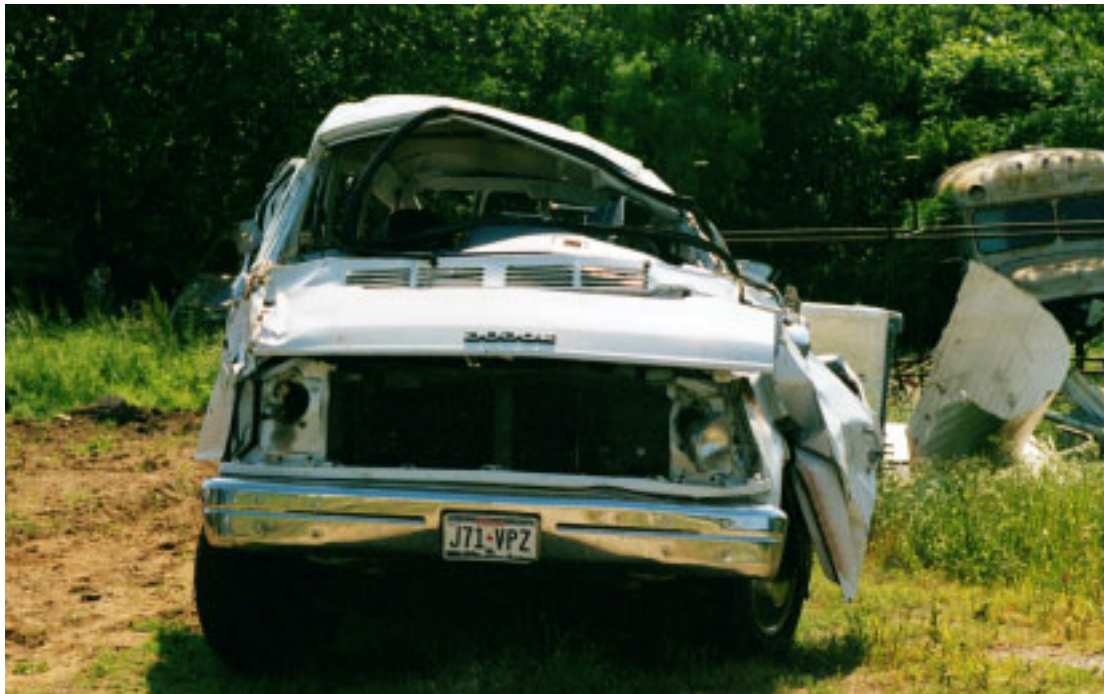
**Figure 12.** Front of Henrietta van.

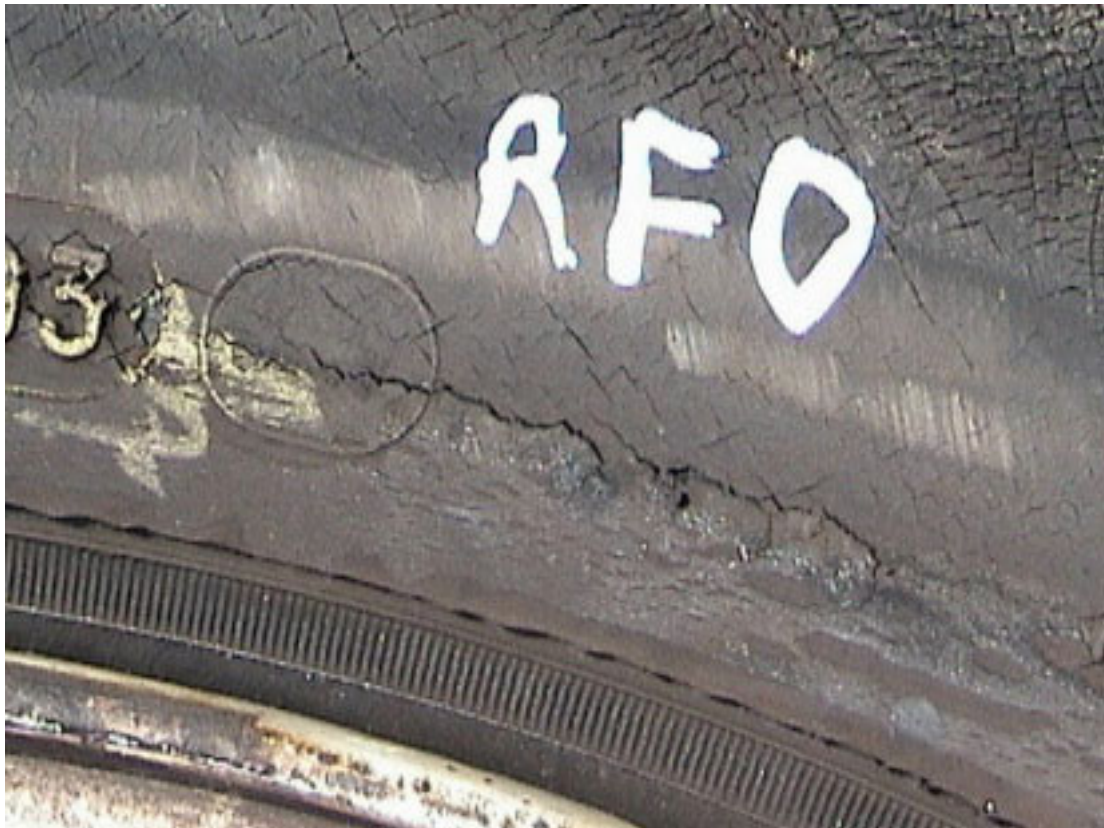
The right front tire exhibited extensive circumferential sidewall and tread groove cracking (see figure 16). Weather checking was evident along the outer sidewall from 1.75 inches above the rim into the tread area. Scrape marks were found on the rim flange. A 0.1875-inch deep radial split was found in the buttress, and a 0.625-inch long near-radial split was 0.75 inch from the rim flange. The body plies<sup>22</sup> were exposed due to missing tire material that measured approximately 0.5 inch long, 0.1875 inch wide, and 0.1875 inch deep.

**Figure 16.** Right front tire sidewall cracking.

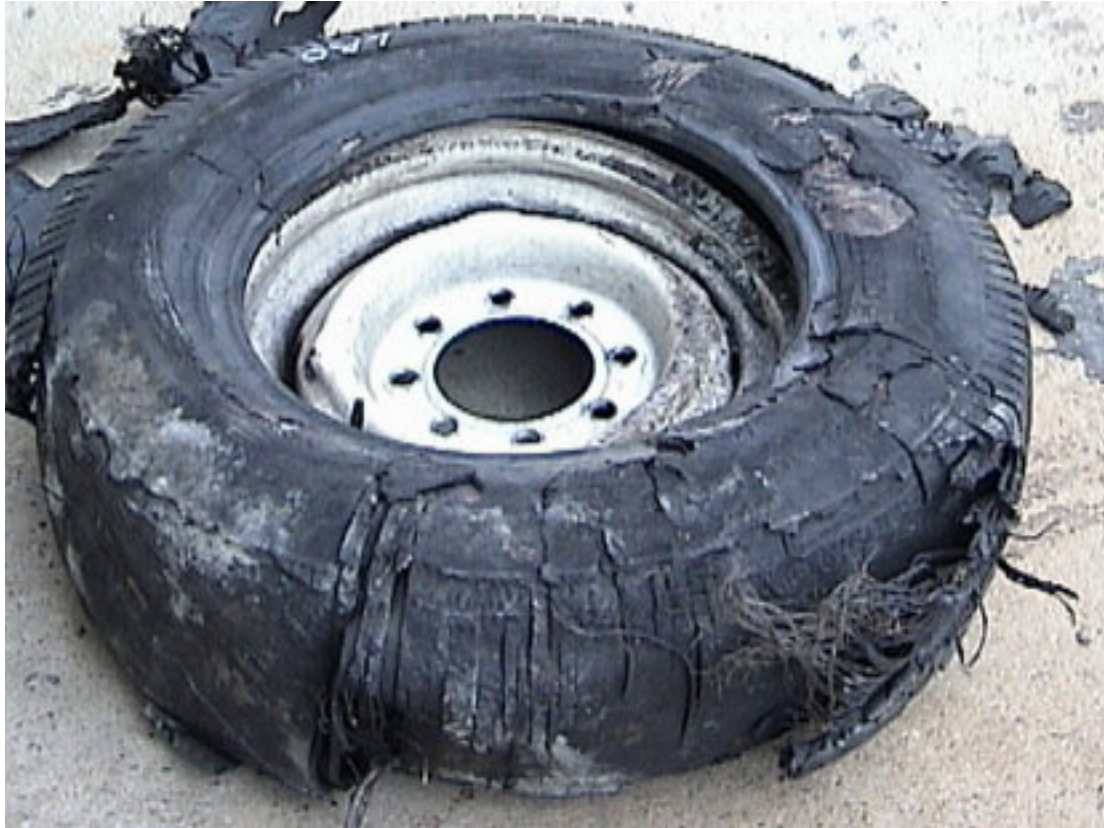
**Figure 17.** Left rear tire.

The left rear tire sustained extensive damage to the inner and outer sidewalls, tread, belts, and body plies (see figure 17). The tire exhibited extensive circumferential cracking and weather checking of the sidewall. The inner and outer beads were unseated from the wheel flanges and a 0.5-inch deep circumferential groove was found in the bead area. In another location, the bead area was cut or torn, exposing the body cords. Some sidewall rubber was missing and bare body cords were exposed. Multiple radial splits had breached the inner liner. A radial split was found in the sidewall rubber, and the rubber was not attached to the body cords. Radial splits were also found in the tread and buttress.

Portions of the tread and all three steel belts were partially detached. Bare body cords were visible in the tread and buttress areas.

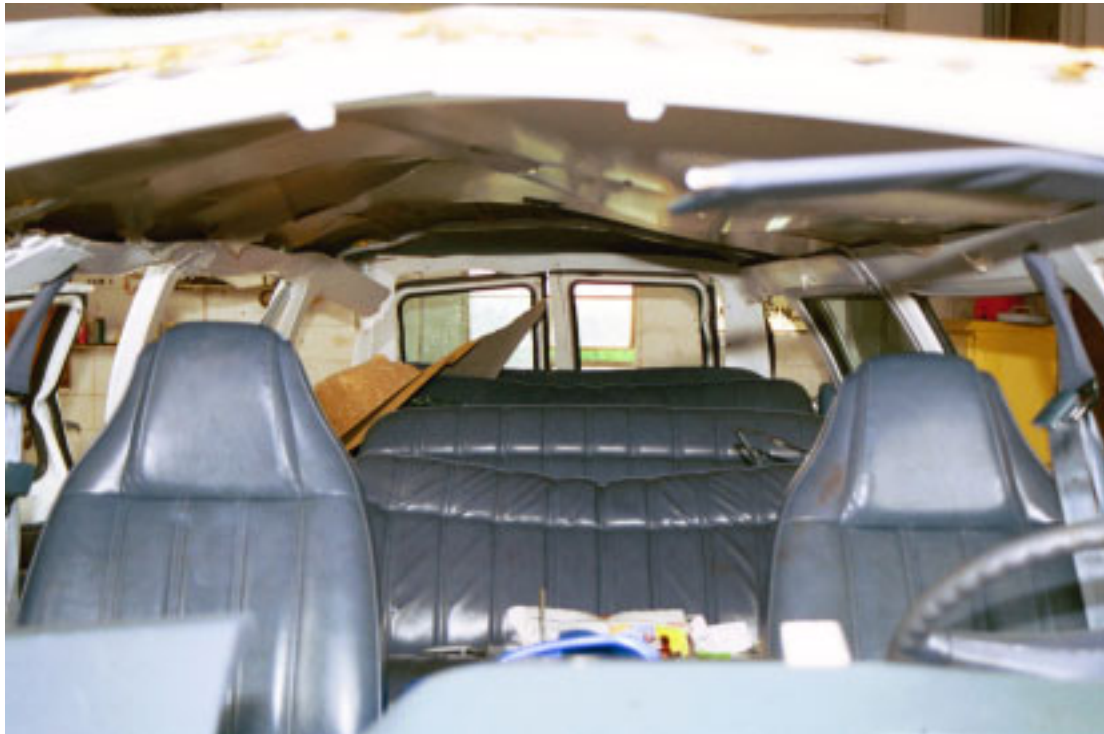
**Interior.** The driver and front passenger bucket seats were equipped with lap/shoulder belts. The first three rows could seat three passengers each. The fourth row could seat four passengers. The center of the seatbacks in all rows bowed rearward (see figure 18) due to accident damage. The outboard armrest was missing on the first row and broken on the second row. The roof deflected upward near the center of the van, extending longitudinally the entire length of the vehicle (see figure 19).

**Figure 18.** Bowed Randleman seatbacks.

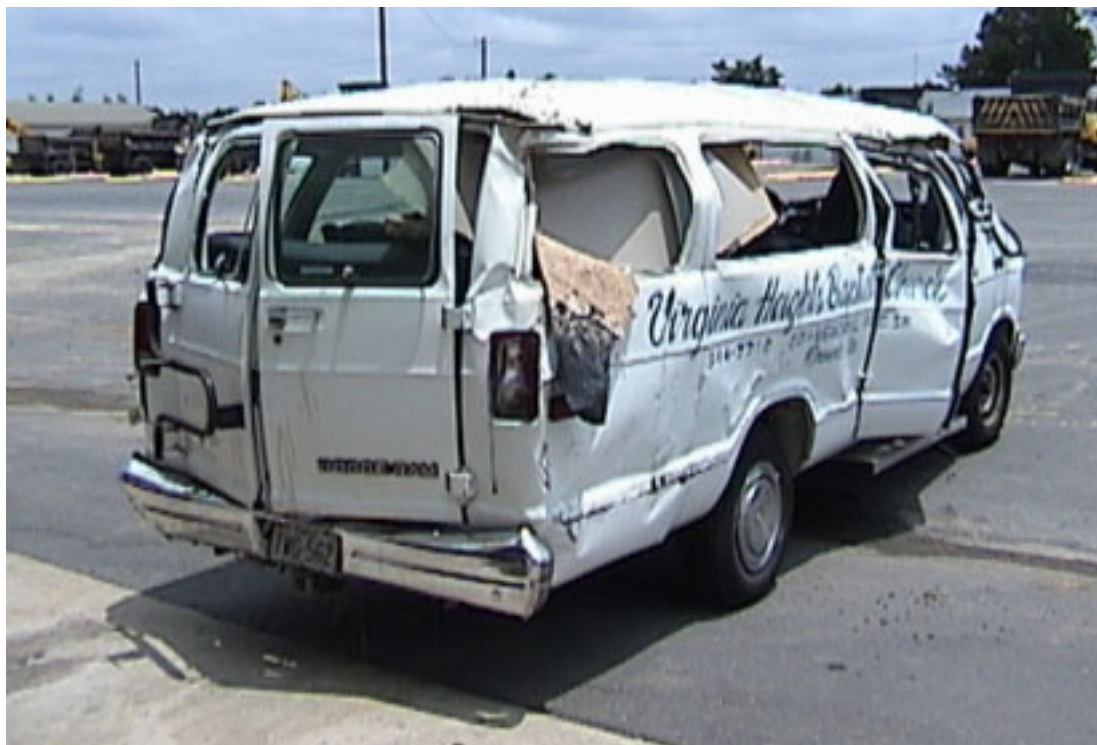
**Figure 19.** Randleman van damage.
