Collision Between Metrolink Train 210 and Ford Crew Cab, Stake Bed Truck at Highway-Rail Grade Crossing, Burbank, California, January 6, 2003

Highway Accident Report
NTSB/HAR-03/04

**NTSB/HAR-03/04
PB2003-916204
Notation 7580
Adopted December 2, 2003**

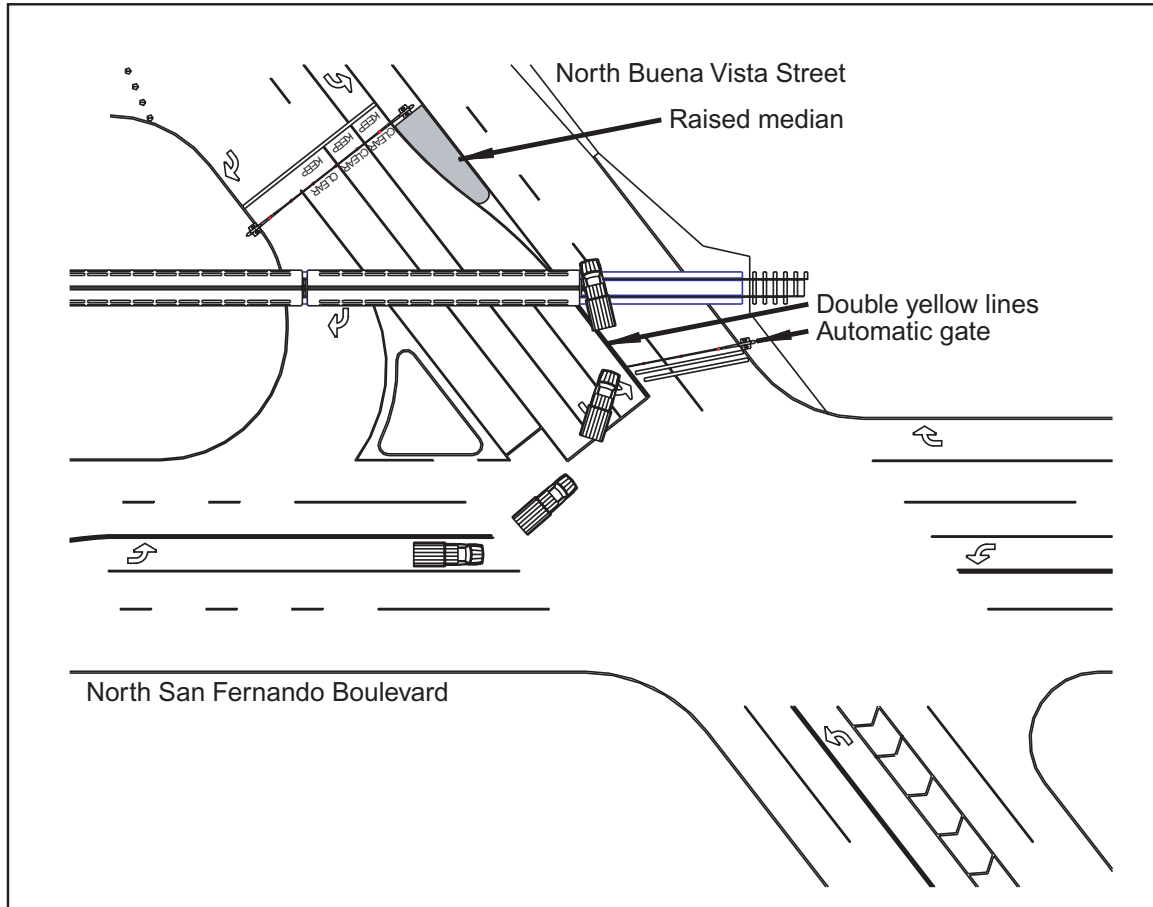
Figure 1. Accident scene.

Upon impact, the truck's fuel tank was compromised, releasing fuel and resulting in a postcrash fire that consumed the stake bed, which remained at the crossing, while the truck's cab, which was not on fire, continued eastward with the train. The train derailed almost immediately and came to a stop about 1,300 feet east of the crossing. The cab car of the train came to rest on its side; its leading end faced west. The second car also came to rest on its side at a 90° angle to the track. The remaining two cars and the locomotive remained upright. The truck cab came to a rest about 1,000 feet east of the crossing. The truck was destroyed; estimated damage to the train and track was \$3 million.

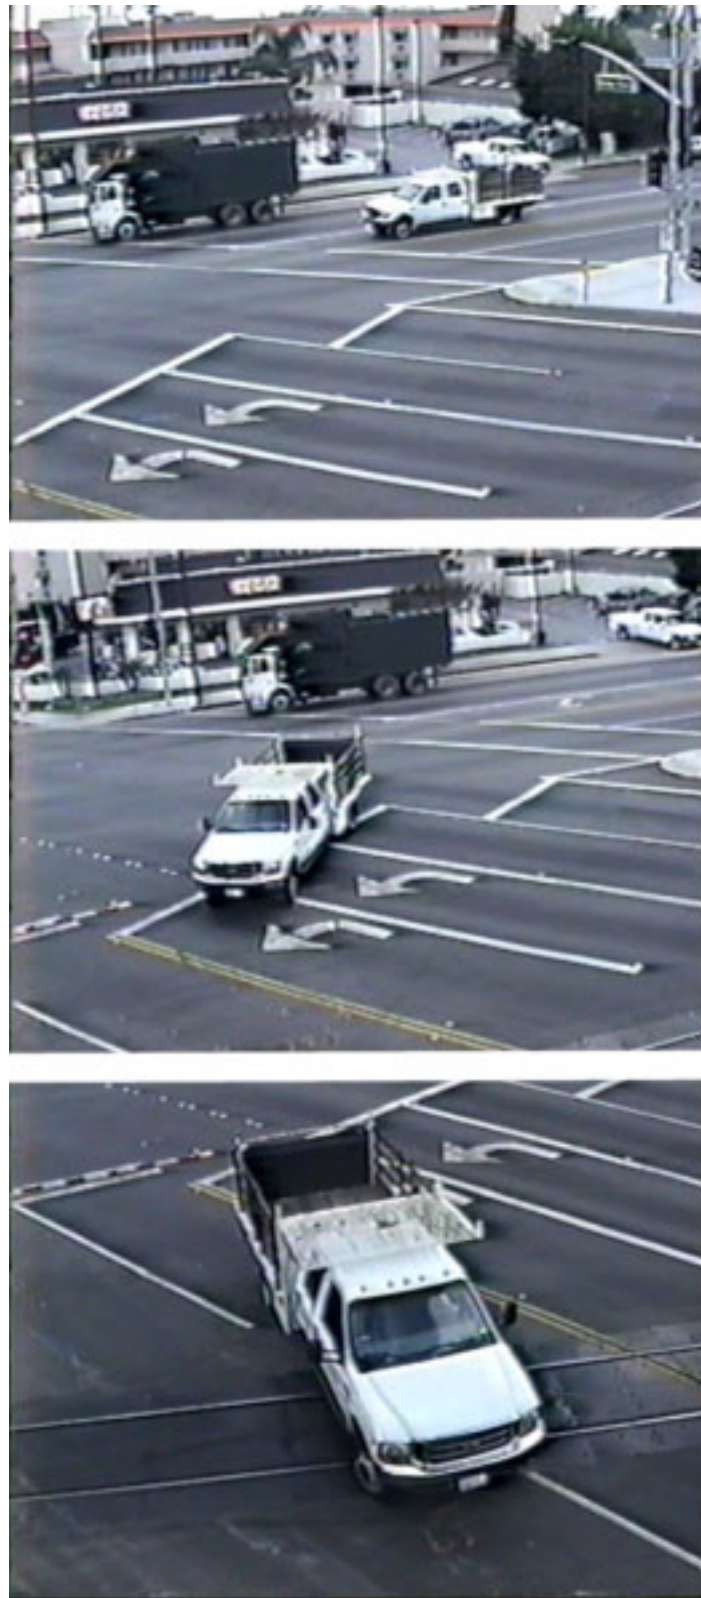
Figure 2. Reenactment of accident truck's left turn.

Because of the acute angle at the intersection, drivers turning left from eastbound North San Fernando Boulevard follow a path that crosses over the south ends of the dual left turn lanes and double yellow centerline on North Buena Vista Street. Wear to the pavement markings in that area and an "oil drip" path on the pavement are evidence of this movement. The path is the same one followed by drivers of the exemplar vehicle during postaccident testing.

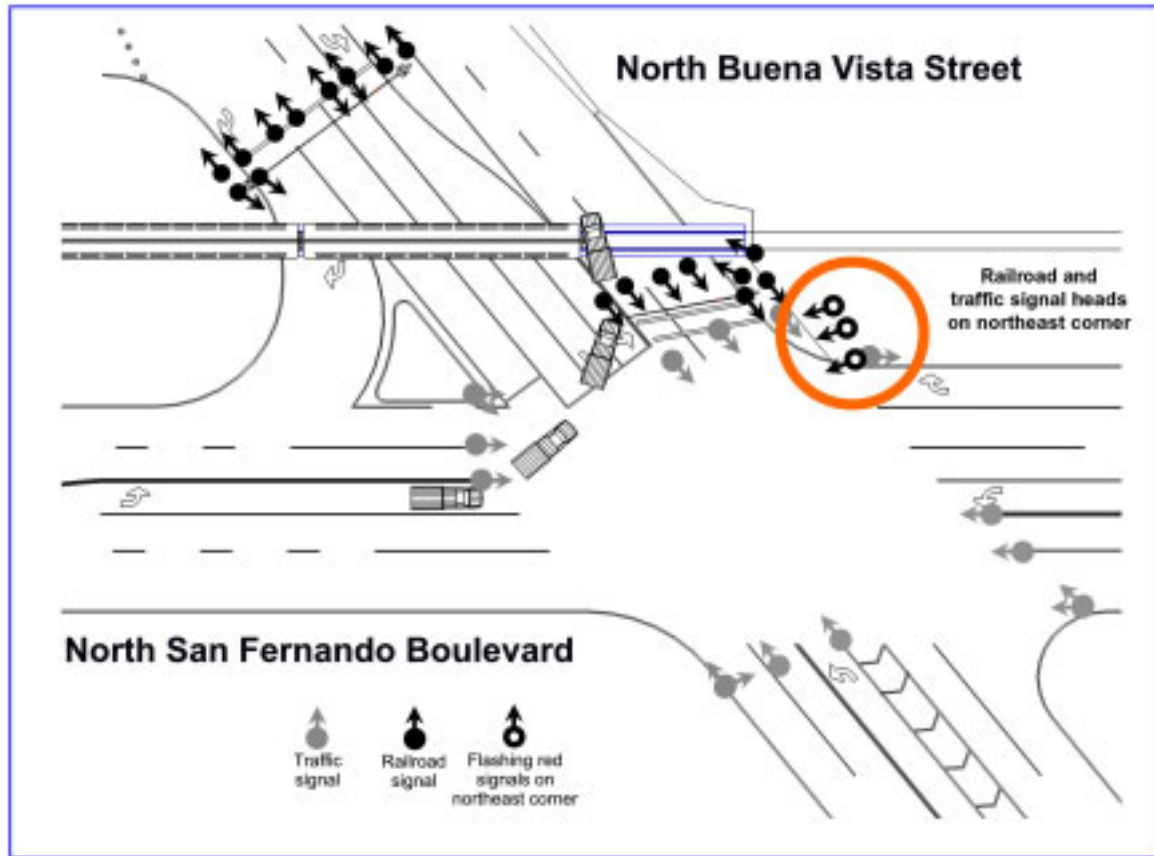
Figure 3. Intersection signals and gates.

flashing-light railroad signals at the grade crossing, the highway traffic control signals transitioned to an “all-red-flash mode” at all intersection approaches and turn signal locations. The all-red-flash mode, also known as a “railroad hold” interval, included the circular red signal indications and the red arrow signal indications.⁹

In addition to the spatial challenges that the accident driver encountered at this site, he received confusing, potentially contradictory, messages from the highway-rail signal system that governed traffic movement. The interconnected signal system, which had been installed less than a year before the accident, did not malfunction. As it was designed to do, the approach of the Metrolink train caused the railroad signals at the crossing to alternately flash red, an indication requiring all oncoming traffic to stop until the signal aspect was extinguished. Flashing red railroad signals are intended to have no other meaning.

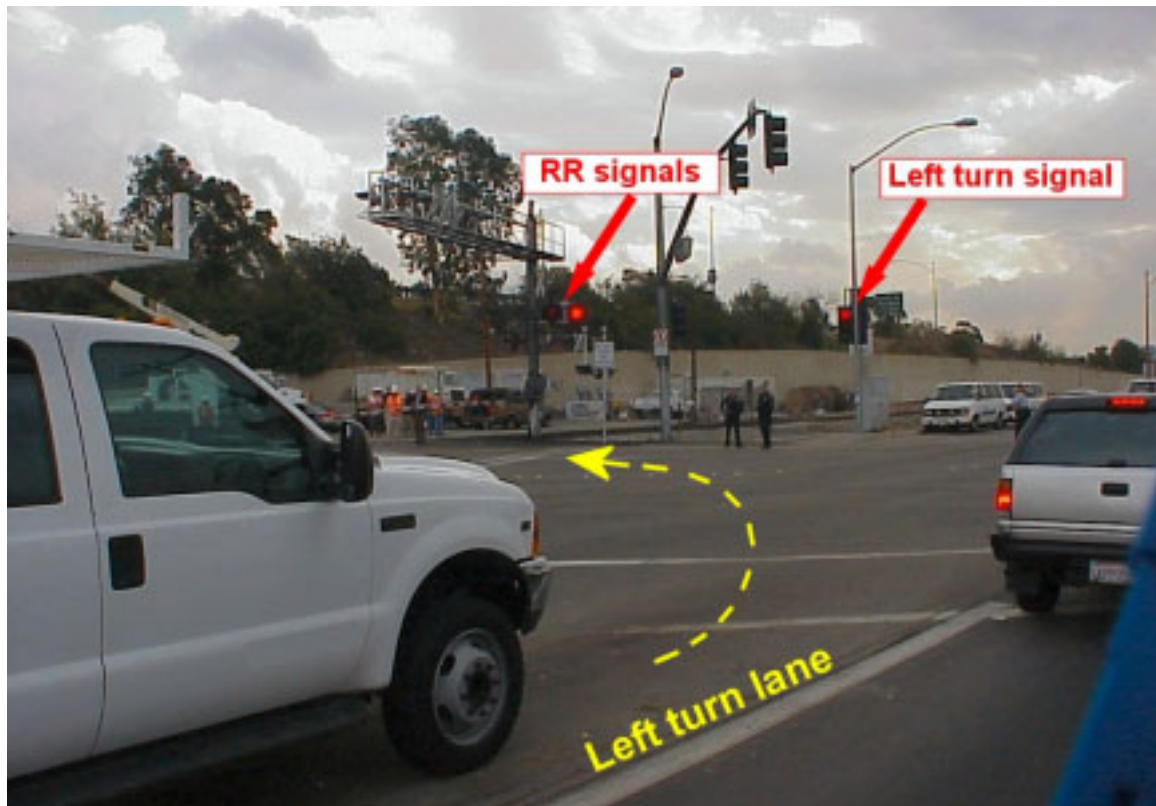
In events leading up to the accident, witnesses reported that the truckdriver had originally stopped his vehicle at the intersection while facing a left red arrow signal indication. While the truck was stopped, the approaching Metrolink train preempted the traffic signals, and as a result, 25 seconds later, the traffic signals switched to the all-red-flash mode or railroad hold interval. From the eastbound left turn lane, both the flashing red circular and the flashing red left arrow traffic control signal indications would have been in the truckdriver’s line of sight. In addition, at least one double-headed railroad crossing flashing light signal would have been within his view (see figure 4). According to witnesses, the truckdriver pulled into the intersection after the signals had entered into the all-red-flash interval.

Figure 4. Accident driver's line of sight (reenactment).

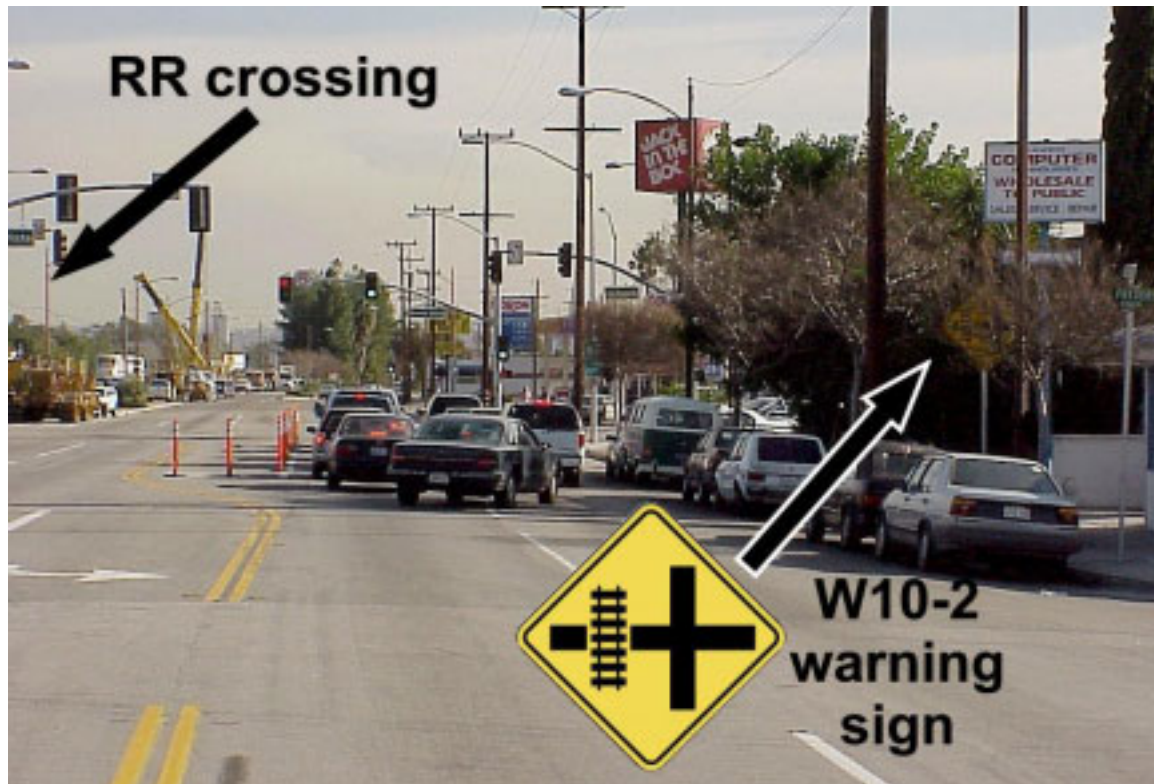
Figure 5. Obscured advance warning sign.

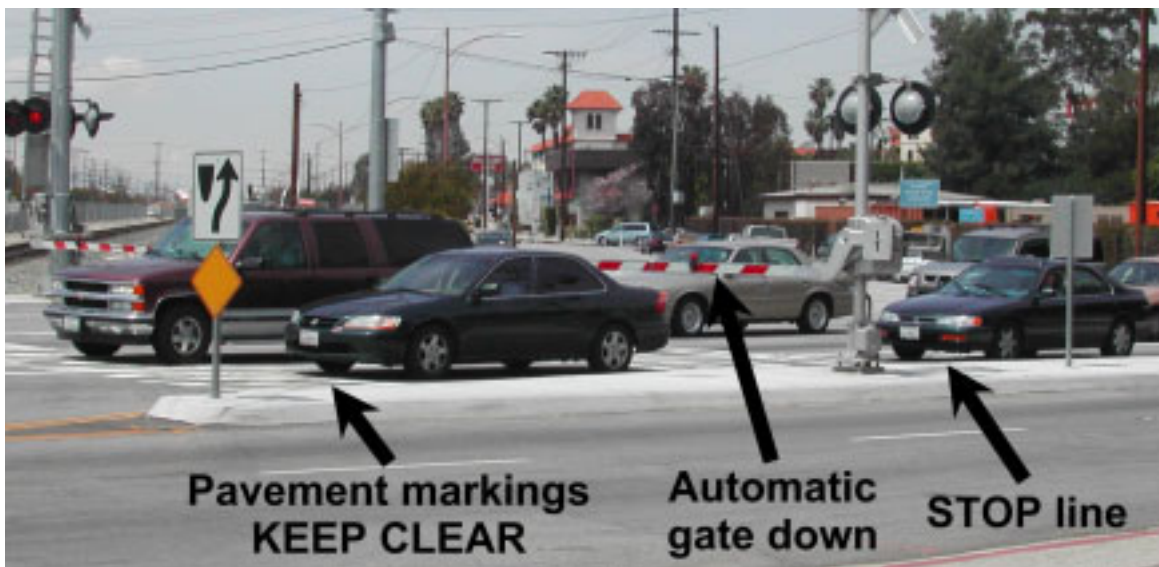
4. Observation of all crossings on both the accident line and another SCRRA line to the west revealed that many of them have similar (or worse) traffic queuing on the crossings. Much of the railroad and highway signal equipment appeared to be older than that at the accident crossing. (See figure 6.)

Figure 6. Postaccident queuing at accident site.

Several months after the accident, queuing was still occurring on this crossing, and Safety Board investigators also observed vehicles queuing from the traffic signal at the intersection of North Buena Vista Street and Winona Avenue just north of the accident site. The traffic signal at North Buena Vista Street and Winona Avenue apparently was not interconnected with the signals at the accident intersection, thereby compounding the queuing problem and adding to the potential hazard. Although storage of vehicles queued onto the crossing from an adjacent traffic signal was not a factor in this accident, it did contribute to several previous train-vehicle accidents at the Burbank crossing.

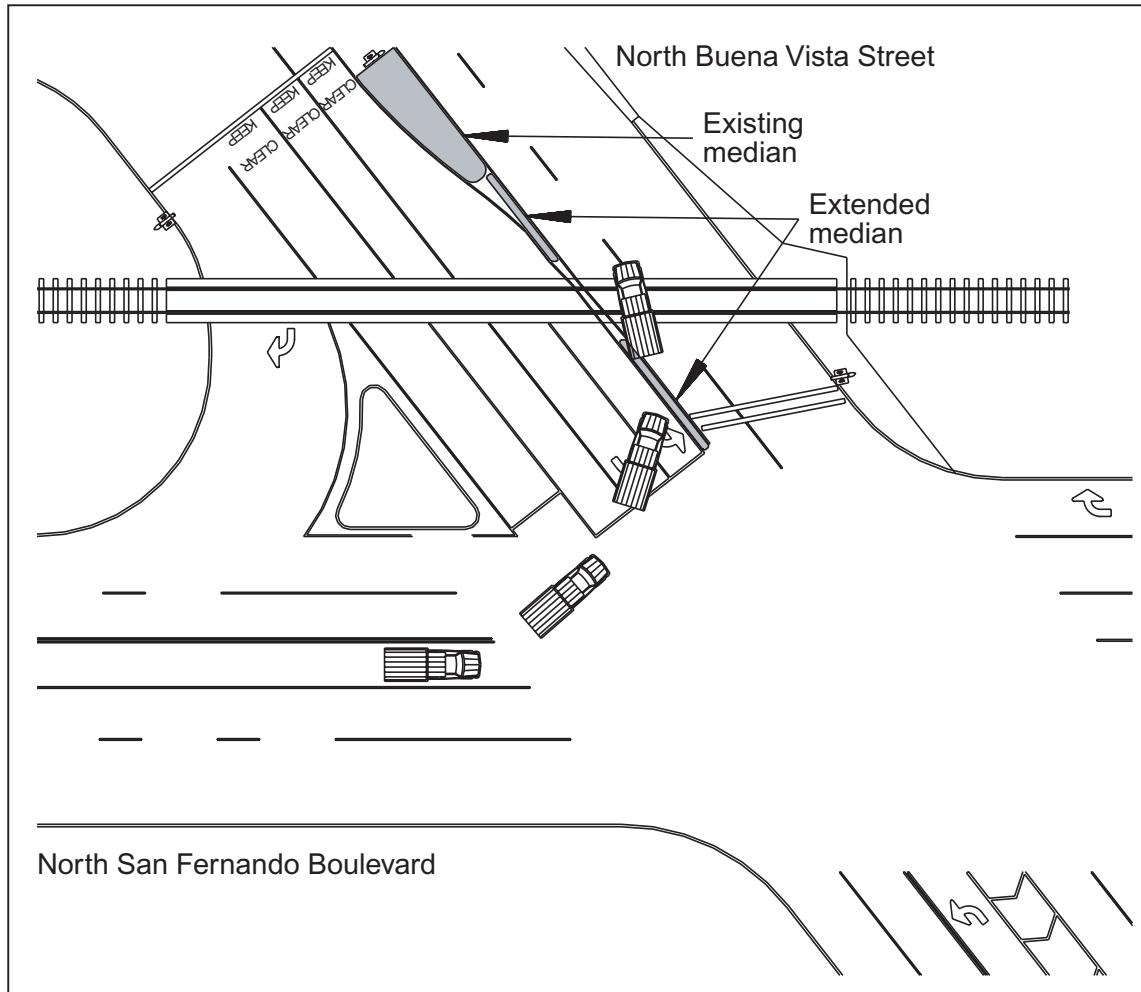
Figure 7. Existing and extended medians at accident site.

Use of raised medians for the centerline approaches to grade crossings is often an effective way to discourage gate running. These medians are barriers several inches high that are intended to prevent or discourage drivers from violating the traffic laws regarding railroad grade crossing signals and automatic gates. At the accident intersection, raised median barriers could also be useful in restricting shallow turns, thus forcing motorists to encounter the grade crossing gates. Several publications issued following the Fox River Grove accident investigation recommend use of raised medians at grade crossings.

³¹ If a raised median were extended to this point, it would have to be discontinued upon reaching the "dynamic envelope" of the tracks, leaving about a 16-foot gap between the end of the median and the tracks. Even so, it would provide a barrier sufficient to discourage gate running.
