Motorcoach Fire on Interstate 45  
During Hurricane Rita Evacuation  
Near Wilmer, Texas  
September 23, 2005

**ACCIDENT REPORT**

NTSB/HAR-07/01  
PB2007-916202

**Motorcoach Fire on Interstate 45  
During Hurricane Rita Evacuation  
Near Wilmer, Texas  
September 23, 2005**

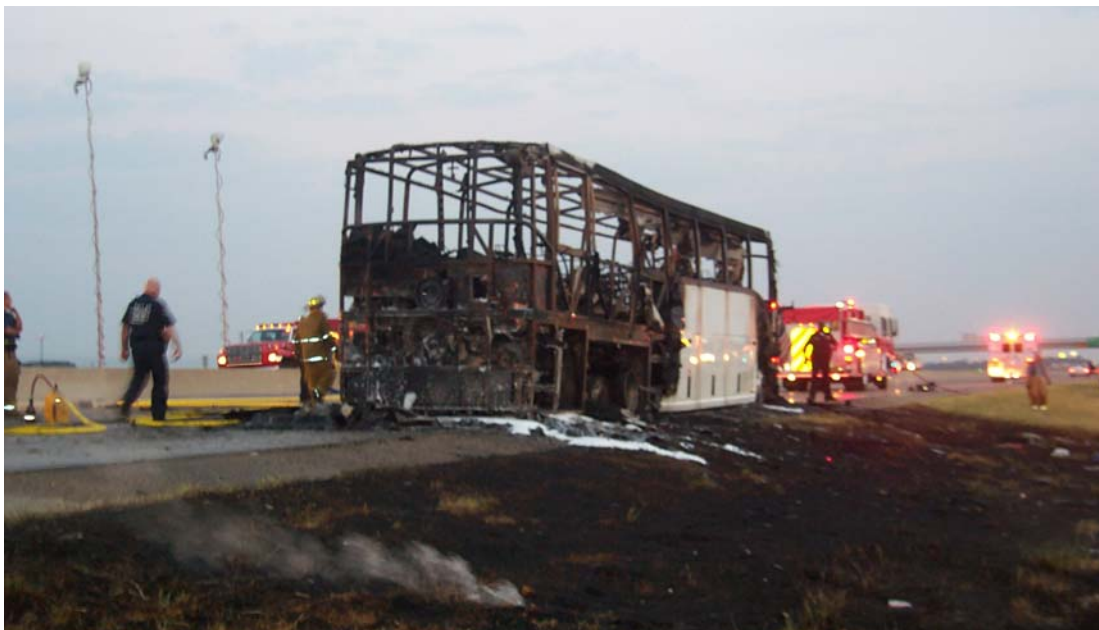
About 6:07 a.m., Dallas County and the city of Wilmer dispatchers received a 911 call reporting the fire. Two Wilmer Police Department officers had arrived on scene by 6:12 a.m., and one officer, along with motorists who had stopped to help, entered the motorcoach to help the nonambulatory passengers evacuate. Witnesses interviewed by the Safety Board reported trying unsuccessfully to pry open the motorcoach windows from outside; two passersby broke the glass in two windows, but they were unable to rescue anyone through the broken windows. (See figure 3.)

**Figure 3.** Damaged motorcoach on I-45 following fire.

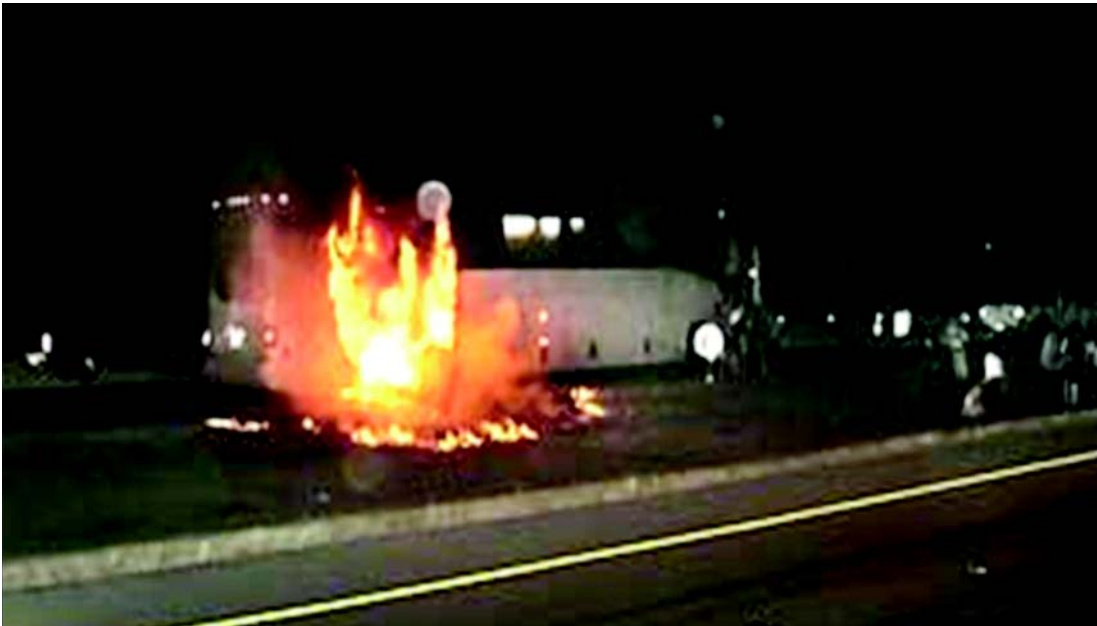
**Figure 4.** Motorcoach tire on fire, witness photo from I-45 frontage road.  
(Courtesy of Dallas County Sheriff's Office)

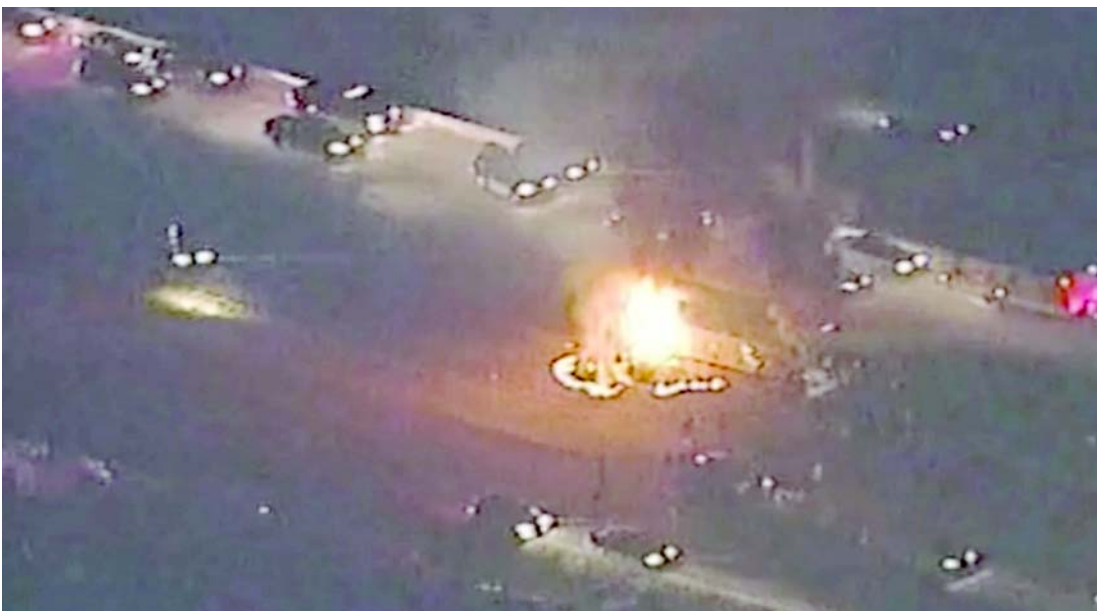
- About 6:08 a.m., approximately 3 minutes after the motorcoach pulled onto the right shoulder of I-45 (the 911 call was placed at 6:07 a.m.), fire is visible from the rear on the right side of the vehicle. (See figure 5.)

**Figure 5.** Video image 1 of accident motorcoach. (Courtesy of KTVT, Dallas-Fort Worth)

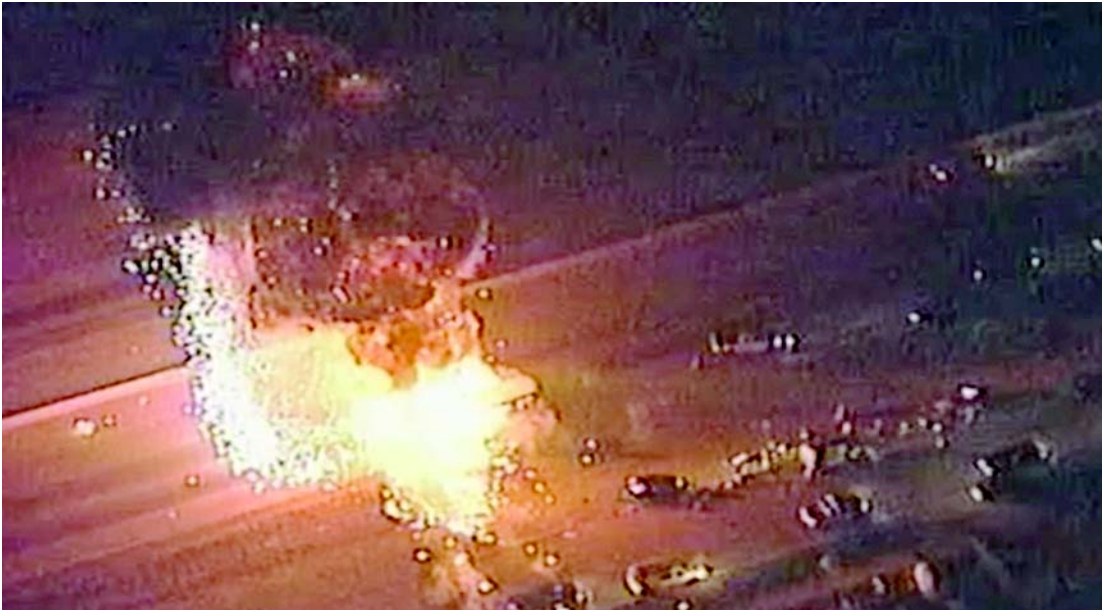
- Less than 15 seconds later, the entire rear of the vehicle is engulfed in flames.
- An intense burst of fire is visible about 3 minutes later. (See figure 6.)
- By 6:15 a.m., 6.5 minutes into the video, the motorcoach is almost completely engulfed in flames. (See figure 7.)

**Figure 6.** Video image 2 of accident motorcoach. (Courtesy of KTVT, Dallas–Fort Worth)

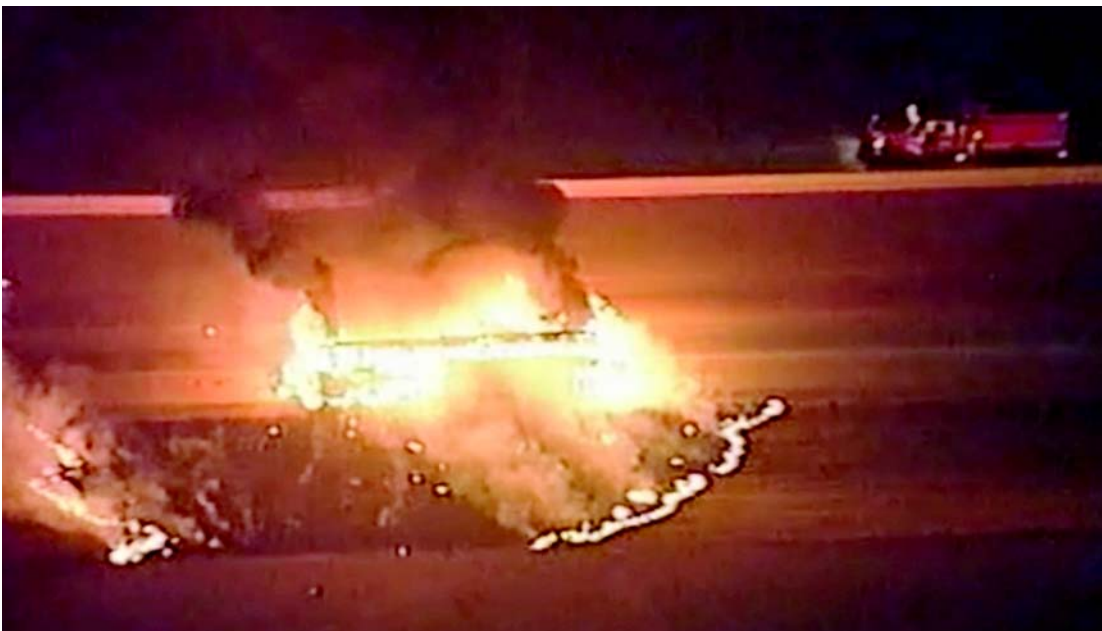
**Figure 7.** Video image 3 of accident motorcoach. (Courtesy of KTVT, Dallas–Fort Worth)

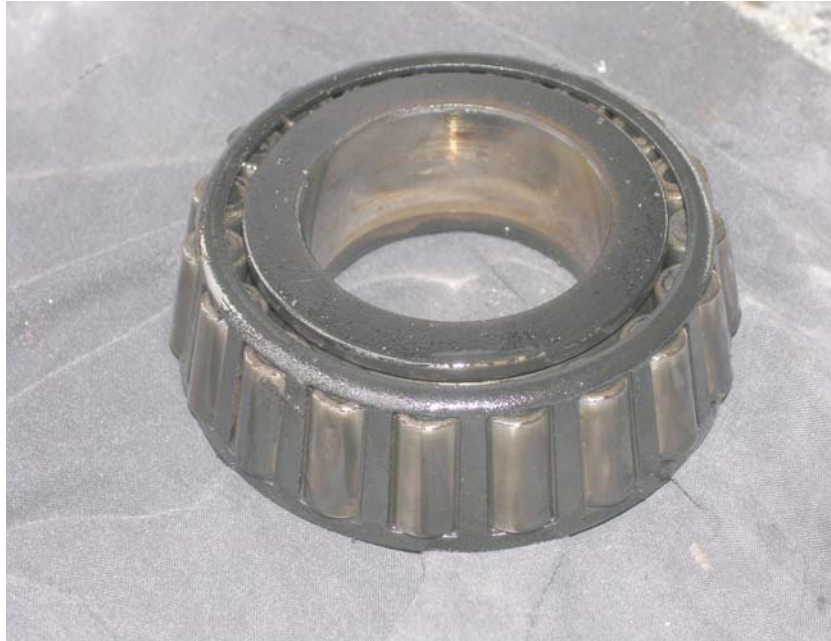
**Figure 13.** Left tag axle outer wheel bearing assembly.

As originally installed, the outer wheel bearing contains 19 rollers evenly spaced and held within a bearing cage. (See figure 13.) Inspection of the 3R wheel bearing revealed four flattened rollers in the hub. Two other flattened rollers were found in the area of the grass fire, near MP 266. The inner wheel bearing, as originally installed, contained 17 rollers. Eight or nine rollers were discovered fused together, two other rollers were found severely flattened, and the bearing cage was destroyed. (See figure 14.) The inner wheel seal was destroyed. According to a chief engineer with Timken Company, the

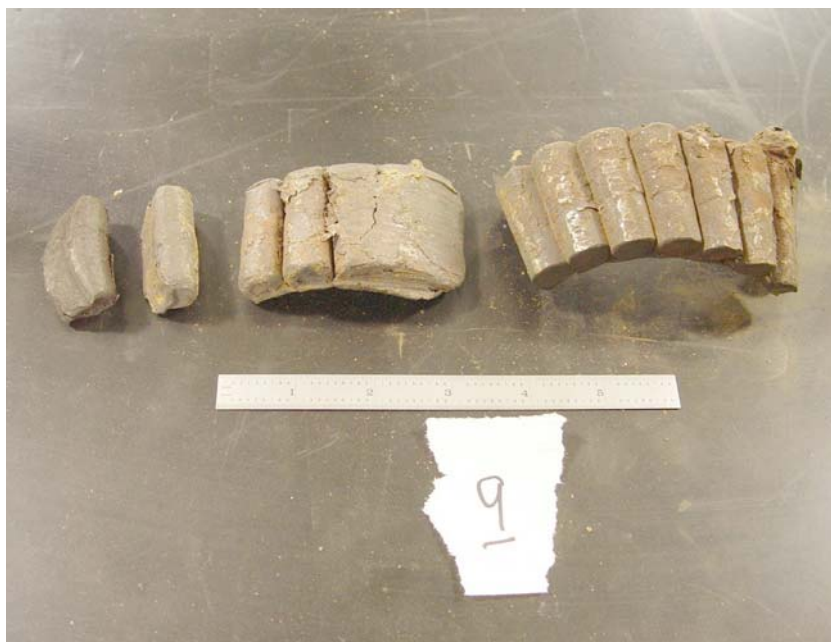
The National Transportation Safety Board determines that the probable cause of the accident was insufficient lubrication in the right-side tag axle wheel bearing assembly of the motorcoach, resulting in increased temperatures and subsequent failed wheel bearings, which led to ignition of the tire and the catastrophic fire. Global Limo Inc. had failed to conduct proper vehicle maintenance, to do pretrip inspections, and to complete posttrip driver vehicle inspection reports, thereby allowing the insufficient wheel bearing lubrication to go undetected. Contributing to the accident was the Federal Motor Carrier Safety Administration's ineffective compliance review system, which resulted in inadequate safety oversight of passenger motor carriers. Contributing to the rapid propagation and severity of the fire and subsequent loss of life was the lack of motorcoach fire-retardant construction materials adjacent to the wheel well. Also contributing to the severity of the accident was the limited ability of passengers with special needs to evacuate the motorcoach.

The inspection revealed that the right-side tag axle (3R) aluminum hubcap melted during the fire; several small fragments were still present around the hubcap mounting bolts. (Aluminum melts at approximately 1,150° F.) The 3R tire was burned, and no rubber remained. The 3R brake rotor was skewed outward and was in contact with the torque plate and the brake caliper housing. Normally, the brake rotor does not make contact with either of these components. This abnormal contact caused grinding marks on the underside of the caliper housing, as well as on the torque plate and brake rotor. Additionally, the brake pad retaining clips, which are normally round, had flat spots from contact with the rotor; the 3R outside brake pad was worn more on the top, and the 3R inside pad was worn heavier at the bottom, consistent with wear from the displaced and tilted rotor.

strength of wheel bearing roller material is a function of temperature. At a temperature as low as 1,000° F, the roller material can begin to lose metal strength. Further, the amount of roller deformation is dependent on the loading (weight) from the motorcoach and the length of time the roller is exposed to this weight and increased temperatures.

**Figure 14.** Damaged right tag axle spindle and inner bearings.
