National Transportation Safety Board

Highway Accident Brief

Accident Number: HWY-04-MH-028
Accident Type: Rear-end chain-reaction collision
Location: Interstate Highway 30 west, near Sulphur Springs, Texas
Date and Time: June 13, 2004, 8:39 p.m.
Vehicles: 1991 Kenworth tractor-auto transporter
2002 Hyundai Santa Fe sport utility vehicle
2000 Peterbilt tractor-semitrailer combination unit
2003 Lincoln Navigator sport utility vehicle
2000 Volvo tractor-semitrailer combination unit
Owners/Operators: Waggoners Trucking Company (USDOT 30176)
Southwest Motor Freight
Pilot Logistics
Private owners
Fatalities/Injuries: 5 fatalities
2 minor injuries

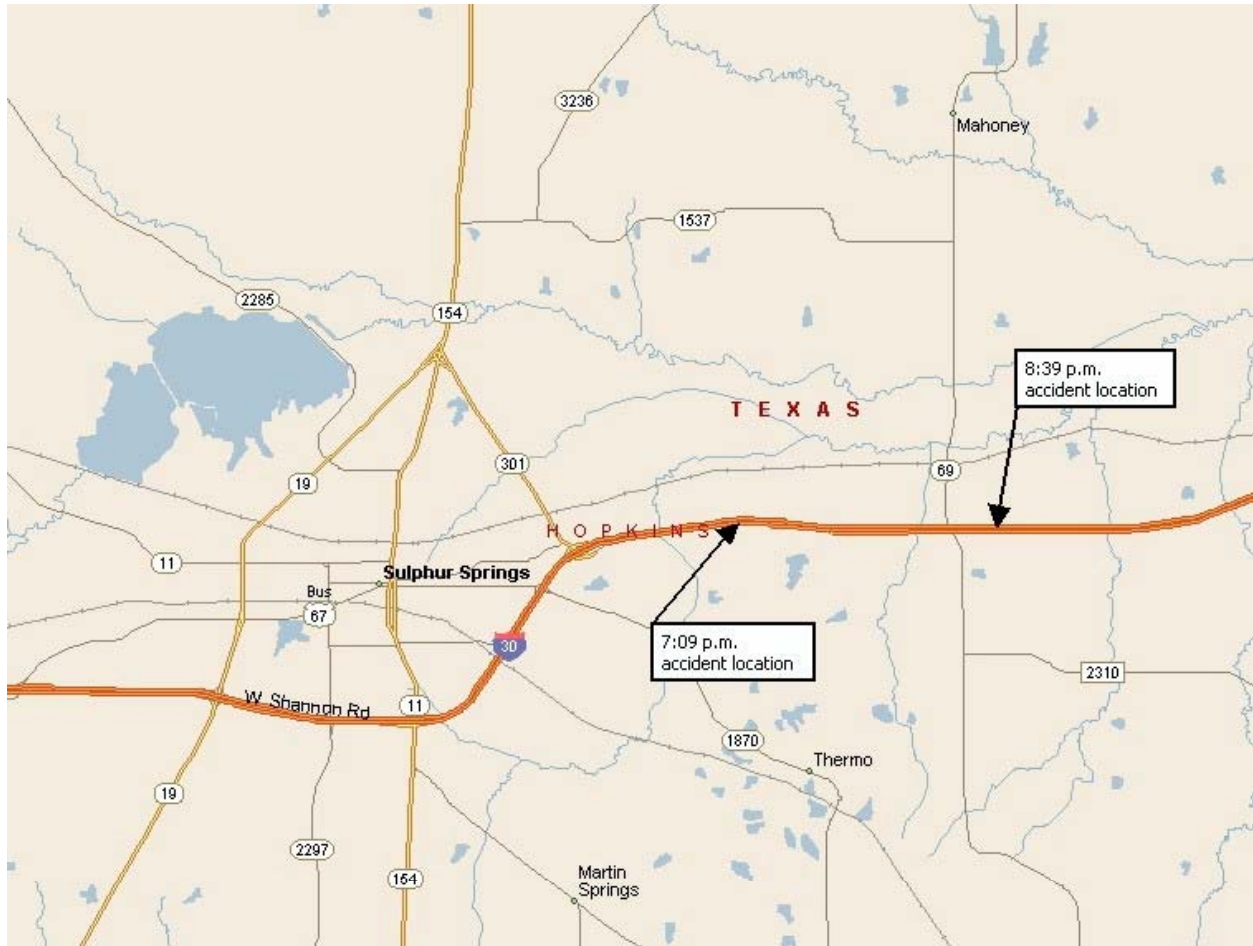
The traffic queue had formed on I-30 west due to a single-vehicle crossover accident with multiple fatalities (see figure 1), which had occurred 1.5 hours earlier, at 7:09 p.m. This accident prompted the Texas Department of Public Safety (DPS) to close all eastbound and westbound lanes of I-30 and detour traffic to parallel service roads.

Figure 1. Locations of Sulphur Springs accidents.

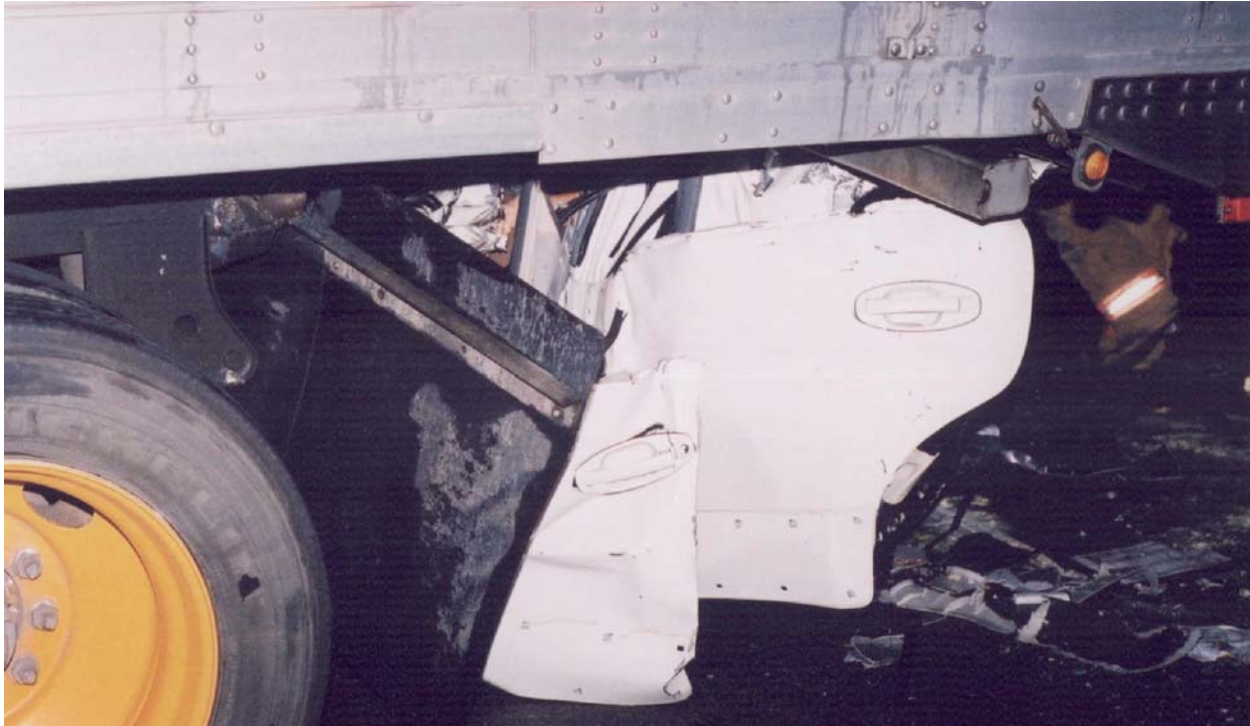
Figure 2. Hyundai lodged under Peterbilt tractor-semitrailer combination unit.

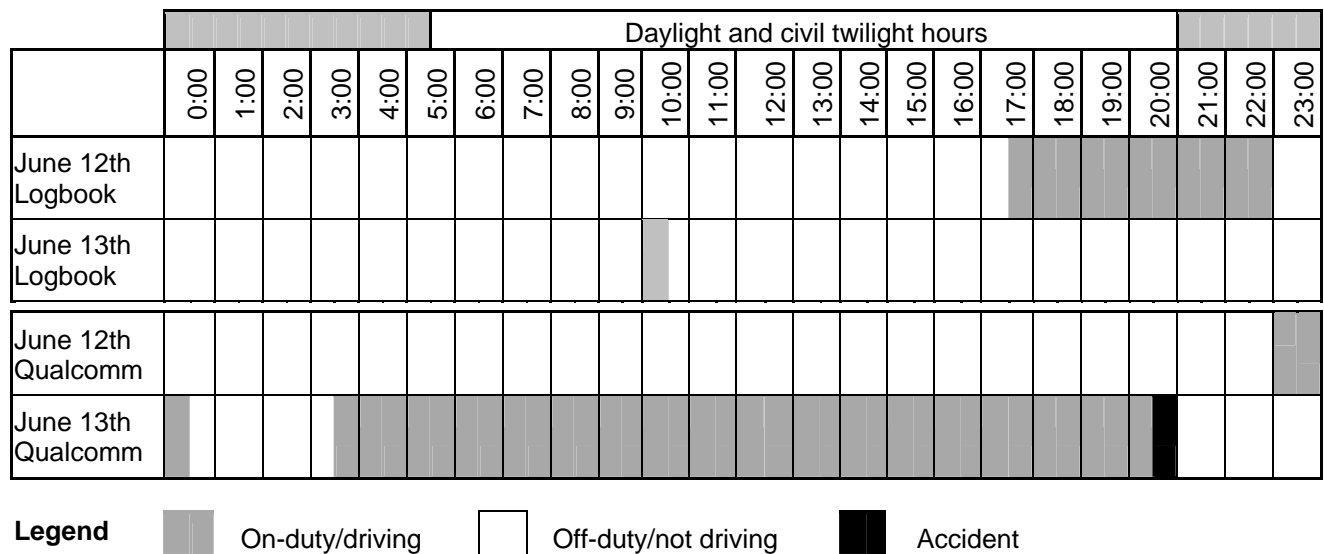
3 hours; he started driving again at 3:41 a.m. on June 13. A gas receipt indicated that he refueled in Nashville at 9:13 a.m. Except for an additional refueling stop at 4:16 p.m. in North Little Rock, Arkansas, the Qualcomm data showed that the driver drove 954 miles, from Fletcher to Sulphur Springs, in about 18 hours, with only the 3-hour break mentioned above. (See figure 3.)

Figure 3. Comparison of Kenworth driver duty status based on logbook entries and Qualcomm Qtracs satellite data.

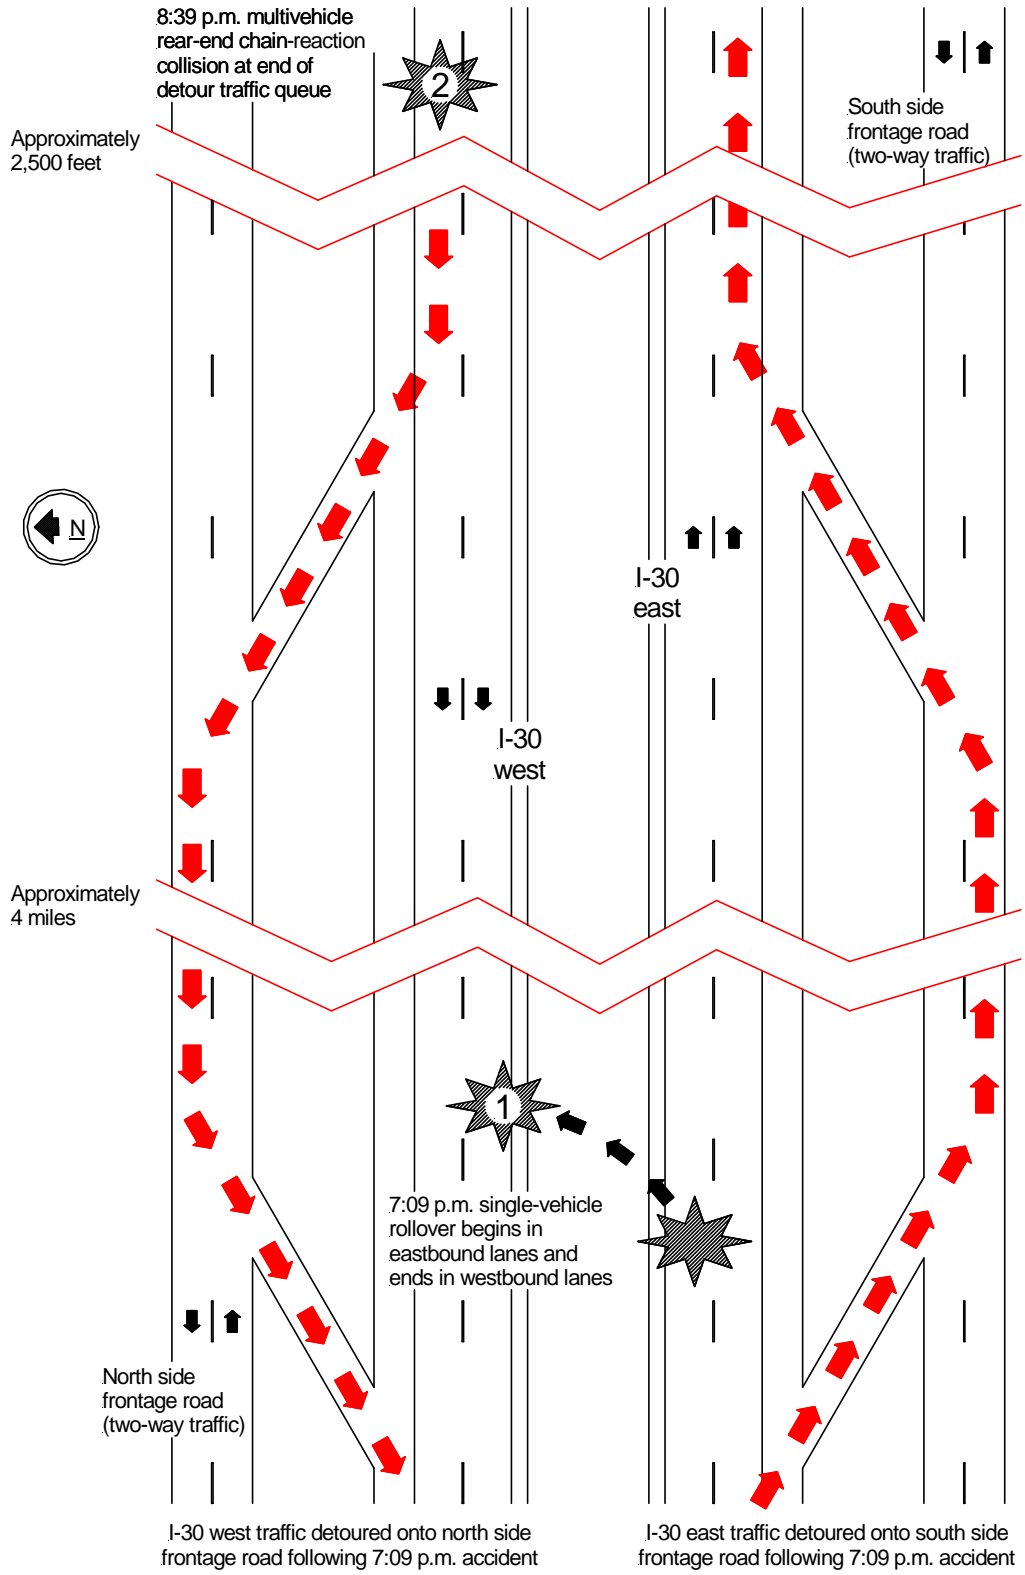
supervisor about the accident. Sheriff's deputies set up temporary traffic control until TxDOT arrived on scene. They diverted I-30 east traffic onto the eastbound service road via exit 126, located 2 miles west of the accident site.¹⁸ Westbound traffic was diverted to exit 131, which led to Farm-to-Market Road [FM] 69, connecting to the westbound service road. (See figure 4.)

Figure 4. Detours on I-30 following 7:09 p.m. accident.

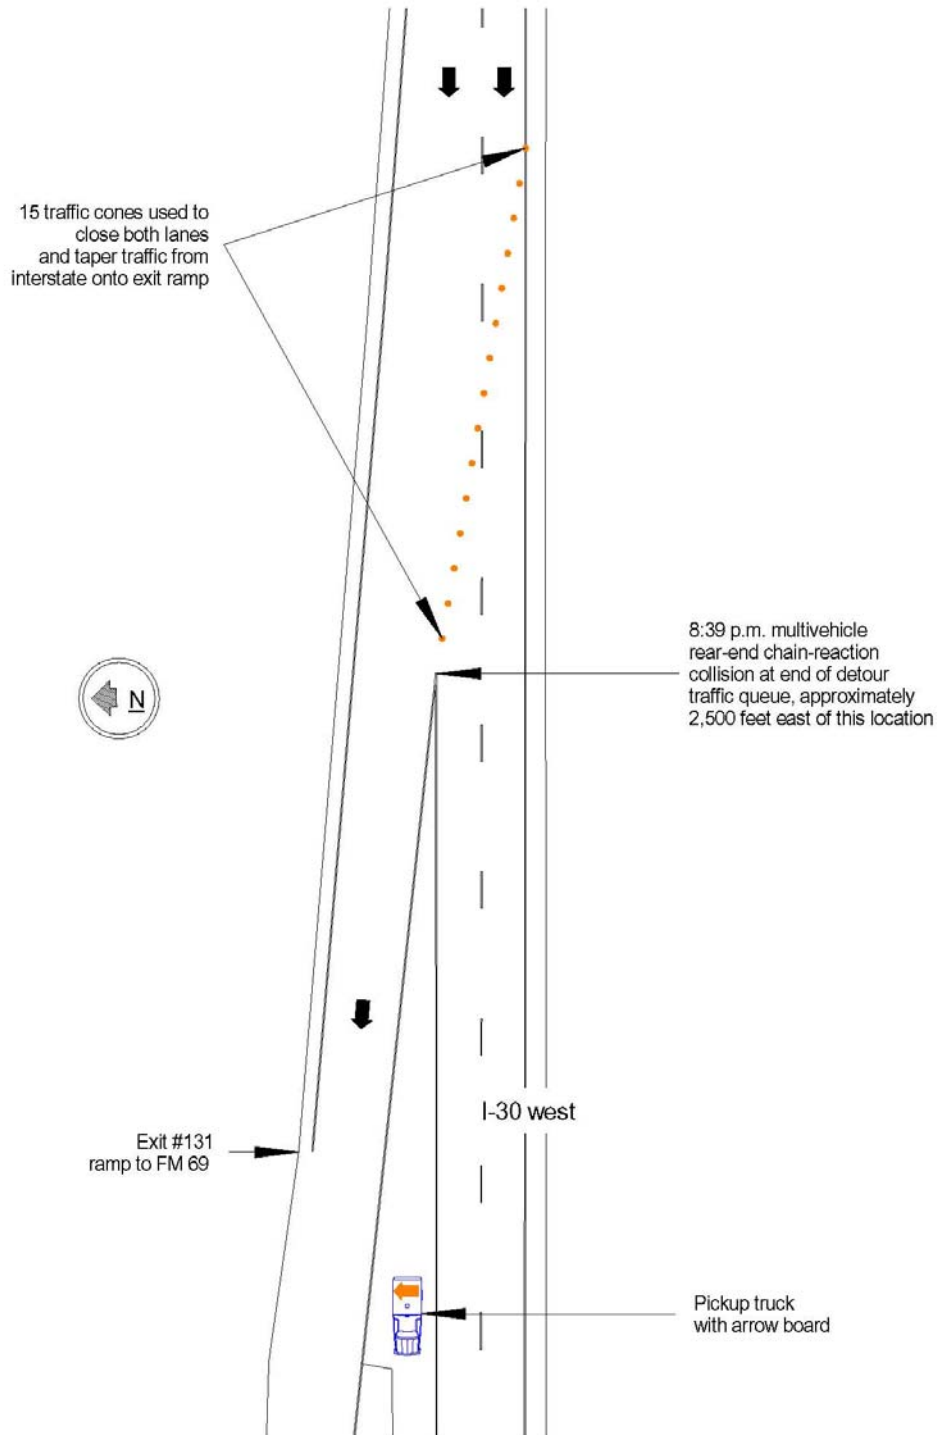
TxDOT used 15 traffic cones to funnel traffic onto exit 131 and sent an attenuator truck¹⁹ and a pickup truck with an electronic arrow board to I-30 west to help direct traffic onto the service roads. The pickup truck was positioned in the gore area leading to exit 131. (See figure 5.) No other control devices were placed upstream of exit 131 to alert motorists to the traffic backup. According to a TxDOT representative, traffic began to queue on the service road and the main lanes of I-30 west, where it extended 2,500 feet back from the exit 131 ramp. Traffic control on I-30 east was set up similarly.

Figure 5. Traffic control devices used to detour traffic from I-30 west following 7:09 p.m. accident.
