HETA 2000-0091-2803
Horry County Assessor's Office
Conway, South Carolina

Indoor Environmental Quality Survey at the Horry County Assessor's Office (801 Main Street Building)

Health Hazard Evaluation Report 2000-0091-2803
Horry County Assessor's Office
Conway, South Carolina
July 2000

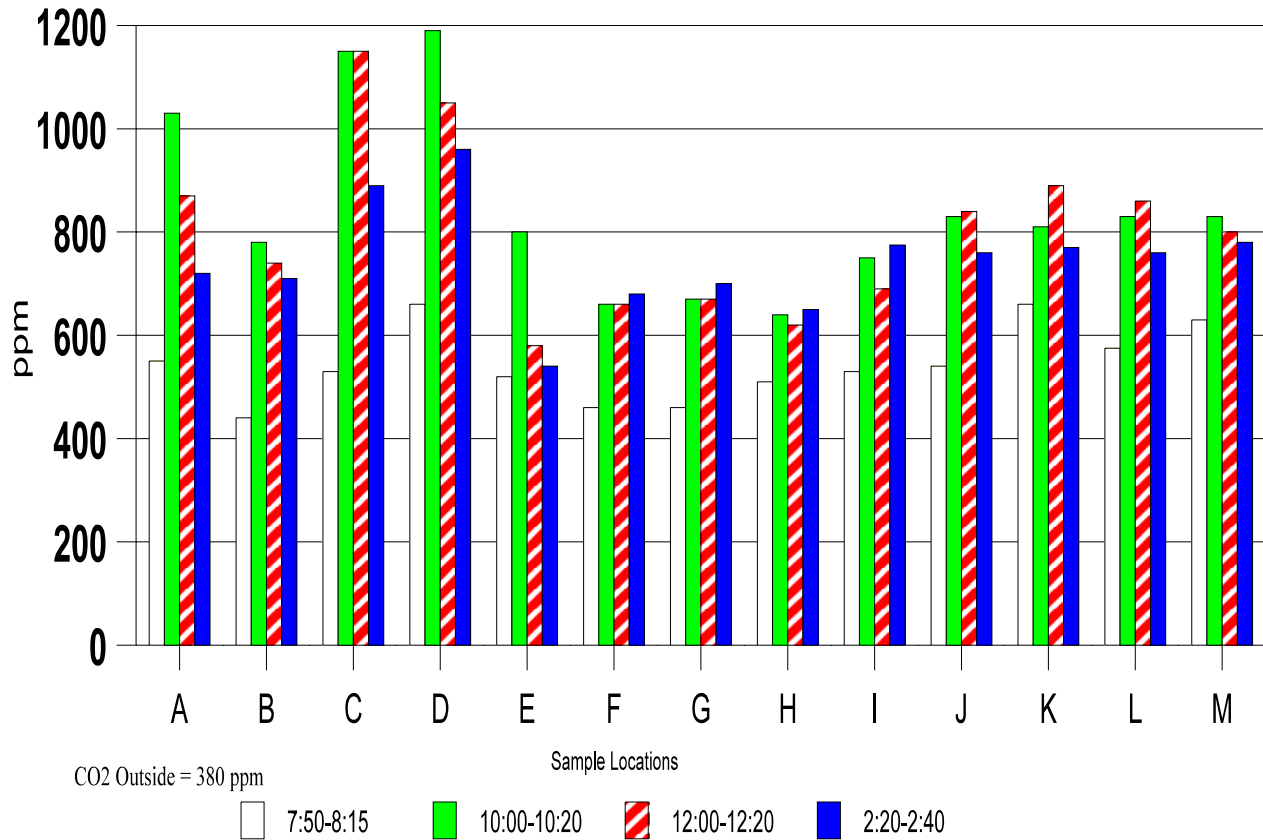
Figure 1
Carbon Dioxide Measurements
Horry County Administrative Building, Conway, South Carolina
HETA 2000-0091-2803

- The highest CO₂ concentrations (ranging from 1030 to 1150 ppm) were measured in the following three areas: Auditor's Office, Building Inspection, and Code Enforcement. It was observed that two of these areas were open to the general public. These

CO₂ concentrations suggest that these office areas may be inadequately ventilated during part of the work day, probably due to the presence of the public in these areas.

Note: NIOSH suspects inadequate ventilation in areas when indoor CO₂ concentrations exceed 800 ppm, where the only known source is exhaled breath, inadequate ventilation is suspected. Elevated CO₂ concentrations suggest that other indoor contaminants may also be increased.
