HETA 2000-0268-2812
Southwest Airlines San Antonio Reservations Center
San Antonio, Texas

Evaluation of Indoor Air Quality at the San Antonio Reservations Center

Health Hazard Evaluation Report 2000-0268-2812
Southwest Airlines San Antonio Reservations Center
San Antonio, Texas
November 2000

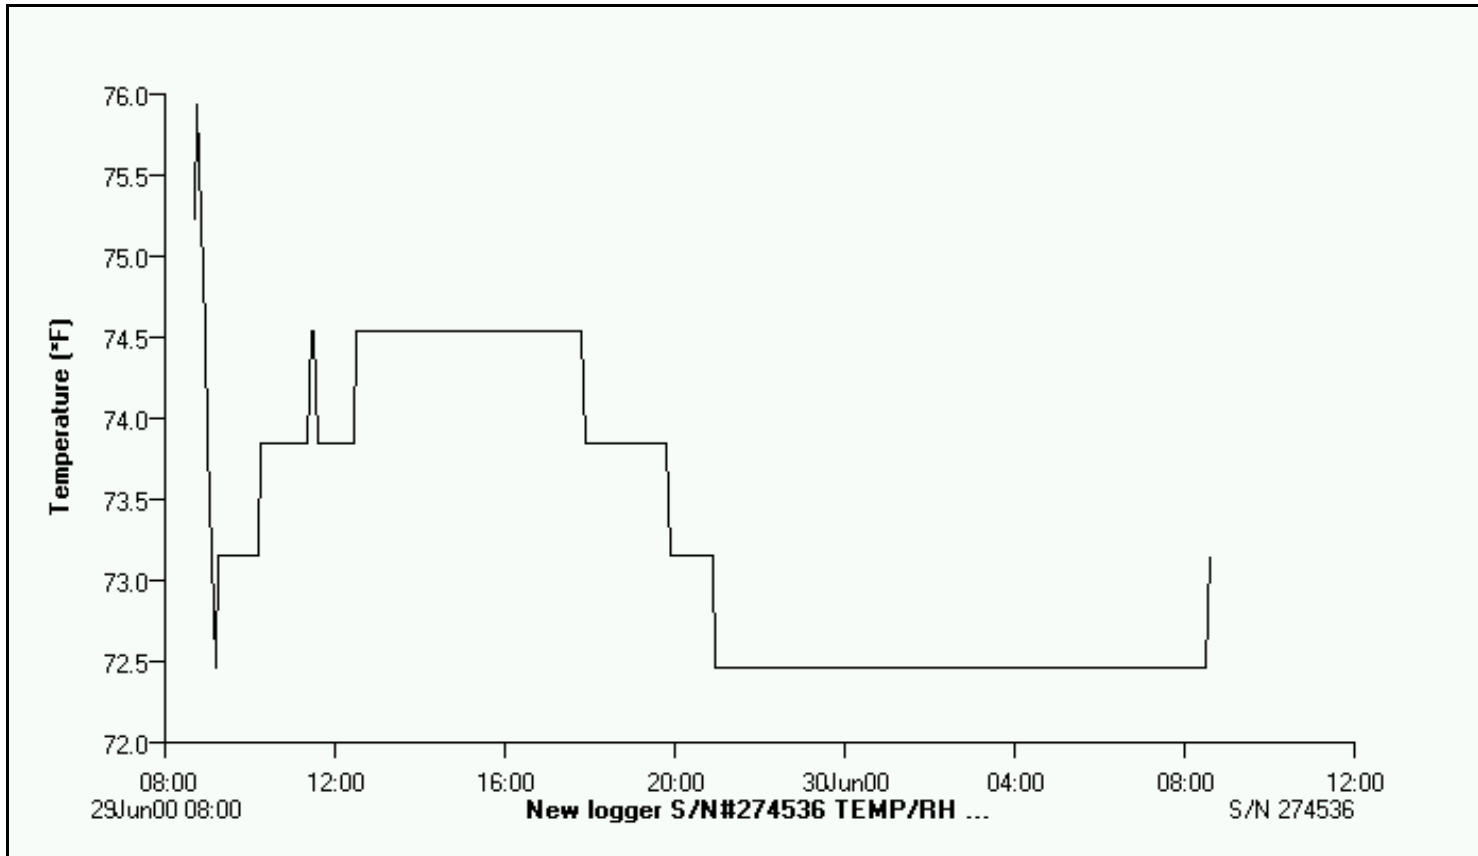
Figure 3
Temperature Variations in Quadrant B
HETA 2000-0268
Southwest Airlines San Antonio Reservations Center, San Antonio, TX
June 29-30, 2000

Measured temperatures in quadrant B, the front reception area, the Q&A office, and the shop steward's office were from 2°F below to 1°F above ASHRAE's recommended range for the summer months (73-79°F). However, with the exception of the shop steward's office, these slight variations outside the recommended range occurred during either unoccupied, or low occupancy times of the day. Temperatures in the remaining locations measured were within the range recommended by ASHRAE Standard 55-1992. Temperature patterns in the reservations center were fairly consistent, with the exception of the temperature fluctuations illustrated in the break room. This is most likely due to the frequency of outside air being introduced into the break room when employees enter or exit the outdoor break area, which is accessible through a door in the break room. Certain areas of the reservations center remain occupied for 24 hours and, as a result, temperature patterns should be uniform and remain stable at all times. RH measured in the building indicated that maximum levels were approaching the upper limit recommended by ASHRAE Standard 55-1992. This factor suggests that the current ventilation system is not sufficiently conditioning the intake air before it is delivered to the building.
