Section 11 Environmental Effects Associated with the Breach of the Upper Reservoir at the Taum Sauk Project

11.1 General Description of the Hydro Project and Project Area

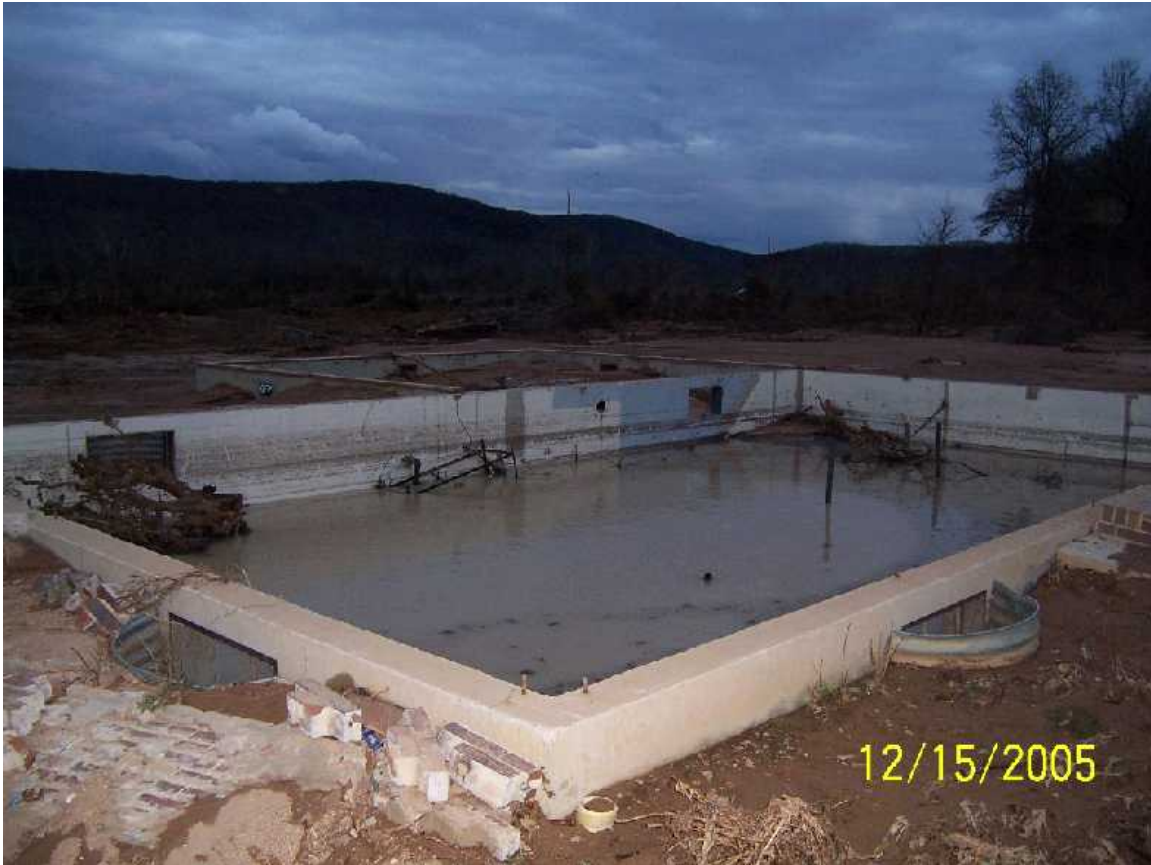
Figure 11.1 - State park superintendent's former home. (Source: Staff)

Search and rescue teams were dispatched within the State Park and vicinity. No other casualties were reported owing in large part to the time of year and time of day when attendance at the park is/was minimal. However, it was reported by the Associated Press that the flood waters slammed into a truck hauling a load of zinc on Route N near the reservoir. The driver climbed onto the roof of the truck and saw that another truck and a car were also submerged, with the drivers also on the roofs of their cars. It was also reported that a mobile home, several cars and a tractor-trailer were washed away.

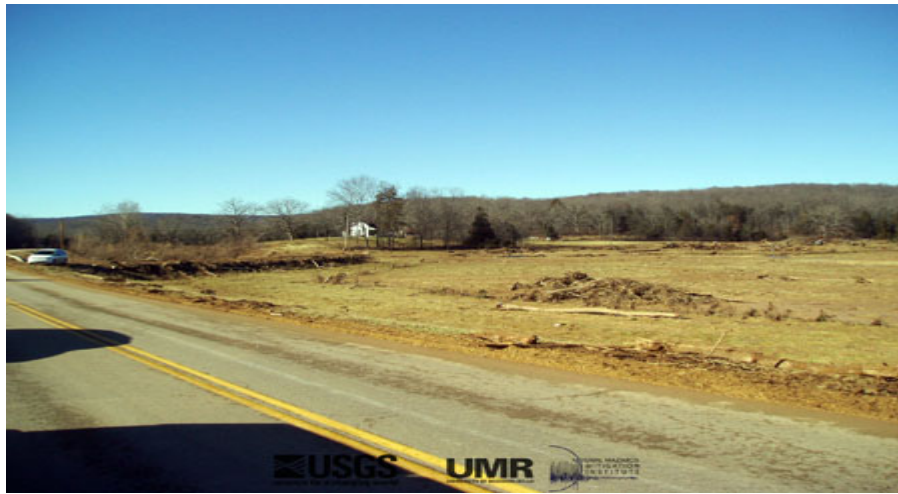
One home approximately 200 hundred yards from the Superintendent's residence (located off Route N) was surrounded by flood waters but, because it is located on a small hill, the flood waters encircled the residence but did not flood it. The surrounding farmland however, was flooded and debris and sediment was deposited in the fields. Additionally, some of the farmland fencing was destroyed (Figure 11.2).

Figure 11.2 - Farmland with debris on north side of Route N. Note home on small hill. (Source: U.S. Geological Survey)

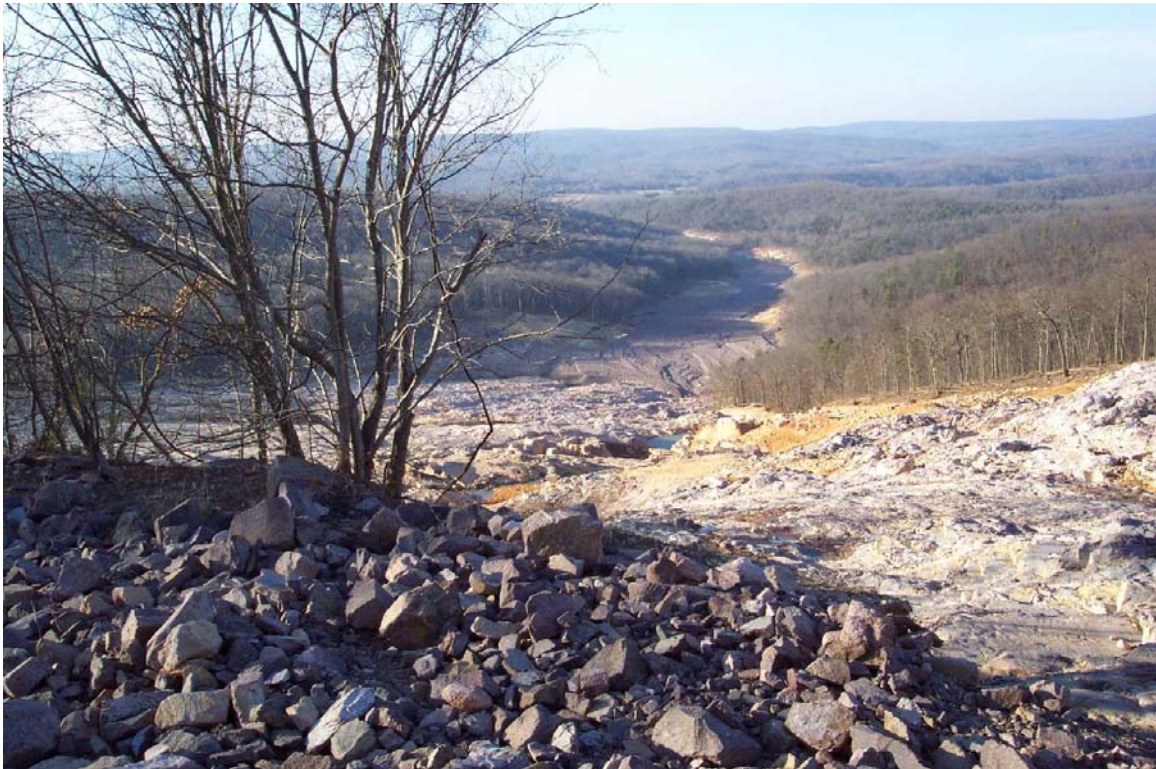
Approximately 317 acres, between the upper and lower reservoir, were directly impacted by the release of water immediately following the dam breach. A map and description of the land uses and soils of this impacted area can be found in Appendix E in the back of this report. The erosive force of the water from the breach removed all topsoil to bedrock in an approximate 200-yard swath, down the face of the Proffit Mountain (Figure 11.3) along the course of an intermittent unnamed tributary. Also, seen in Figure 11.3 is the shallowness of the topsoil along the tree line.

Figure 11.3– Downstream view from breach (Source: Staff, 12/22/05)

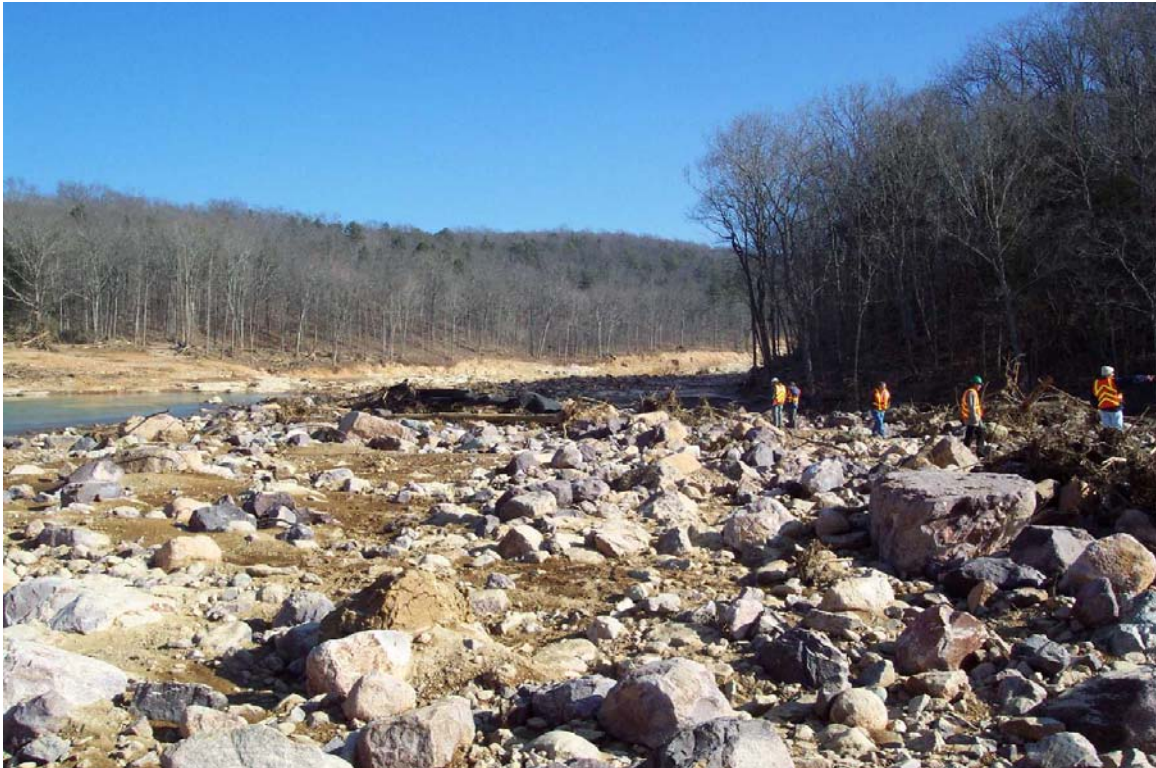
A break in the slope of the terrain is located where the unnamed tributary joins the East Fork Black River at the lower portion of the mountain. Most of the deposition of eroded sediments and rock fill from the dam embankment occurred at this point, forming a debris dam (Figure 11.4) and pond at the approximate location of U.S. Geological Survey gage station (No. 070661270) which was severely damaged during the event. The material deposited at this point ranged from boulders several feet in diameter to sand and fine silts. Concrete, rebar, and

sections of the geomembrane lining from the Upper reservoir were also present in the debris field.

Figure 11.4 – Looking upstream from debris dam (Source: Staff, 12/22/05)

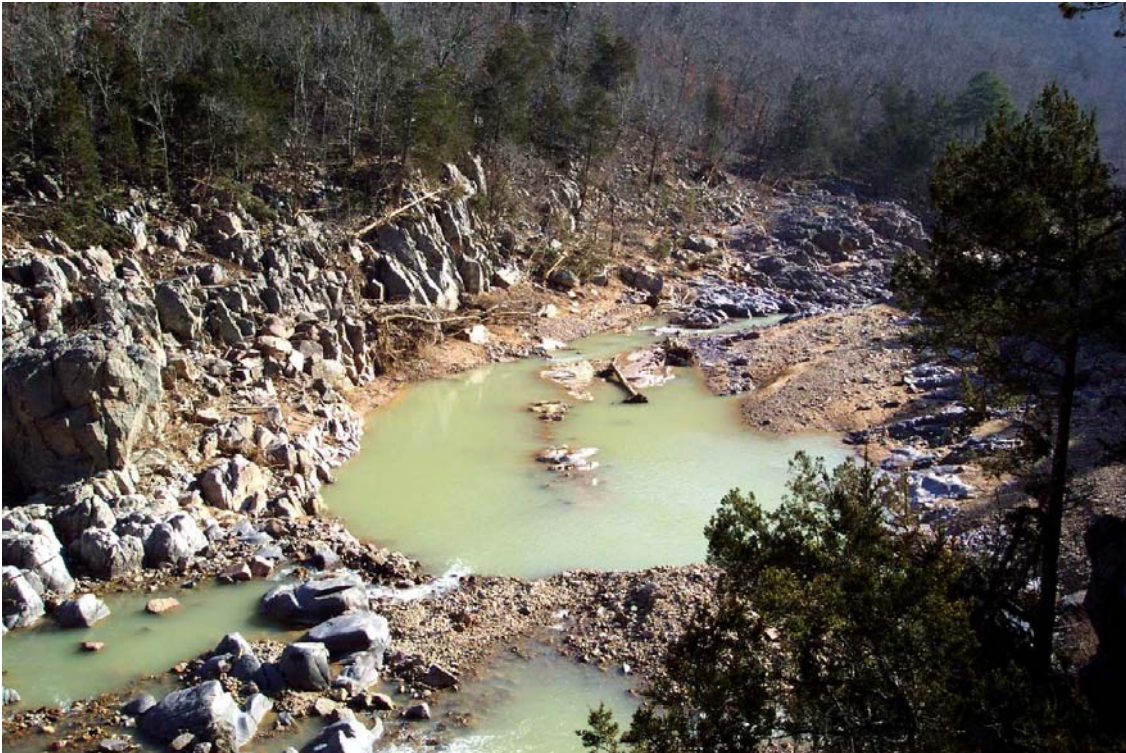
Data collected to date suggest that the impact to water quality is a large increase in turbidity. The initial breach removed all of the overburden on the slope of Proffit Mountain. The larger sediments, and the material from the embankment, were mostly deposited upstream of the “shut-ins” area in the state park. Smaller clay particles suspended during the event stayed in suspension, and did not show any signs of settling two weeks after the event. Small particles, such as clays, can have an electrostatic charge that repels other particles and allows clay to stay in suspension in the water column indefinitely.

Figure 11.5 – Turbidity at Johnson’s Shut-ins (Source: Staff, 12/22/05)

In order to reduce turbidity in the lower reservoir, AmerenUE, with the approval of the Missouri DNR and Commission, used common alum based flocculants (used primarily for drinking water treatment) to remove the charge on

the particles and allow them to settle. Flocculation is a process by which the electrostatic charge of suspended particles is neutralized by a flocculent, allowing the particles to stick to one another and form flocs. Once the flocs are large enough they fall from suspension. After receiving state approval of the plan on January 20, 2006, and Commission approval on January 25, 2006, the licensee applied the flocculent to the lower reservoir on January 25-27, 2006. Without use of a flocculent the particles would have stayed in suspension, and the water in the lower reservoir would have cleared much more slowly. In addition, turbidity caused by suspended clay particles would have remained in the river downstream over a longer period and likely extended further downstream.

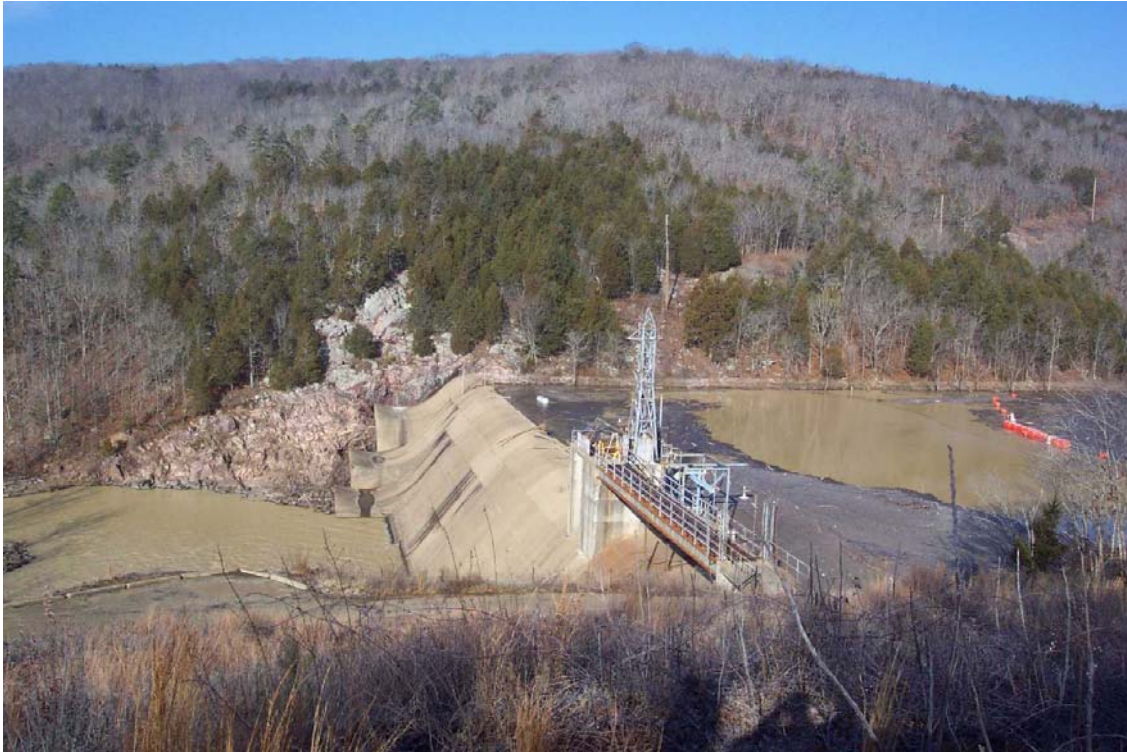
Figure 11.6 – Turbidity at Lower Dam (Source: Staff, 12/22/05)

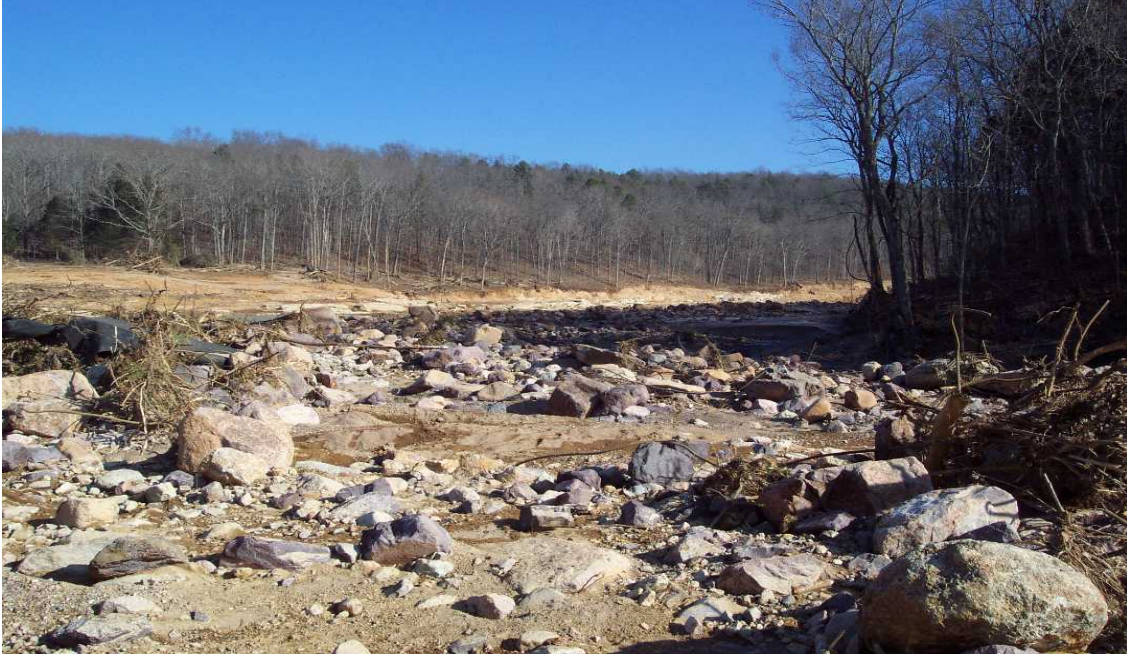
The high flows immediately following the rim dike breach, carried a tremendous amount of sediment and boulders into the river from the upper dam's embankment, in addition to the scour created down the side of the mountain. Vegetative debris and earthen sediment was deposited on the valley floor and in the East Fork Black River (Figure 11.7). The volume of the debris and sediment altered the configuration of the river from the point of entry to the Shut-Ins area of the park and destroyed riparian habitat (Figure 11.8). It also reduced aquatic habitat and adversely affected the river channel by creating pools, barrier dams and disjoining habitats.

Figure 11.7 - Modified channel of the East Fork Black River (Source: Staff)

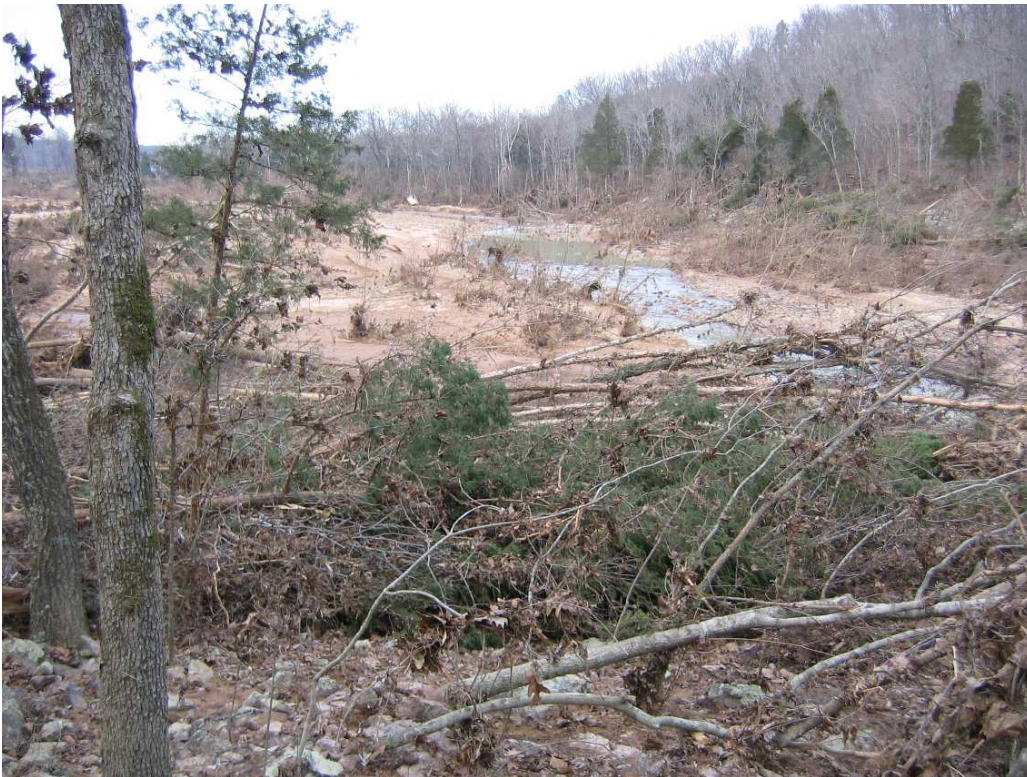
Figure 11.8 - East Fork Black River within State Park. (Source: Missouri Department of Conservation)

The channel modification was most extensive upstream from the Shut-Ins at the entrance to the State Park. The natural boulder and bedrock area of the Shut-Ins helped prevent excessive scour and the reconfiguration of the channel in that area; however, below the Shut-Ins area and upstream of the lower reservoir, significant loss of riparian habitat, flooding, scour, and turbidity were sustained (Figure 11.9).

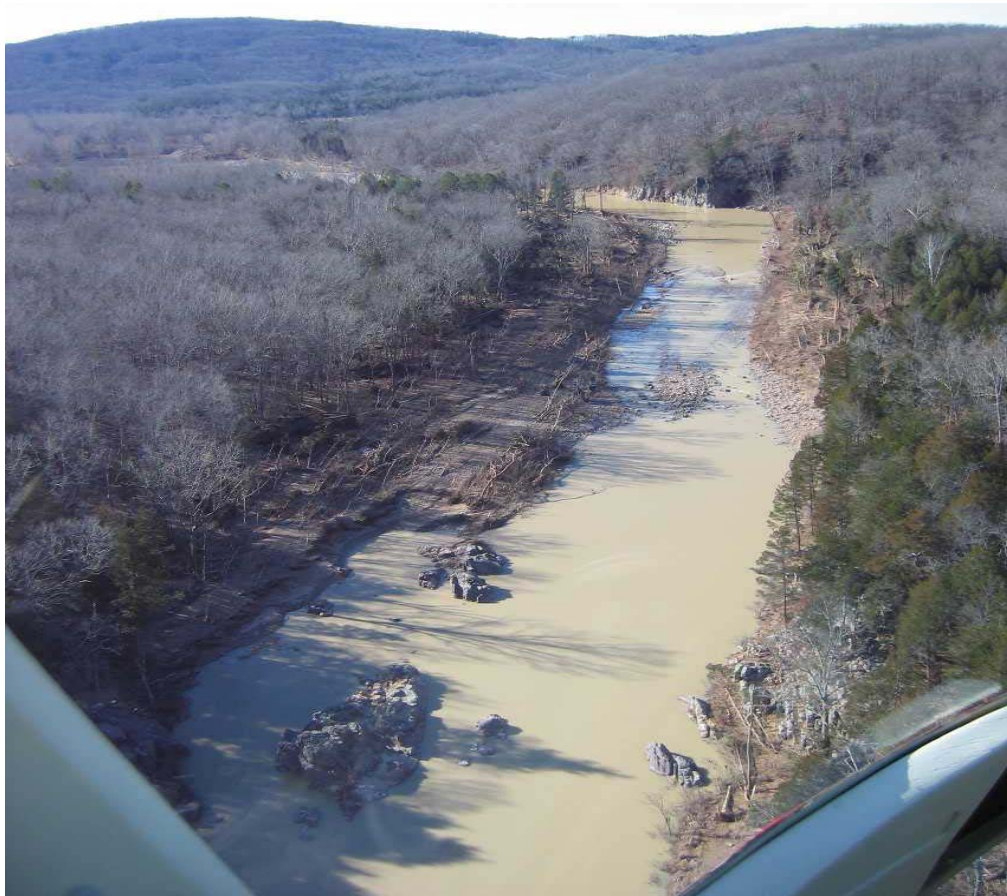
For natural fish reproduction in streams, the channel generally consists of a series of pools, chutes and riffles. Inspection of the stream channel within the state park to the Shut-Ins area indicated substantial alteration of the natural stream channel thereby creating the loss of habitat as well as food sources.

Figure 11.9 - Scour and loss of riparian habitat below the Shut-Ins. (Source: Missouri Department of Conservation)

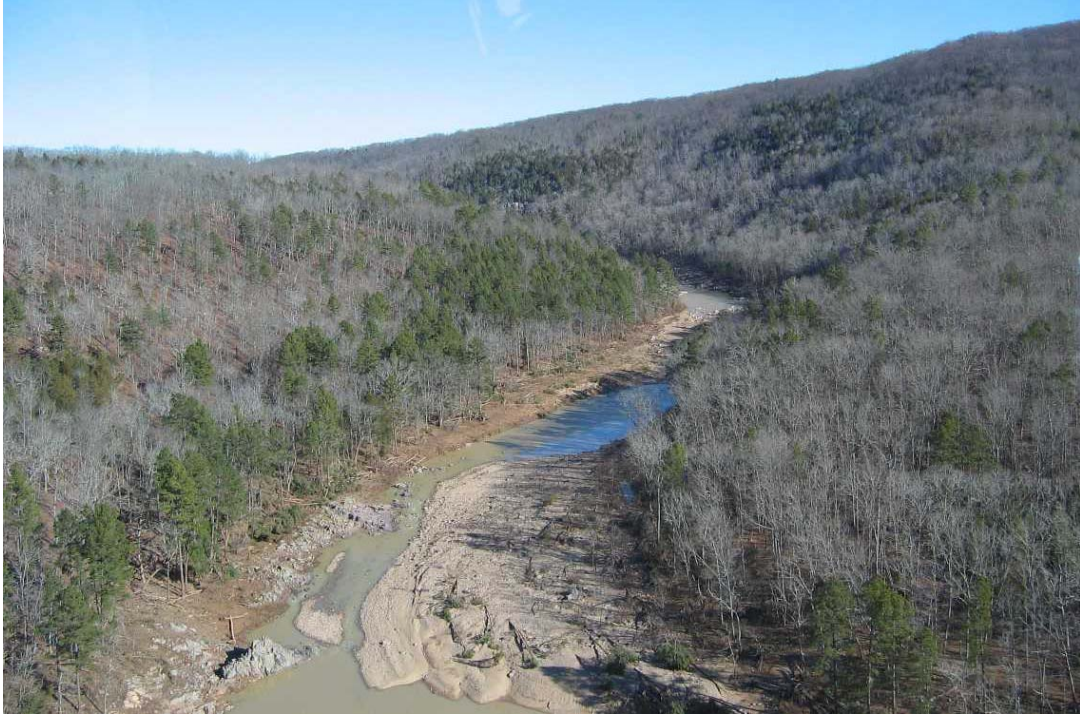
Figure 11.14 - Deforested riparian vegetation below Shut-Ins area of state park. (Source: MDC)

The riparian vegetation along the East Fork Black River was another area that suffered substantial deforestation (Figures 11.1-11.5). The extent of the damage is severe and extends from the entrance to the state park through the Shut-Ins area and below the Shut-Ins area to the lower reservoir. In some areas over one hundred yards of riparian vegetation was washed out due to the breach. In other areas ground-covering riparian vegetation was buried in silt and sand limiting recruitment. Natural recovery of the riparian areas will be hampered by poor soil quality and lack of soil (bedrock exposure) due to the flood.
