Mercury Alert Antique Mirrors

Elemental Services and Consulting, Inc. (ESCO) was retained to obtain mercury vapor concentrations from an antique dresser with attached mirror. The owner of the dresser upon learning that mercury was used in making mirrors decades ago was concerned that mercury vapor was contaminating their home.

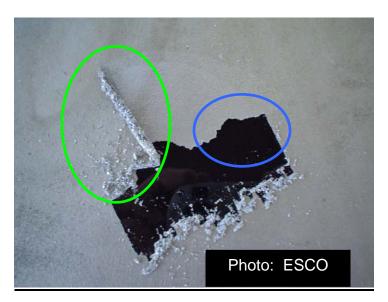
The following photograph shows how the tin amalgam behaves when scraped off the glass. Note how there are crisp edges at the leading edge (blue). Also note when the removed amalgam is pushed together, it binds quite readily (green).

Mercury vapor concentrations of this amalgam were $>100 \mu g/m^3$.

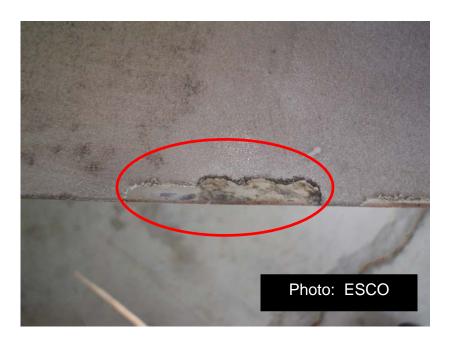
Additionally, flakes of the silver backing were observed around the bevel of the wood holding the mirror in place. Several flakes of silver backing were discovered behind the dresser in the bedroom (see following photograph).

The mercury vapor concentration in the area of these flakes was $> 100 \mu g/m^3$.

The following photograph shows the detail where braces held the mirror within the frame. It is believed that these areas are where the flakes came from that were observed in the frame and on the floor below the dresser.
