**Request for Additional Information Related to Bulletin 2002-01
Arkansas Nuclear One, Unit 1 (ANO-1)**

ANO-1 Draft Response to NRCB 2002-01 RAI

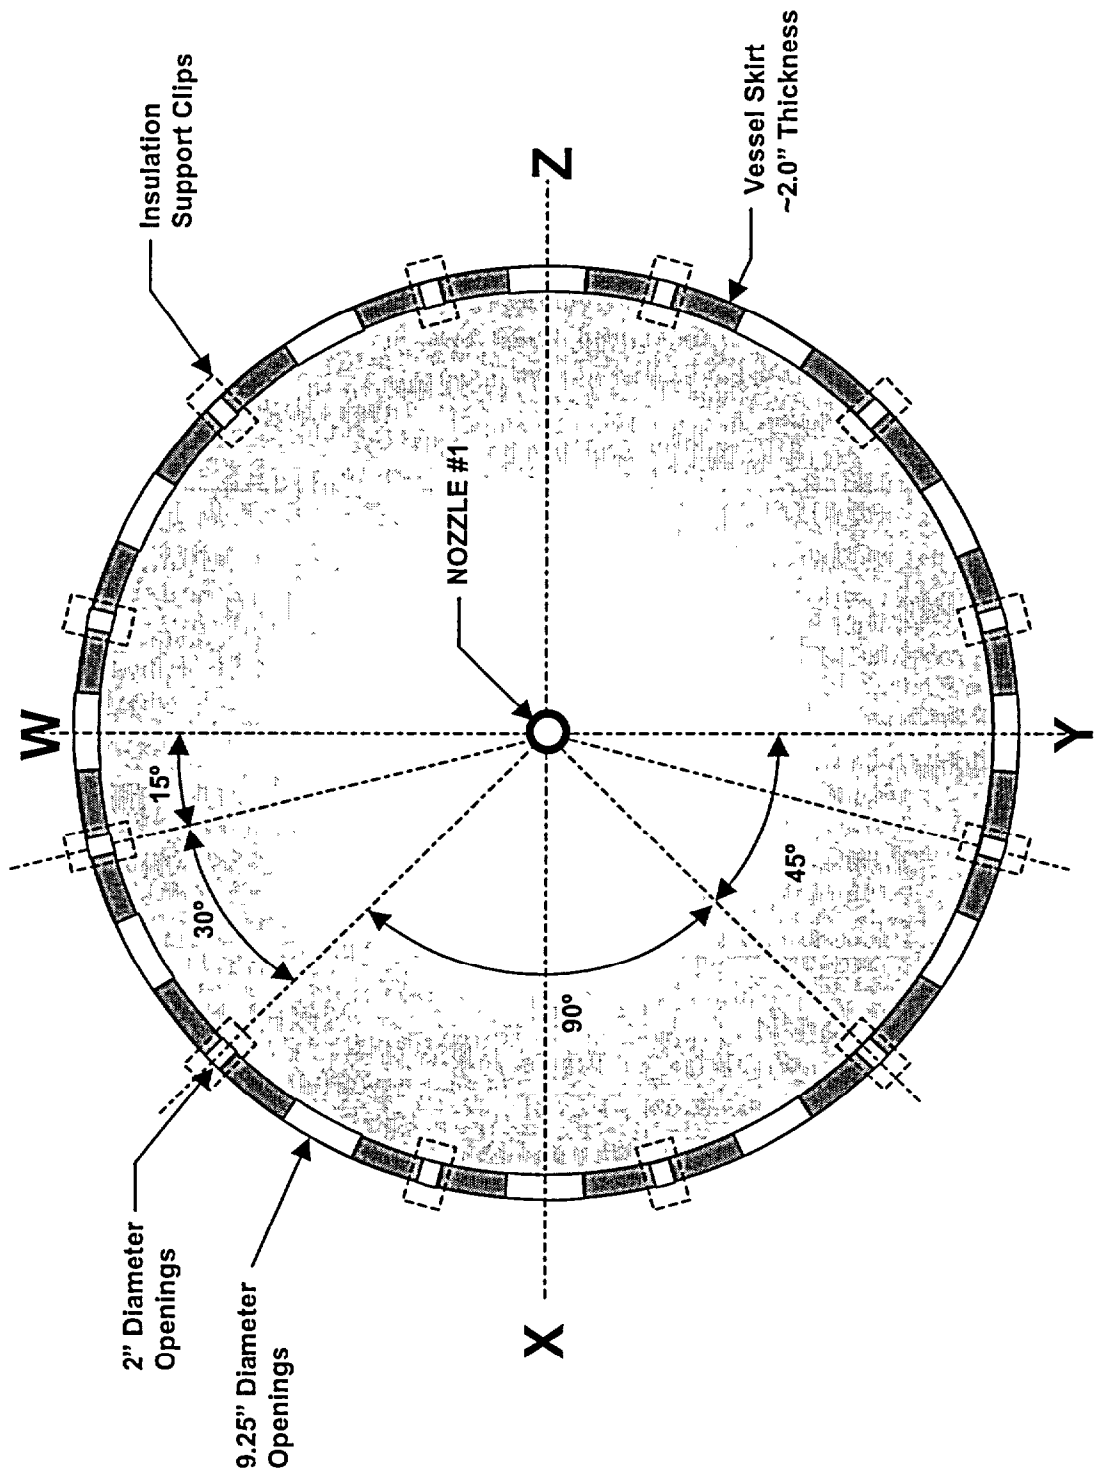
Reactor Vessel Skirt Openings and Locations

The only other access to the area between the vessel skirt and the vessel insulation is from the bottom of the vessel. Access of this area is difficult to accomplish. One horizontal insulation panel in proximity to nozzle 30 could be removed to gain access to the area below the holes and a boroscope inserted through the area between the two adjacent incore nozzles, up to the accessible two (2) inch diameter holes located

around the circumference of the skirt. Once through the hole, a limited local area between the skirt and insulation could be viewed.

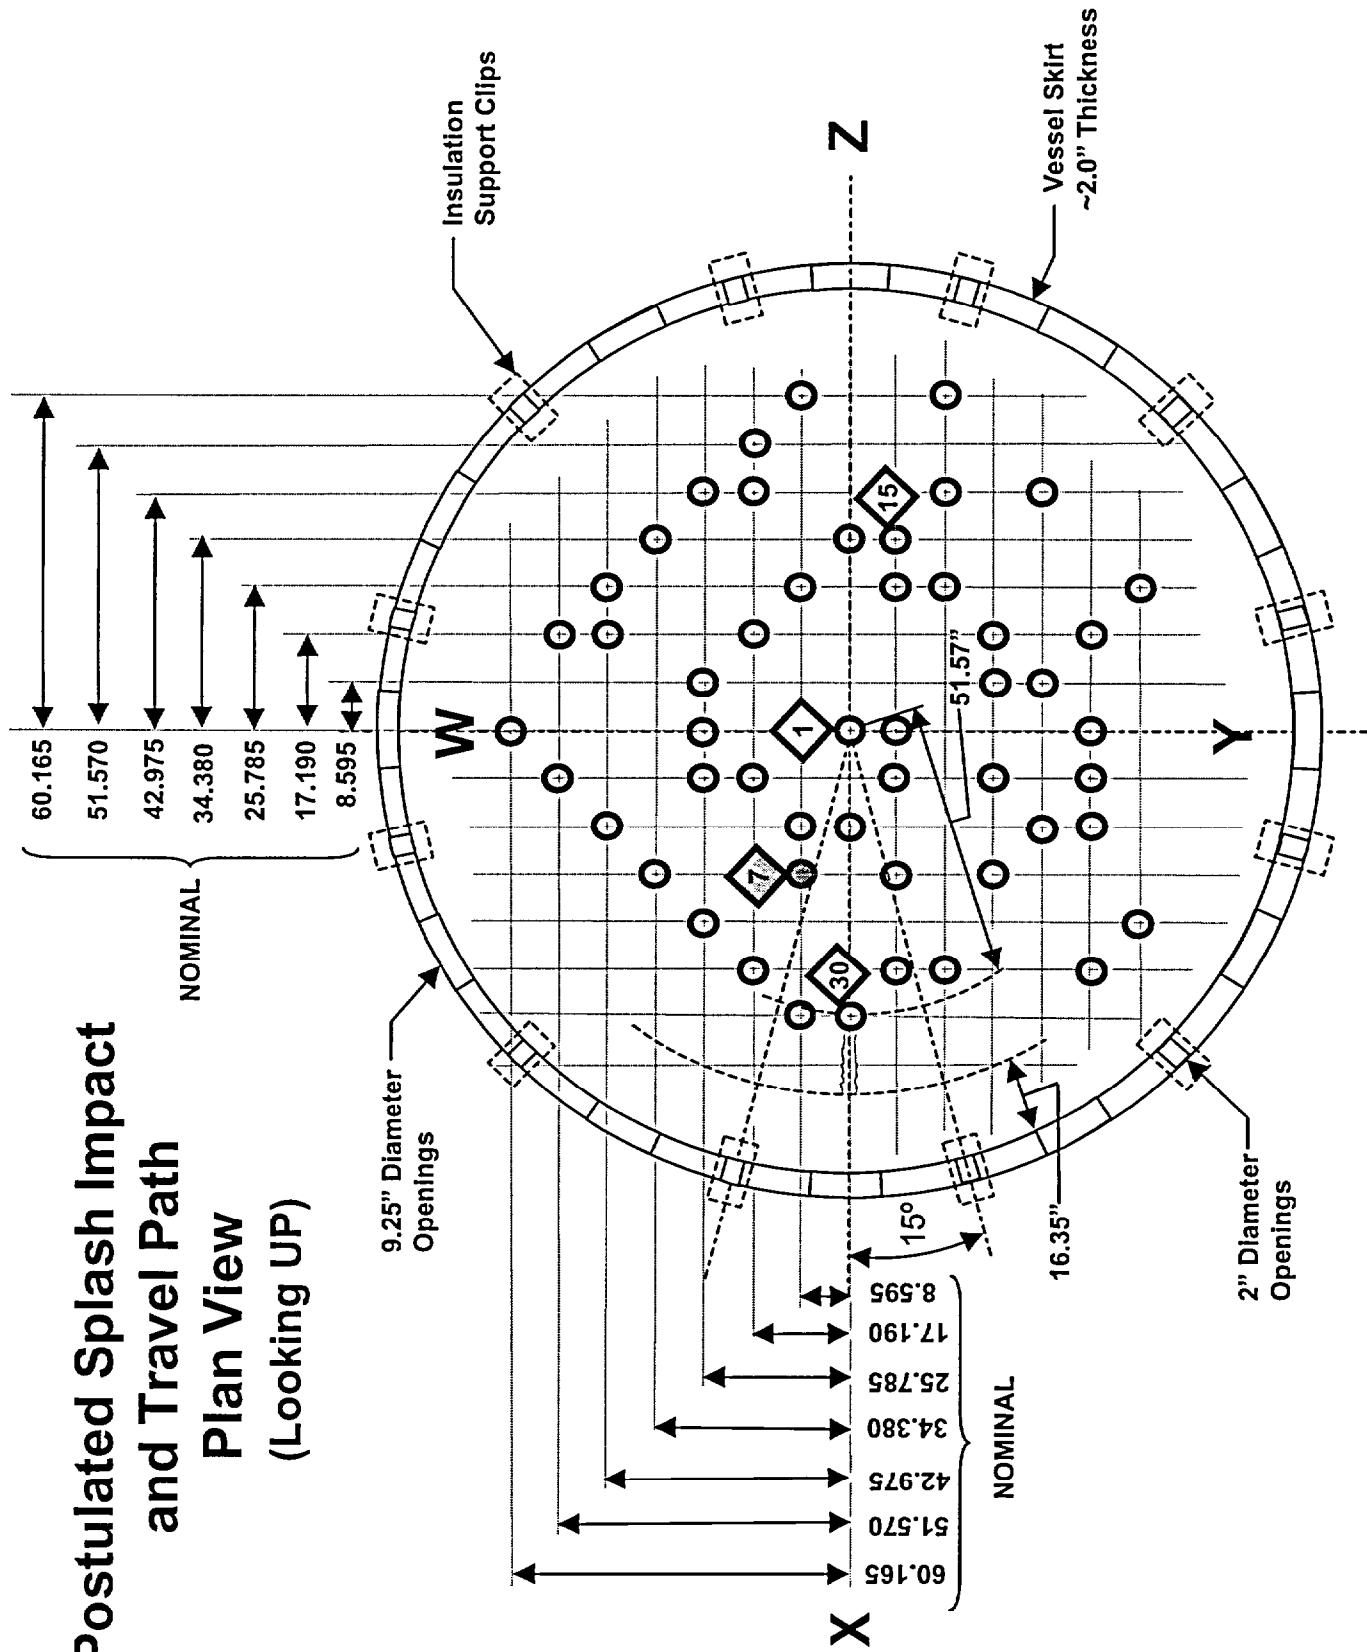
Postulated Splash Impact and Travel Path Plan View (Looking UP)

Nozzle 30	<p>Two thin, faint white traces appear uphill. The source is out of sight of the boroscope on the vessel. The traces run to and down Nozzle 30. The traces appear less than a pencil width</p>	Seal plate leakage that splashed onto the bottom of the vessel.	Past the ID or OD of the seal plate, down the side of the vessel inside the vertical insulation panel, through the upper 2" holes in the vessel support skirt, splashing onto the underside of	Nozzle 30 is on the outer edge of the ICI nozzle pattern, which means there are no other nozzles located uphill of Nozzle 30 that could have acted as a source for these traces.

Two thin, faint white traces appear uphill, out of sight of the boroscope on the vessel and run to and down Nozzle 30. The traces appear less than a pencil width wide and are approximately 1 inch to 1.5 inches apart. Faint white staining of the nozzle piping is visible (approximately one to two pencil widths wide). These traces did not appear to be "active" sources, but rather appeared to be residue left over from a past occurrence when fluid may have gotten on and ran down the side of the vessel. A 360-degree close-up inspection of the nozzle shows no indication of boron originating from the annulus.

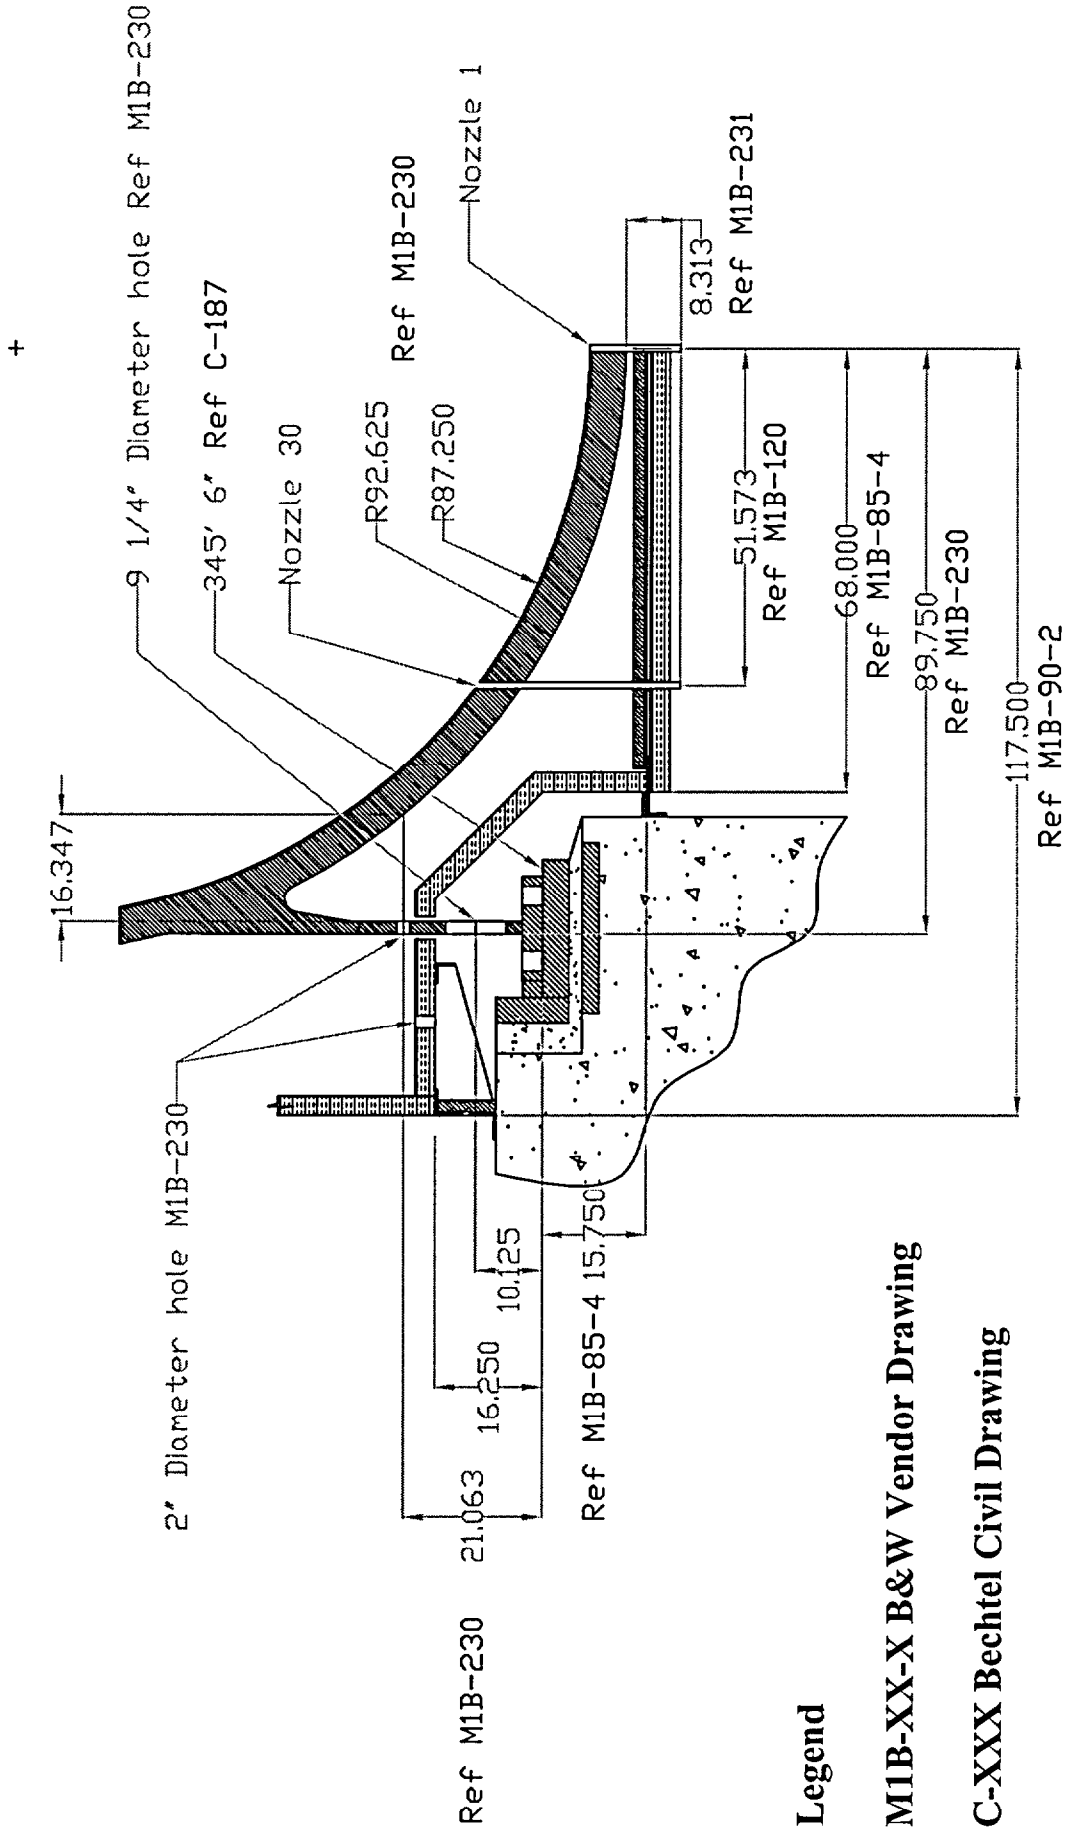
Attachment 1 (Diagrams of penetrations through vessel skirt, nozzle layout, and description) identifies the nozzles that were inspected using a boroscope and the results. The four nozzles inspected by a boroscope were the only incore tubes that had staining below the insulation. The purpose of the boroscope inspection was to determine whether these nozzles had any evidence of leakage at the vessel interface. Attachment 2 provides a scale composite drawing showing the dimensions of the reactor vessel, support skirt, insulation details, and nozzle 1 and 30.
