May 14, 2002

Subject: Duke Power Company, Oconee Nuclear Station, Unit 1
Docket No. 50-269
Reactor Vessel Head and Penetration Nozzle Condition Report

**Oconee Unit 1
End-of-Cycle 20 Refueling Outage
Reactor Vessel Head Penetration Nozzle Indication Report**

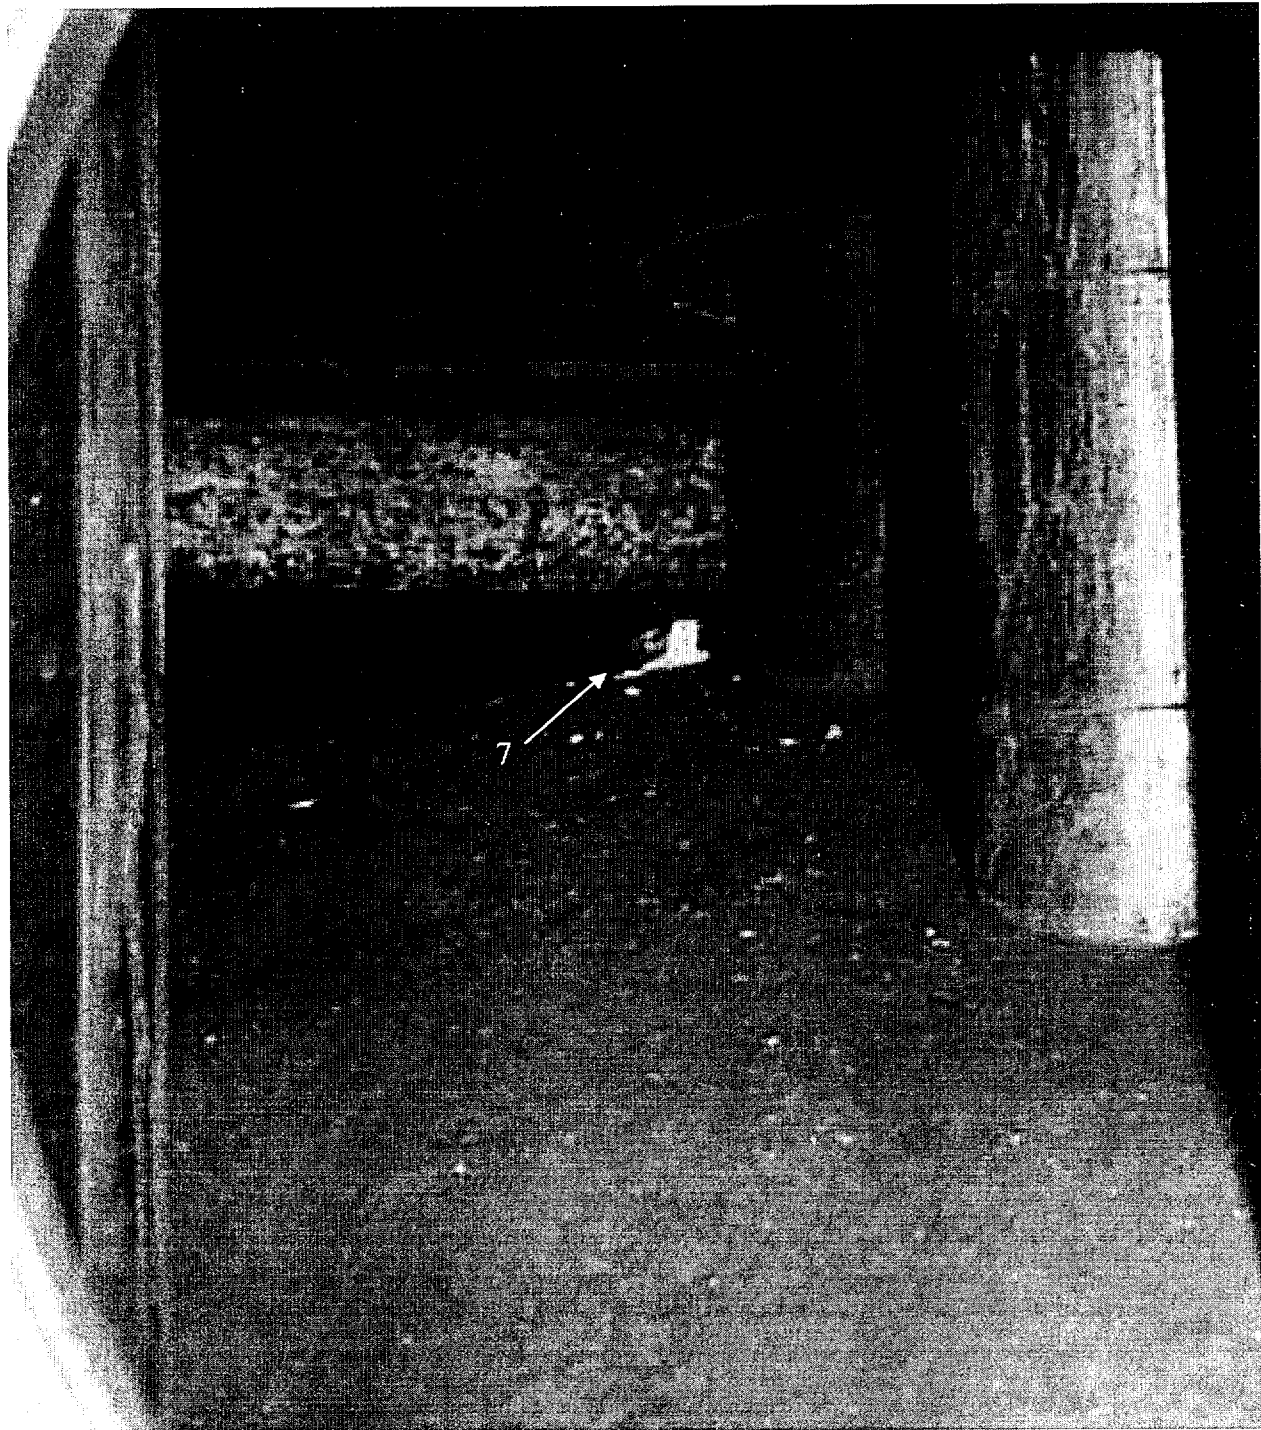
Nozzle 7 was masked by a fresh looking deposit (white) with a band going up the side of the nozzle. The band extending up the nozzle, shown in Figure 1, opened the possibility that the boric acid crystals may have originated from a CRDM flange leak. Further video inspections, after the head was placed on the stand, disclosed that the band stopped before tying into any leakage indications from above (which would be more indicative of a CRDM flange leak). Ultrasonic inspection looking for indications in Nozzle 7, showed 5 axial indications (none of which constituted a leak path within the nozzle) extending from below the J-groove weld up into the nozzle area adjacent to the weld. The longest of the indications extended up about 2/3 of the length through the adjacent weld thickness. The liquid penetrant examination of the bore of Nozzle 7 after removal of the nozzle revealed two axial indications high in the original weld. This could indicate a leak path through the weld. The video inspection for CRDM flange leaks found no leaking flanges, and a review of a video of the top of the head made during the previous outage did not show evidence of the new deposit around nozzle 7. All the evidence above make a circumstantial case that Nozzle 7 was leaking through the weld and that the leak initiated during the past operating cycle.

Figure 1 Oconee Unit 1 CRDM Nozzle 7, Top of RV head inspection for Boric acid crystals, 03/31/02

Two CRDM Nozzles (numbers 7 and 8) were repaired during this outage using the automated Framatome-ANP "ID Ambient Temper Bead Repair" technique as described in the Relief Requests 02-02 and 02-03. Corrective action taken and future outage plans remain consistent with Duke's NRC Bulletin 2001-01 and 2002-01 submittals.

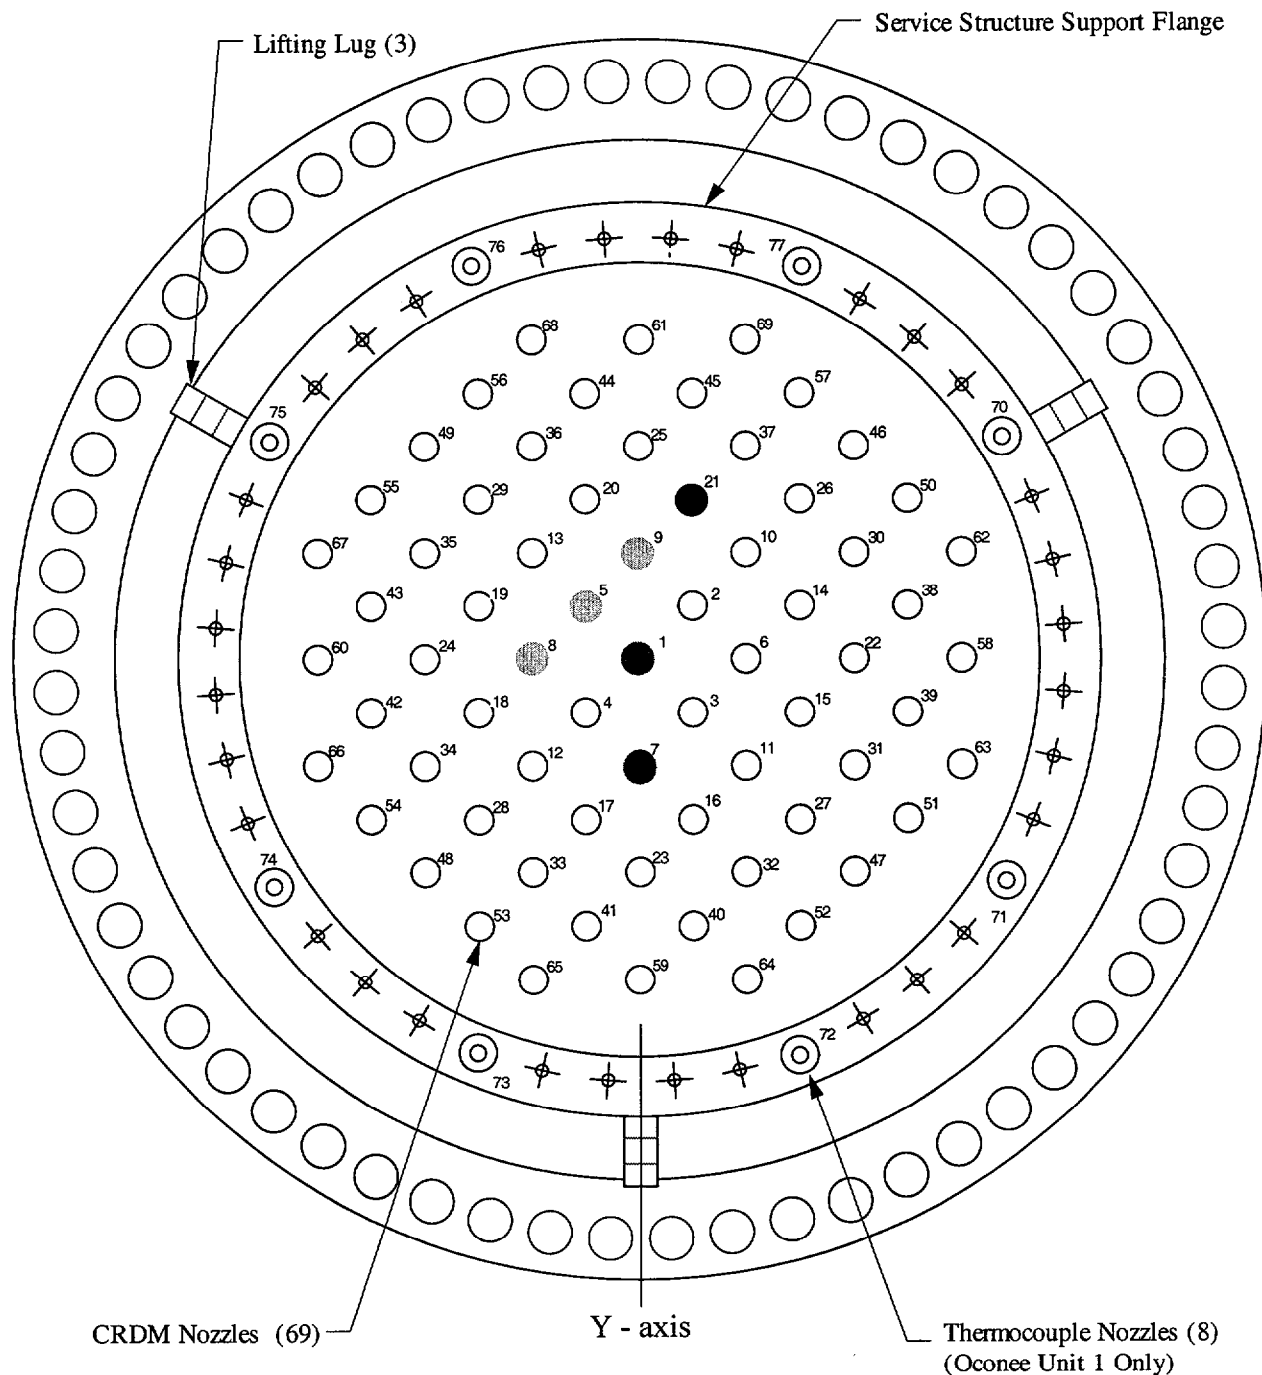
After the head was cleaned and placed on the reactor vessel head stand, a visual inspection was performed looking for wastage. The inspection using fiber scopes where needed was able to see 360° around each nozzle and no wastage was identified. Figure 2 shows the location of the above described CRDM nozzles on RV head for this outage (EOC-20) and the location of Nozzle 21, which was found to be leaking in November 2000.

- Nozzles 1 and 7 identified as masked during EOC-20
- Nozzles 5, 8 and 9 identified as not being able to see 360° around nozzle
- Nozzle 21 identified as leaking by top of head visual inspection during EOC-19 and repaired

Figure 2 Bare metal visual inspections of RV head, Oconee Unit 1 CRDM nozzles identified as suspect, during EOC-20 refueling outage, March 31, 2002
