WOLF CREEK

NUCLEAR OPERATING CORPORATION

Subject: Docket No. 50-482: 30-Day Response for NRC Bulletin 2002-01,
"Reactor Pressure Vessel Head Degradation and Reactor Coolant
Pressure Boundary Integrity"

**30-Day Response to NRC Bulletin 2002-01
Reactor Pressure Vessel Head Degradation and
Reactor Coolant Pressure Boundary Integrity**

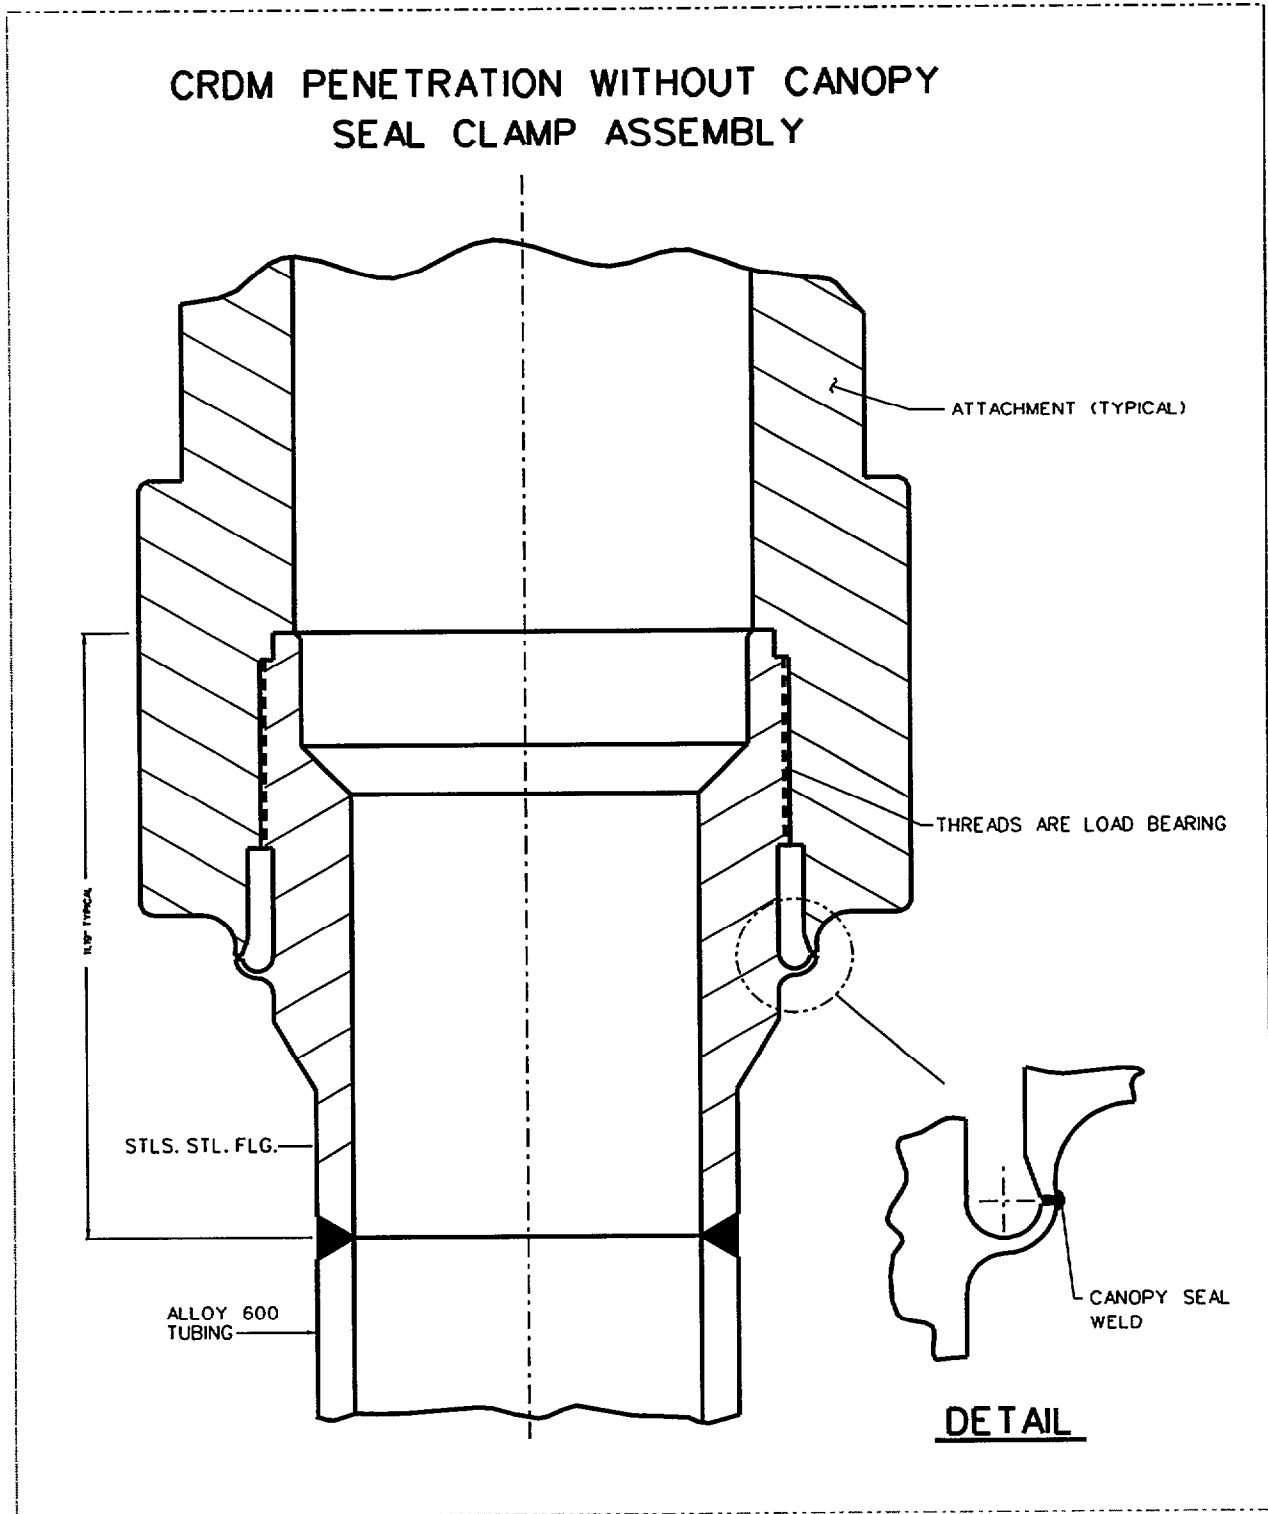
The canopy seal welds are thin welds of about 0.070" thickness that serve to seal the threaded pressure boundary connection. The canopy seal weld configuration forms a "dead end" in which impurities in water that works its way past the threads can accumulate (Figure 1). It is suspected that the water used during cold hydrostatic testing and hot functional testing remains in the canopy seal area for the life of the joint (unless a leak develops). Additionally, each time the head is removed from the vessel and reinstalled, and the vessel is repressurized, the trapped water in the seal area is oxygenated. This environment establishes conditions that appear to increase the probability of stress corrosion cracking. Annealed stainless steels are known to be susceptible to transgranular stress corrosion cracking (TGSCC) in this type of high temperature, stagnant chloride/oxygen environment.

Figure 1. Typical Reactor Pressure Vessel Head Penetration Construction Illustrating Flange, Tube, and Attachment Relationship

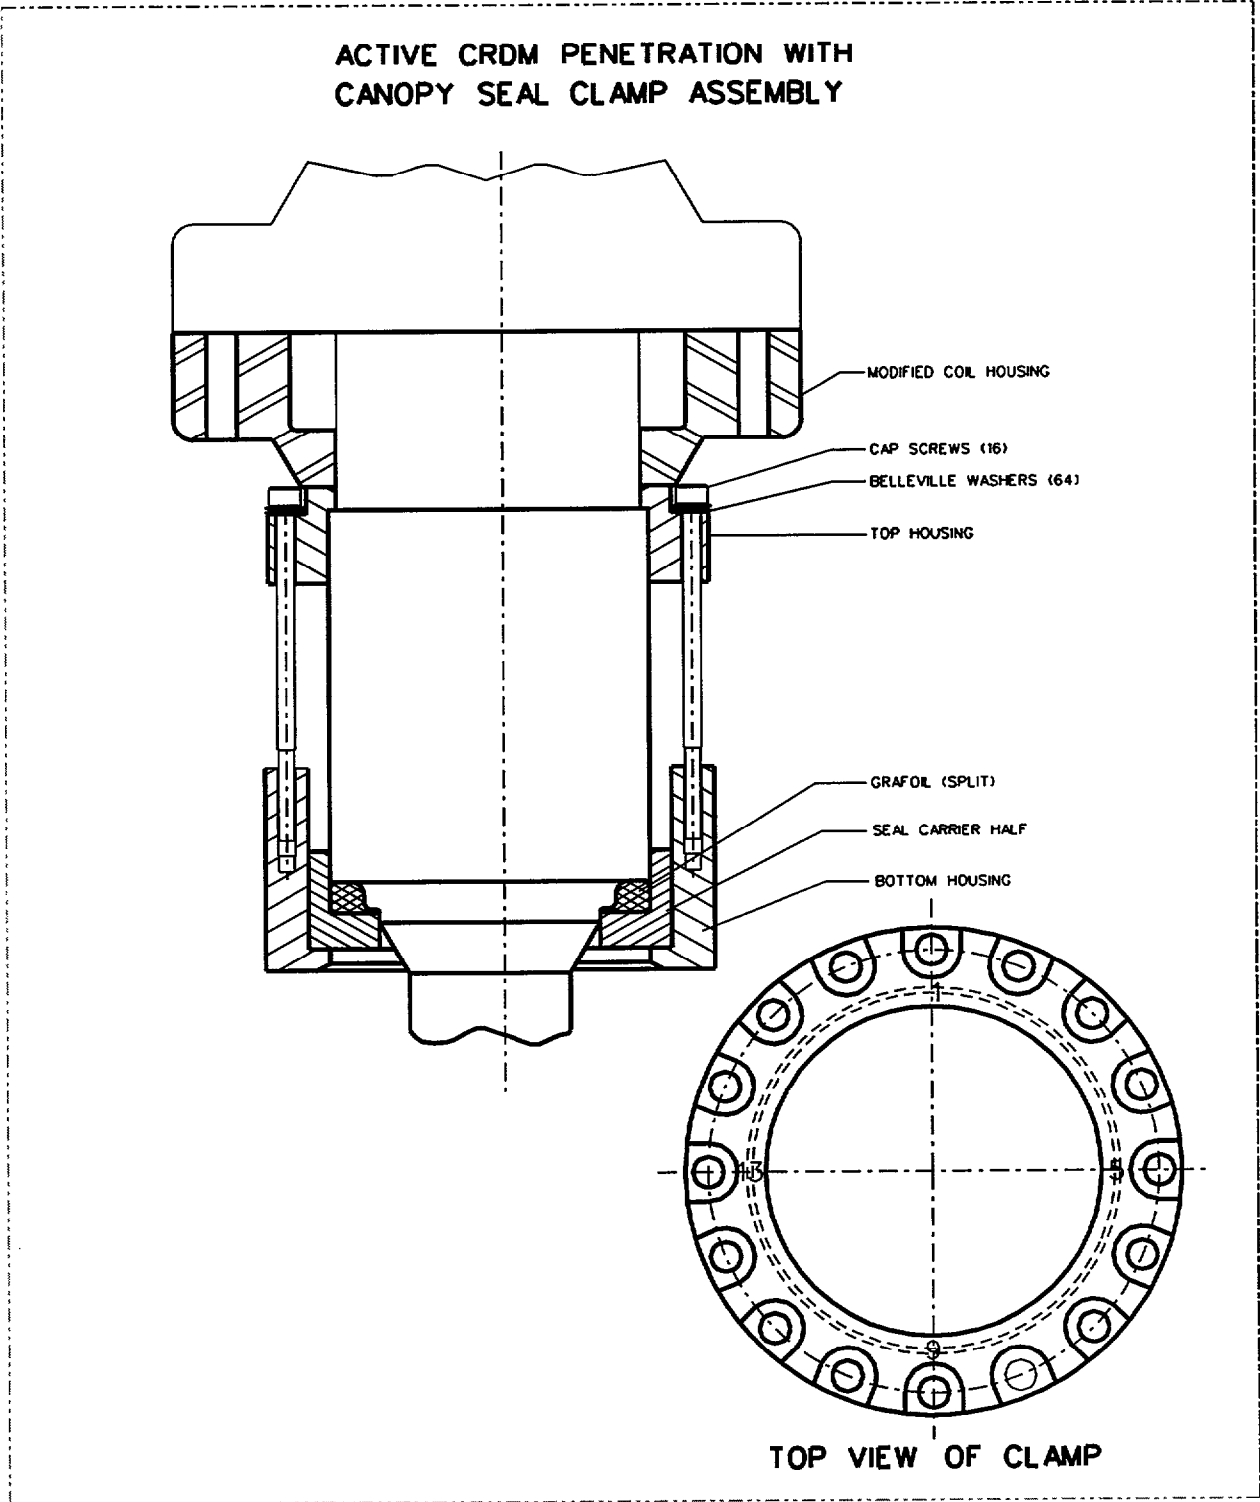
Figure 4. Typical Canopy Seal Clamp Assembly Cutaway

When a suspected leaking lower canopy seal weld is identified following the supplemental visual examination, WCGS installs a Canopy Seal Clamp Assembly (CSCA) (References 6 and 7). Figure 4 is a sketch of the CSCA design utilized at WCGS. The CSCAs are designed and fabricated as Class 1 components to the 1986 Edition of the ASME B&PV Code, Section III (Reference 8). Construction Code date reconciliation has been performed to document the acceptability of using a later edition of the Construction Code for the CSCAs (Reference 9)

In the CSCA design, a large ring of Grafoil™ (graphite) sealant that is compressed against the canopy seal weld region provides the barrier against fluid leakage. The Grafoil™ is held in place by the seal carrier halves, top and bottom housings, and attachment cap screws.
