EPA CHEMICAL ACCIDENT INVESTIGATION REPORT

Tosco Avon Refinery Martinez, California

EPA550-R-98-009
November 1998

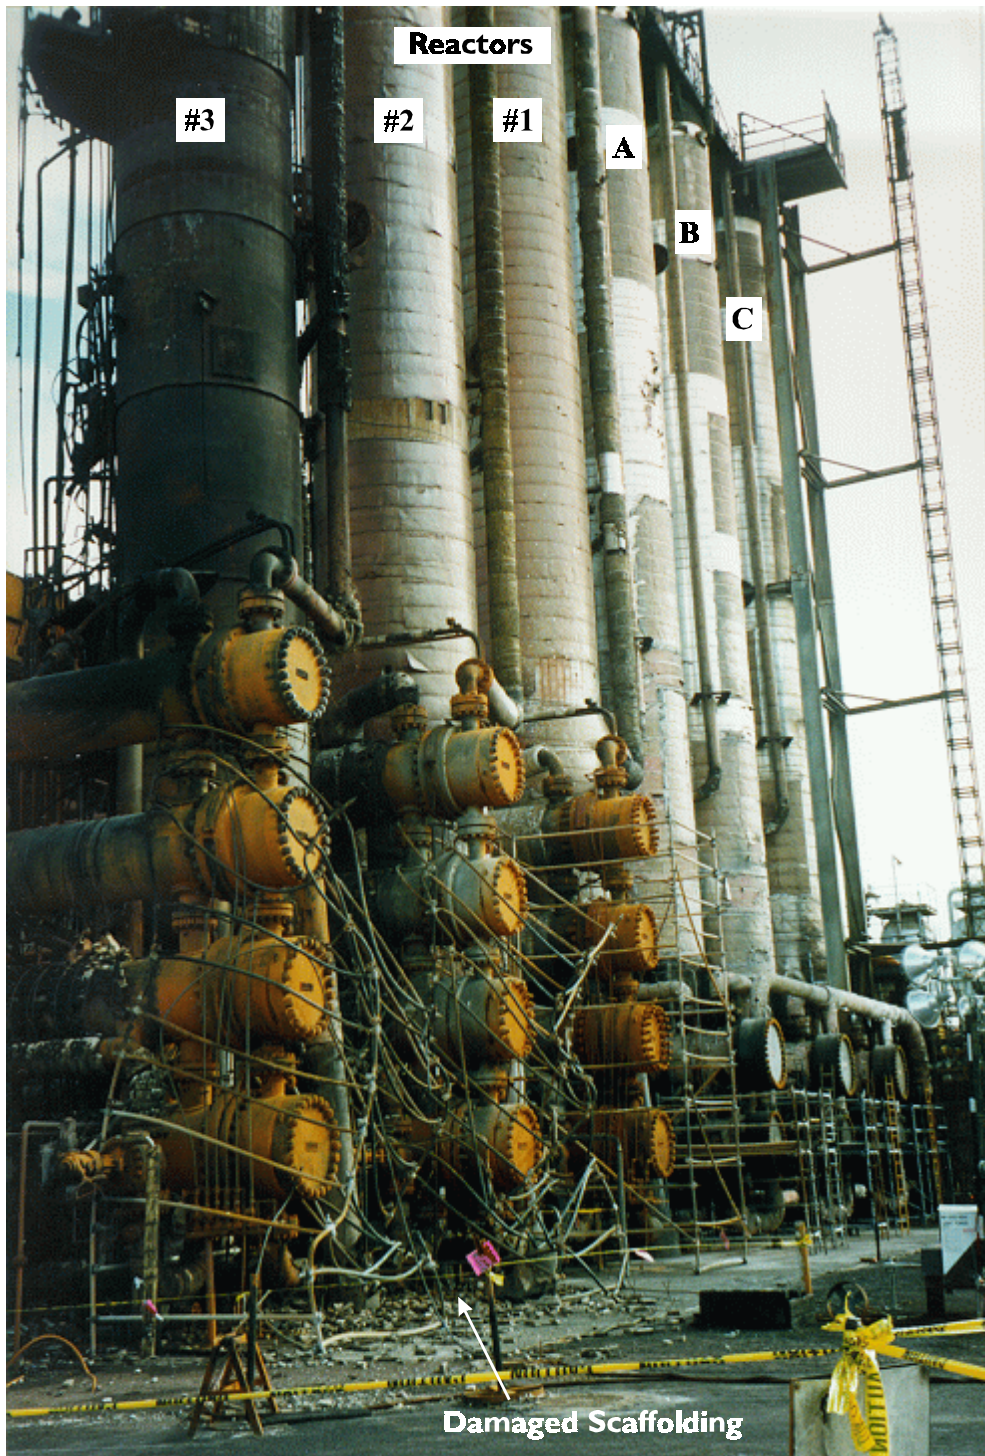
Figure 9 First and Second Stage Reactors

The rupture created about an 18 inch long tear in the Reactor 3 effluent piping. The photographs in Figures 9-13 show some of the resulting damage. The fire melted a light pole on the road next to the reactors. The lower part of a metal ladder on Reactor 3 was damaged by the heat. Scaffolding around the Stage 1 and 2 reactors was misshapen from the heat of the fire, but there did not appear to be much blast damage. The fire fighting equipment next to Reactor Road (see Figure 6) was damaged. Wooden platforms near the unit were charred. The six reactors were covered with asbestos insulation overlaid with aluminum, which was blackened by the fire. A large valve on the fire water piping near the road was damaged.

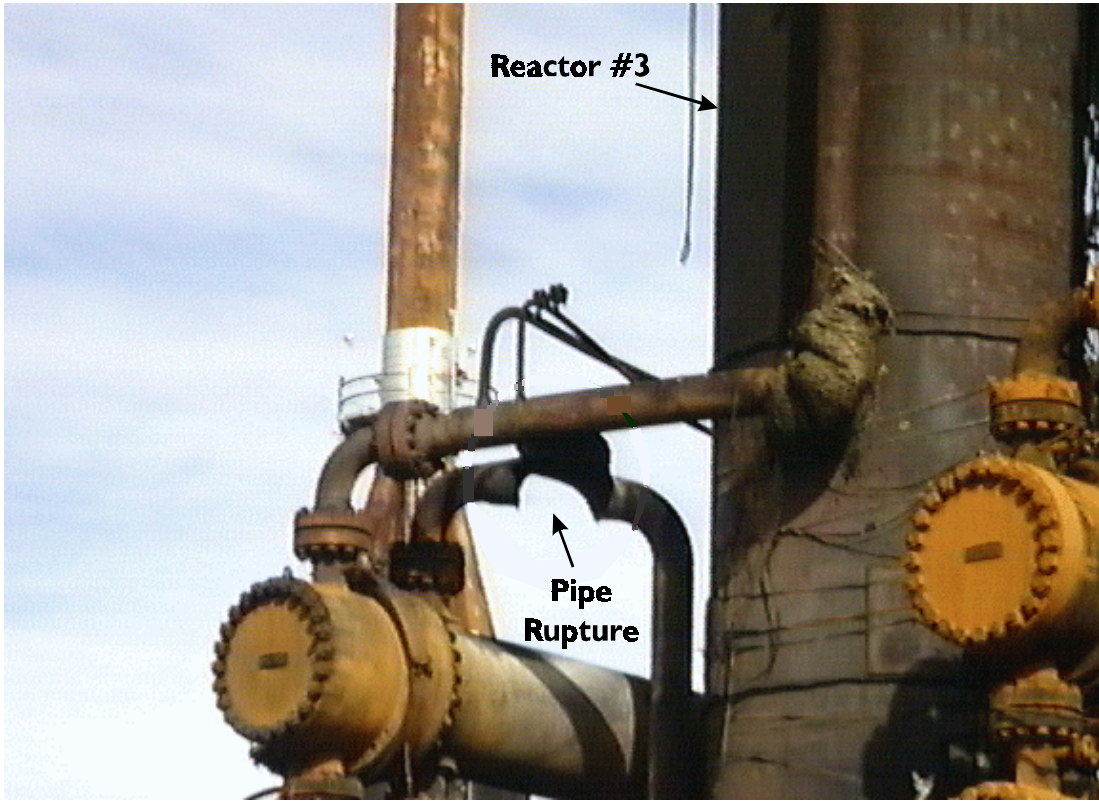
Figure 10 Reactor 3 Effluent Piping Rupture

The immediate cause of the hydrocarbon and hydrogen release and subsequent fire was a failure and rupture of a Stage 2 Reactor 3 effluent pipe due to excessively high temperature, likely in excess of 1400°F. This high operating temperature was initiated by a reactor temperature excursion that began in Bed 4 of Reactor 3 and spread through the next catalyst bed, Bed 5. The excessive heat generated in Bed 5 raised the temperature in the reactor effluent pipe. The excursion was not brought under control because the Stage 2 reactors were not depressured and shut down as required when the reactor temperatures exceeded the 800°F temperature limit specified in the written operating procedures.

Several Tosco and contractor employees reported hearing a pop or crack sound, followed by two explosions, one small and one bigger. A horizontal straight section of 12" diameter Reactor 3 effluent piping had ruptured just upstream of a 12"x 10" diameter reducer. Beyond the reducer, the 10" diameter pipe entered the top of the 40-foot high feed/effluent exchanger structure for Reactor 3. The hydrocarbon and hydrogen mixture released from the pipe rupture apparently autoignited very shortly after the initial release, causing a fireball over 100 feet high.

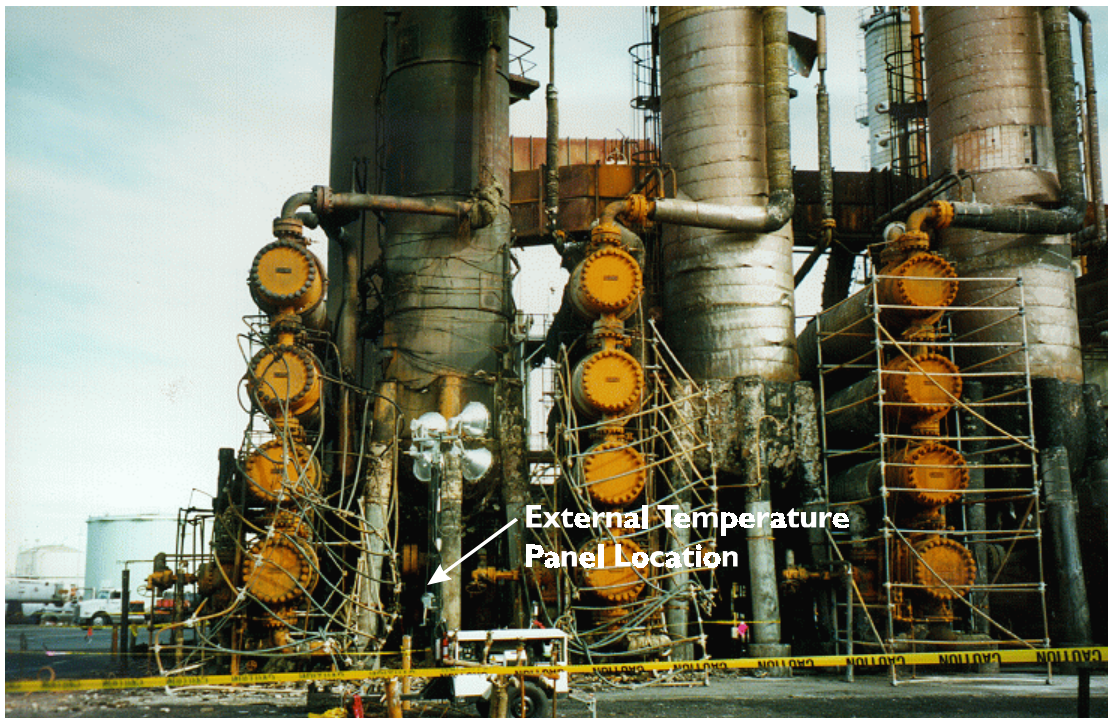
Figure 11 Field Panel Location

A Tosco Hydrocracker operator, who was in the process of checking the temperature panel located at the base of Reactor 3, was killed. He was severely burned as a result of being in close proximity to the fire from the ruptured pipe. According to the coroner, he died of third-degree burns on 100 percent of his body and smoke inhalation. A total of 46 personnel were injured; eight were Tosco employees and 38 were contractor personnel. Injuries consisted of a fractured foot, emotional trauma, headaches, ringing ears, cuts and scrapes, and twisted knees. Thirteen injured personnel were taken by ambulance to local hospitals, treated and released. There were no reported injuries to the public or other offsite personnel.
