# RUBBLIZING WITH BITUMINOUS CONCRETE OVERLAY – 10 YEARS’ EXPERIENCE IN ILLINOIS

**PHYSICAL RESEARCH REPORT NO. 137**

**APRIL 2002**

**Illinois Department of Transportation**

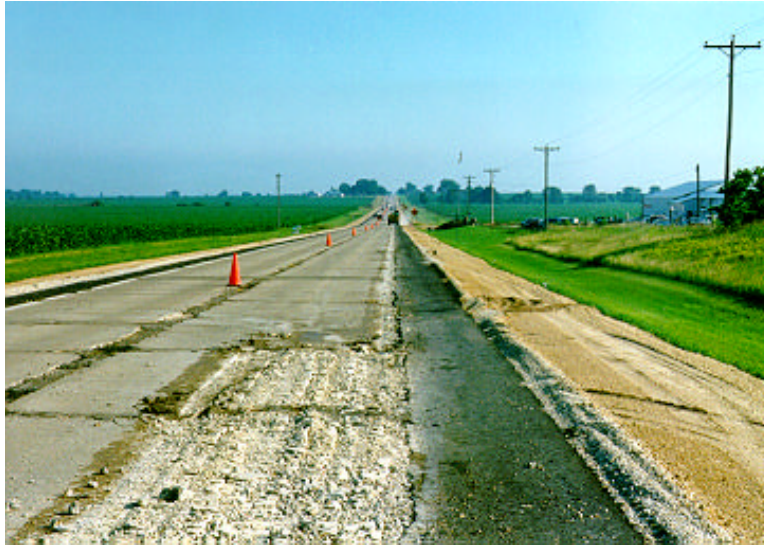
Figure 9. Preconstruction Condition Background, Rubblizing Foreground (IL 38 1994).

The CRS value and existing distresses were obtained to determine the existing condition of the pavement. The CRS value of this section averaged 4.4 in 1990. This is considered pavement in poor condition. Extensive transverse cracking and some D-cracking were evident on this pavement. In addition, the centerline joint was highly distressed. Figure 9 shows the preconstruction condition of this pavement.

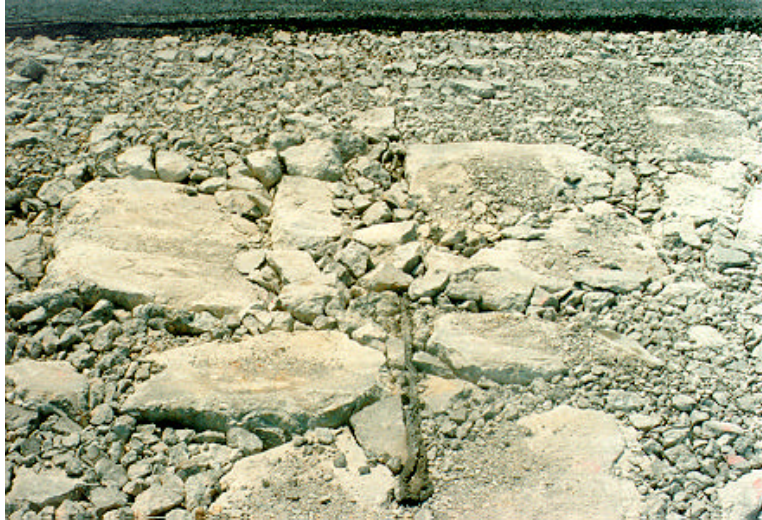
Figure 12. Large Rubblized Pieces (IL 38 1994).

This soft subbase caused large pieces of concrete to remain at the joints and cracks (see Figure 12). Several pieces larger than 12 inches on the surface that moved under rolling were removed and replaced with an open-graded, clean coarse aggregate (ASTM 57 gradation). The rubblizing machine's breaking frequency was increased, the travel speed was slowed, and the distance between subsequent passes of the PB-4 was narrowed to improve the breaking effectiveness.

The soft subgrade caused additional problems once paving began. Traffic was allowed on the first 3-inch lift of binder. Severe rutting problems occurred when vehicles traveled on this lift. In one location, the pavement failed and had to be excavated and replaced with a coarse aggregate having a 2.5-inch top size. As a result of this early rutting, the first lift of binder was increased from 3 inches to an average of 4 inches.

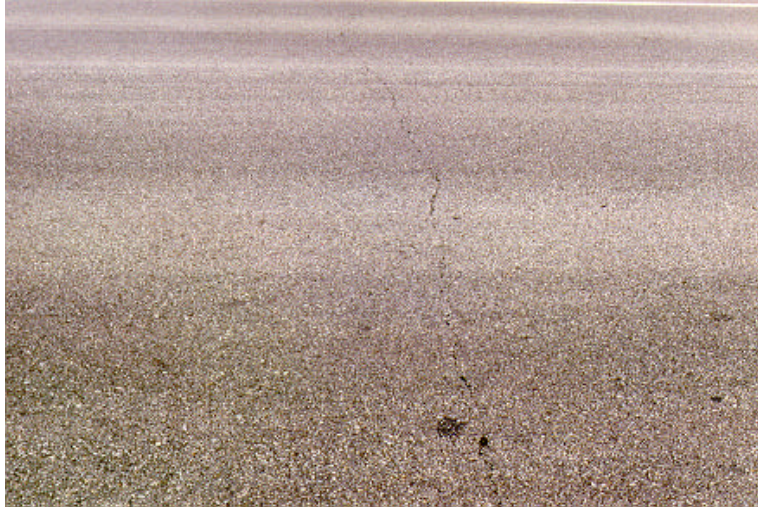
Figure 13. Rubblize and Overlay in 1996 (IL 38 1994).

The CRS value of the rubblized section was 7.2 in 1999, considered good. The distresses for the section that was rubblized and overlaid with bituminous concrete are summarized in Table 6. Figure 13 shows the pavement, with a transverse crack, in 1996.

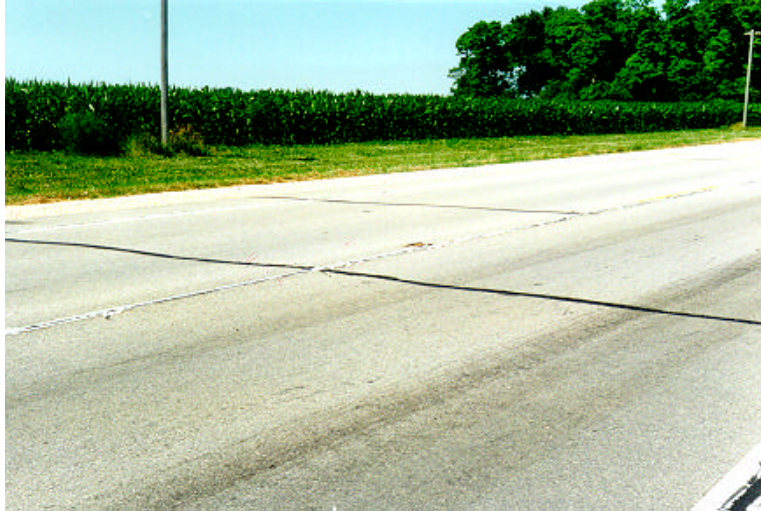
Figure 14. OGBC and Overlay in 1997 (IL 38 1994).

The CRS value of the OGBC section was 6.7 in 1999, considered good. The distresses for the section that was constructed with an OGBC and overlaid with bituminous concrete are summarized in Table 7. Figure 14 shows the pavement, with two sealed transverse cracks, in 1997.

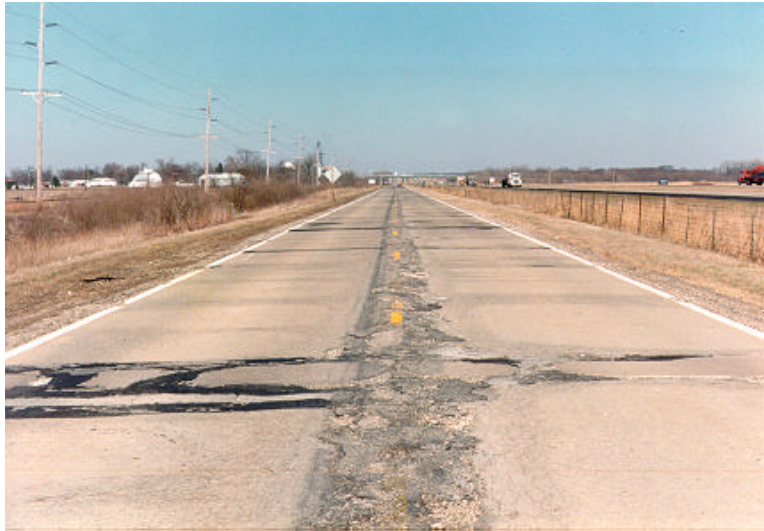
Figure 17. Preconstruction Condition (I-55 FR 1994).

distressed transverse cracks existed every 5 to 15 feet. Patching, if performed, could have totaled up to 18 percent of the pavement. Figure 17 shows the preconstruction condition of this pavement.

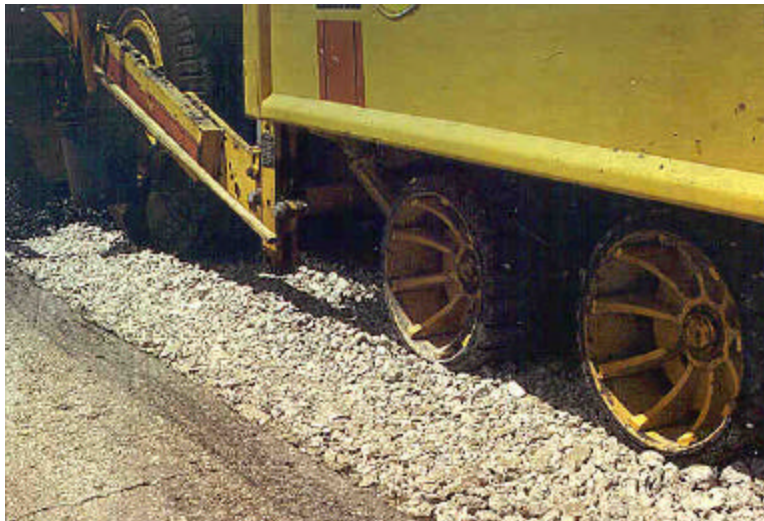
Figure 23. Rubblized Material Moving Under Bogey Tires of Paver (I-57 1996).

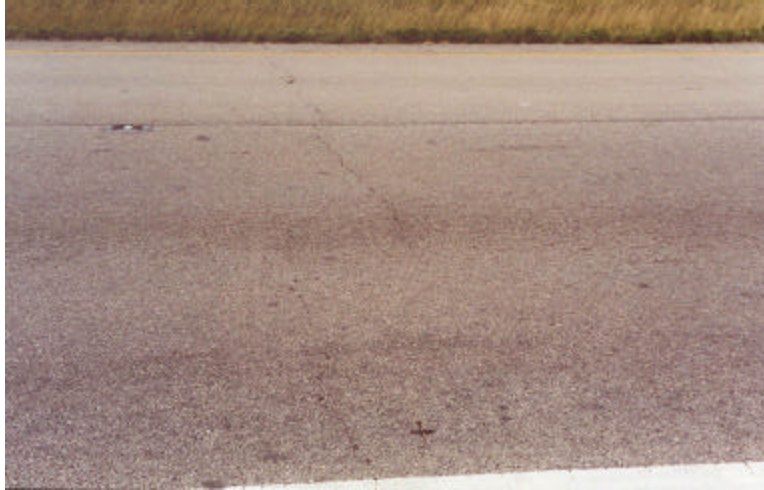
Figure 24. Rubblize and 8" Overlay in 1998 (I-57 1996).

The CRS value in 2000 for all sections was 7.8, considered excellent. Distress surveys were performed in 1998 and 2000. In 2000, the 5-inch overlay control section exhibited 5 low-severity transverse cracks, or 10.2 cracks per lane-mile, and 4 feet of low-severity longitudinal cracking, or 8.2 feet per lane-mile. The rubblized and 8-inch overlay section had 2 low-severity transverse cracks, or 0.4 cracks per lane-mile. The other two sections did not show any distresses. Figure 24 shows one transverse crack in the rubblized and 8-inch overlay section in 1998.

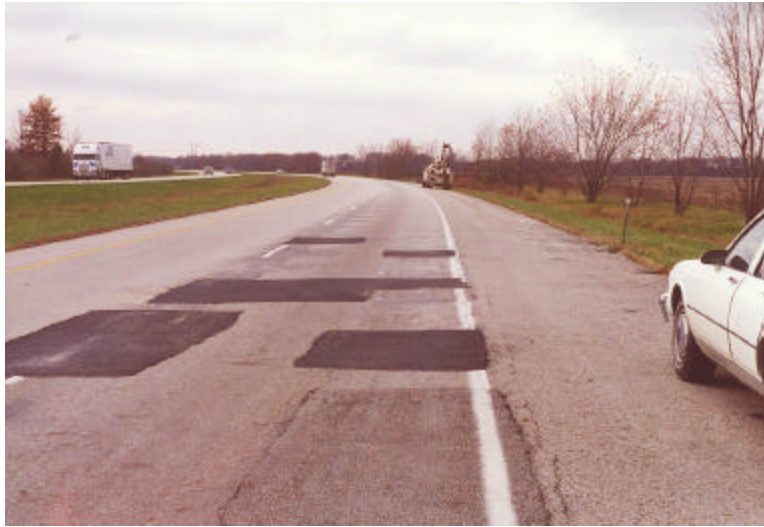
Figure 26. Preconstruction Condition (I-70 1997).

rubble process existed. IBVs were found to range from 3 to 5, the minimum level needed to support rubble operations.

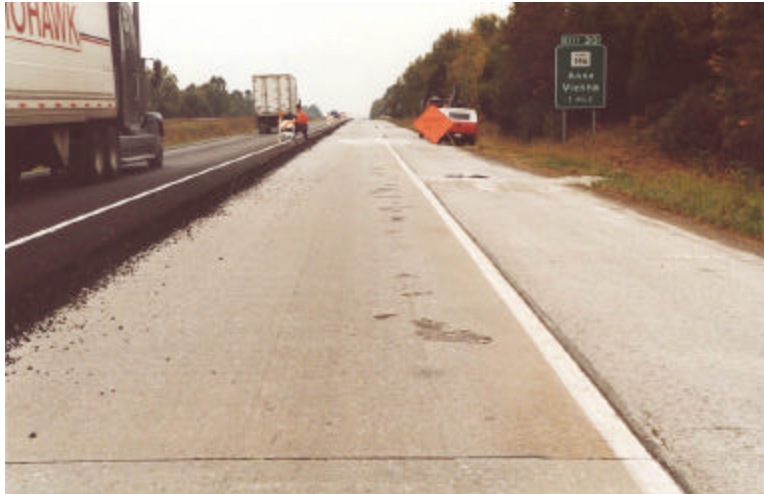
Figure 29. Preconstruction Condition (I-57 1997).

Cores and soil samples were taken to help evaluate possible problems that might be encountered during construction. In situ soil strength was gathered to determine if a minimum level of soil support for the rubblizing process existed. IBVs were found to be about 5, an acceptable level to support rubblizing operations.

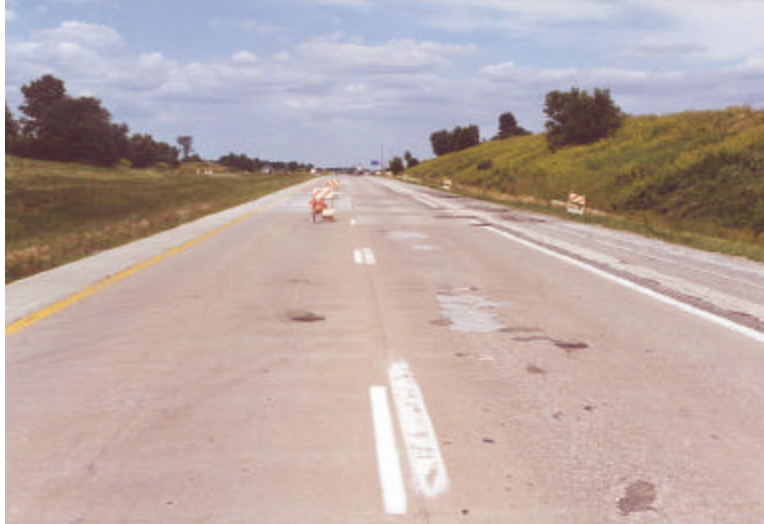
Figure 32. Preconstruction Condition (I-74 1999).

The CRS value was obtained to determine the existing condition of the pavement. The CRS value of the section was 5.1, fair condition, in 1998. Main distresses observed were punchouts, local areas of pavement breakup, and failing patches (see Figure 32). These distresses are not uncommon for a thin CRC pavement section. The section was very rough, with an IRI over 300 in 1998.
