**Subject: Beaver Valley Power Station, Unit No. 1  
Docket No. 50-334, License No. DPR-66  
Bulletin 2000-01 Circumferential Cracking of Reactor  
Pressure Vessel Head Penetration Nozzles**

**Evaluation Report for 1R14 Visual Inspection of  
Beaver Valley Unit 1 CRDM Penetrations**

# **Summary Report for Beaver Valley Unit 1 RVH CRDM Penetration Visual Inspection**

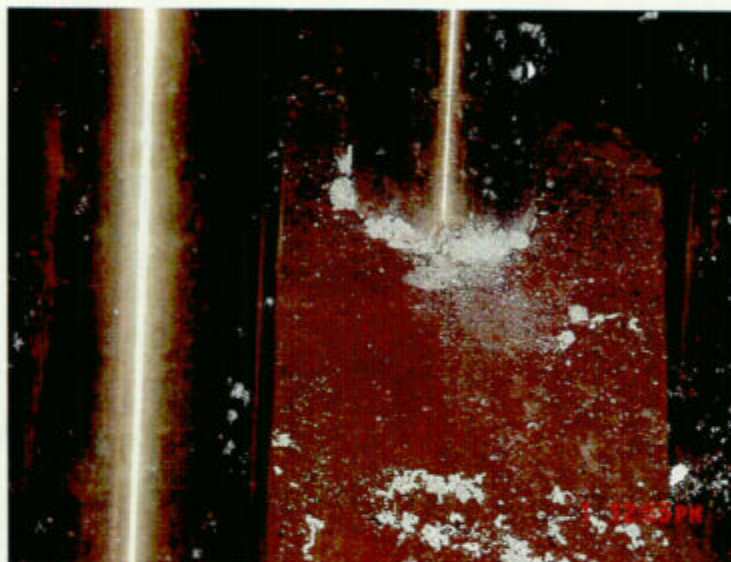
**Figure 1 – Typical Boric Acid Accumulation Around a Failed CRDM**

shown in Figure 1 (shown below). This picture illustrates the configuration of boric acid accumulation that is associated with through wall leakage from a CRDM Tubing. None of the penetrations on the Beaver Valley Unit 1 displayed boric acid accumulations of a similar configuration. Additionally all indications of boric acid accumulations were associated with previously identified Conoseal leakage, as a result it is concluded that no penetrations at Beaver Valley Unit 1 contain a leaking through wall flaw.

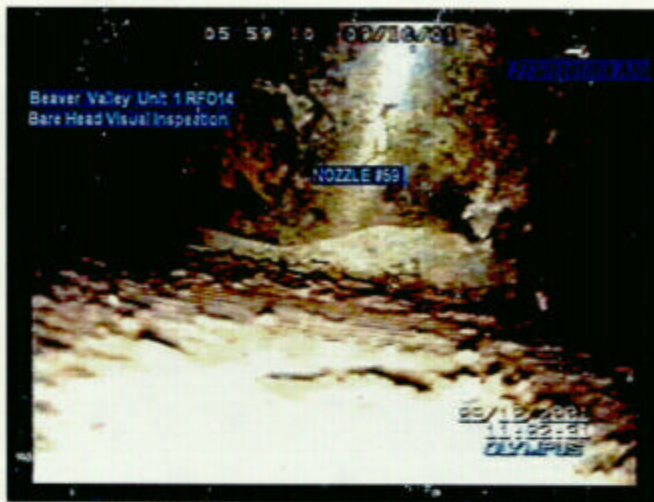
Figure 2 – Penetration #59

The two (2) locations, CRDM penetration numbers 59 and 65, identified as having boric acid deposits on and around the CRDM tubing are shown on the next page.

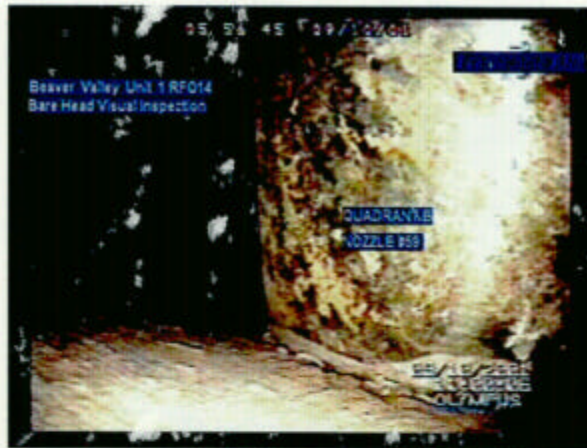
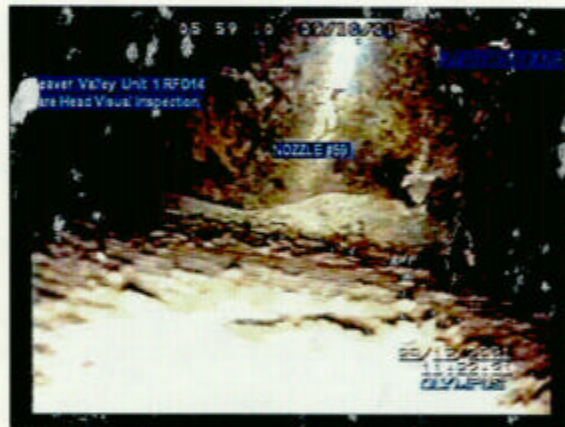
Figures 4(a) and 4(b) show the area around the base of Penetration #59 where it meets the Reactor Vessel Head. As can be observed, very little accumulation of boric acid residue can be seen at the base of the penetrations. The accumulation around the base of the penetration is light dry boric acid no more than 1/16 inch in thickness in the form of a film or coating rather than distinct accumulations of boric acid "puff balls". These film like accumulations of this type are not similar in any way to that shown in Figure 1.

Figure 4 (a) – Penetration #59

Figure 4 (b) – Penetration #59

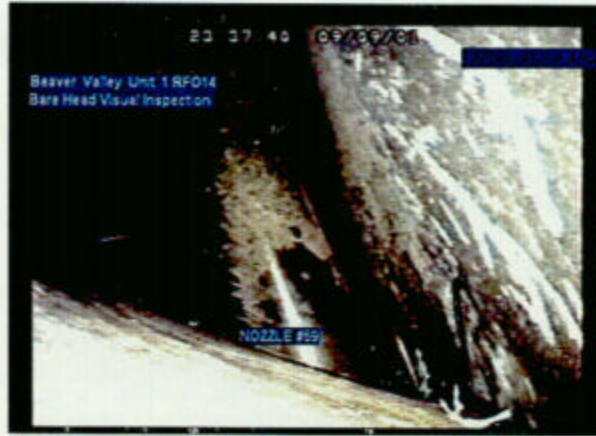
Figure 5 – CRDM #59

The residue pattern that can be observed on the sides of the penetration are consistent with leakage from above (like that of a Conoseal leak). The distinct spray pattern (shown in Figures 5 and 6) across the CRDM tubing is well above the intersection of the CRDM tube and the Reactor Vessel Head and is also displayed on the surrounding insulation panels. A review of the Unit 1 Refueling Logs indicates that leakage from a conoseal occurred during 1R04 (October of 1984). The Log noted that boric acid residue was removed from the head, there was no indication that the area around the CRDM was cleaned. Penetration #59 is located near Conoseal #1 and leakage from this Conoseal would spray onto and run down around the insulation opening at Penetration #59. The appearance of the spray pattern on CRDMs #53 and #59 is one of liquid being dropped into a high velocity air flow and then splattered on the surrounding surfaces.

In the case of nozzle penetration #59, the visual inspection shows a distinct spray pattern across the nozzle above the intersection of the CRDM and reactor vessel head onto the surrounding insulation and onto nozzle #35. The boric acid was deposited in a rooster tail pattern that seems to reflect a bottom-up direction. However, the conoseal leakage would have yielded a top-down flow of boric acid. The spray effect resulted from the high upward air flow of the CRD cooling ventilation, which will form air jets in gaps between the insulation and the head around the periphery locations. The high flow air picks up and atomizes the boric acid running down the shroud and throws it across the face of the nearest nozzle and insulation. This conclusion is bolstered by the fact that no streaming stains or deposits are present anywhere on the head surface. If the boric acid at nozzle 59 were from a penetration leak, it should have run down to the shroud as was seen at the Oconee and ANO leaks.

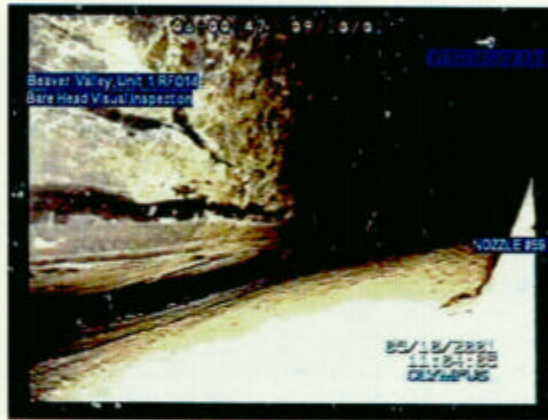
Figure 7 – Insulation Gap at Penetration #59

Figure 7 shows that there is a gap of nearly 1/8 inch or more at the base of the insulation package where it meets the Reactor Vessel Head near Penetration #59. During plant operations the CRDM Cooling Fans pull approximately 440 CFM of air through the Reactor Vessel Head area. Figures 5, 6 and 7 show the accumulation of the boric acid spray on the surrounding areas consistent with leakage from above being carried by high velocity air on to the CRDM tubing. This fact coupled with the lack of boric acid accumulation around the base of Penetration #59, as displayed in Figures 4(a) and (b), provides sufficient evidence that the boric acid residue is a result of Conoseal leakage and not from a through wall leak of the CRDM tubing.

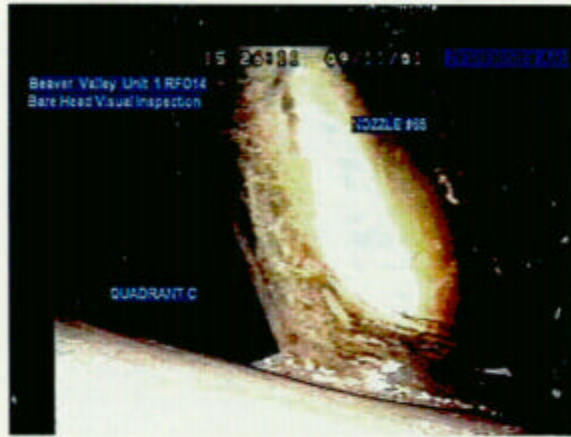
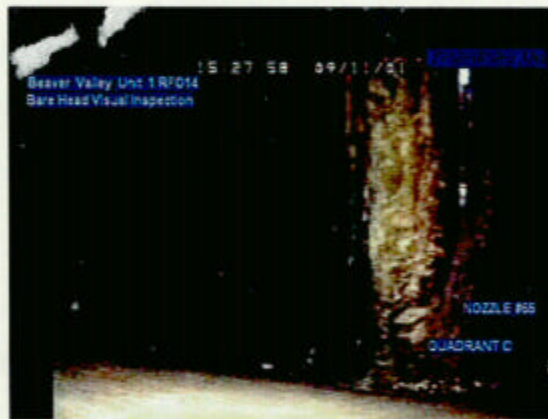
Figure 8(a) and 8(b) show the base of Penetration #65 where it meets the Reactor Vessel Head. As can be observed there is some slight accumulation of boric acid residue around the penetration. None of the accumulation has the fluffy appearance like that displayed in Figure 1. There is some small amount of gradual residue that has accumulated on the up hill side of this penetration as can be observed in Figure 8(a). It should also be noted that the staining on the sides of the penetration indicate that leakage from above has occurred in the past (see Figures 8(a) and 8(b)).

Figure 8 (a) – Penetration #65

Figure 8 (b) – Penetration #65

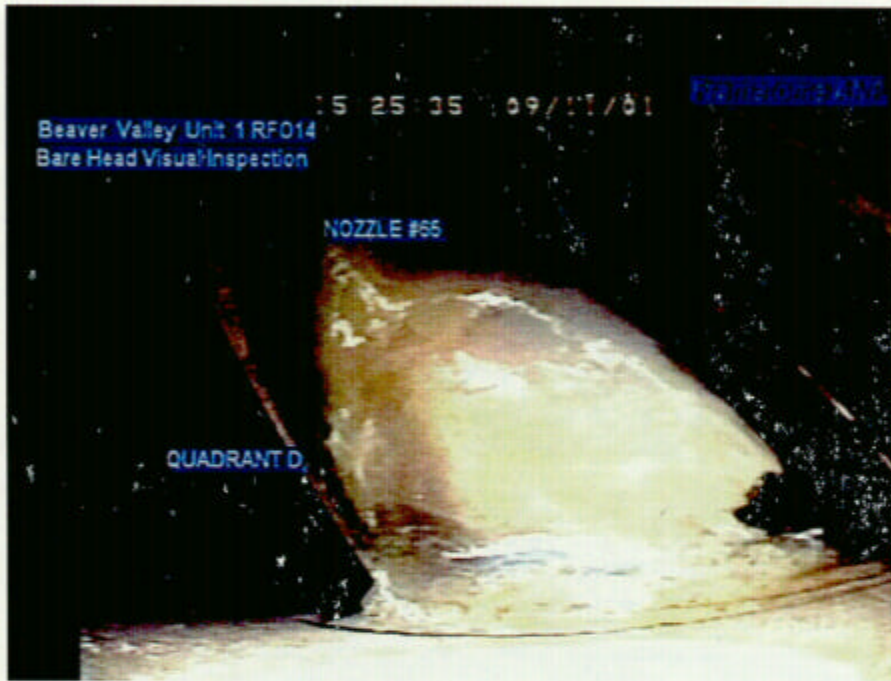
A closer inspection of the area around the base of Penetration #65, as shown in Figure 9, indicates that some corrosion wastage of the Reactor Vessel Head has occurred. The depth of this corrosion is between 1/16 inch and 1/8 inch in depth and approximately 1/2 inch in width. Wastage of this type is consistent with the damage one would expect from a borated fluid coming in contact with a hot carbon steel surface. It is concluded from the photographs of the extent of boric acid accumulations (Figure 11) found around the #2 Conoseal upon shutdown for 1R07 Refueling Outage that a significant amount of reactor coolant came in contact with the surface of the Reactor Vessel Head during the end of the power operation cycle and during shutdown prior to depressurization. It is further concluded that the corrosion wastage occurred during the shutdown process, when there was insufficient heat to boil off the water in the leaking reactor coolant prior to it coming in contact with the carbon steel Reactor Vessel Head. During this period the wastage occurred to the wetted Reactor Vessel Head surface. A review of the design analysis for the Reactor Vessel Head indicates that a minimum wall thickness for the head is 6.188 inches. During ISI inspections the actual head thickness was determined to be 6.78 inches using a straight beam Ultrasonic probe. This minor localized corrosion (0.125 to 0.200 inches) does not infringe upon the specified minimum wall thickness use for design, which includes the design margins; therefore it is concluded that this area of localized corrosion wastage does not present a structural concern.

Figure 9 – Penetration #65  
Corrosion at Base of Penetration

The second conoseal leak occurred near the reactor vessel stud location #57. As a result, the #65 nozzle was affected by a flow of boric acid. Refer to the attached map for stud and nozzle location data. In this case, the boric acid seems to flow directly down the nozzle on the uphill side. As the acid flowed around the nozzle, at operating temperatures, the carbon steel of the head was affected. Erosion to a depth of less than .125 inches for about 1/2 inch around the base of the

nozzle was noted and present only at the #65 nozzle location. This does not appear to be an active mechanism.

It was recommended that following the inspection of the CRDM penetrations no cleaning of the as found condition be performed. This recommendation is based upon the following rationale; first the as found condition was recorded and can be used as a baseline for inspections to be performed during the next refueling outage; secondly, to remove the boric acid residue would result in unnecessary man-rem exposure and finally the dried boric acid residue presents no corrosion concerns and will not affect the function of the components adversely.

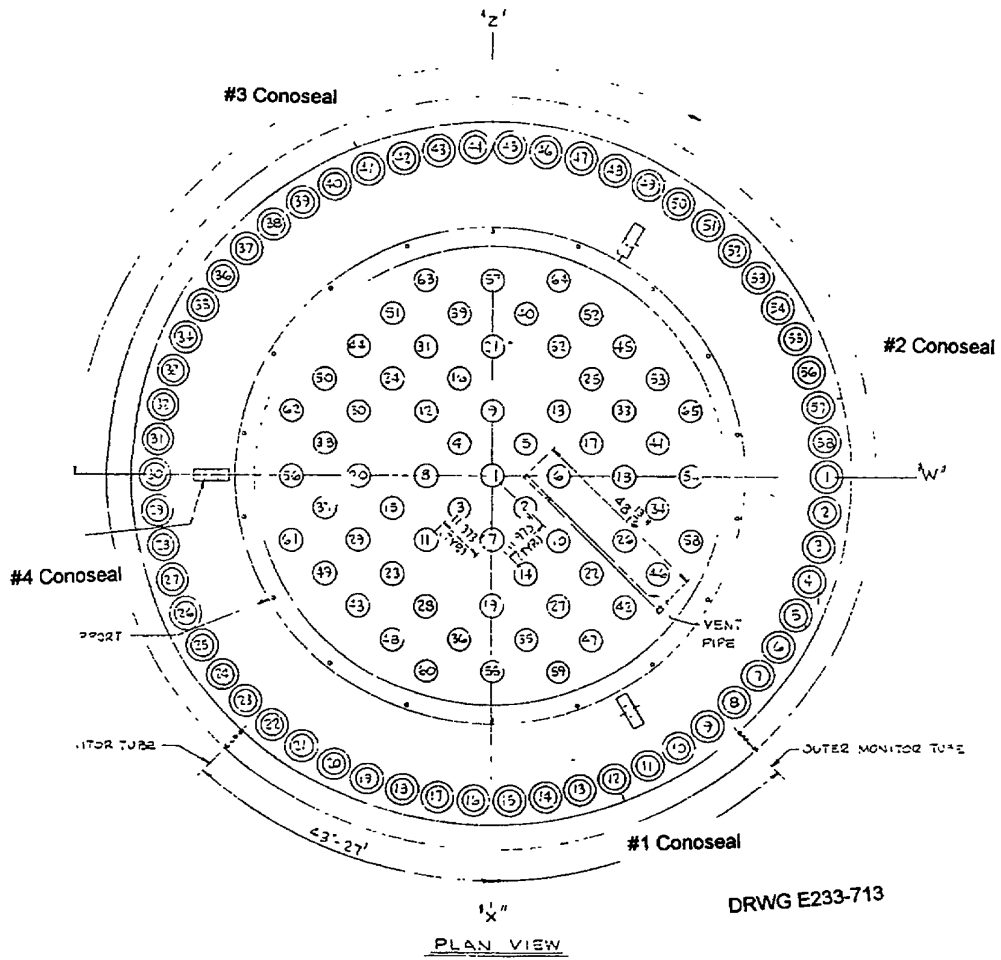
The boric acid accumulations around and on Penetrations #59 and #65 are discussed in this section. Pictures of the penetrations and the surrounding area are identified as Figures 4 thru 9. These figures will be used to illustrate the conclusions and evaluations described. Figure 10 describes the location of the Conoseals relative to the Penetrations #59 and #65. This sketch on Figure 10 shows that Penetration #59 is located near Conoseal #1 and Penetration #65 is located near Conoseal #2.
