Docket No. 50-336
B18662

Millstone Nuclear Power Station, Unit No. 2
Reply to Request for Additional Information
Related to NRC Bulletin 2001-01

Reply to Request for Additional Information
Related to NRC Bulletin 2001-01

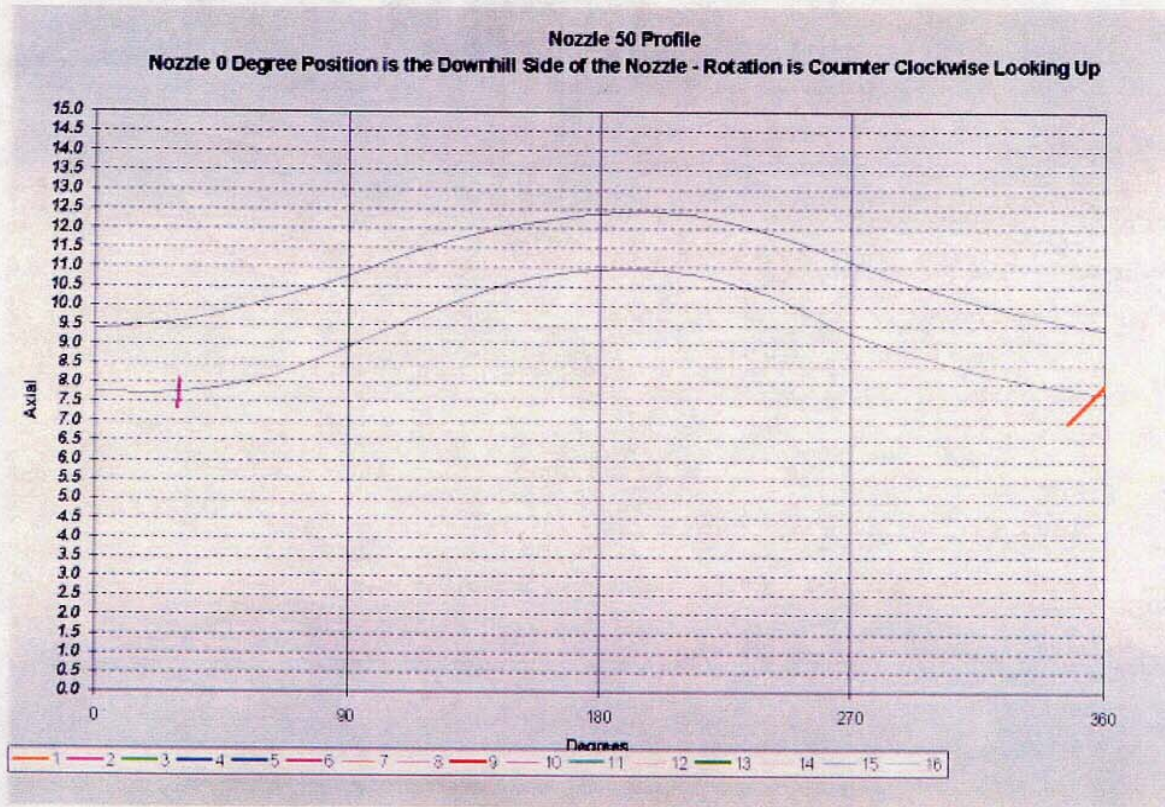
Figure 3 Location of UT indications in Nozzle 50 from 2R14 Inspection
