**Fourth
Five-Year Review Report**

**Des Moines TCE Site
Des Moines, Iowa**

February 2008

Prepared by:
EPA Region 7
Kansas City, Kansas

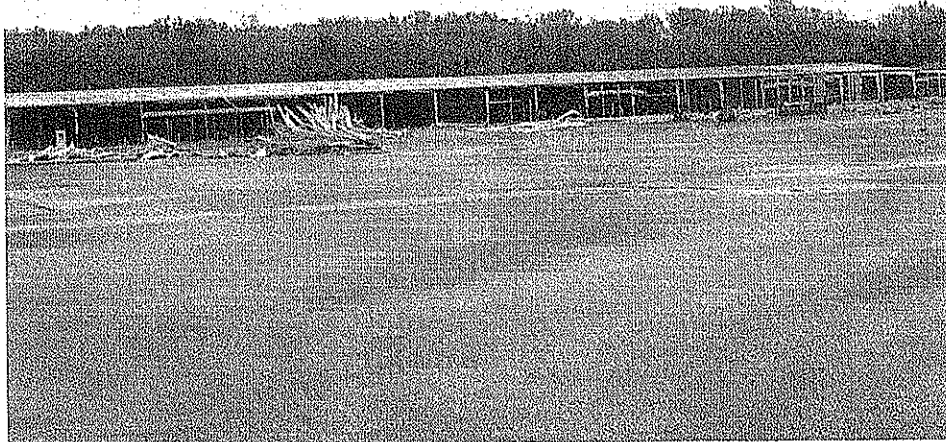
OU2/OU4: The buildings, the asphalt cap, and the South Pond drainage area and ditch east of the site were included in the inspection of OU2 and OU4. The most notable change is the demolition of building 4/5. Dico indicated that the building support structures are being sold and will be erected at another site. Sheet metal will be recycled and other materials will be sent offsite for disposal. The concrete foundation will remain in place. Louis Barrentine indicated that he will provide documentation to EPA regarding the disposition of materials leaving the site. Photographs 1, 2, and 3 depict building 4/5 in the process of demolition.

Dico Building 4/5 demolition; view to the east
9/19/07

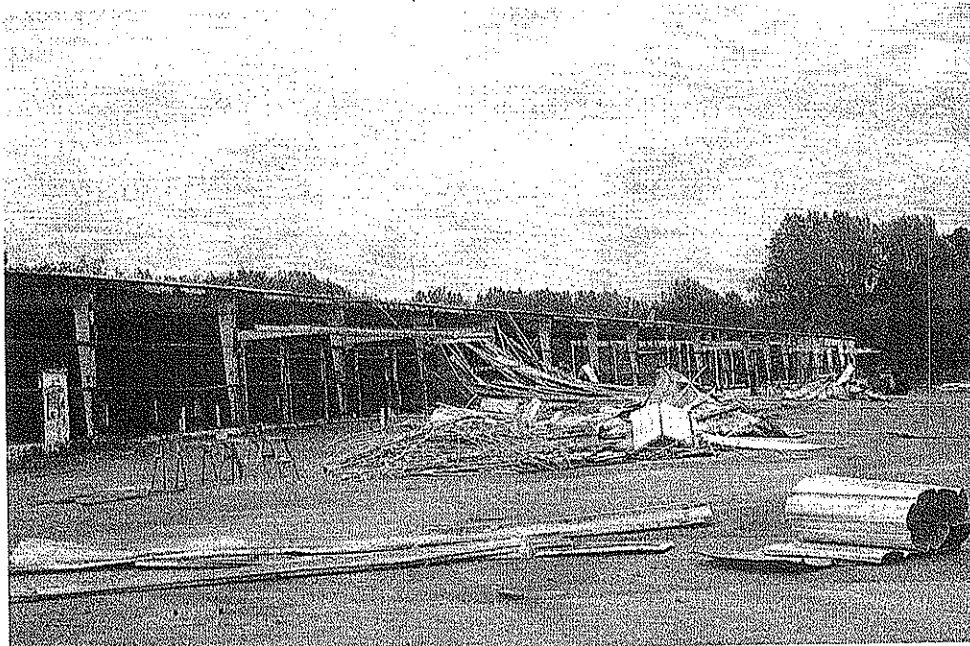
Dico Building 4/5 demolition; view to the south
9/19/07

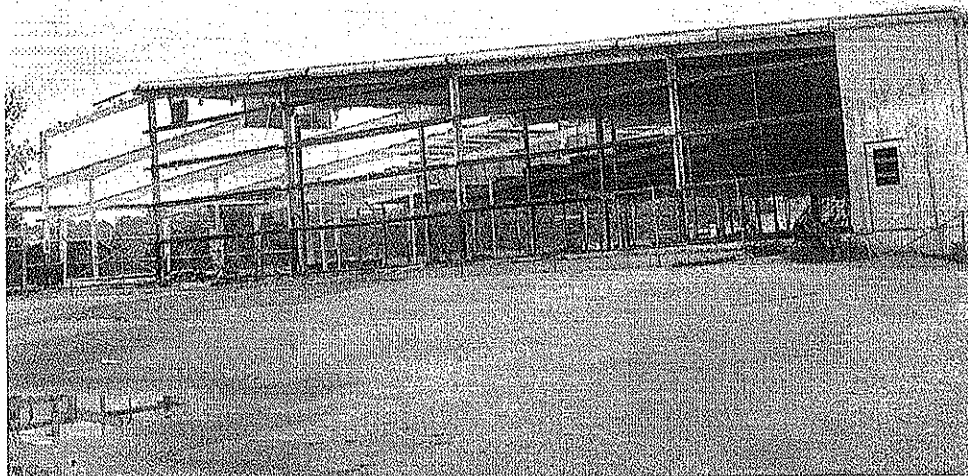
Dico Building 4/5 demolition; view to the northwest
9/19/07

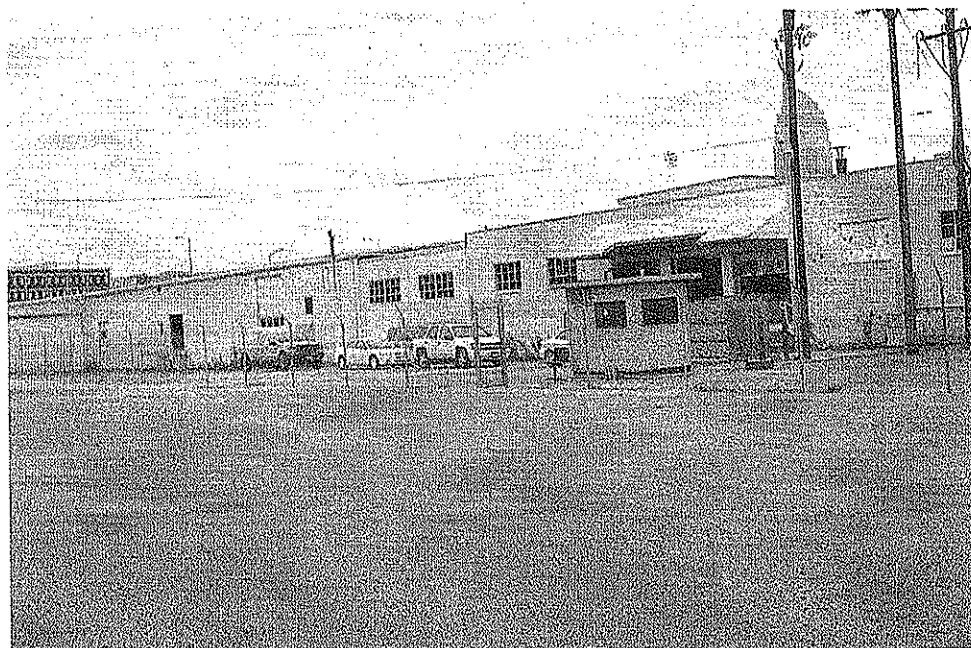
Dico Production Building; view to the east
Shows new security fencing and guard shack
9/19/07

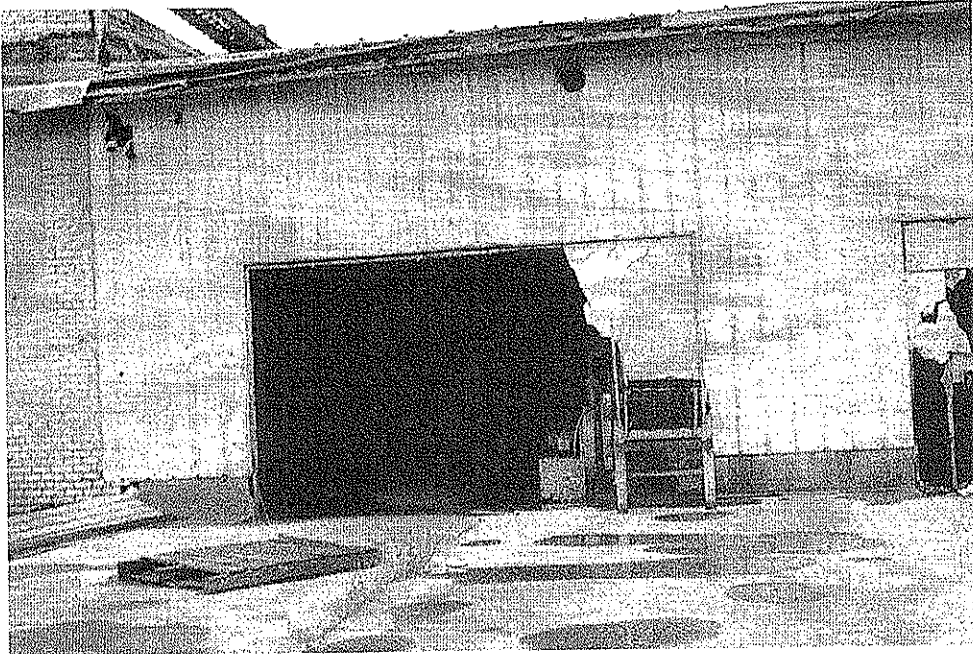
All other buildings remain intact. However, all windows have been broken out and most doors have been knocked in. Approximately 18 months ago, Dico erected a six foot chain link fence with barbed wire across the top to prevent trespassers from accessing the buildings on the property. Photograph 4 shows the fence and the Production building with the guard shack in the foreground. Photograph 5 depicts the general condition of the buildings at the site. Photograph 6 shows buildings 1-3 and the Maintenance building.

Dico building; shows general condition of onsite buildings
9/19/07

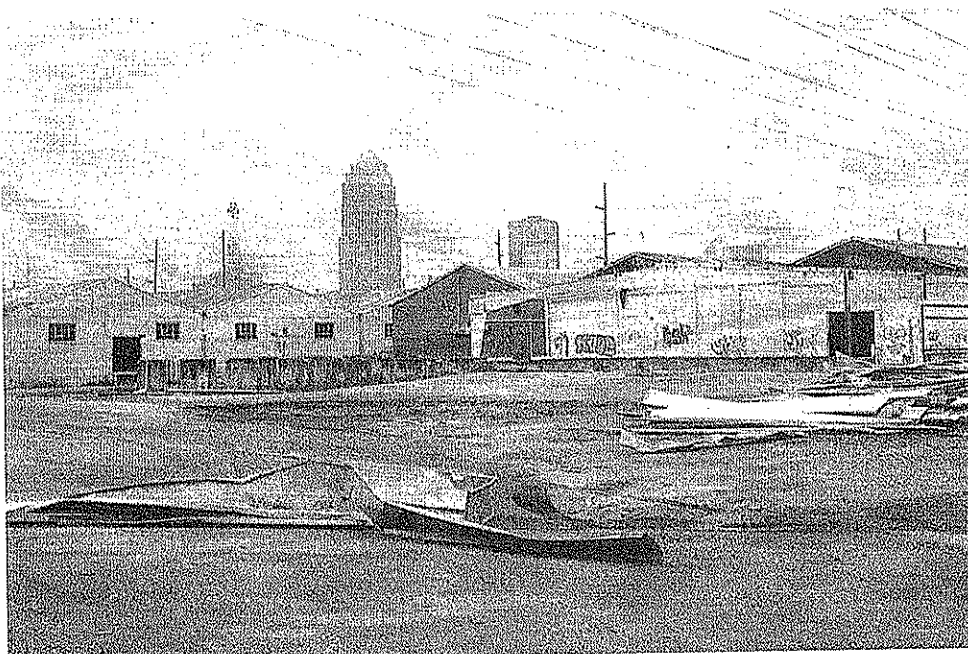
Dico Buildings 1-3 and Maintenance Building; downtown visible in background
9/19/07

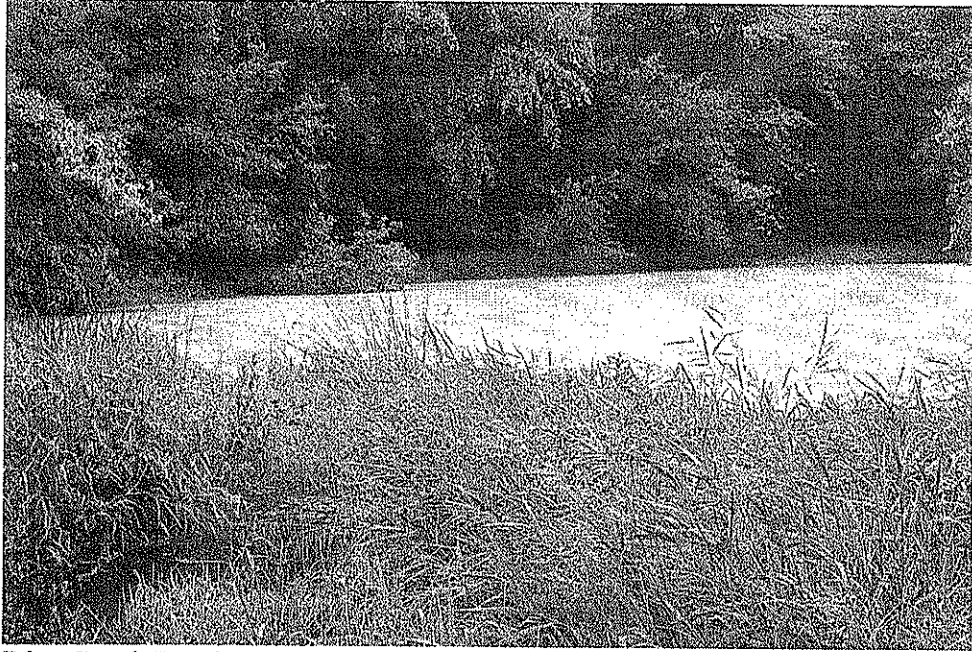
Dico South Pond Area
9/19/07

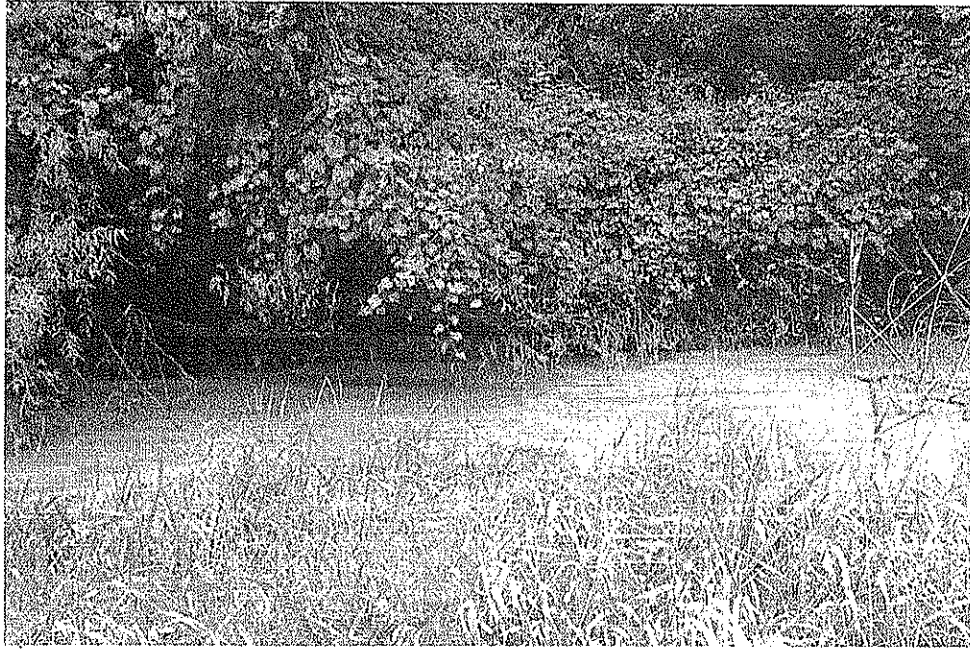
Dico East drainage ditch; full and stagnant
9/19/07
