Crash Injury Mechanisms in Vehicle Mismatch Collisions

Presenters: Stephanie Acierno, MD
Rob Kaufman, BS

CIREN Seattle

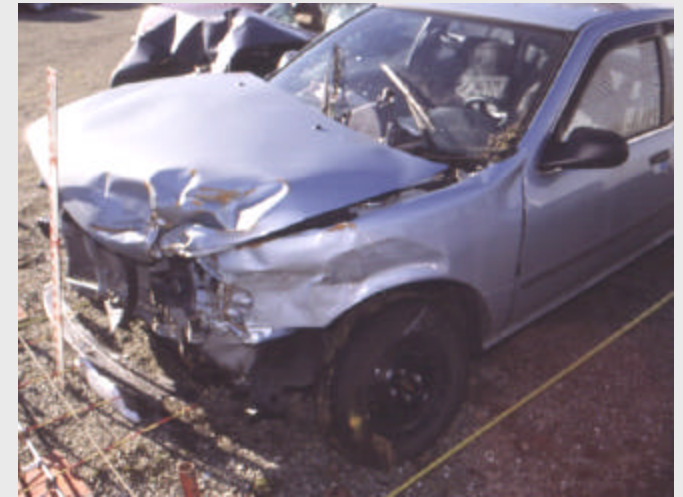
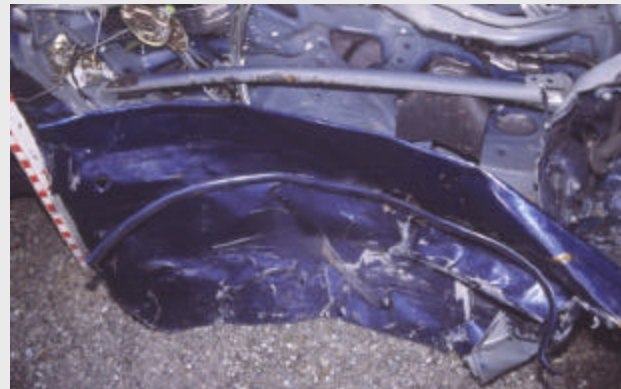
- Minimal intrusion
- No injury
- Delta V = 12 mph
- 01RYEW2

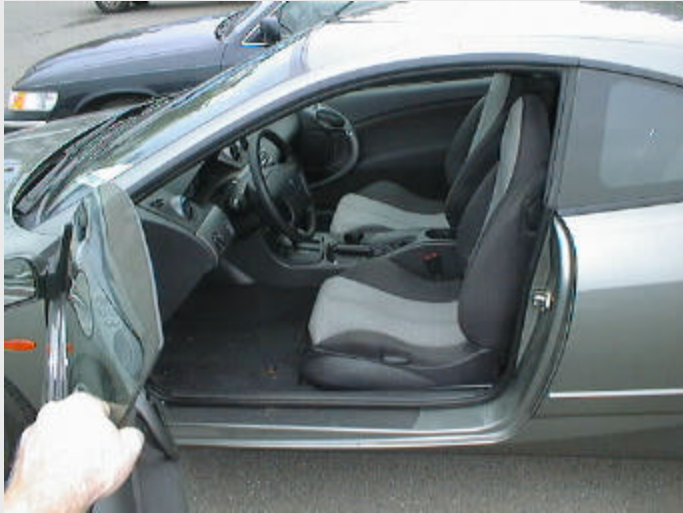
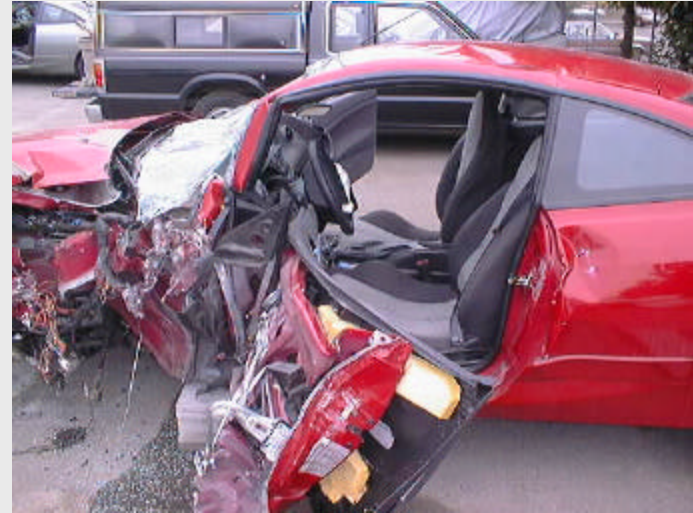
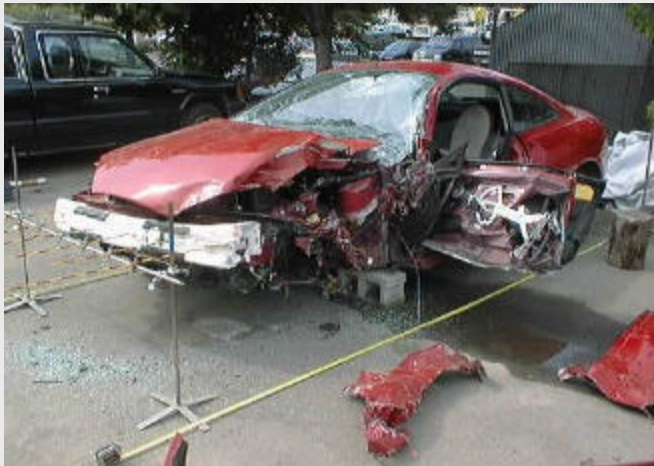
Left mid-shaft femur fracture due to override impact and intrusion to instrument panel

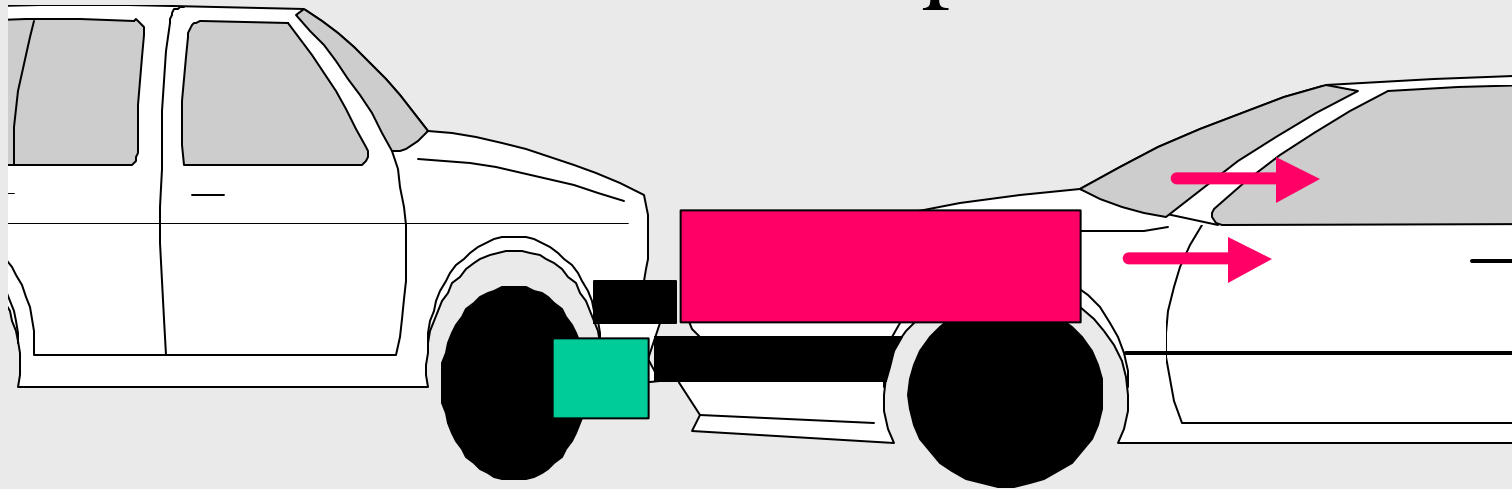
Override impact creates significant intrusion of instrument panel/hood

■ SUV bumper into grill of sedan

■ Sedan bumper into front tire/axle

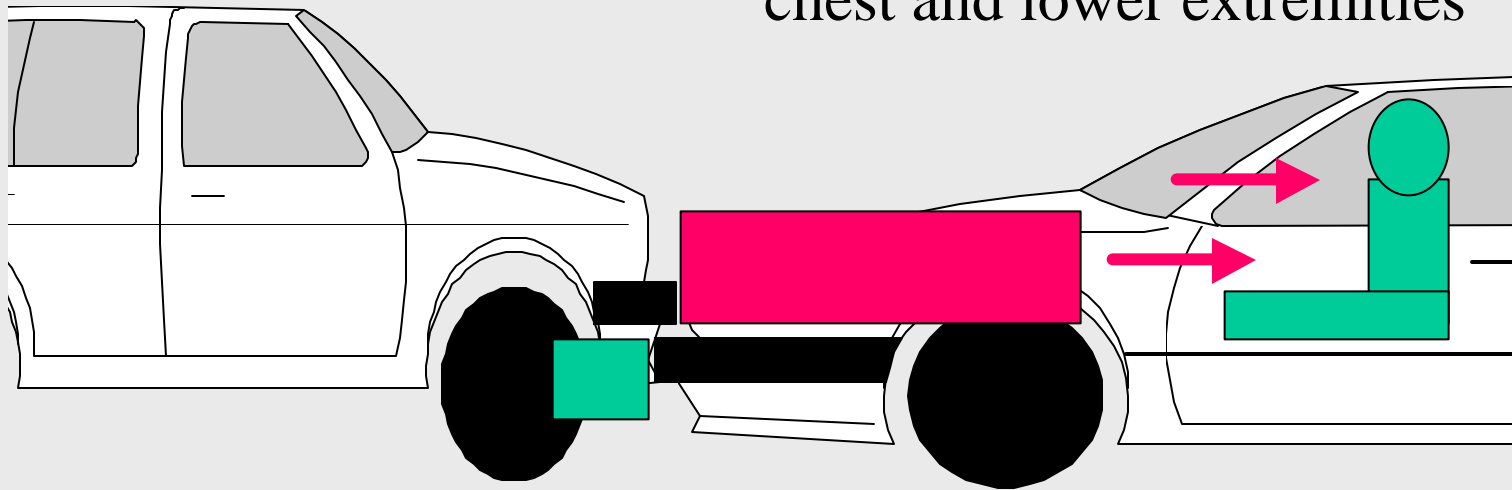
Longitudinal intrusion is created and impacts the head, chest and lower extremities

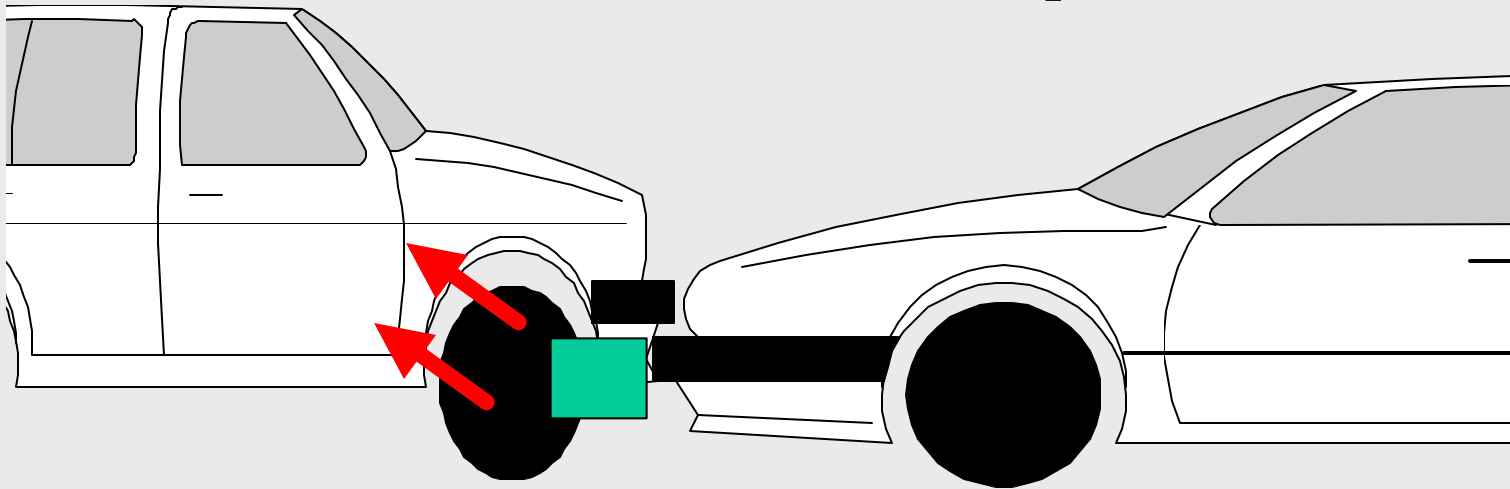
Passenger bumper frame impacts the SUV tires and axle which become forced into the floor and toe pans

Better reinforcement behind wheel wells to prevent toe pan intrusion from front tires

Lower bumper frame to match passenger cars

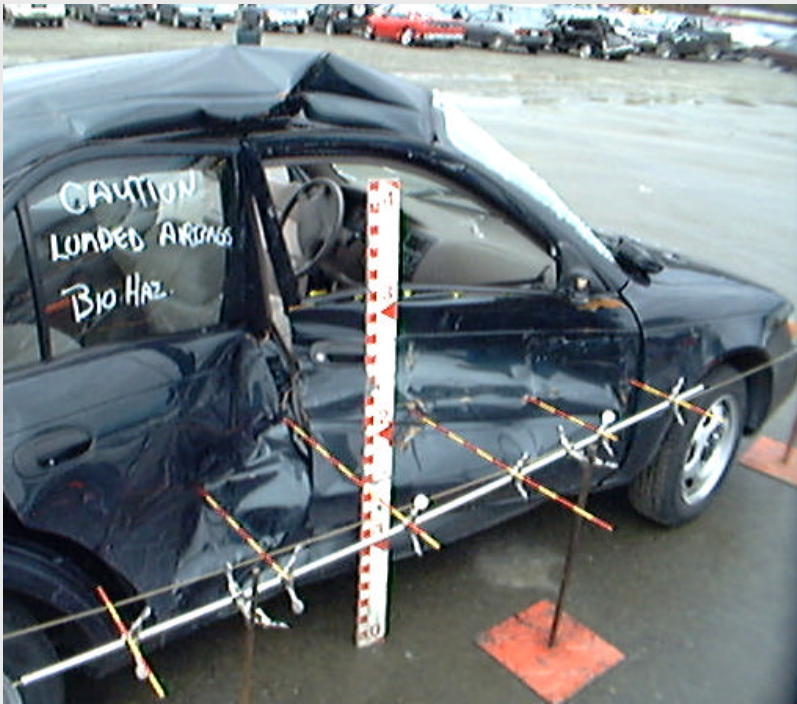
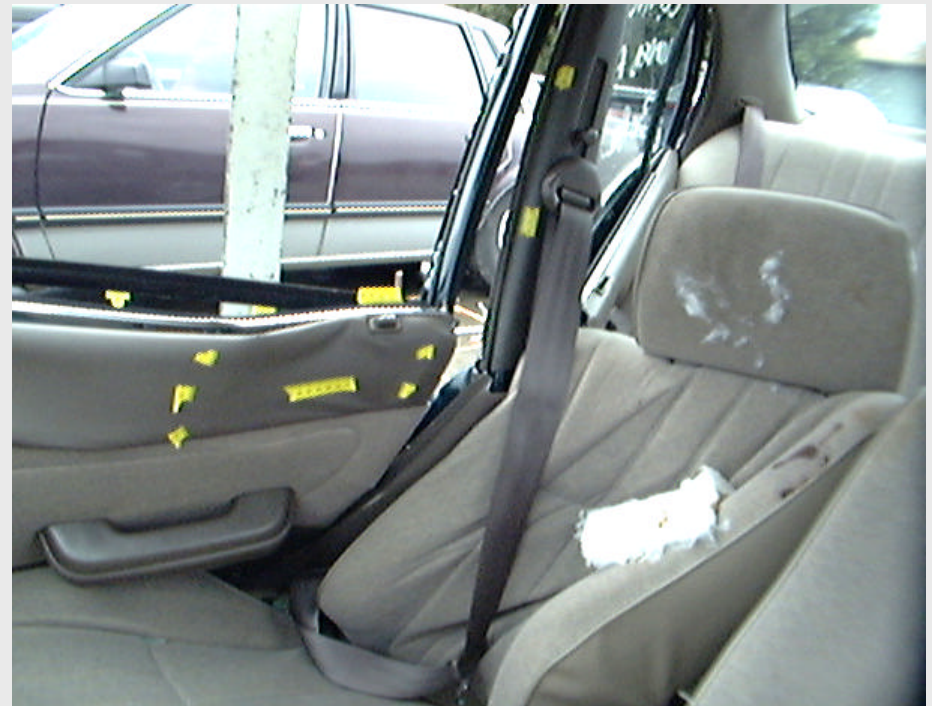
Upper door panel intrusion Override of support beams

Toyota Corolla struck by large F250 pickup truck

Upper door panel intrusion

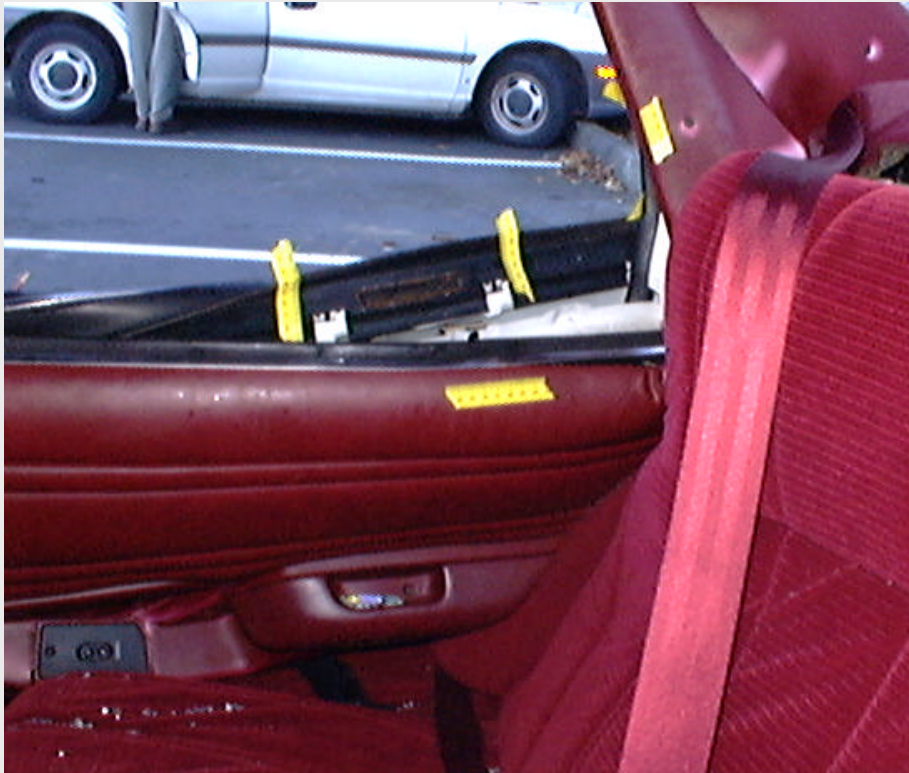
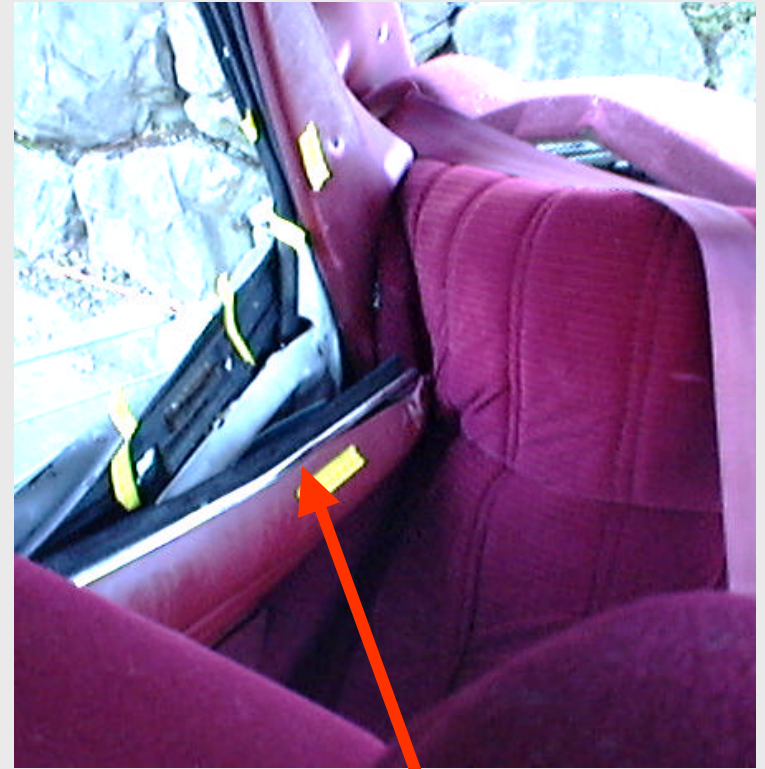
40 cm of intrusion at door panel, window sill

Deformation from head contact

- Serious Brain Injury, AIS = 5

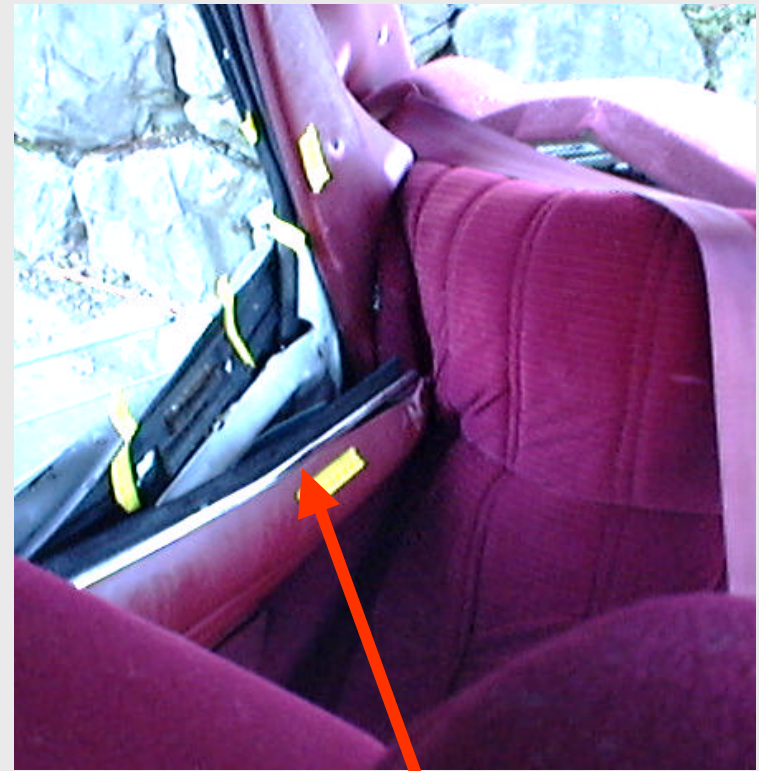
40 cm of intrusion at door panel, window sill

Deformation from head contact

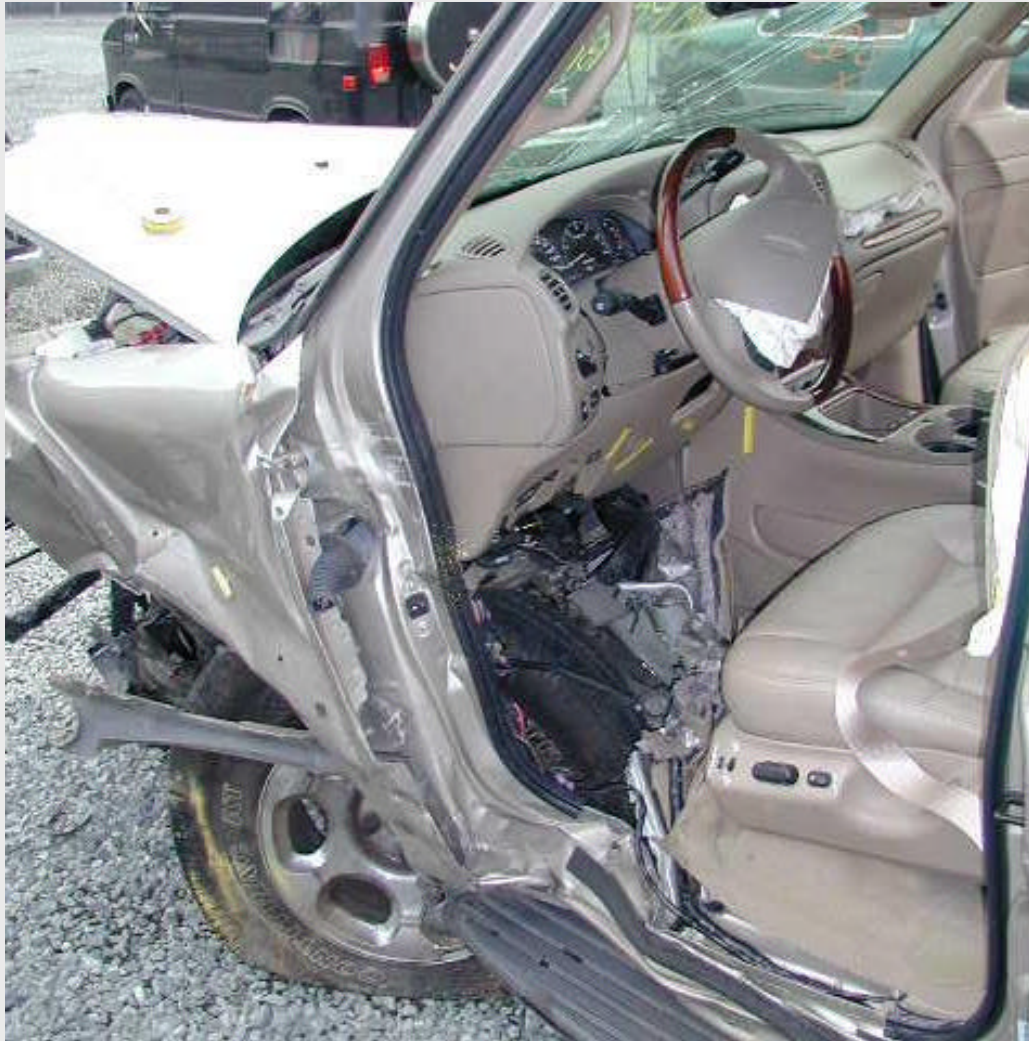
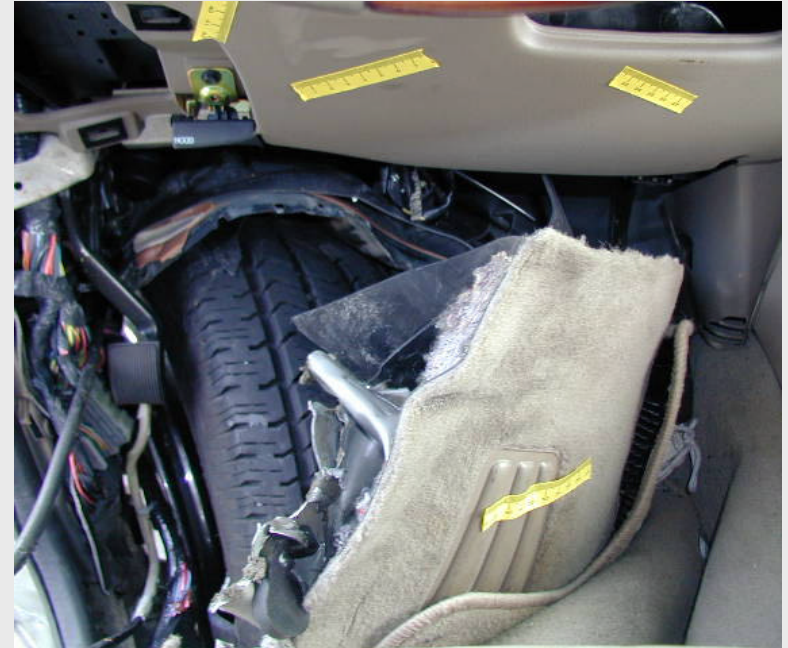
Impact to front left tire

55 cm (21") longitudinal intrusion of toe pan

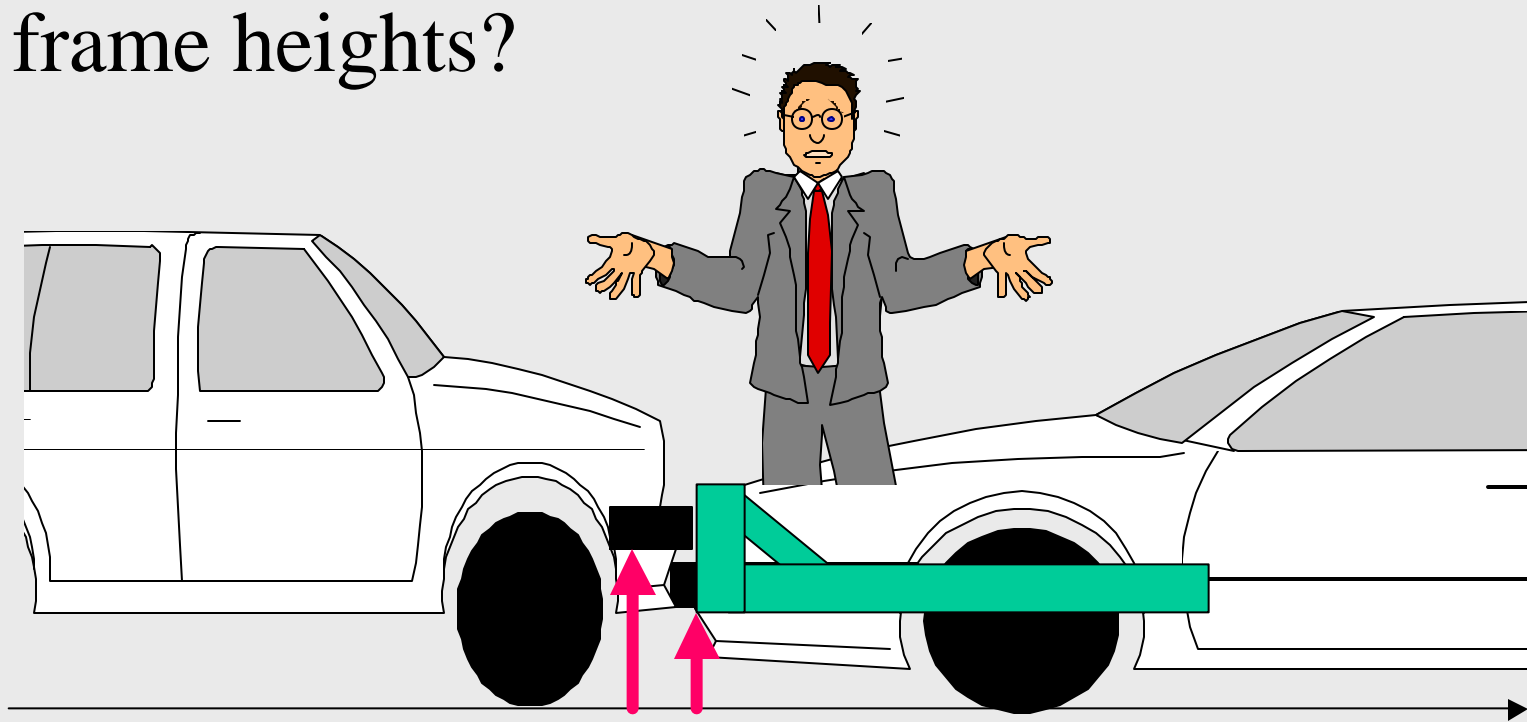
What to do about mismatch bumper frame heights?

Create a vertical component on the frame rail ends of the sedan or spoiler frame on LTV's

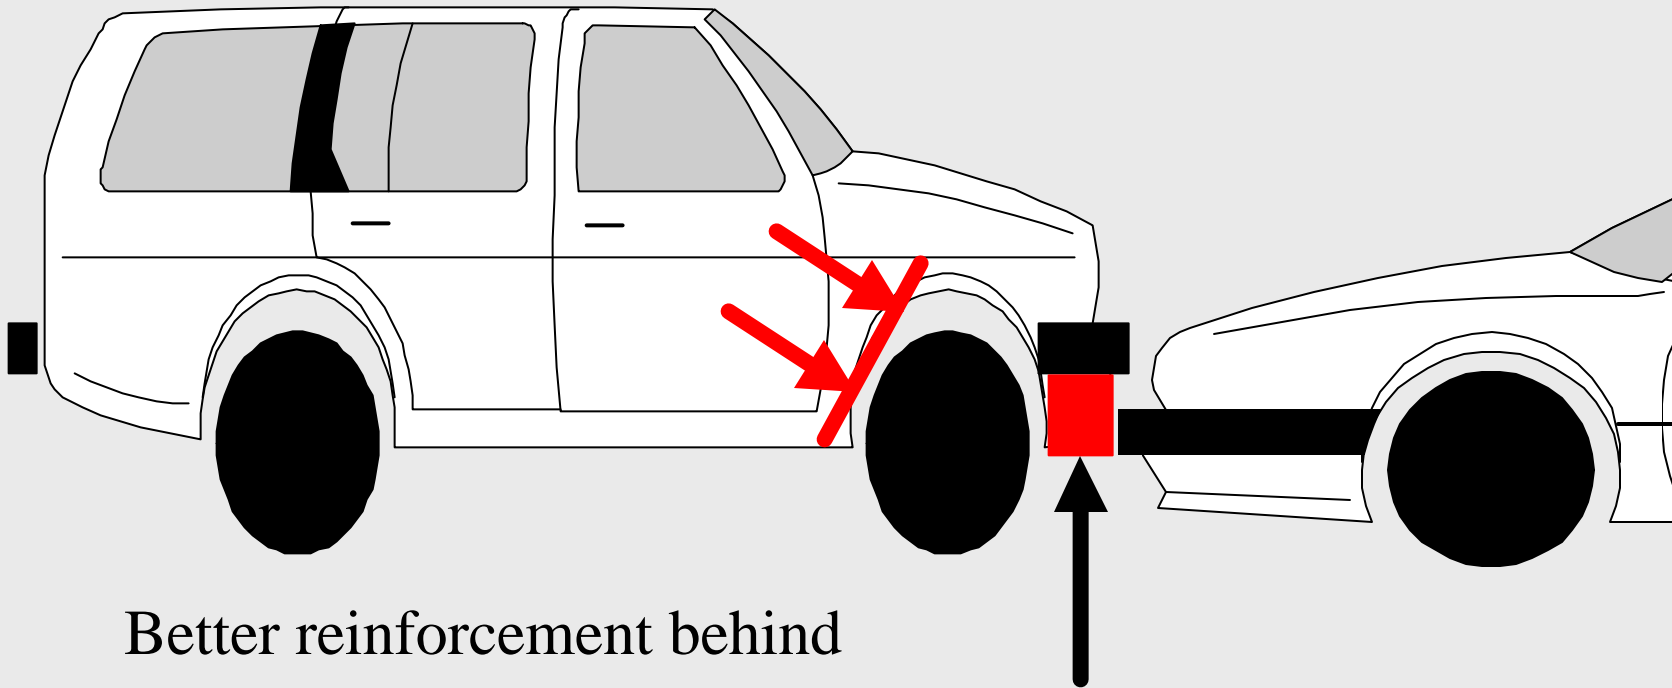
Toe Pan intrusion to SUV/Trucks
