**Hydraulic Pressure Cycling and Performance Evaluation of a DOT-3AA 2265
Cylinder, M9501**

FINAL REPORT

October 23, 2007

**Prepared for
Mark Toughiry
Office of Hazardous Materials Technology
Pipeline and Hazardous
Materials Safety Administration
U.S. Department of Transportation**

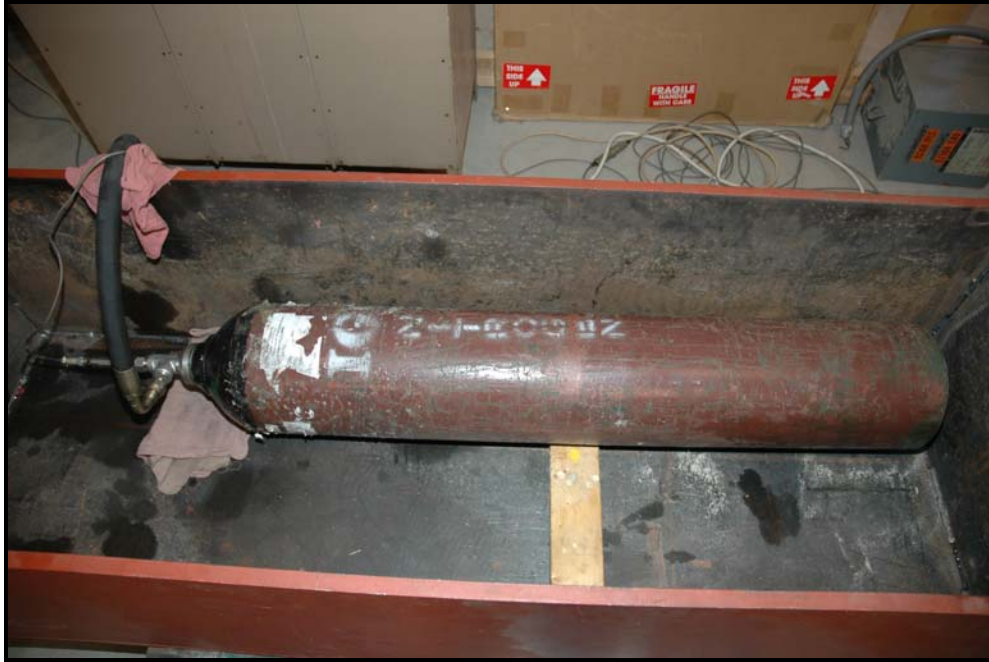
The cylinder was identified as a DOT - 3AA cylinder with serial number 441098 as shown in Figure 1. The indented markings on the cylinder are as shown in Figure 2.

Figure 1: DOT-3AA cylinder as received.

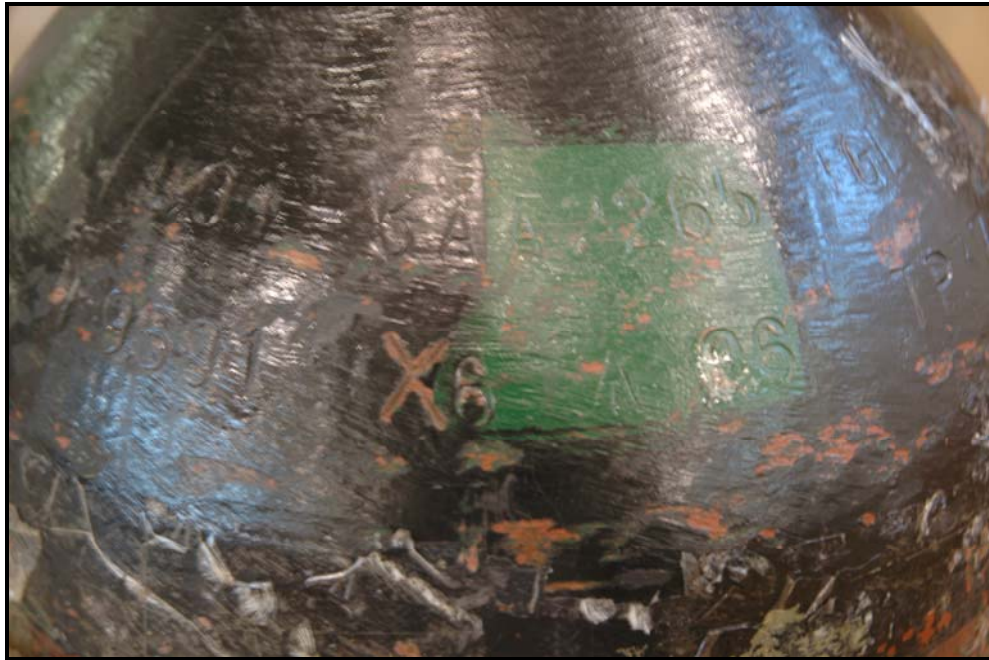
- The cylinder is marked as DOT –3AA 2265 GL Limited 441106 M9501 X6A 06 TP3775 PSI W53.8 VA3.3
- As per the information provided to Packer Engineering Inc by DOT the service pressure of the cylinder is 2,265 psi.
- There were no visible cracks observed on the outer surface of the cylinder. The paint on the cylinder was scratched at several locations.
- Internal observation of the cylinder was done after the burst test. The cylinder showed no major signs of corrosion on the inside. Figure 3 shows a typical view of the inside surface of the cylinder.

Figure 2: Indented marking on the DOT-3AA cylinder

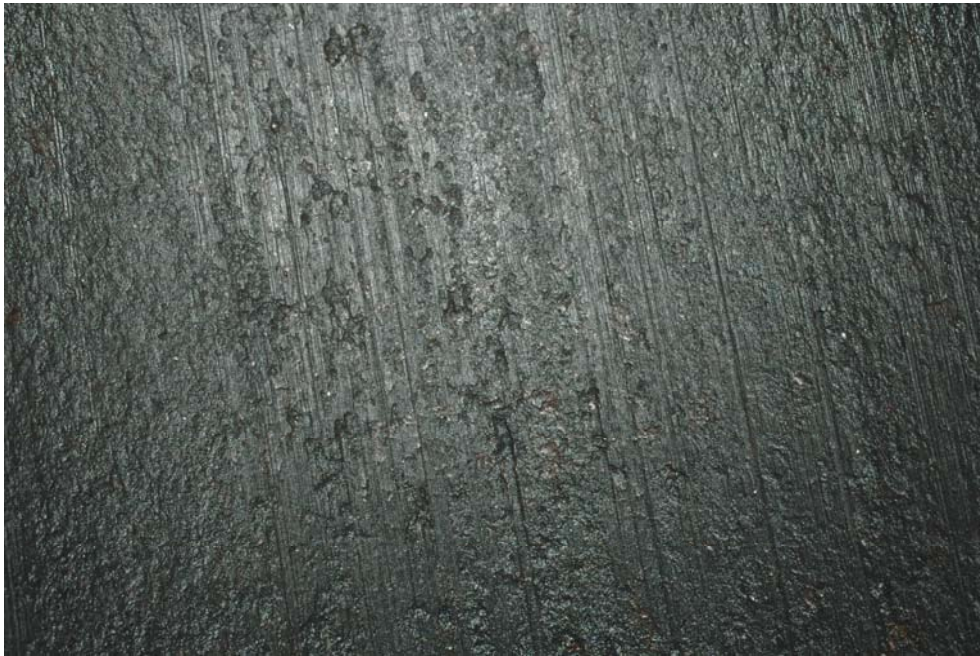
External observation of the received DOT – 3AA cylinder showed no signs of leaks or cracks. The paint had come off the cylinder at some locations and there were some scratches on the cylinder. Internal observation of the cylinder was done after the burst test. The cylinder showed no signs of corrosion on the inside.

Figure 3: Inside surface of the DOT-3AA cylinder. No major corrosion observed.

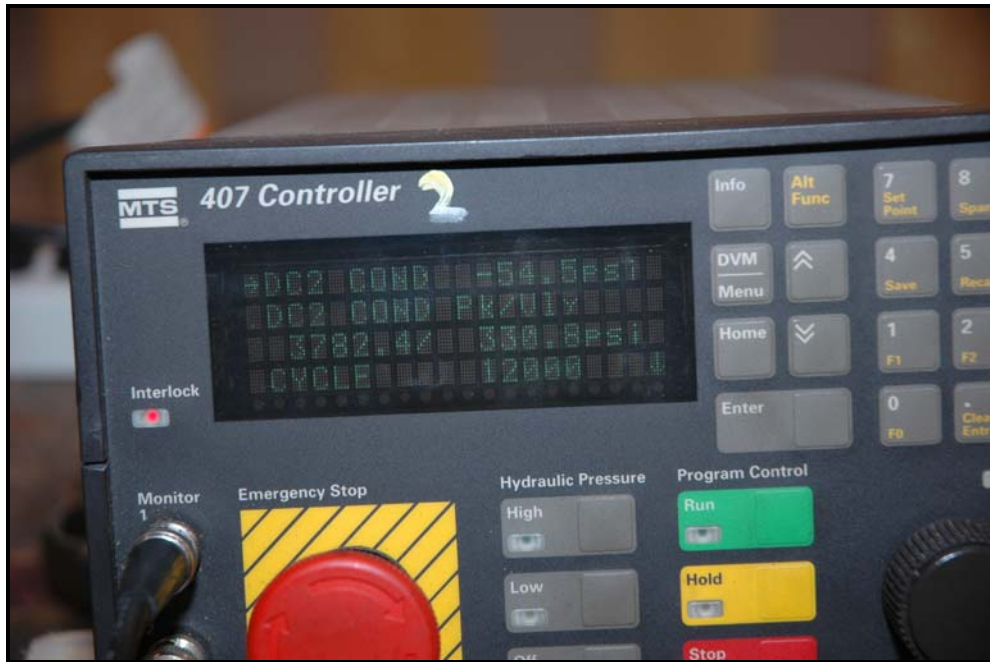
The cylinder passed the 12,000 cycle pressure cycling test. The maximum test pressure was 3,782 psi and minimum was 331 psi. The frequency of reversals was 0.25 Hz (15 cycles/min). No leak was detected during the 12,000 cycle pressure testing.

Figure 5: Shows the maximum/minimum pressure and cycles completed during cyclic testing of the DOT – 3AA cylinder.

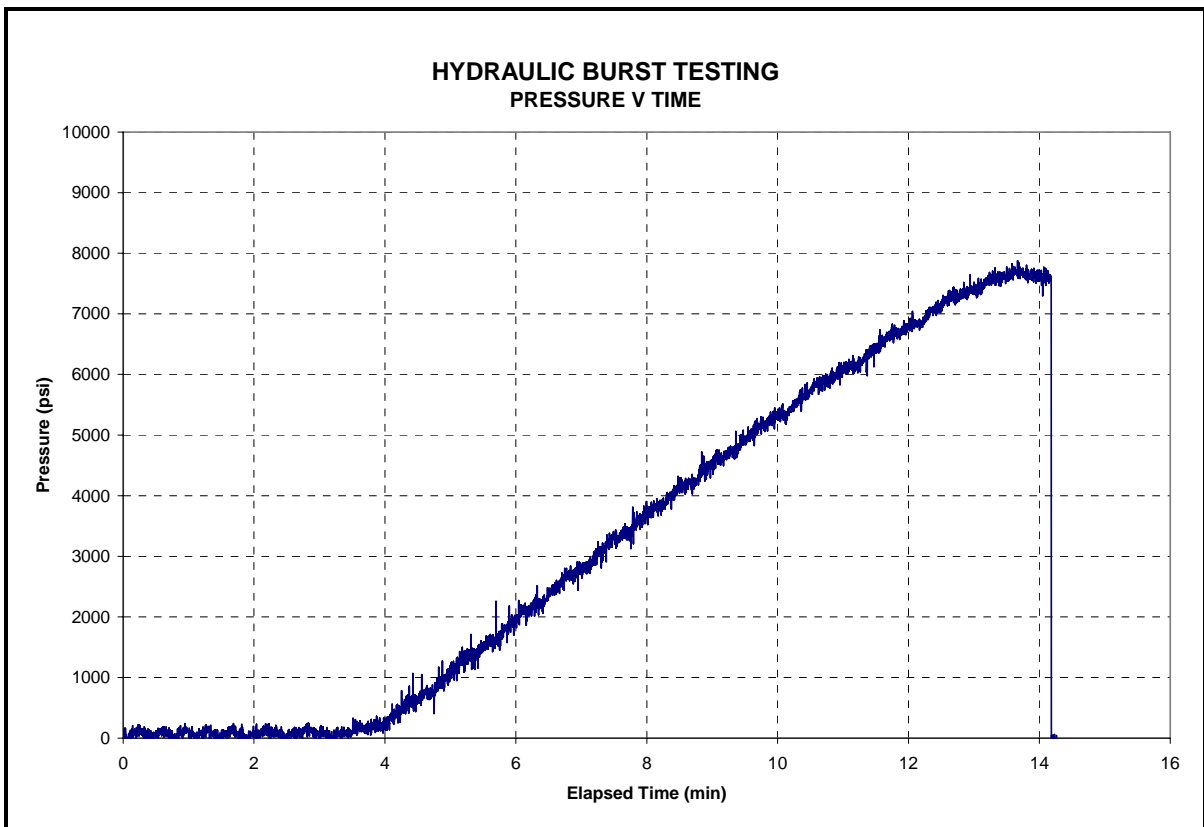
During the hydraulic burst test, the cylinder reached a maximum pressure of 7,755 psi in about 13.71 min (13 min 42 sec) and failed after 14.18 min (14 min and 10 sec). The cylinder burst along the length of the cylinder. The maximum pressure that the cylinder could withstand is greater than the service pressure of 2,265 psi.

Figure 10: Pressure v Time data for Hydraulic burst test.

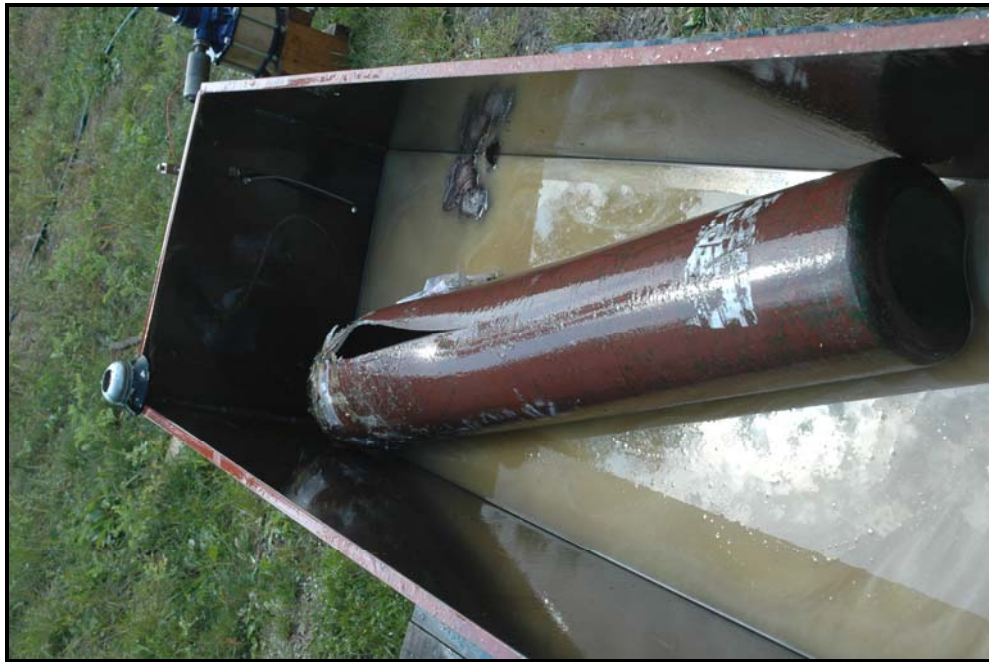
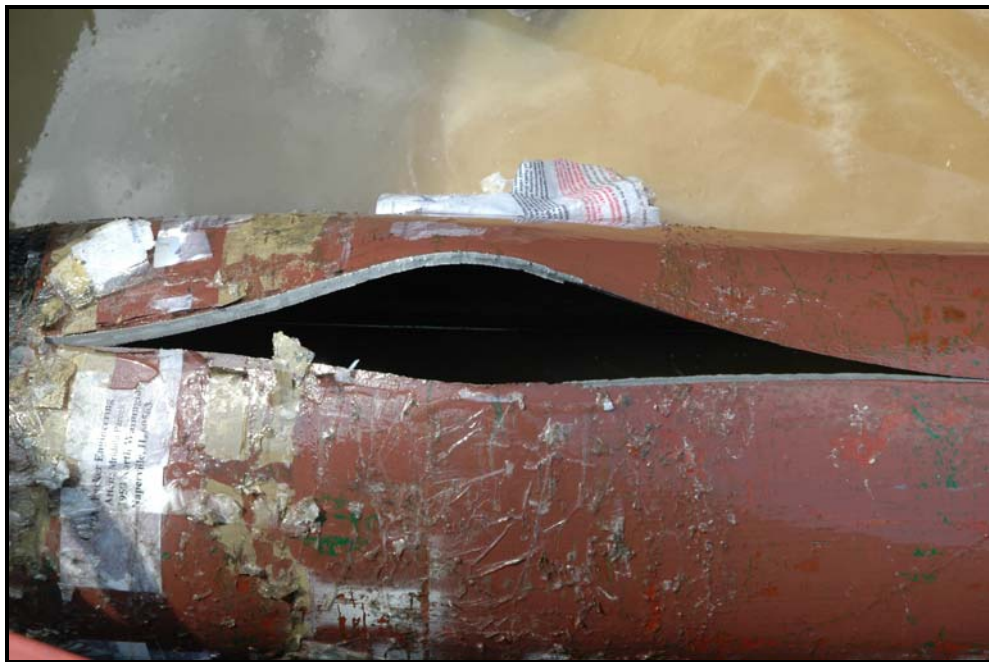
The cylinder was filled with hydraulic fluid and hydrostatically tested to failure. An air-over-water pump was used to apply the pressure to the cylinder. Pressure was measured using an Omegadyne Model PX91N0 pressure transducer, and was recorded using computerized data acquisition equipment at a rate of 5 samples per second. Care was taken to avoid air entrapment in the circuit. The test setup is as shown in Figures 6 to 9. The pressure data is shown in Figure 10. The cylinder reached a maximum pressure of 7,755 psi in about 13.71 min (13 min 42 sec) and failed after 14.18 min (14 min and 10 sec). The cylinder burst along the length of the cylinder. The failure location is as shown in Figures 11 and 12.

Figure 11: Ruptured cylinder after hydraulic burst testing.

Figure 12: Ruptured cylinder after hydraulic burst testing.

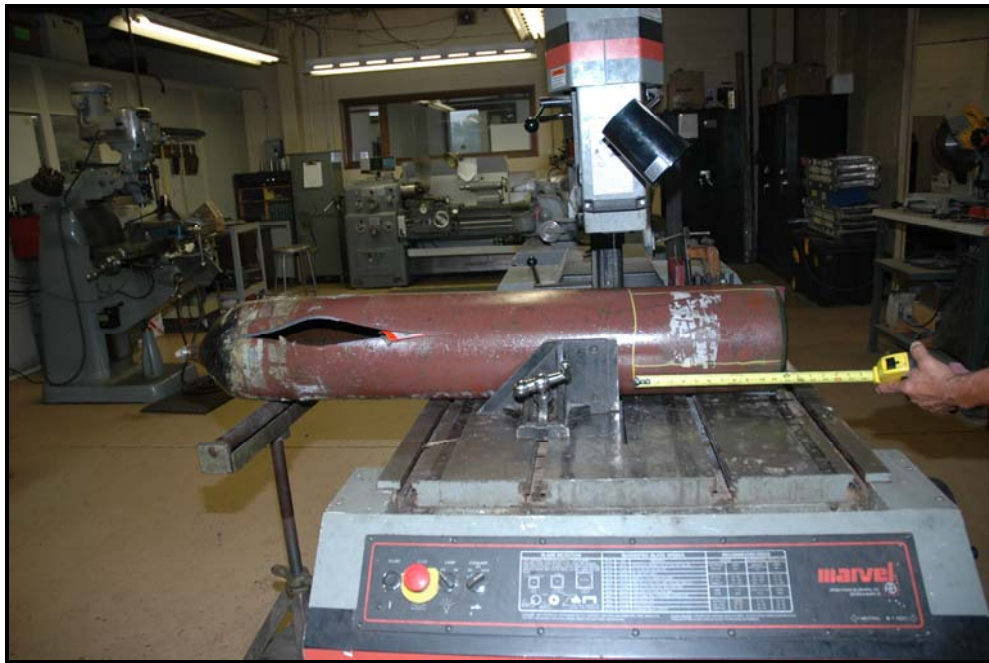
Tensile sample was obtained from the location as shown in Figure 13. The testing was performed in accordance with 49 CFR 178.37-K [1]. The results are as shown in Table III. The tensile properties of the subject DOT 3AA cylinder was compared to the mechanical property of 4130 steel at tempering temperatures of 1000 °F and 1200 °F [2]. Part 178.37 (g) (4) of 49 CFR indicates that the minimum tempering temperature may not be less than 1000 °F hence the tensile test results were compared to only the values listed at 1000 °F and above. As seen in the table the tensile properties of the subject DOT 3AA meets the specifications of 4130 steel.

Figure 13: Location from which the samples were cut for mechanical property evaluation.
