[Docket No. 2003-NM-209-AD; Amendment 39-13353; AD 2003-19-51]

Airworthiness Directives; Bombardier Model CL-600-2C10 (Regional Jet Series 700 & 701) and CL-600-2D24 (Regional Jet Series 900) Series Airplanes

2003-19-51 Bombardier, Inc. (Formerly Canadair): Amendment 39-13353. Docket 2003-NM-209-AD.

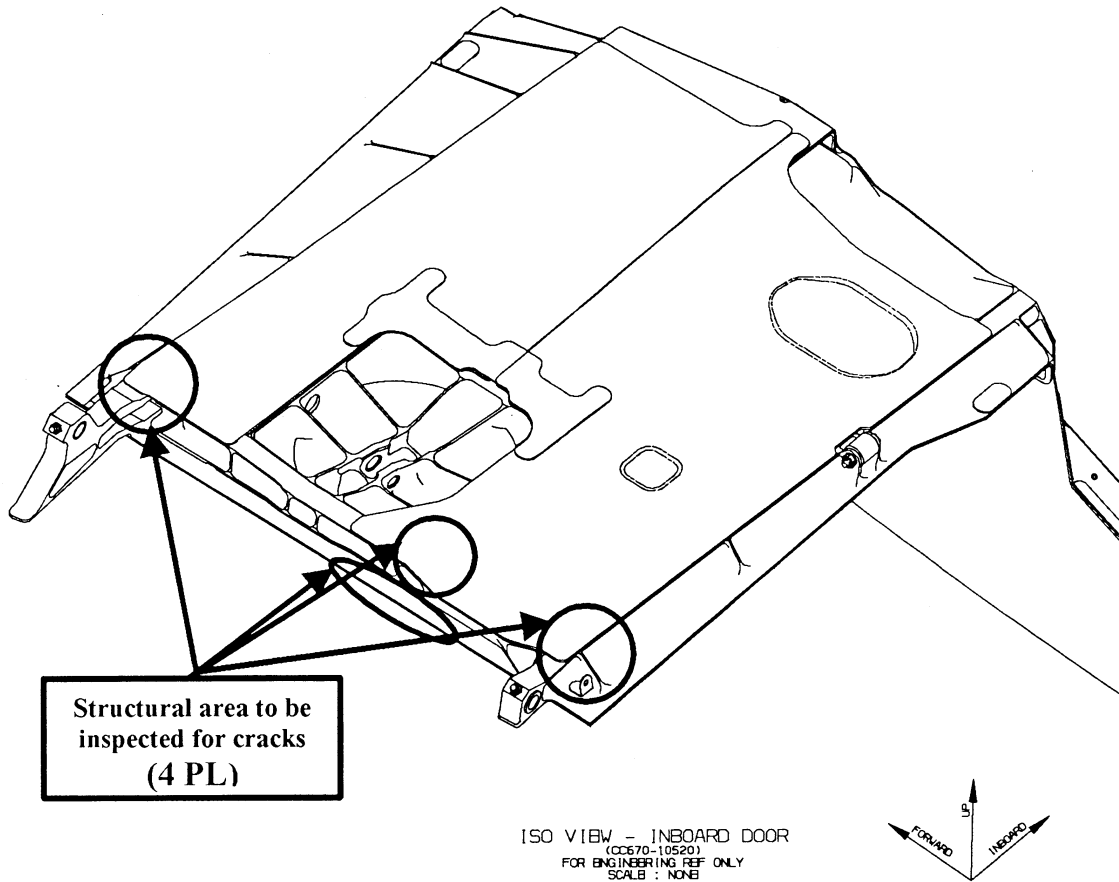
Figure 1
LH side shown
RH side opposite

(b) Perform detailed inspections of the lower panel, P/N CC670-10520, of the left- and right-hand MLG doors for the conditions and in the areas specified in paragraphs (b)(1), (b)(2), (b)(3), and (b)(4) of this AD; and Figures 1, 2, and 3 of this AD.

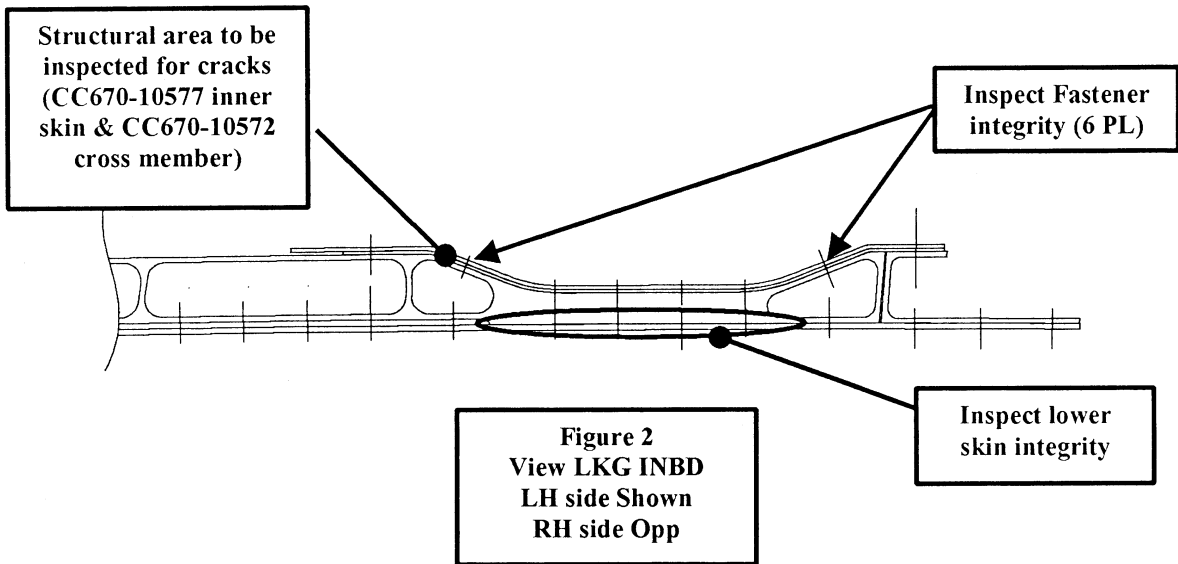
(1) Inspect the cross member, part number (P/N) CC670-10572, of the MLG door lower panel for cracking or deformation, in accordance with Figure 2 of this AD.

(2) Inspect the inner skin, P/N CC670-10577, of the MLG door lower panel at the cross member (P/N CC670-10572) for cracking or deformation, or pulled or missing fasteners, in accordance with Figure 2 of this AD.

(3) Inspect the outer skin, P/N CC670-10574, of the MLG door lower panel at the cross member (P/N CC670-10572) for cracking or deformation, or pulled or missing fasteners, in accordance with Figure 2 of this AD.

(d) If any cracking or deformation, or pulled or missing fastener, as applicable, is found during any inspection in accordance with paragraph (b) or (c) of this AD: Before further flight, accomplish paragraph (d)(1), (d)(2), or (d)(3) of this AD.

(1) Repair the damage in accordance with a method approved by either the Manager, New York Aircraft Certification Office (ACO), FAA; or Transport Canada Civil Aviation (or its delegated agent); and accomplish repetitive inspections in accordance with a method and at a repetitive interval approved by same.

(2) Replace the lower panel assembly, P/N CC670-10520, of the affected MLG door with a new or serviceable lower panel assembly having the same P/N, in accordance with Task Cards 32-12-01-000-801-A01 and 32-12-01-400-801-A01 of the CRJ 700/900 Series Regional Jet Aircraft Maintenance Manual; and repeat the inspections specified in paragraph (b) of this AD at intervals not to exceed 100 flight cycles.

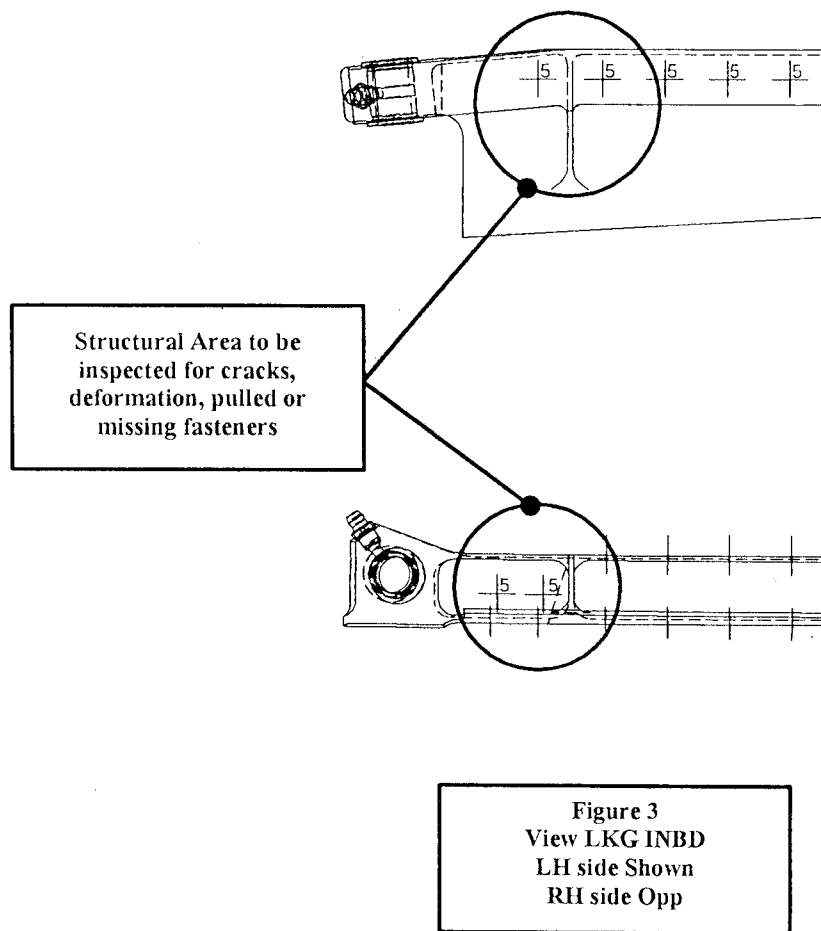
(4) Inspect the forward member, P/N CC670-10570, and aft member, P/N CC670-10571, of the MLG door lower panel, for cracking or deformation, or pulled or missing fasteners, in accordance with Figure 3 of this AD. Figures 1 through 3 of this AD follow.
