[Docket No. 2003-SW-02-AD]

#### Airworthiness Directives; Eurocopter France Model AS350B, B1, B2, B3, BA, and D Helicopters

**ACTION:** Notice of proposed rulemaking (NPRM).

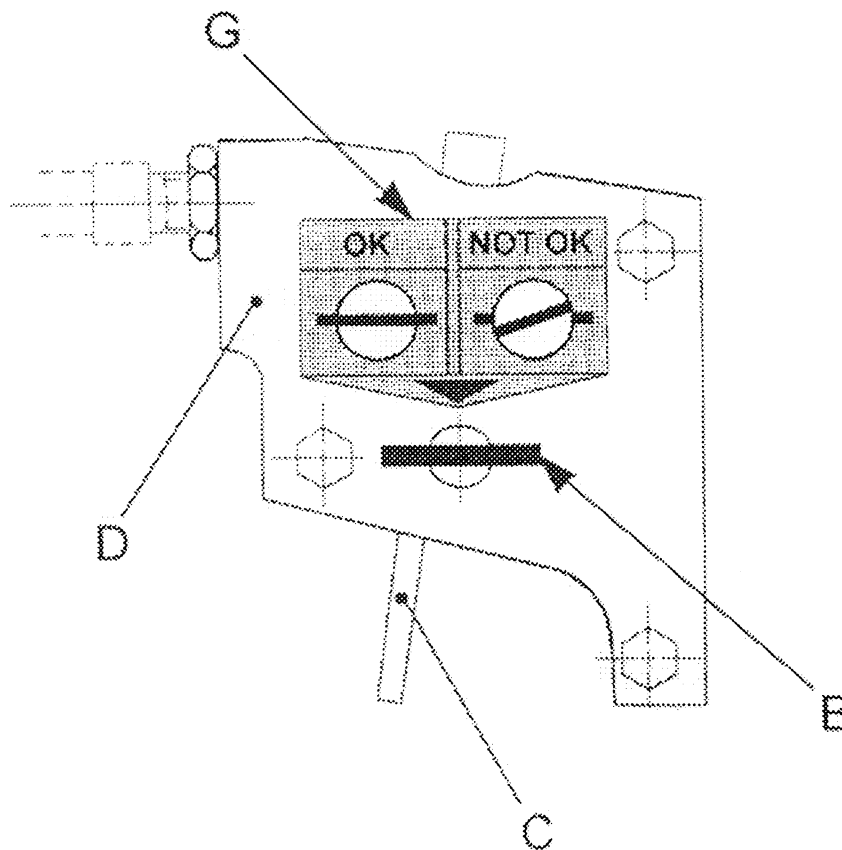
Figure 1

(3) Determine whether the section of reference line (B) marked on the bolt (A) and the section of reference line (B) marked on the cover plate (D) form a straight line.

(i) If the reference line is straight, the cargo hook is considered airworthy.

(ii) If the reference line is not straight, the cargo hook is unairworthy and may not be used.
