[Docket No. 2003-NE-52-AD Amendment 39-13410; AD 2003-24-12R1]

Airworthiness Directives; Pratt & Whitney JT9D-3A, -7, -7A, -7F, -7H, -7AH, and -7J Turbofan Engines**AGENCY:** Federal Aviation Administration (FAA), DOT.**ACTION:** Final rule; request for comments.

2003-24-12R1 Pratt & Whitney:

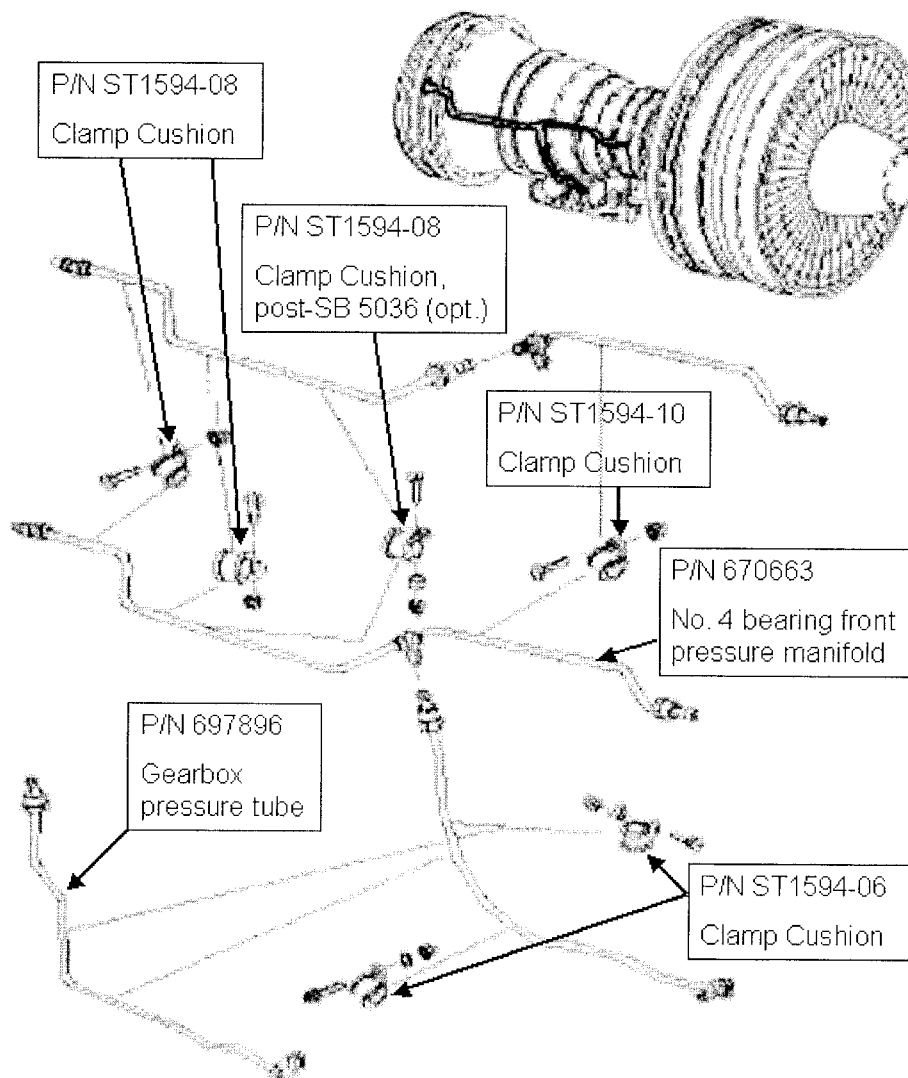
(f) Visually inspect the clamp assemblies, P/Ns ST1594-06, ST1594-08, and ST1594-10, (see Figure 1 of this AD) that attach the gearbox pressure tube and the No. 4 bearing front pressure manifold to the engine. Replace clamp assemblies before further flight that are rejected by any of the following rejection criteria:

(1) Cracks, wear, or distortion in clamp metal.

(2) Clamp cushions that are worn, compacted, cracked, coming apart in chunks, deteriorated, or missing. A reddish powder found around the clamp is an indication of deterioration.

(g) If one or more clamp assemblies are rejected as described in paragraph (f) of this AD, or out of position or missing (see Figure 1 of this AD), clean any debris and oil from the outer surface of the gearbox pressure tube and No. 4 bearing front pressure manifold and visually inspect the tube and manifold. Repair or replace the affected tube or manifold before further flight if it is rejected by any of the following rejection criteria:

- (1) Nicks, chafing, scratches, and or pitting 0.003 inch or greater in depth.
- (2) Dents within 0.25 inch of the ferrules or will not permit free passage of a ball having a minimum diameter of 80% of the tubing inner diameter.
- (3) Corrosion that is unable to be removed by a light polishing.
- (4) Tube or manifold is leaking oil.

(h) Ensure that the gearbox pressure tube, No. 4 bearing front pressure manifold, and clamp assemblies are properly positioned, before further flight, as shown in Figure 1 of this AD.
