[Docket No. FAA-2004-18744; Directorate Identifier 2004-CE-24-AD; Amendment 39-13910; AD 2004-25-22]

Airworthiness Directives; Great Lakes Aircraft Company, LLC, Models 2T-1A-1 and 2T-1A-2 Airplanes

2004-25-22 Great Lakes Aircraft

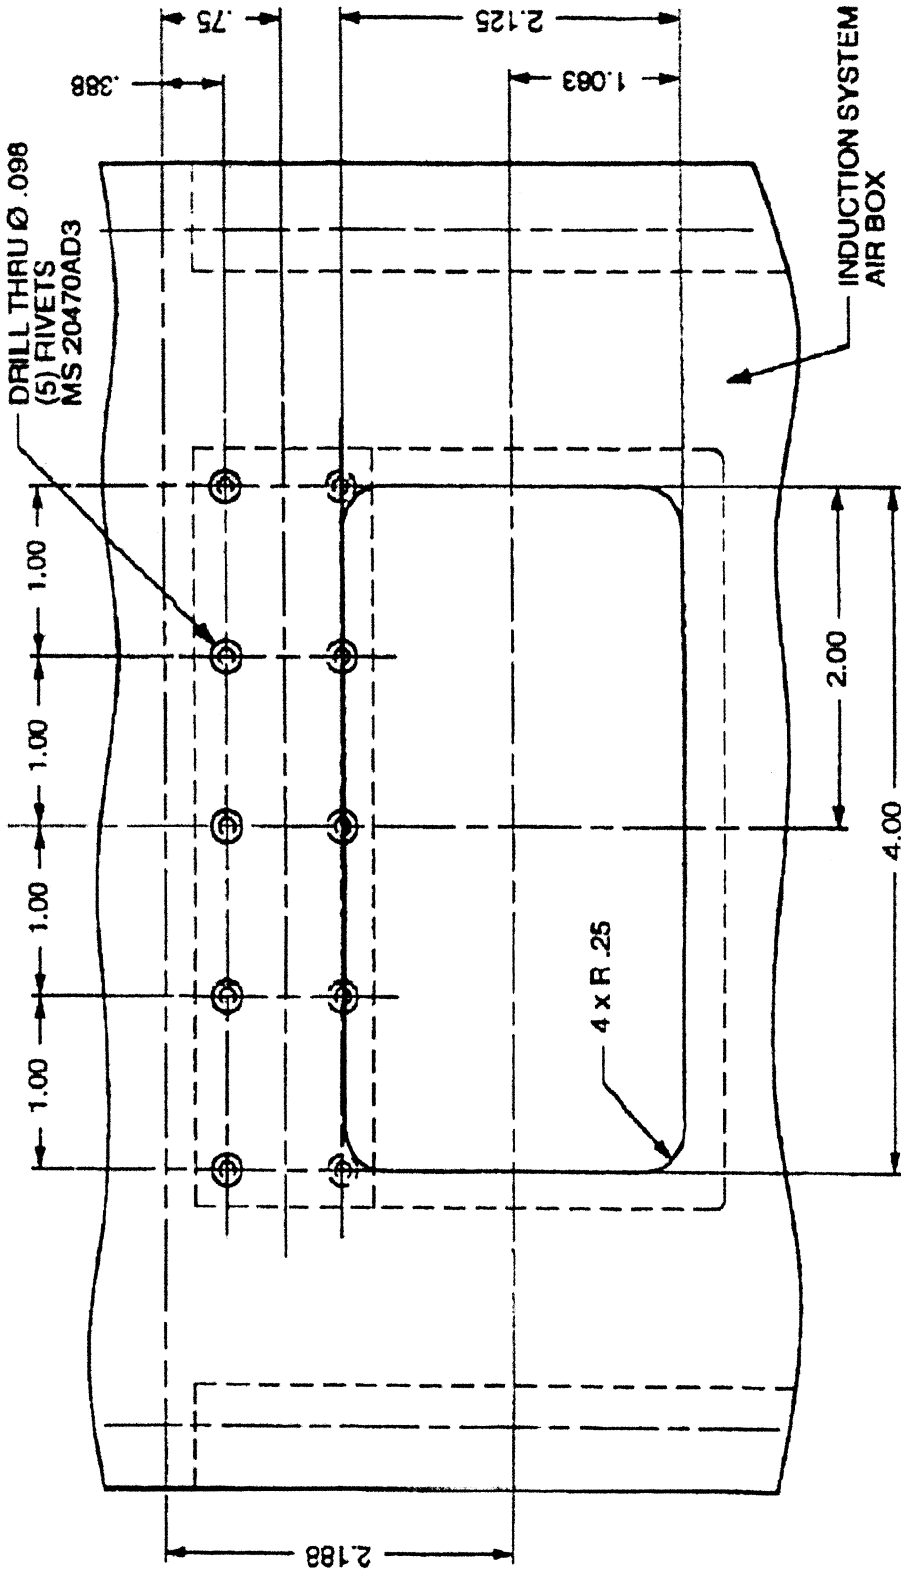
Figure 1

GREAT LAKES AIRCRAFT, TYPES 2T-1A-1 AND 2T-1A-2
ENGINE INDUCTION SYSTEM AD 79-20-08
ALTERNATE AIR DOOR INSTALLATION
FULL SCALE

Actions	Compliance	Procedures
(2) Visually inspect the alternate air door for distortion, heat damage, and cracks. If any damage is found, repair or fabricate a new door following Figure 1, Figure 2, and Figure 3 in this AD.	<i>For airplanes previously affected by AD 79-20-08:</i> Initially inspect at the next scheduled inspection required by AD 79-20-08 or within the next 25 hours TIS after January 28, 2005 (the effective date of this AD), whichever occurs later. Repetitively inspect thereafter at intervals not to exceed 100 hours TIS. <i>For airplanes not previously affected by AD 79-20-08:</i> Inspect within the next 25 hours TIS after January 28, 2005 (the effective date of this AD). Repetitively inspect thereafter at intervals not to exceed 100 hours TIS. <i>For all affected airplanes:</i> After each inspection, if damage is found during any inspection, before further flight, repair, replace the damaged alternate air door.	Not applicable.

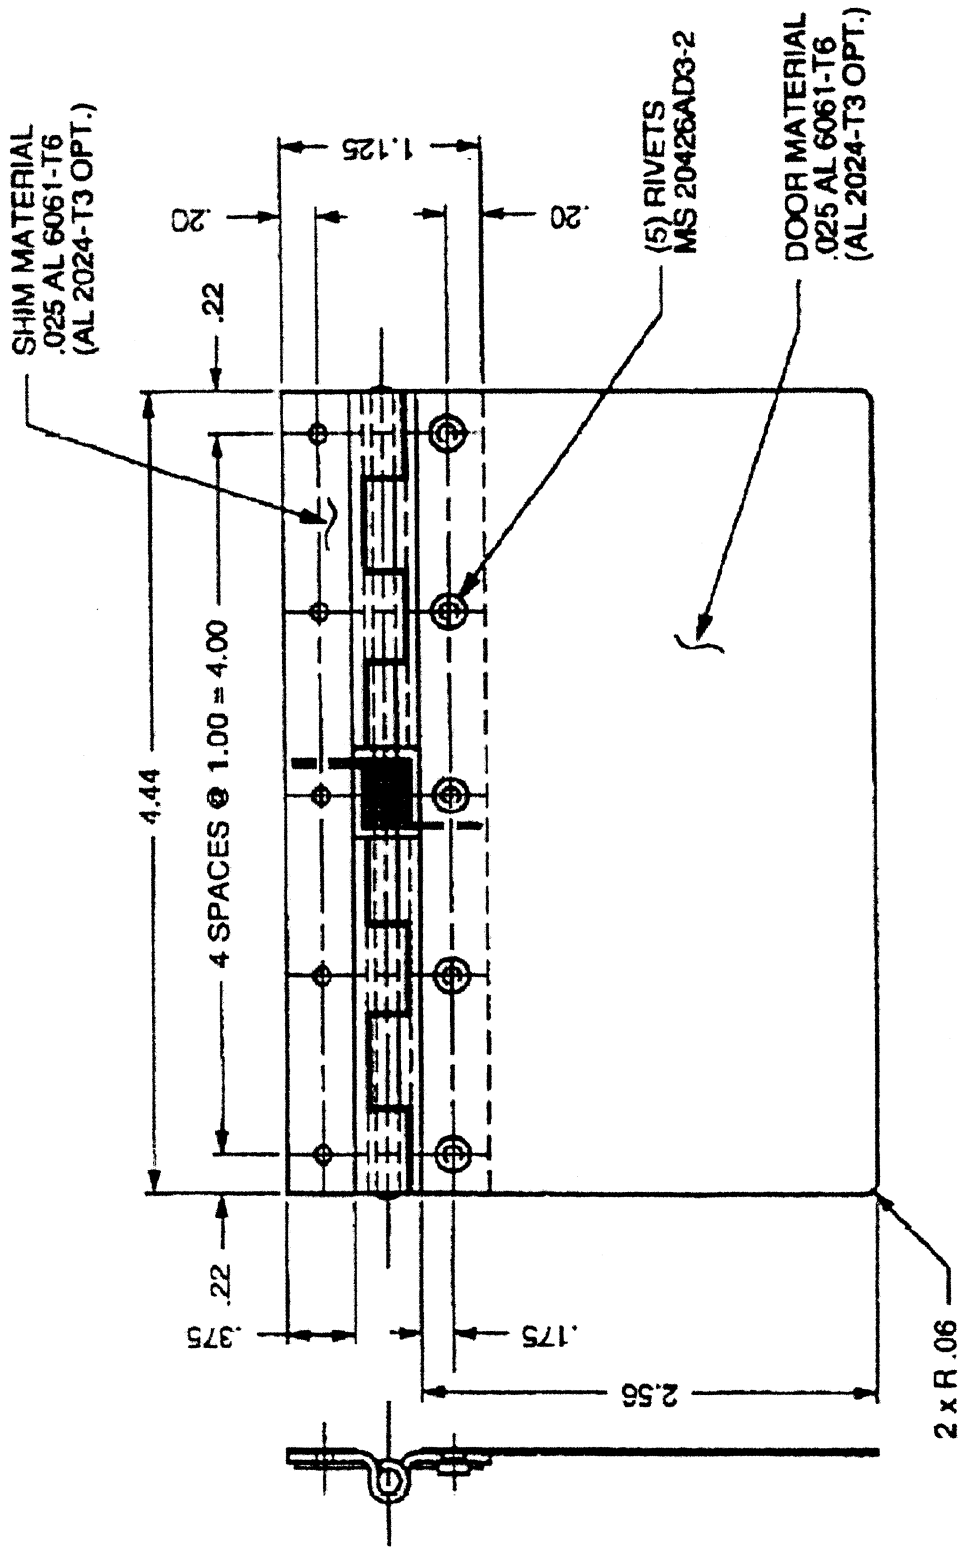
Figure 2

GREAT LAKES AIRCRAFT, TYPES 2T-1A-1 AND 2T-1A-2
ENGINE INDUCTION SYSTEM AD 79-20-08
ALTERNATE AIR DOOR FABRICATION DETAIL
FULL SCALE
