RP950170

It has been determined that these 16.5" 1993 Raleigh MT 400 bicycle frames (300 total) may be susceptible to cracking at the headlug. This potential headlug cracking, during riding, could possibly lead to serious injury and/or death.

Subject: Failure Analysis of a Forged Aluminum Bicycle Head Lug

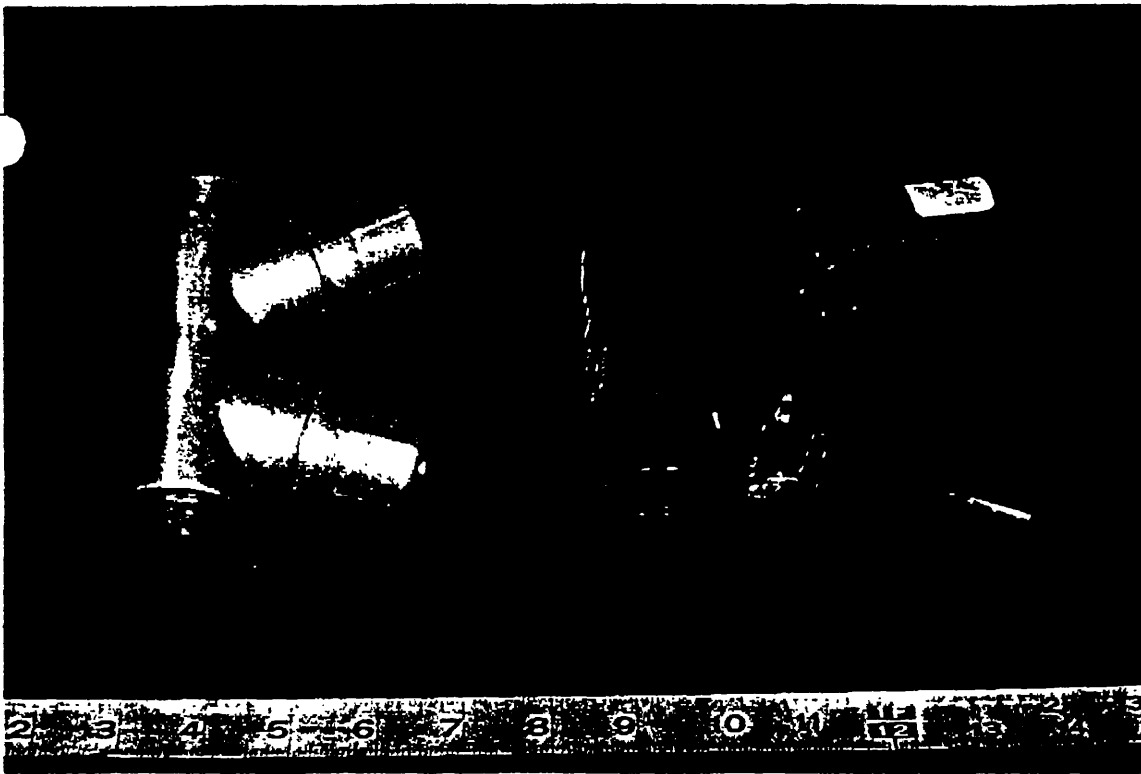
1. The upper tubing of the fractured head lug was precracked at the time of final separation, i.e., grey deposits were noticed on the fracture face.
2. The failure of the tubing occurred in a brittle fashion without any plastic deformation. This is unusual since the material will normally exhibit considerable plastic deformation prior to failure.
3. One section was removed from each head lug (A and B) and subsequently prepared for a tensile test. However during the machining of the tensile specimen (lug A) brittle fracture of the material occurred.

Fig. 1: The two submitted head lugs (A - fractured and B - new) are shown.

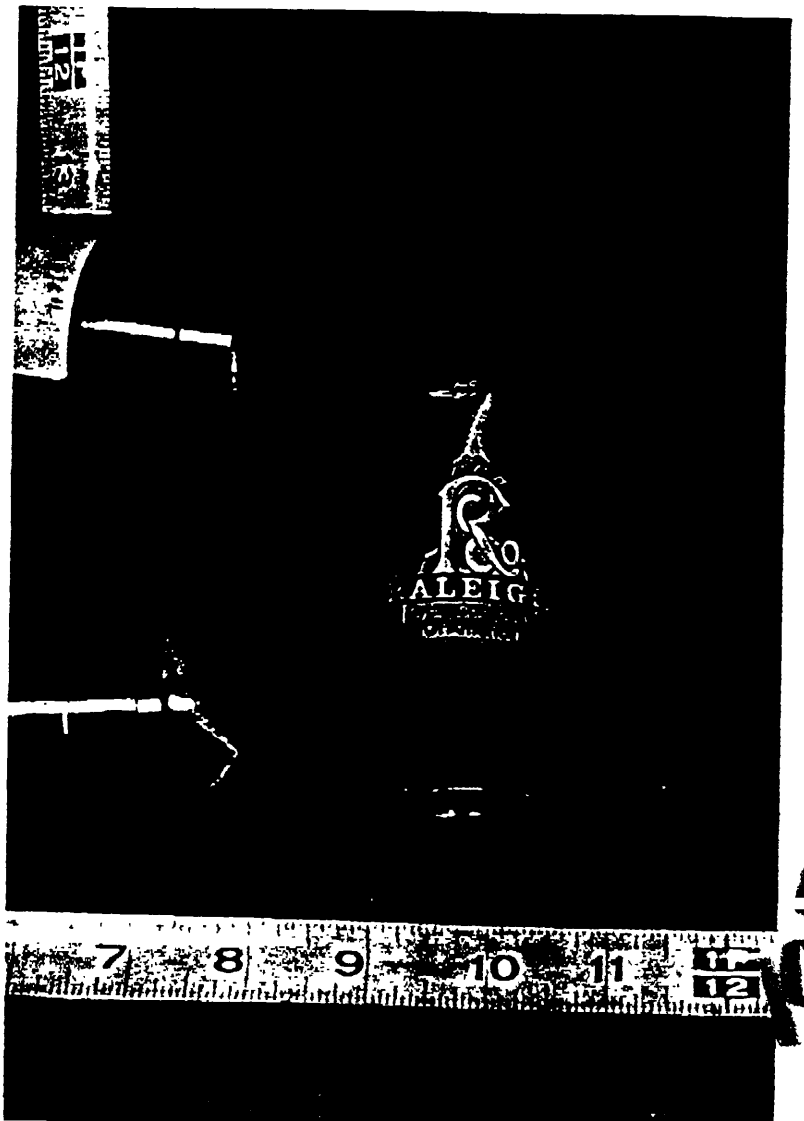
Fig. 4:
Same as Fig. 3, but the tube is
viewed from the front.

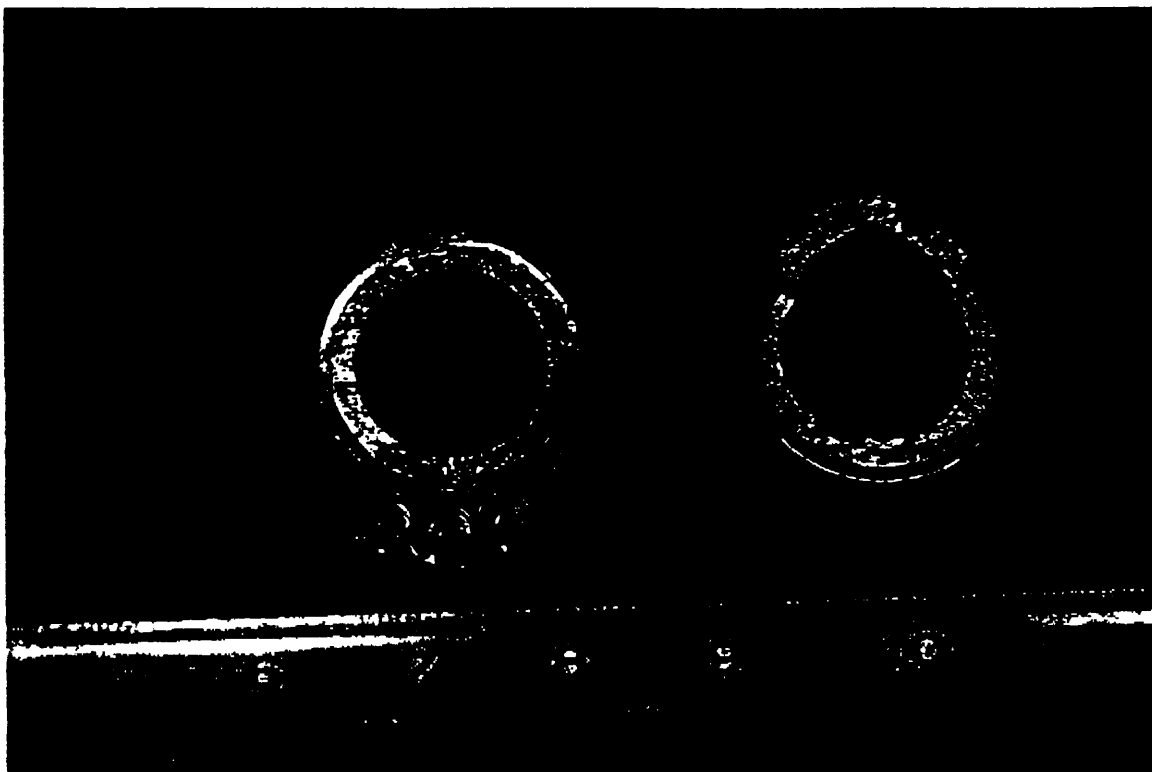
Fig. 6: The two fracture faces (upper and lower tubing) are shown.

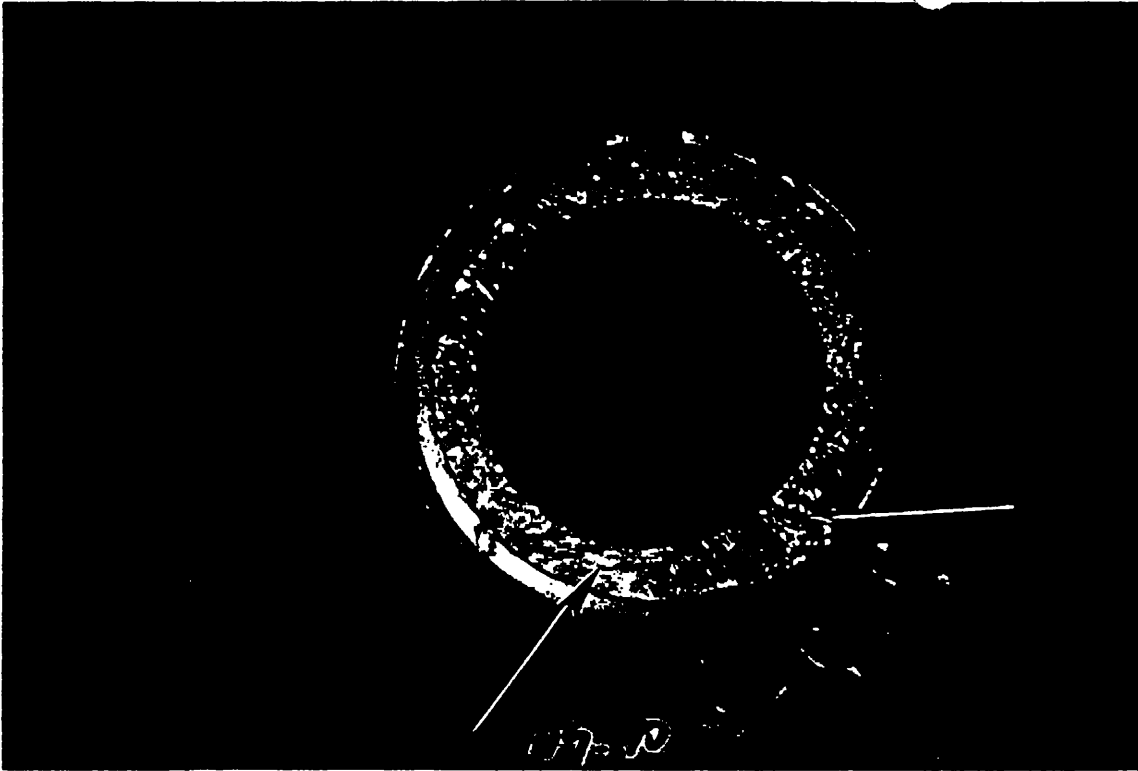
Fig. 7: The fracture face (upper tubing) is shown in greater detail. Please note, the majority of the fracture face was covered with foreign debris (dirt, see thin arrow) indicating the tube was precracked at the time of the accident. Thick arrow points to the area of final break (new, fresh break). Arrows with numbers refer to close up shots.

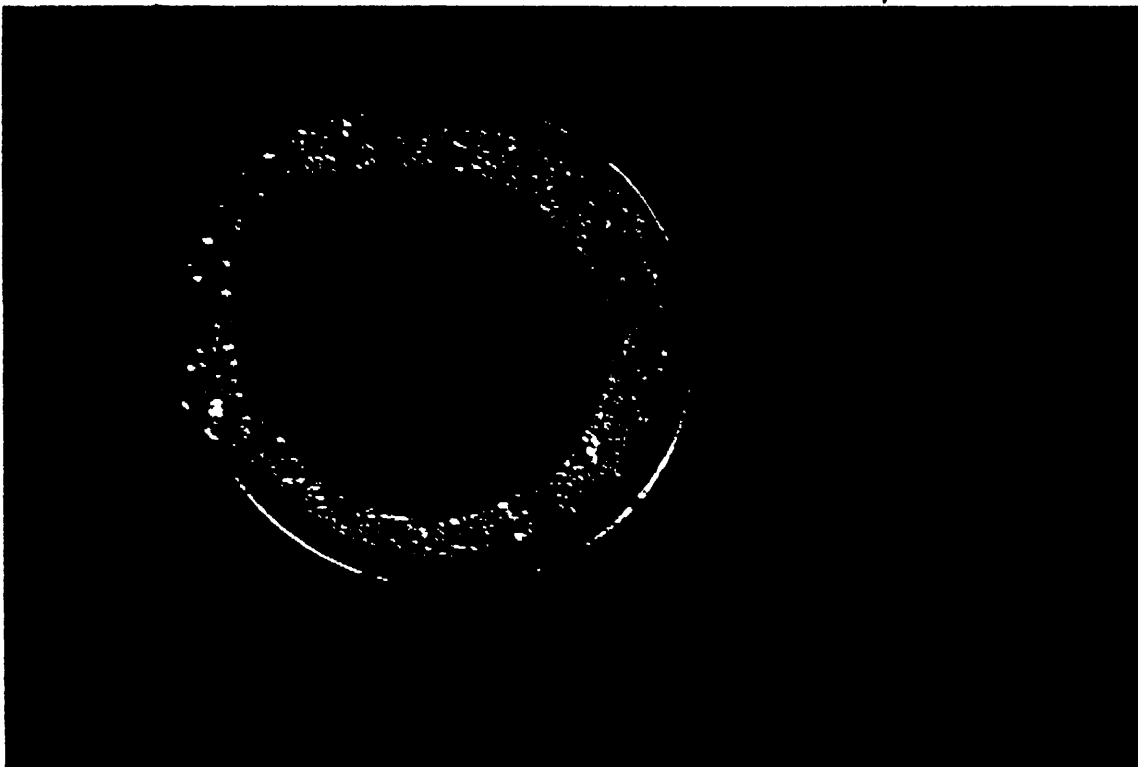
Fig. 8: Same as Fig. 7, but the lower tubing is shown.

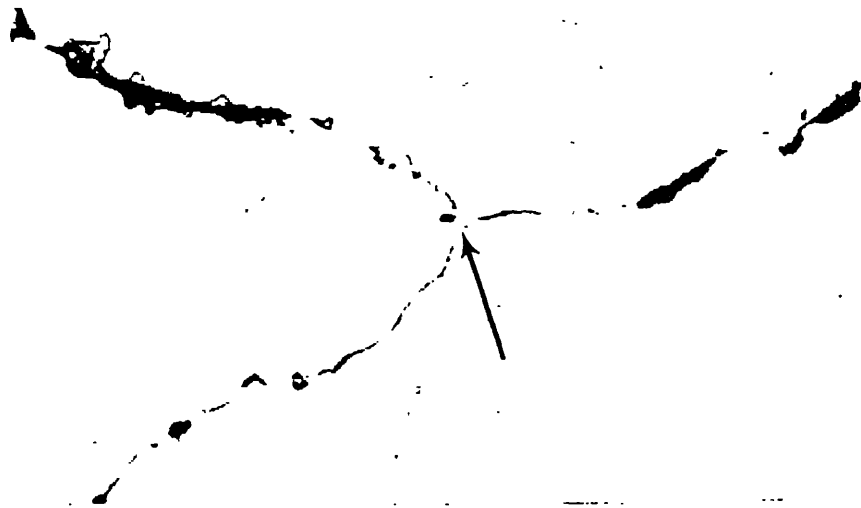
Fig. 13: Close up of Fig. 12 shows a triple grain boundary point. Arrow points to a grey grain boundary deposit. Magnification 400x.

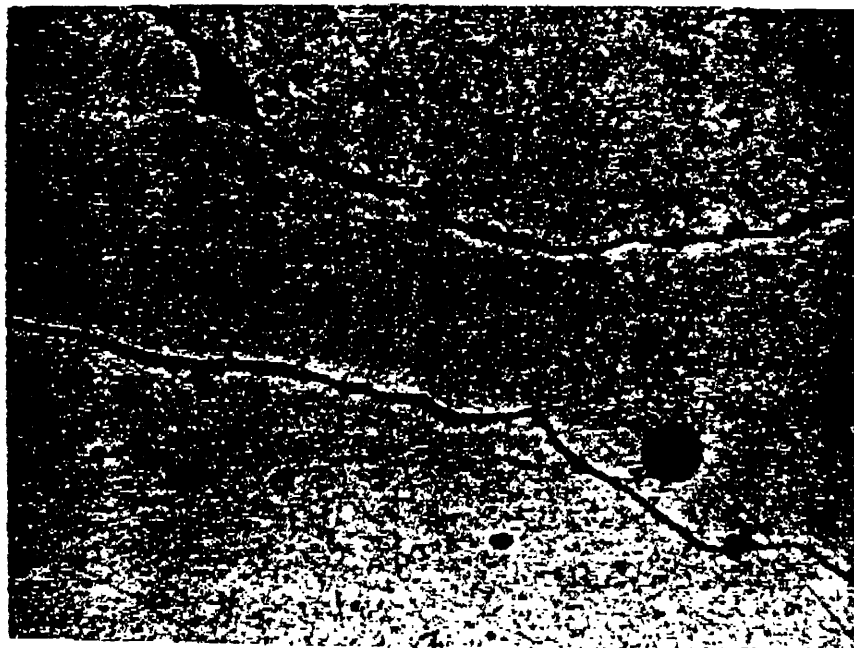
Fig. 14: Close up of Fig 12 at 1000x shows the grain boundary deposit in greater detail. This area should be examined in the SEM and the grain boundary composition determined. Sample was slightly etched.
