MEMORANDUM FOR DCMA IRAQ

FROM: DCMAC-JSM, Mr. Paul W. Dickinson, [REDACTED] 1 February 2007

18 February 2007

SUBJECT: DCMA Iraq Safety Assessment

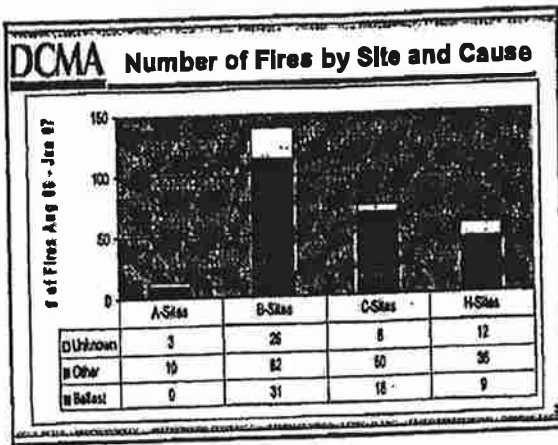
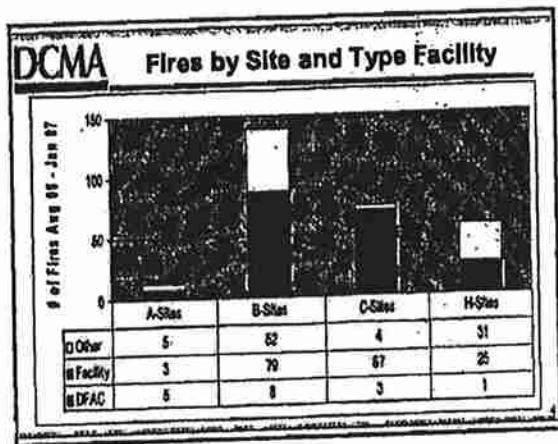
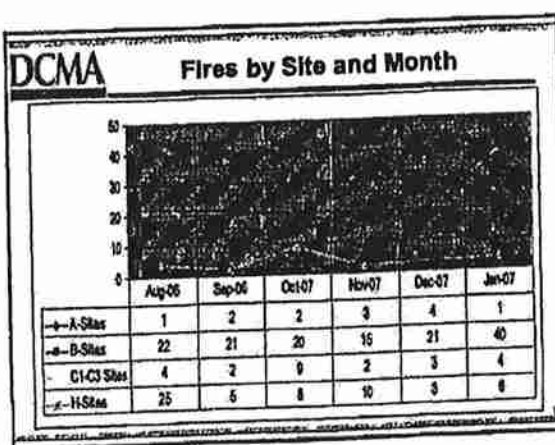
- I asked for data from the installation KBR safety/fire departments for August 06 - January 07.
- B-sites had the most fires at 139 (includes Al Asad and Fallujah); C-sites were next with 74; H-sites = 67; A-sites = 14
- Of the 17 DFAC fires reported through January, only 3 have undetermined/unknown causes. The rest were caused by electrical shorts or "failure to clean & maintain."
- Anaconda had no ballast fires, as they were the first camp to detect the overheat condition and install spacers.
- Overheating/faulty ballasts accounted for 22% and 23% of the fires at the B & C sites, respectively.
- While most of the facility fires were due to electrical shorts or overheating, there was no real trend. The cause of fires in some reports was just classified as "electrical."

- "Other" in the "Fire by Site and Type Facility" chart means a storage area, generator, vehicle, or grass fire.
- I did include vehicle fires in the total number, because some of them did have "human" causes.
- Sites C7-C8 did not provide the data by month, so I did not include them in the site-by-month chart.
- Al Asad did not provide reported fires for August, so I could only plot it for Sep-Jan in the site-by-month chart.
- Site data does not include the H-S DFAC fire on 5 Feb, or the DFAC (ilt-grill fire at Al Asad on 14 Feb. These fires are still under investigation. If you count the month of February (so far), we would have had 19 DFAC fires since August (almost 3 DFAC fires each month).
- The number of fires at the B-sites has gone down this month (so far).
