Analysis of Performance of the Inner Harbor Navigation Canal (IHNC)

Executive Summary

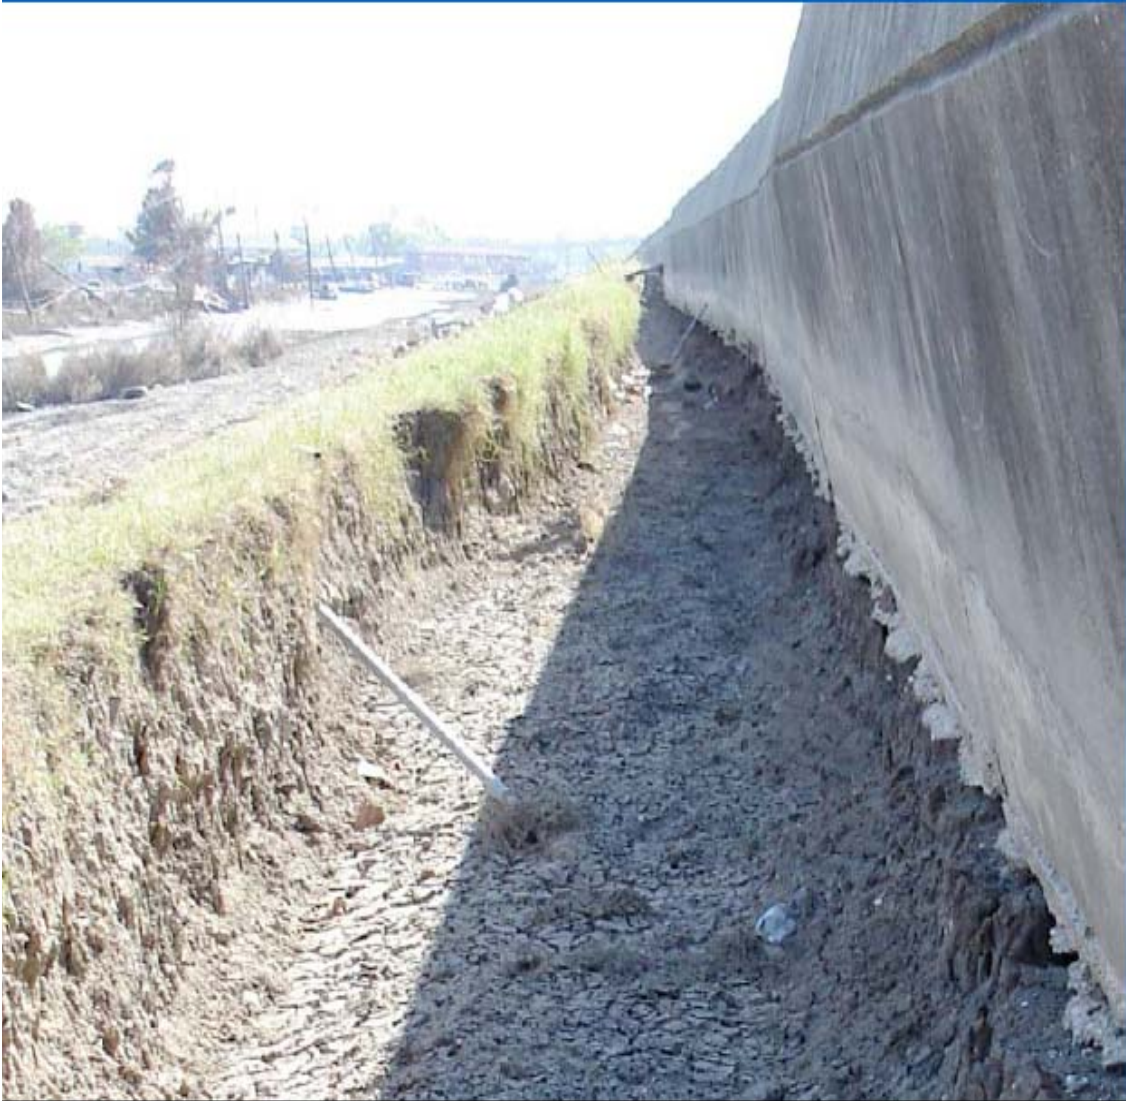
Initial observations after the hurricane revealed that overtopping had eroded at least one section of levee along the west bank and had eroded the soil adjacent to the wall on the protected side along the east and west bank. It appeared that water flowing over the floodwall scoured and eroded the levee on the protected side of the I-wall, exposing the supporting sheet piles and reducing the passive resistance (Figure 4). The erosion appeared to be so severe in the breach locations that the sheet piles may have lost all of their foundation support, resulting in failure (Figure 5). Perhaps the best evidence of this scour can be seen along the unbreached reaches of the east bank I-walls on the Inner Harbor Navigation Canal where U-shaped scour trenches could be found adjacent to the I-walls. As the scour increased, the I-wall may have moved laterally and leaned to the protected side, causing the scour trench to grow as the water began cascading farther down the slope until sufficient soil resistance was lost and the wall was carried landward.

Figure 4. Scour and erosion on the protected side of the IHNC adjacent to the 9th Ward in the vicinity of the south breach.

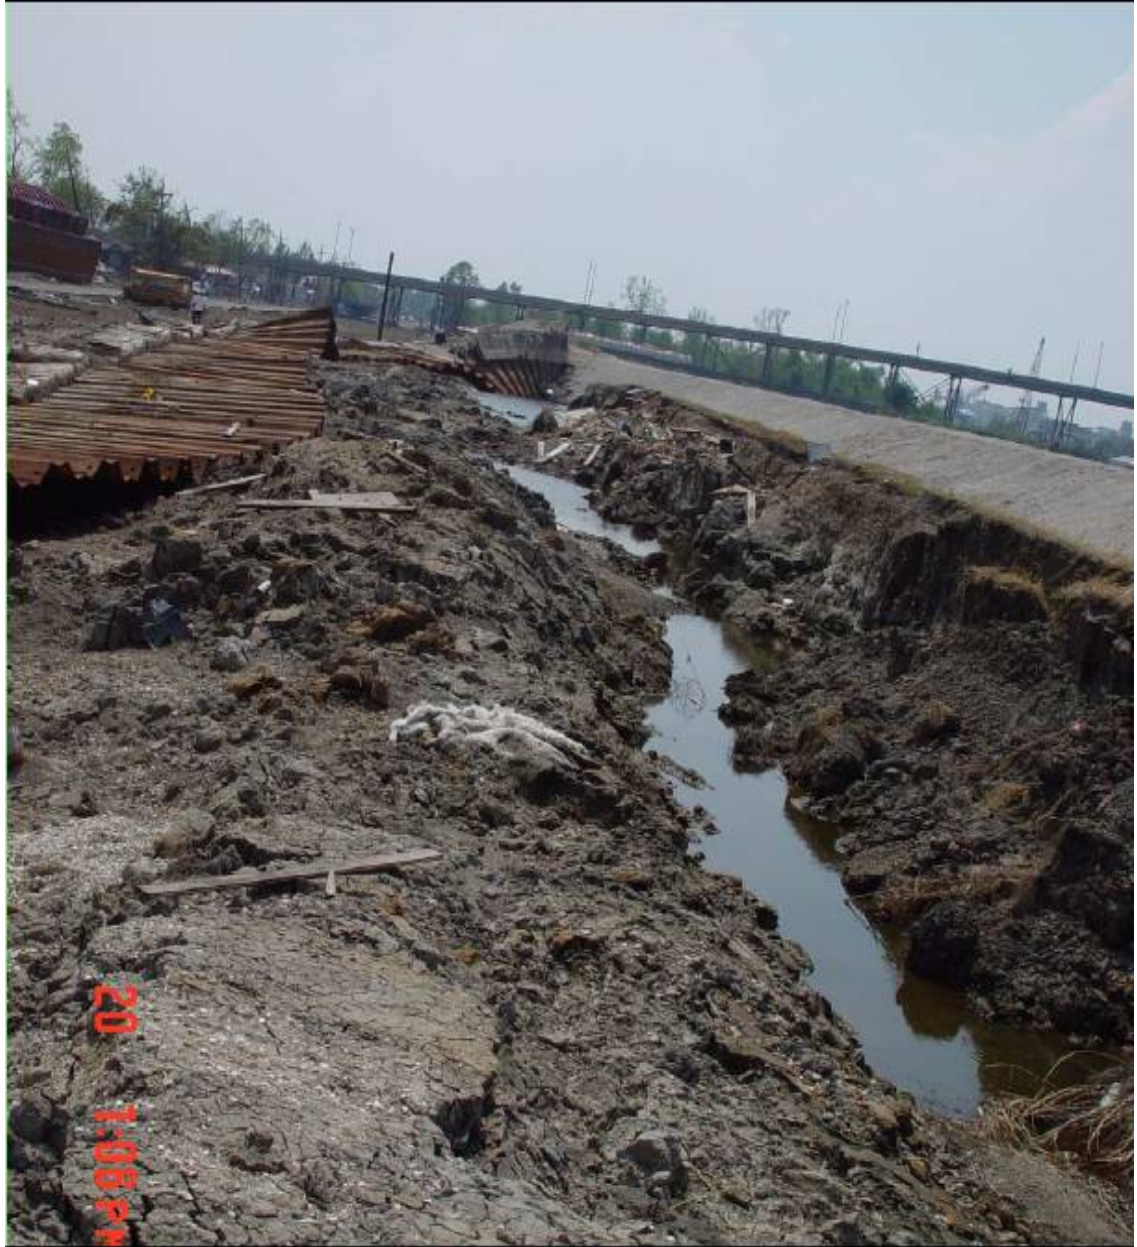
Figure 5. Scour and erosion leading to the failure of the I-wall on the IHNC adjacent the south breach (9th Ward).

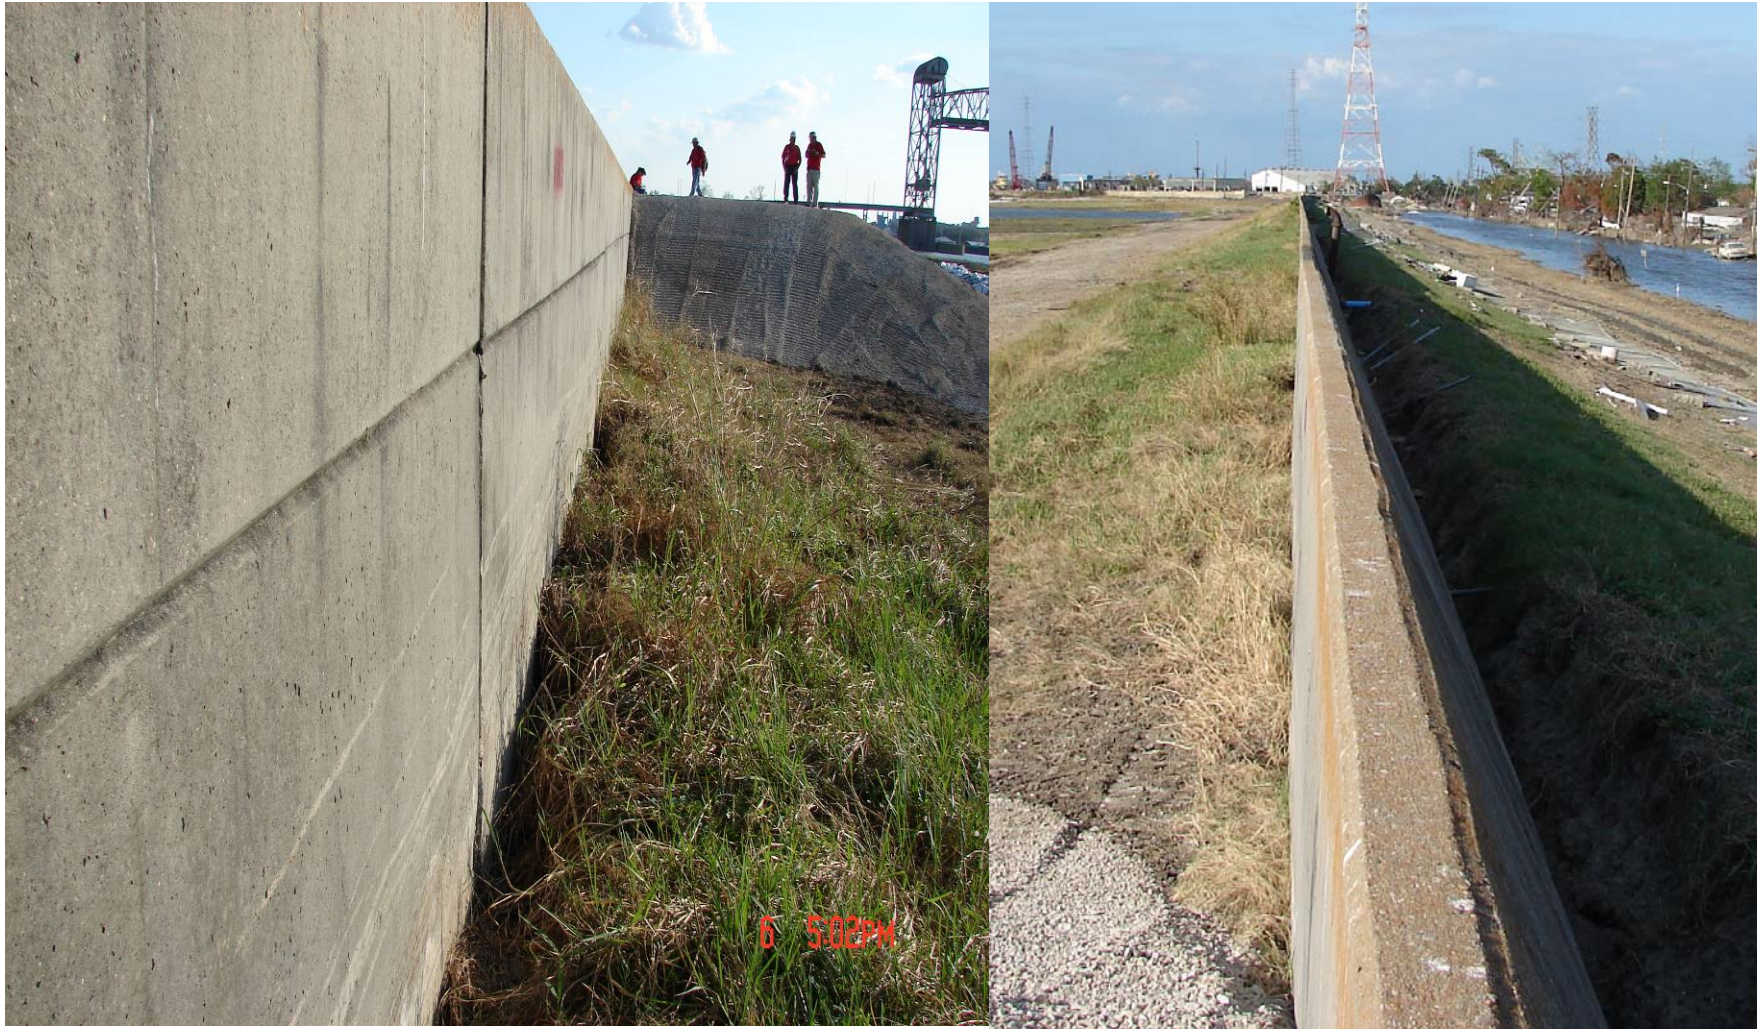
Formation of a crack on the canal side of the wall, allowing hydrostatic water pressure acting through the full depth of the crack, causes a very significant reduction in the value of the calculated factor of safety. Evidence that a crack did form behind the wall near the breaches can be seen in Figures 6 and 7.

Figure 6. IHNC East Bank – South Breach – Wall movement.

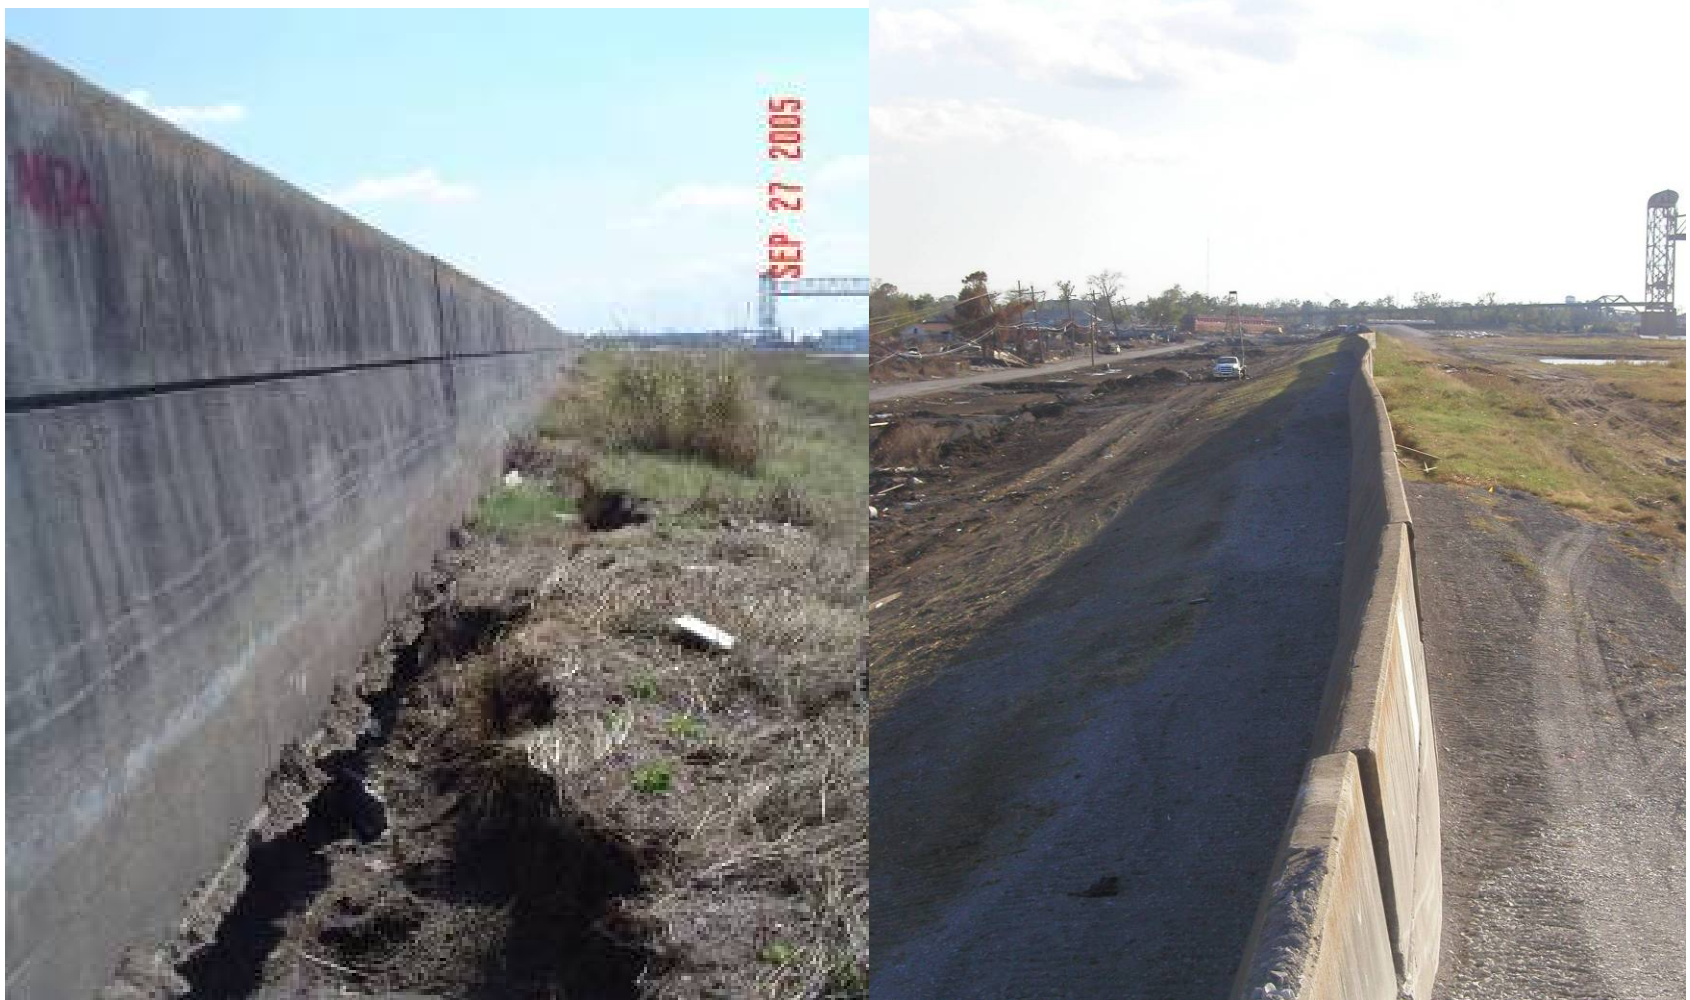
It is necessary to investigate the possibility of sliding instability to determine if the I-walls could breach as a result of shear through the foundation. The foundation conditions are similar to the 17th Street Canal. As shown in Figure 6, no significant wall movement was found in the wall sections adjacent the south breach. However, Figure 7 shows significant wall movement did occur in the wall sections adjacent to the north breach.

Figure 7. IHNC East Bank – North Breach – Wall movement (View looking south)

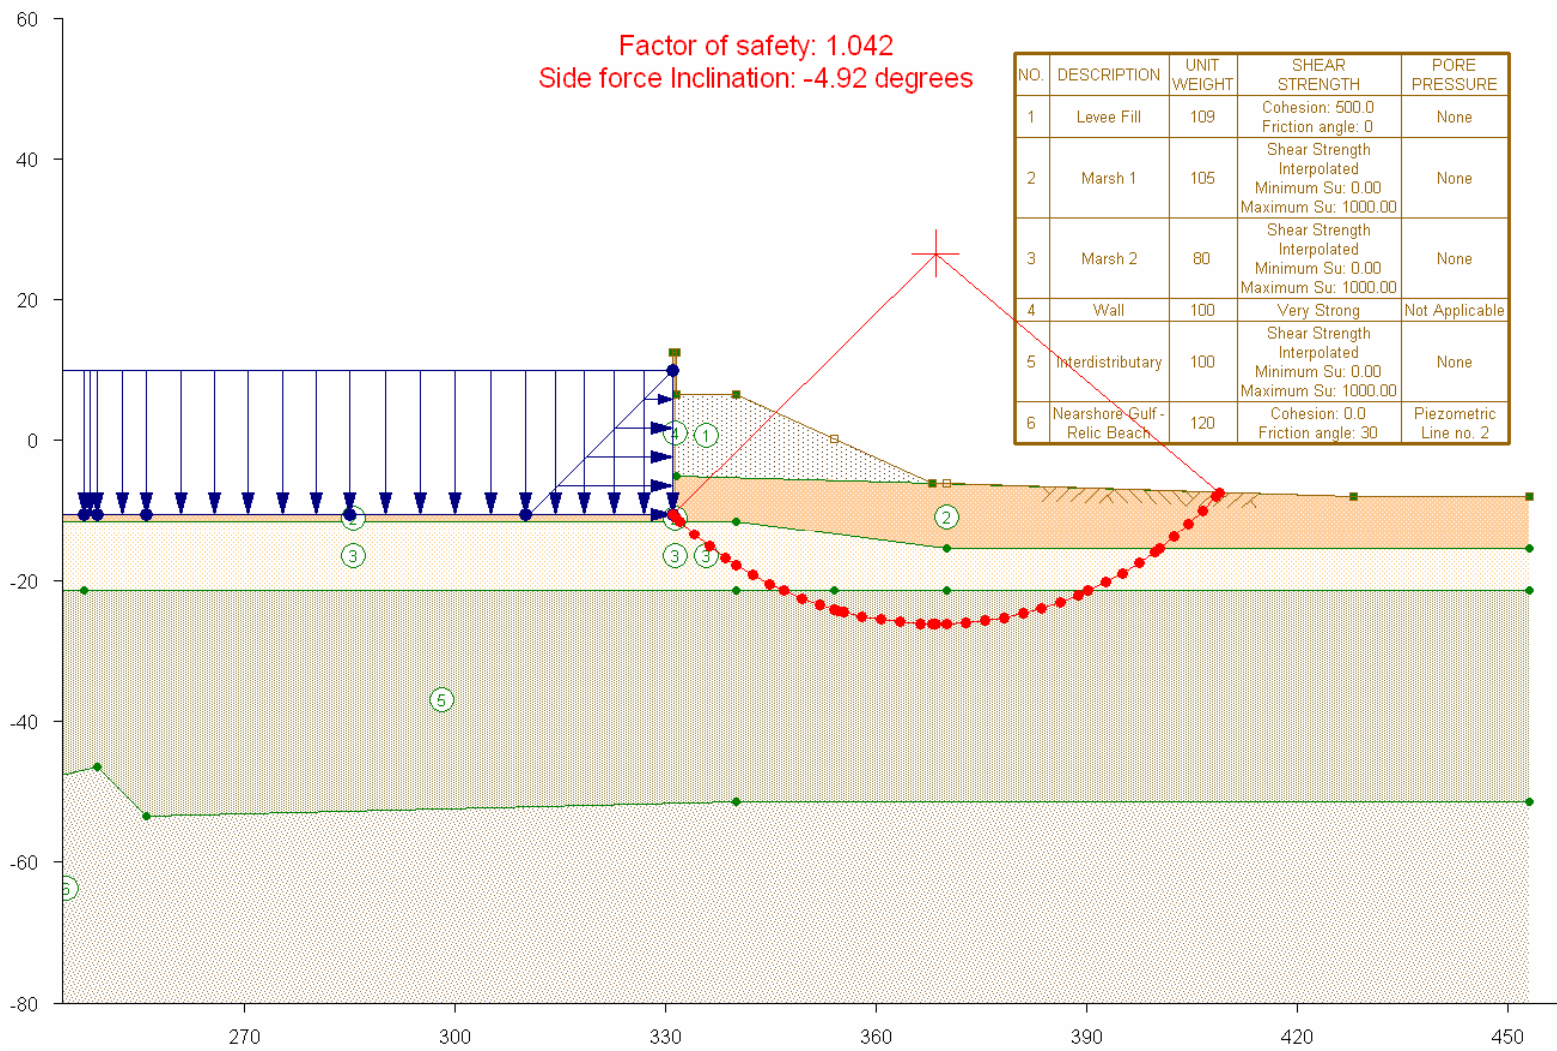
For the north breach (Station 55+00), with the canal water level at elevation 12.5 ft (top of the wall), the calculated factor of safety for the cracked condition is 0.96, as compared to 1.13 for the uncracked condition (Cases 5 and 5a). A canal water elevation of 11.2 ft produces a factor of safety of unity for the cracked condition (Case 4). Figures 20 through 25 show the critical circles from UTEXAS4 analyses for the north breach for Cases 1 through 5 and Case 5a.

Figure 20. IHNC – East Bank (North Breach), Case 1, Canal Water Level = 10.0 ft (NAVD 88), with Crack

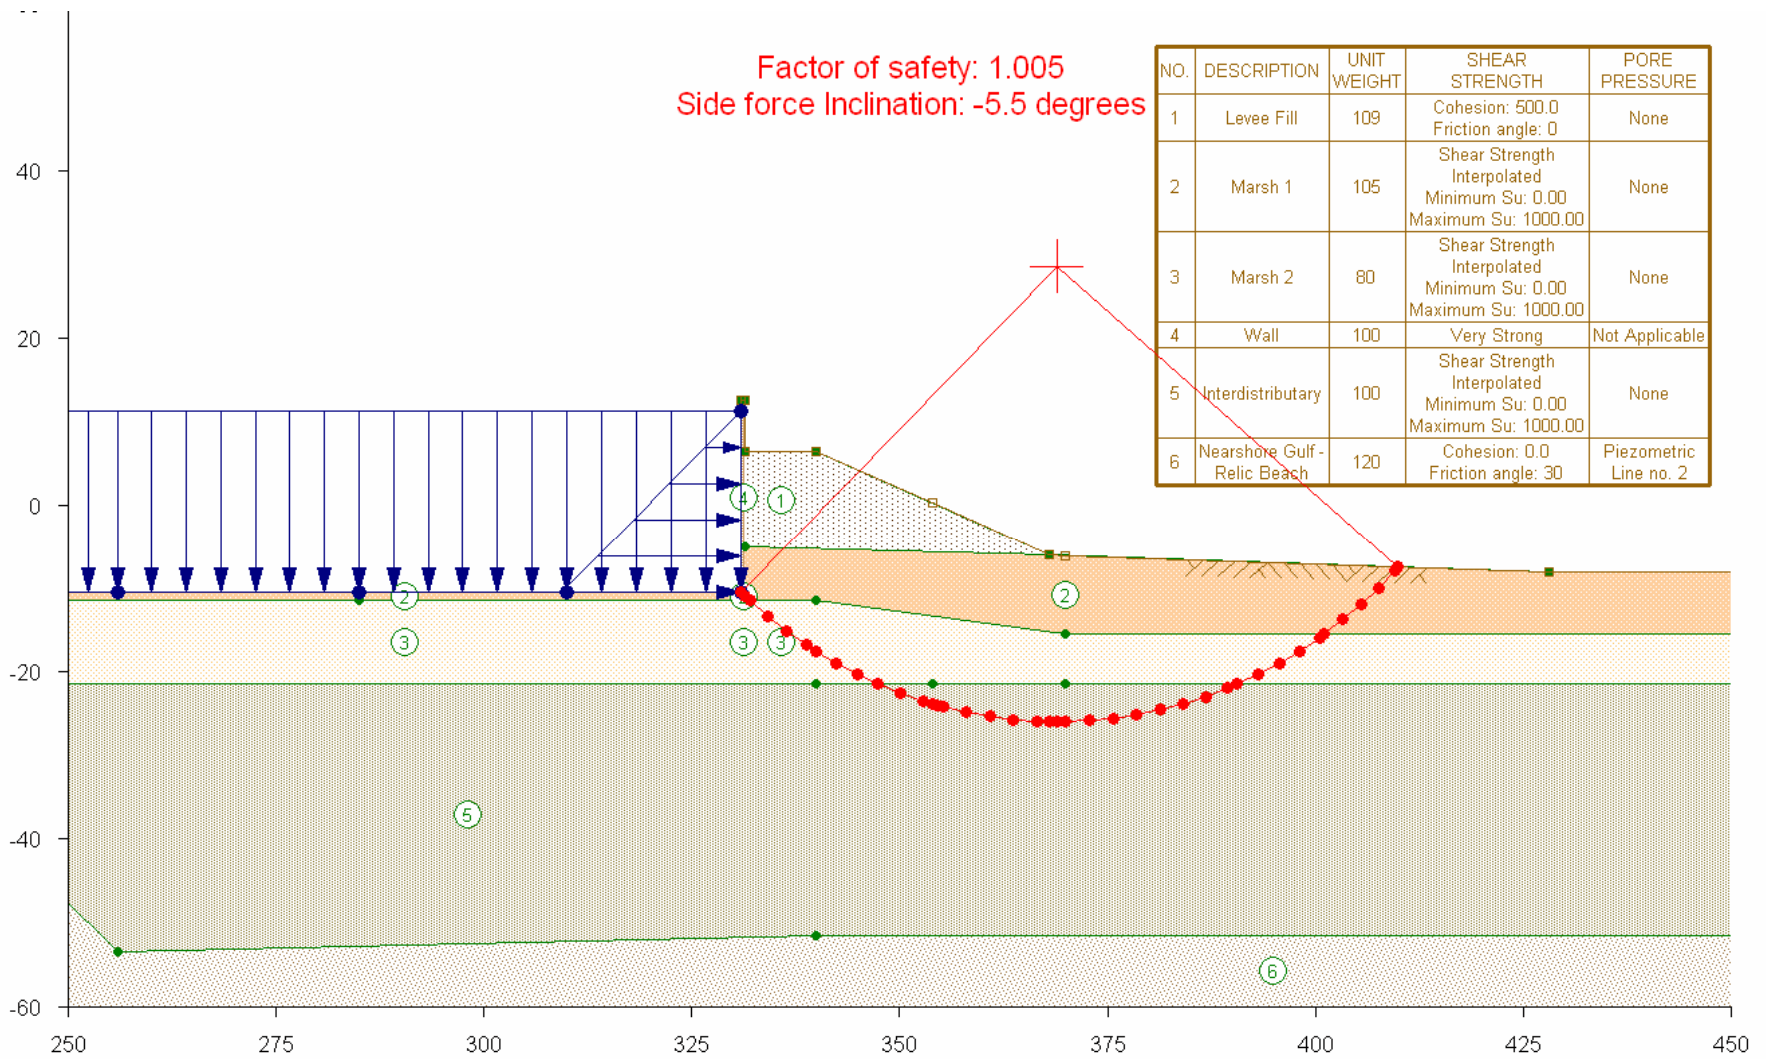
Stability analyses of the north breach on the east side resulted in a computed factor of safety equal to 1.0 with a crack on the canal side of the wall and water in the IHNC at elevation 11.2 ft. This is about 1.0 ft higher than the average IHNC water level at the time flood water was observed in the 9th Ward. Considering that the effective water level could have been one foot higher due to wave effects, this result is consistent with the observed IHNC water level when flood water was first reported in the 9th Ward.

Figure 23. IHNC – East Bank (North Breach), Case 4, Canal Water Level = 11.2 ft (NAVD 88), with Crack

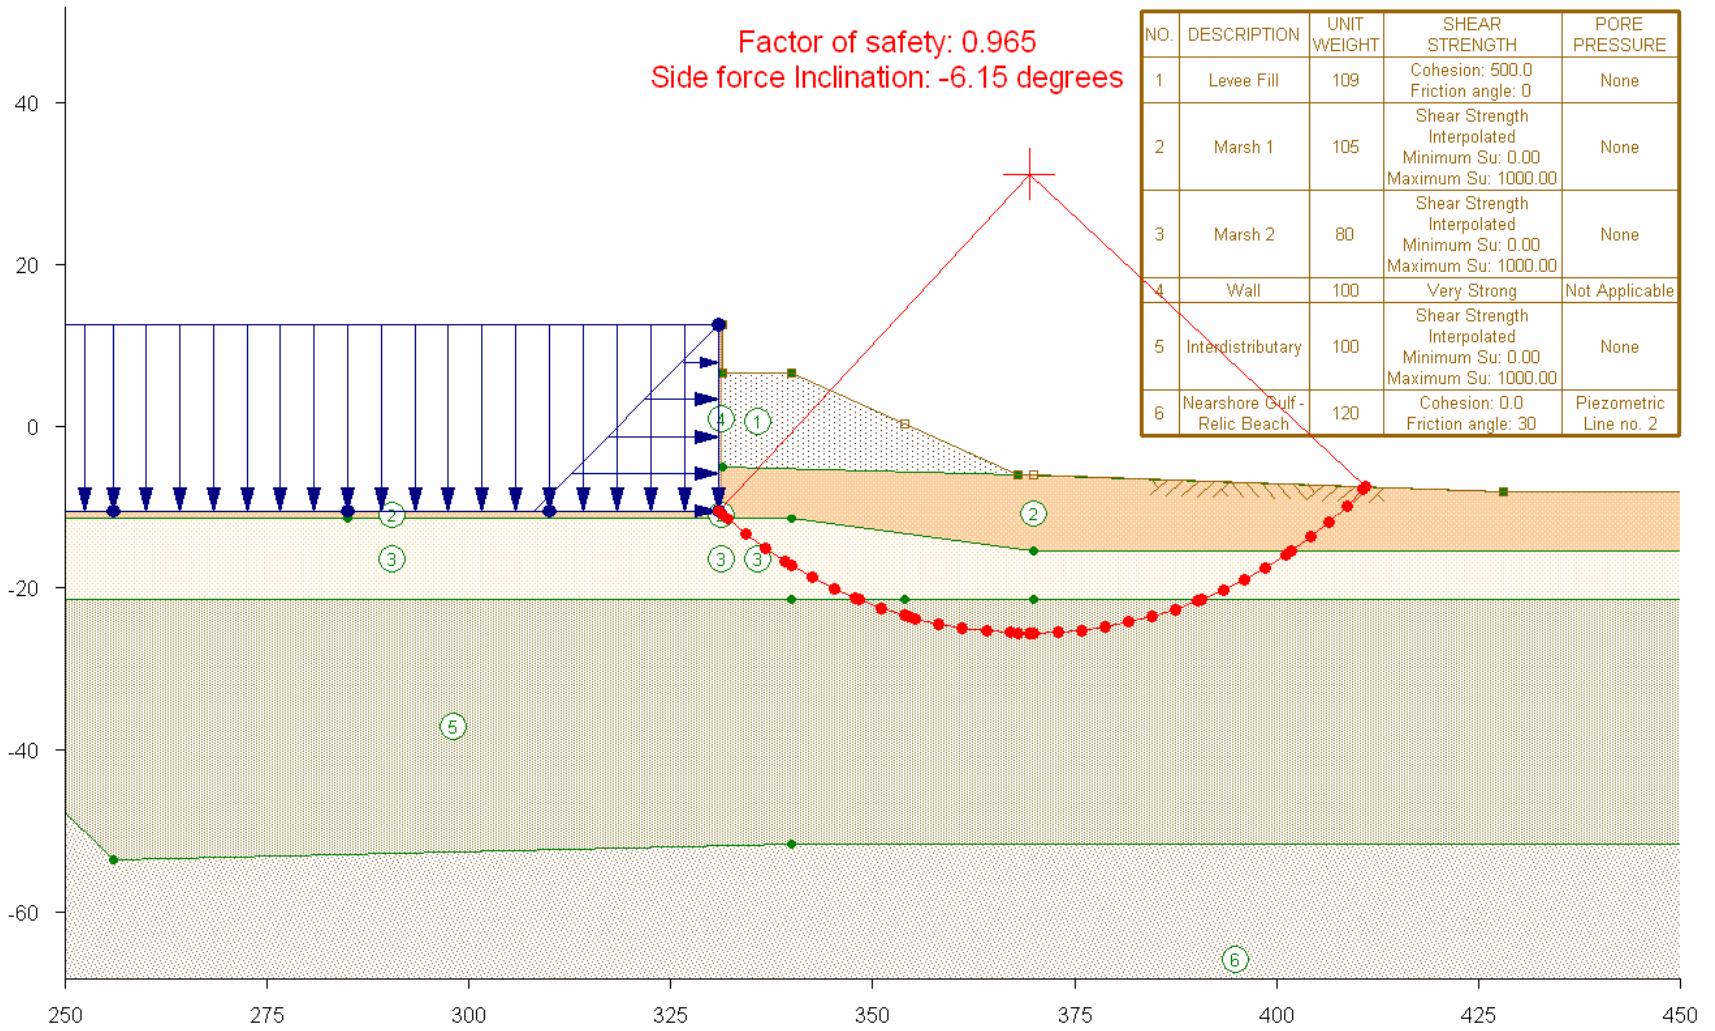
Figure 24. IHNC – East Bank (North Breach), Case 5, Canal Water Level = Top of Wall = 12.5 ft (NAVD 88), with Crack

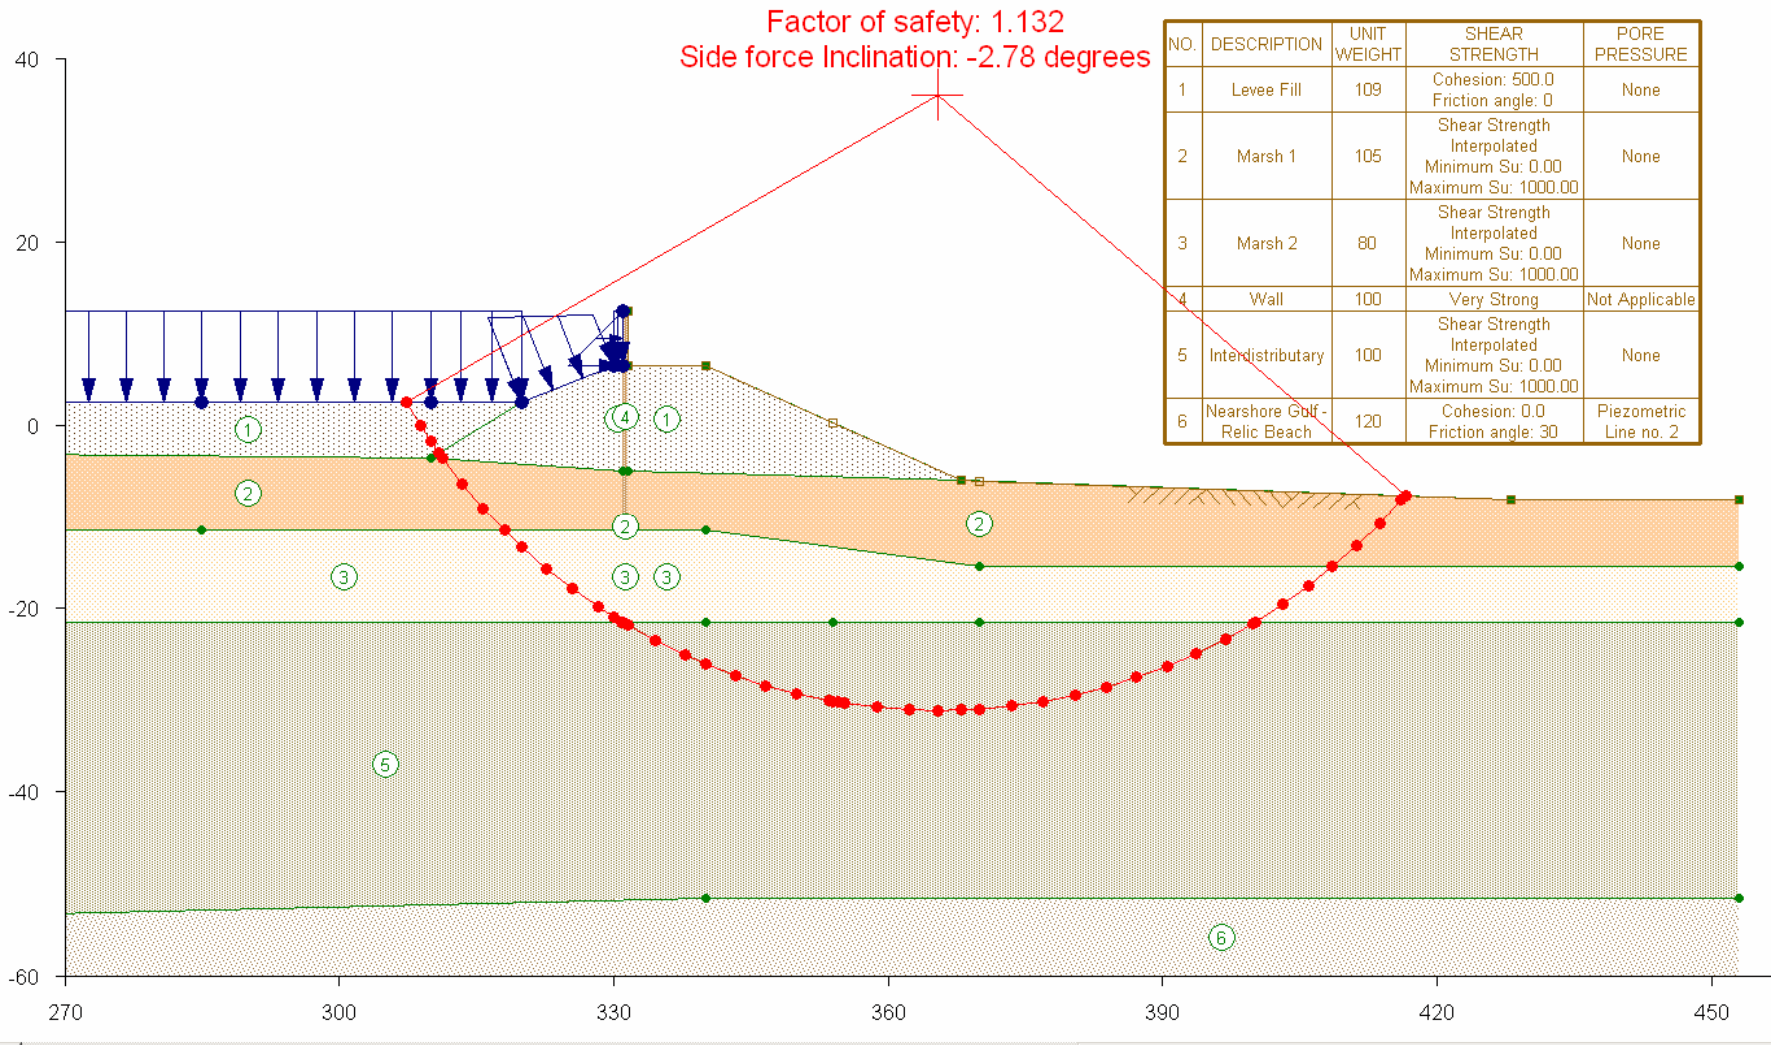
Figure 25. IHNC – East Bank (North Breach), Case 5a, Canal Water Level = Top of Wall = 12.5 ft (NAVD 88), without Crack

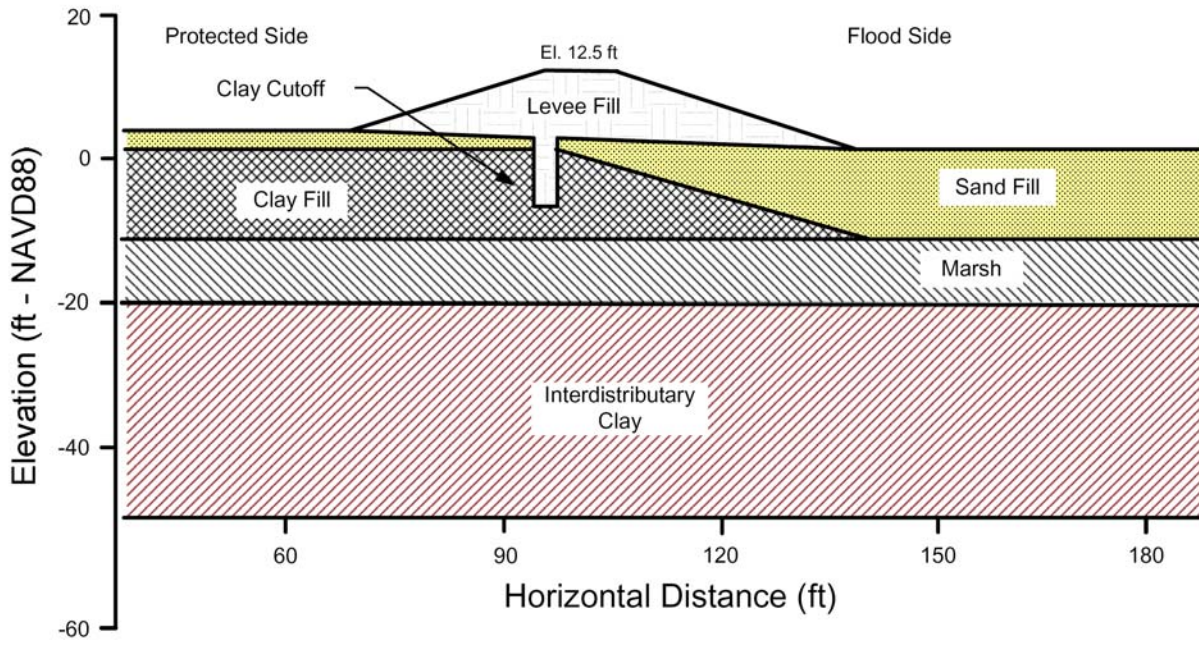
Stability analyses of the south breach section were performed using UTEXAS4⁸ for a canal water elevation of 12.5 ft (the top of the levee). The factor of safety for this condition was found to be 2.08. The concept of a gap does not apply to this section since there is no sheet pile wall on or in the embankment. The high factor of safety indicates that the breach was the result of erosion of the levee.

Figure 36. IHNC – West Bank – Cross section of South Breach.
