**LAKE PONTCHARTRAIN, LA AND VICINITY HURRICANE
PROTECTION PROJECT
ORLEANS, ST. BERNARD, JEFFERSON AND ST. CHARLES
PARISHES, LA**

NEW ORLEANS EAST

DAMAGE SURVEY REPORT (DSR)

updated July 2009

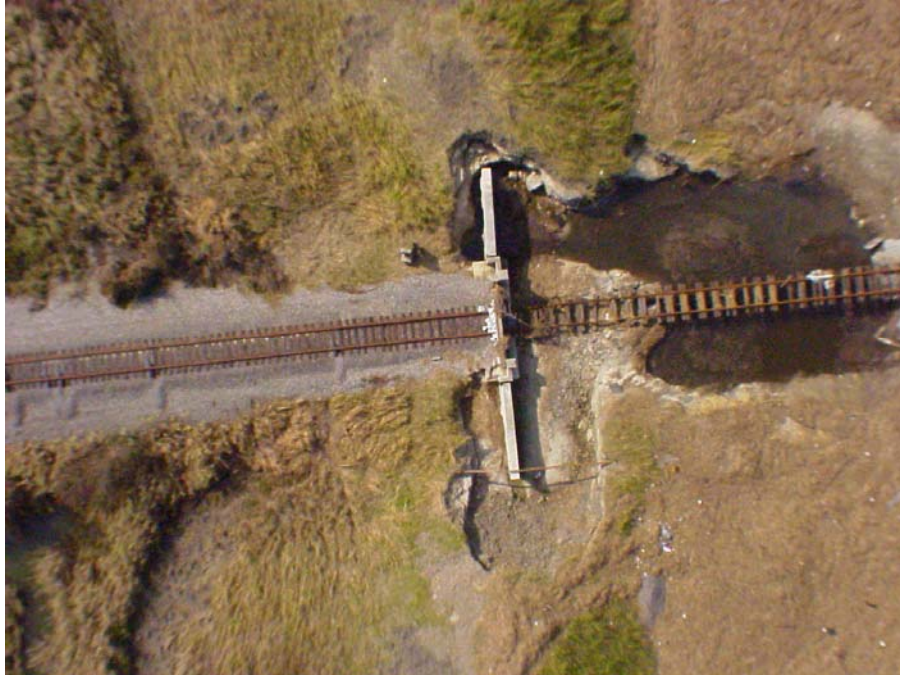
1. **Railroad Floodgate**: The CSX railroad floodgate and adjacent section of the levee were damaged during the storm event. There was scour of the structural fill material resulting from overtopping of the closure gate and levee.

Figure 1 CSX Railroad gate (Photo S-1)

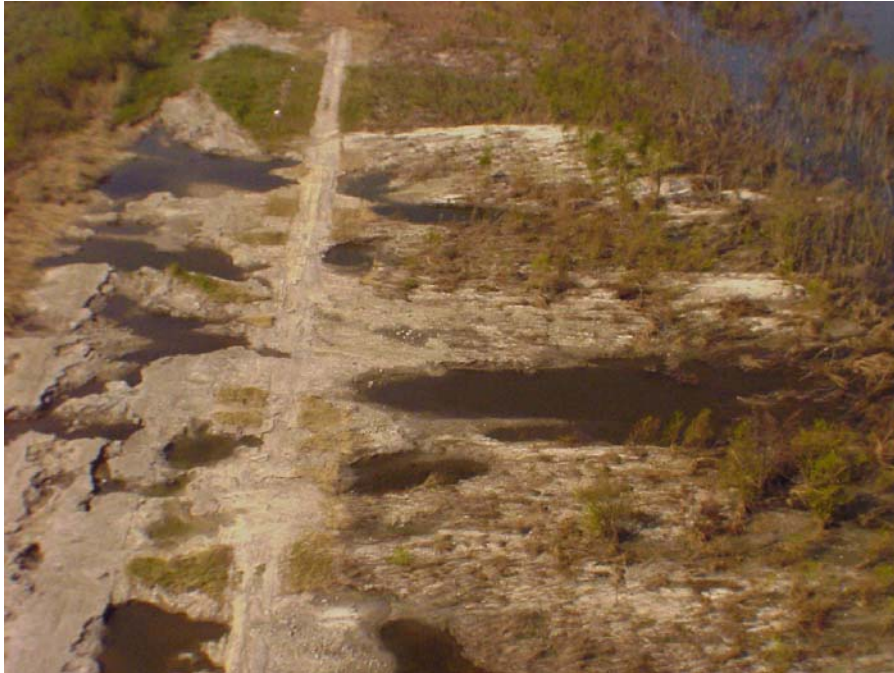
2. **New Orleans East Back Levee:** There is 12,750 feet of levee east of Pump Station #15 that is completely degraded. West of the pump station, 9,800 feet of levee is completely degraded. The remaining level of protection is EL 4.0. It is estimated that 400,000 cys of fill will be required to restore the degraded levee in the reach.

**Figure 2 Intracoastal Waterway Breach east of Pump Station #15 - levee completely degraded
(Photo S-7)**

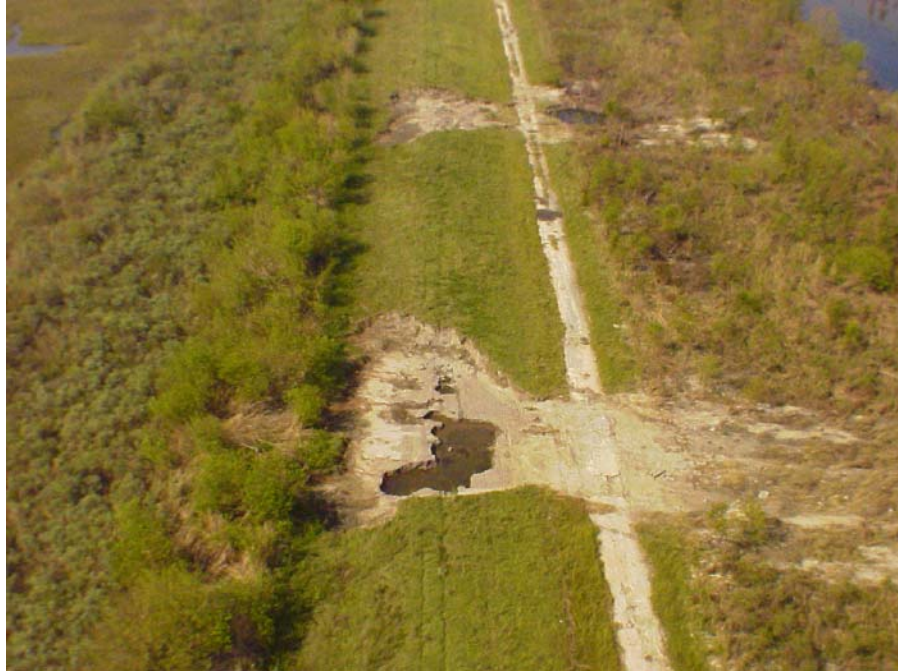
Figure 3 Partial breach east of Pump Station #15 (Photo S-8 thru 19)

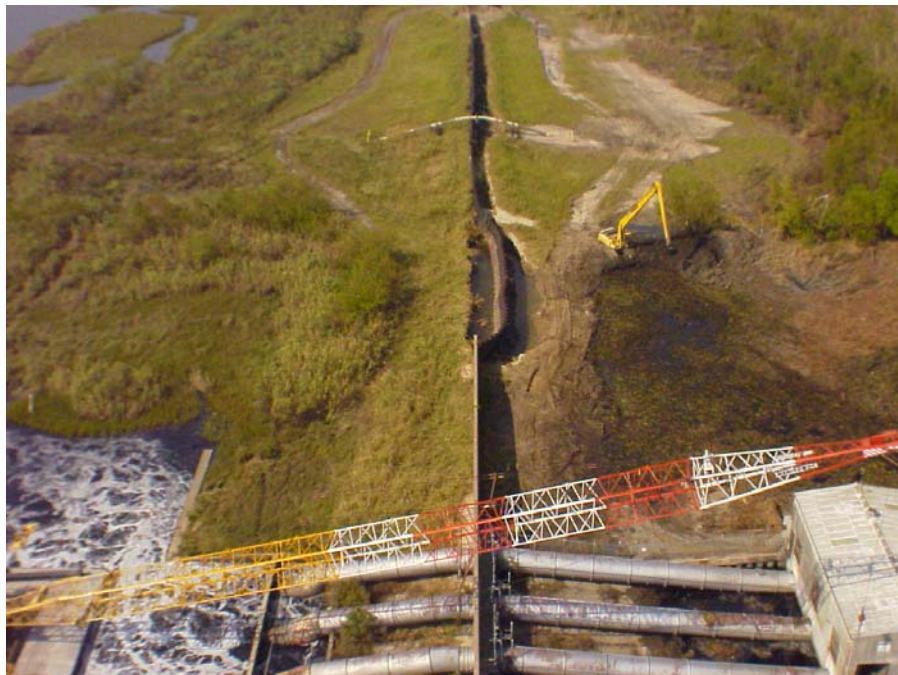
Figure 4 I-wall failure with erosion and scouring (Photo S-20)

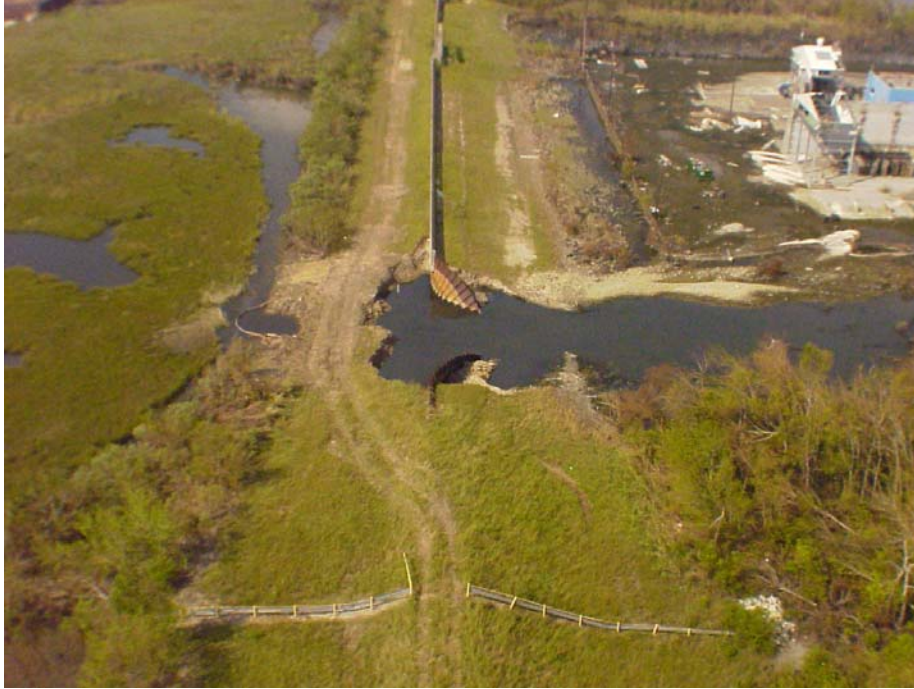
Figure 5 Hydrogen Plant (Air Products) Breach. I-wall failure (Photo S-32)

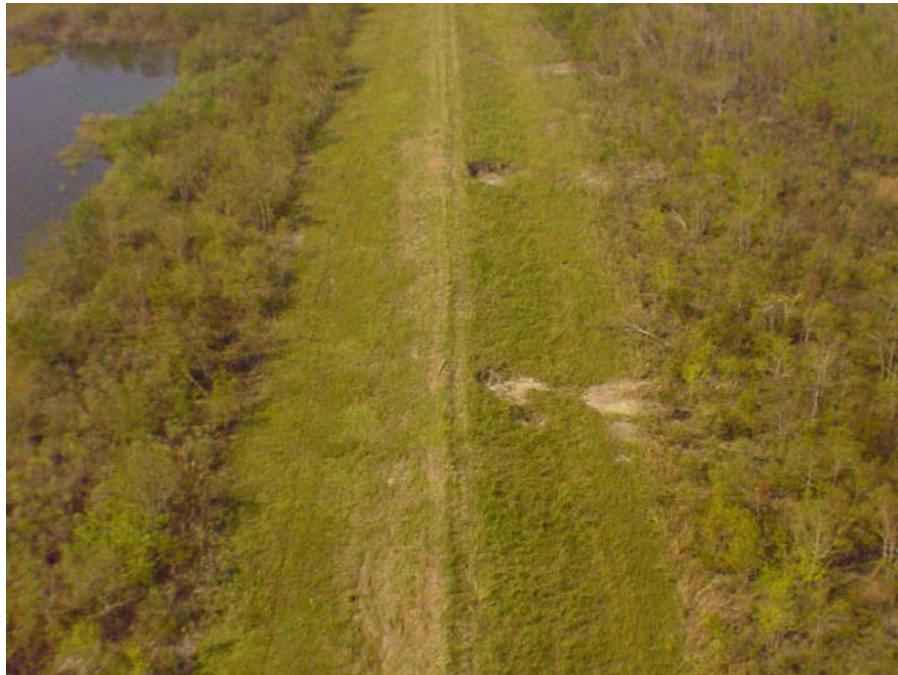
**Figure 6 Localized scouring - typical of several locations
(S- 22 thru 26 and 28 thru 31)**

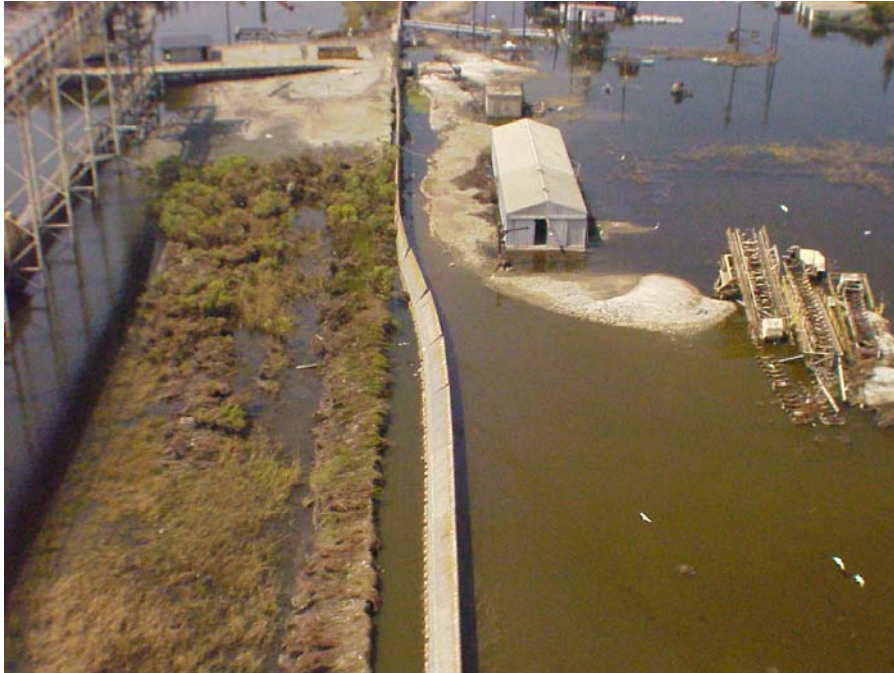
(Photo S-37)

The most severe damage in this reach is a 2000 ft. section of I-wall that failed by rotation, with attendant erosion and scouring. The extend of material below the water surface that has been removed by the scouring is unknown. Localized scouring occurred at several locations along this reach. The total quantity of material removed by scouring within this reach is estimated at 150,000 cys.

Figure 7 I-wall failed by rotation with attendant erosion and scouring. Quantity of materials removed estimated at 65,000 cys

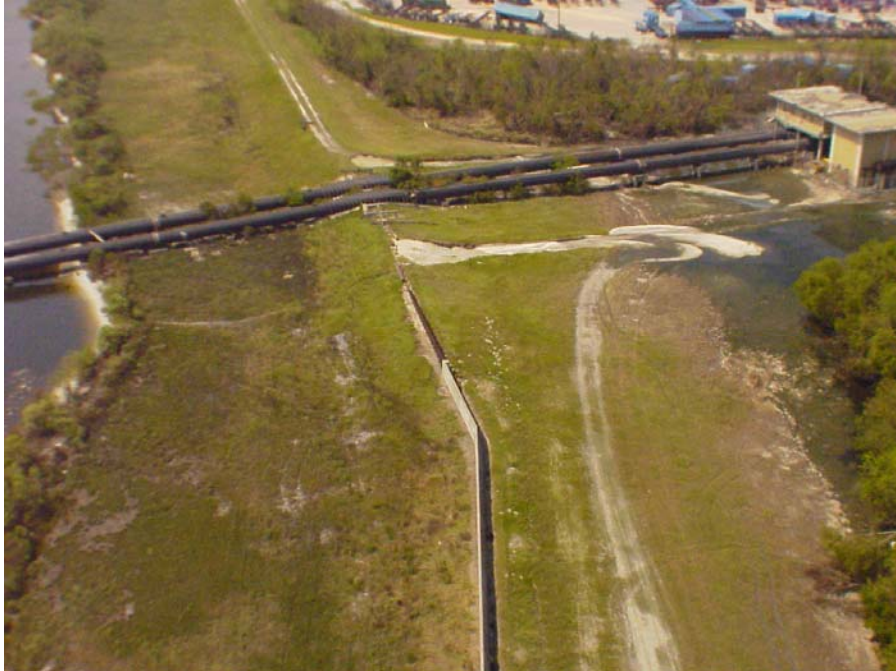
Figure 8 Land side slope erosion at utility crossing
(Photo S - 38 thru 40)

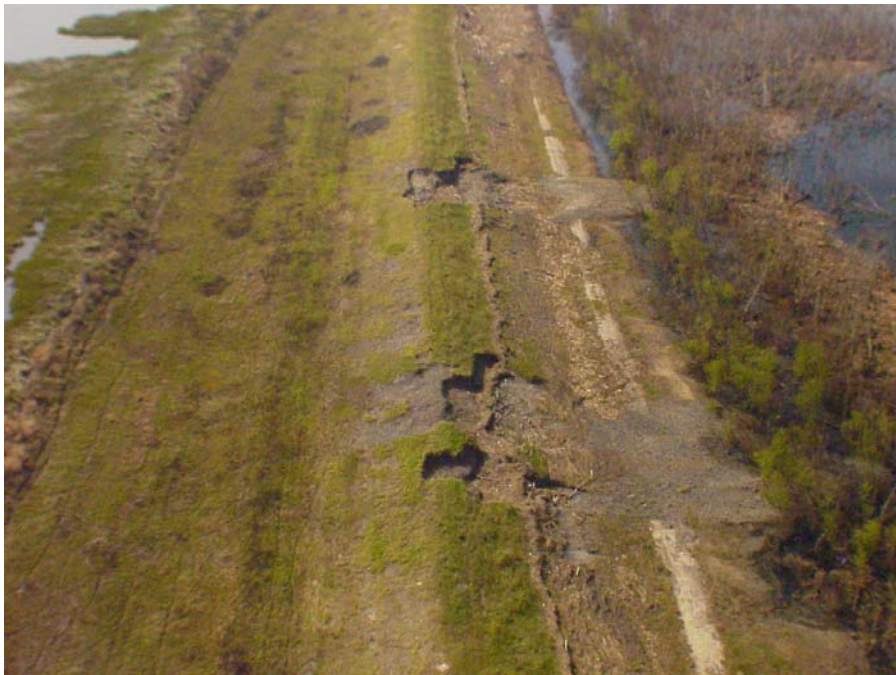
Figure 9 Major erosion of crown, river and land side slopes
(Photo S - 4 and 5)

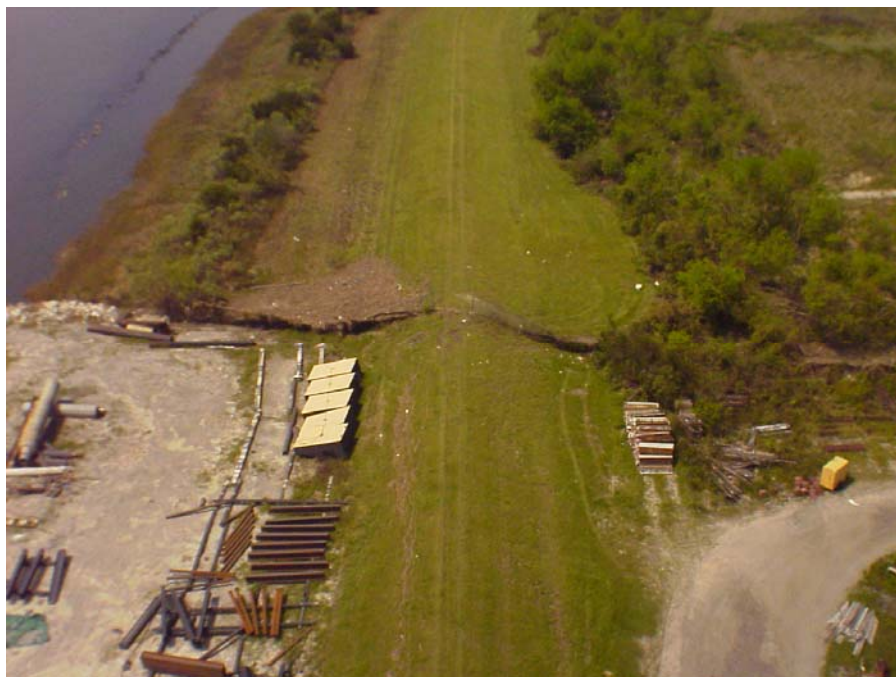
Figure 10 Narrow breach (Photo S - 34)

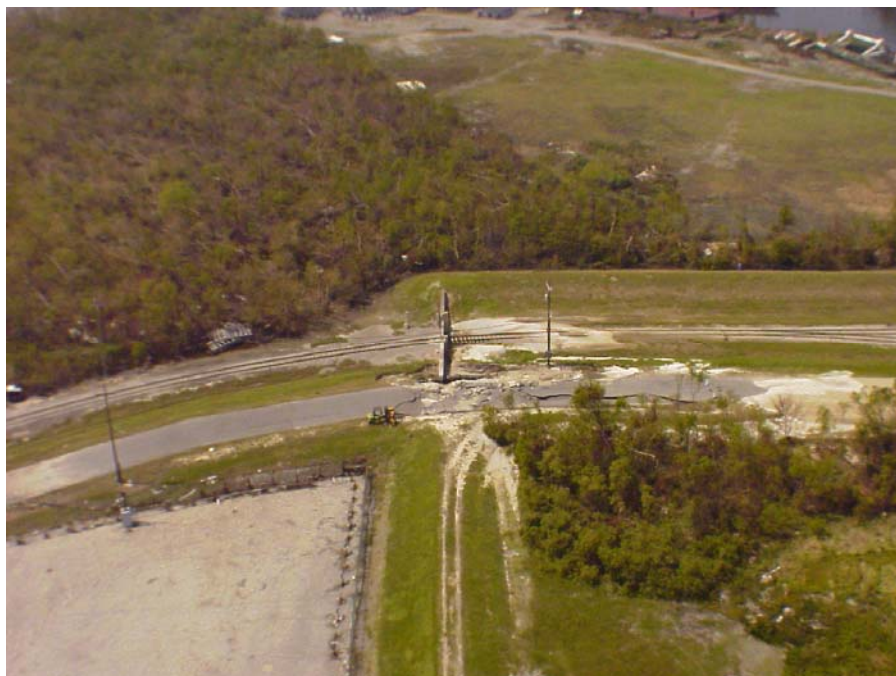
Figure 11 Scouring at closure structure and road
(Photo S - 42)

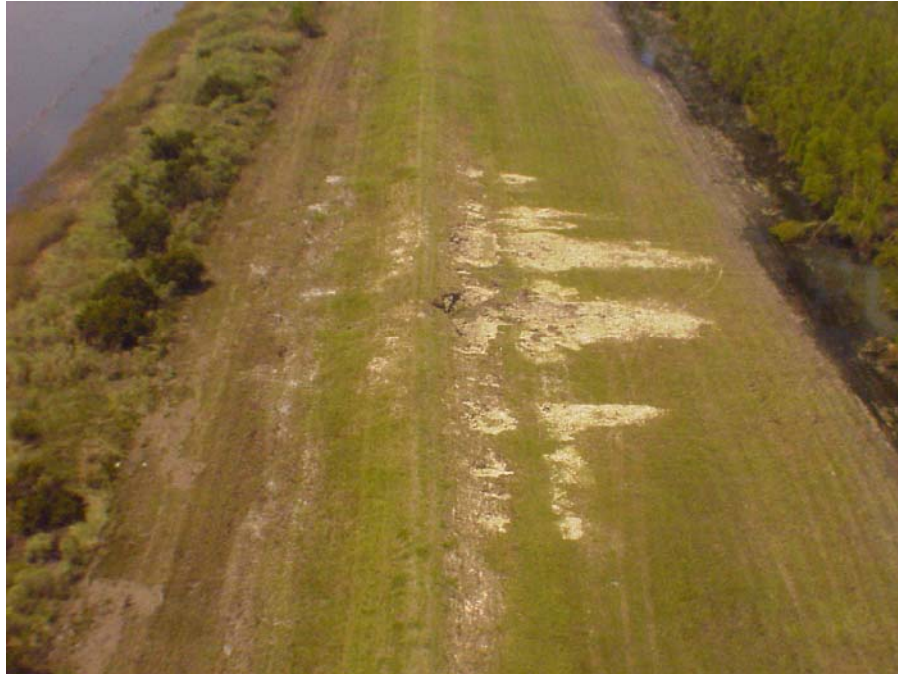
Figure 12 L/S Scouring of 600 ft reach (Photo S- 35)

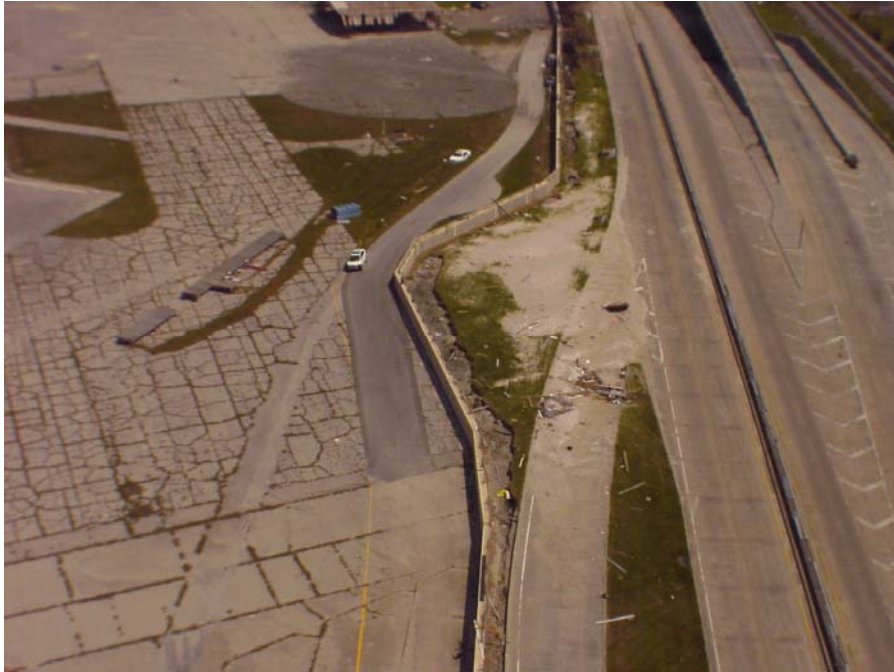
Figure 13 Scouring at N.O. Airport Floodwall
(Photo S - 49)

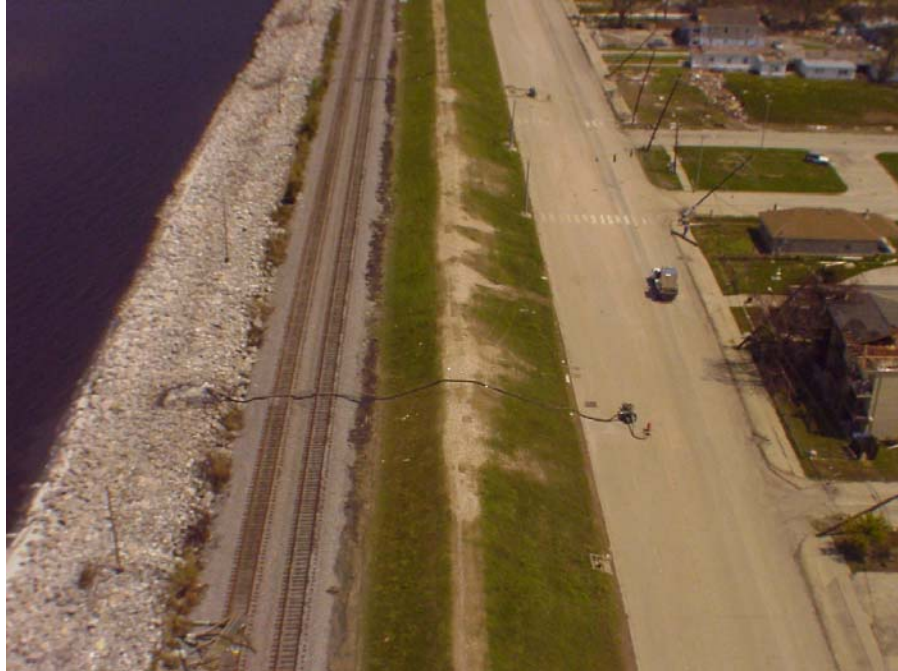
**Figure 14 Crown and L/S scouring - typical of this reach
(Photo S - 52)**

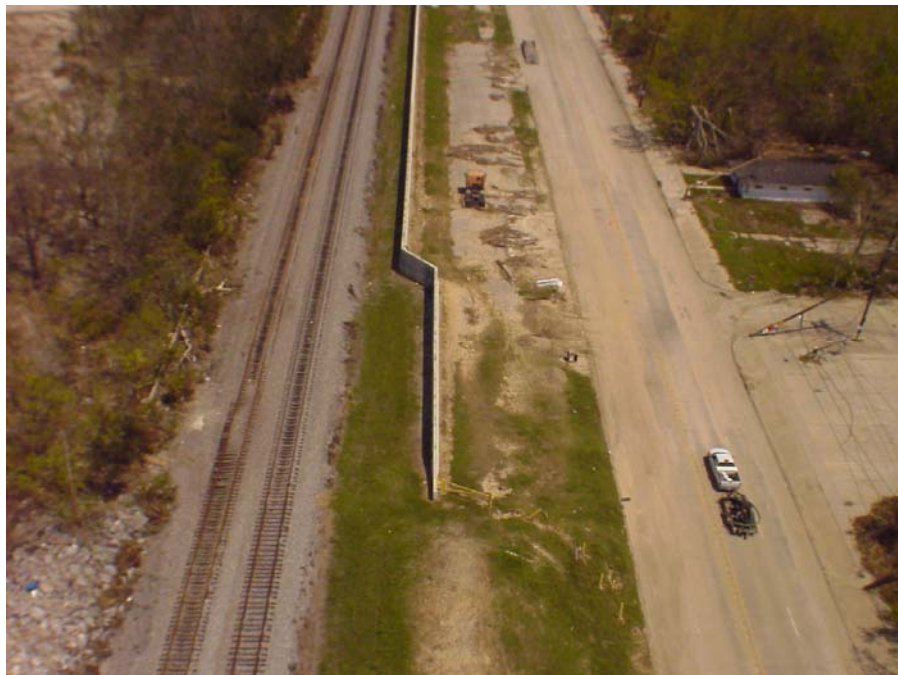
**Figure 15 Minor scouring L/S of floodwall
(Photo S - 53 and 54)**
