Subject: Field Notes on New Orleans

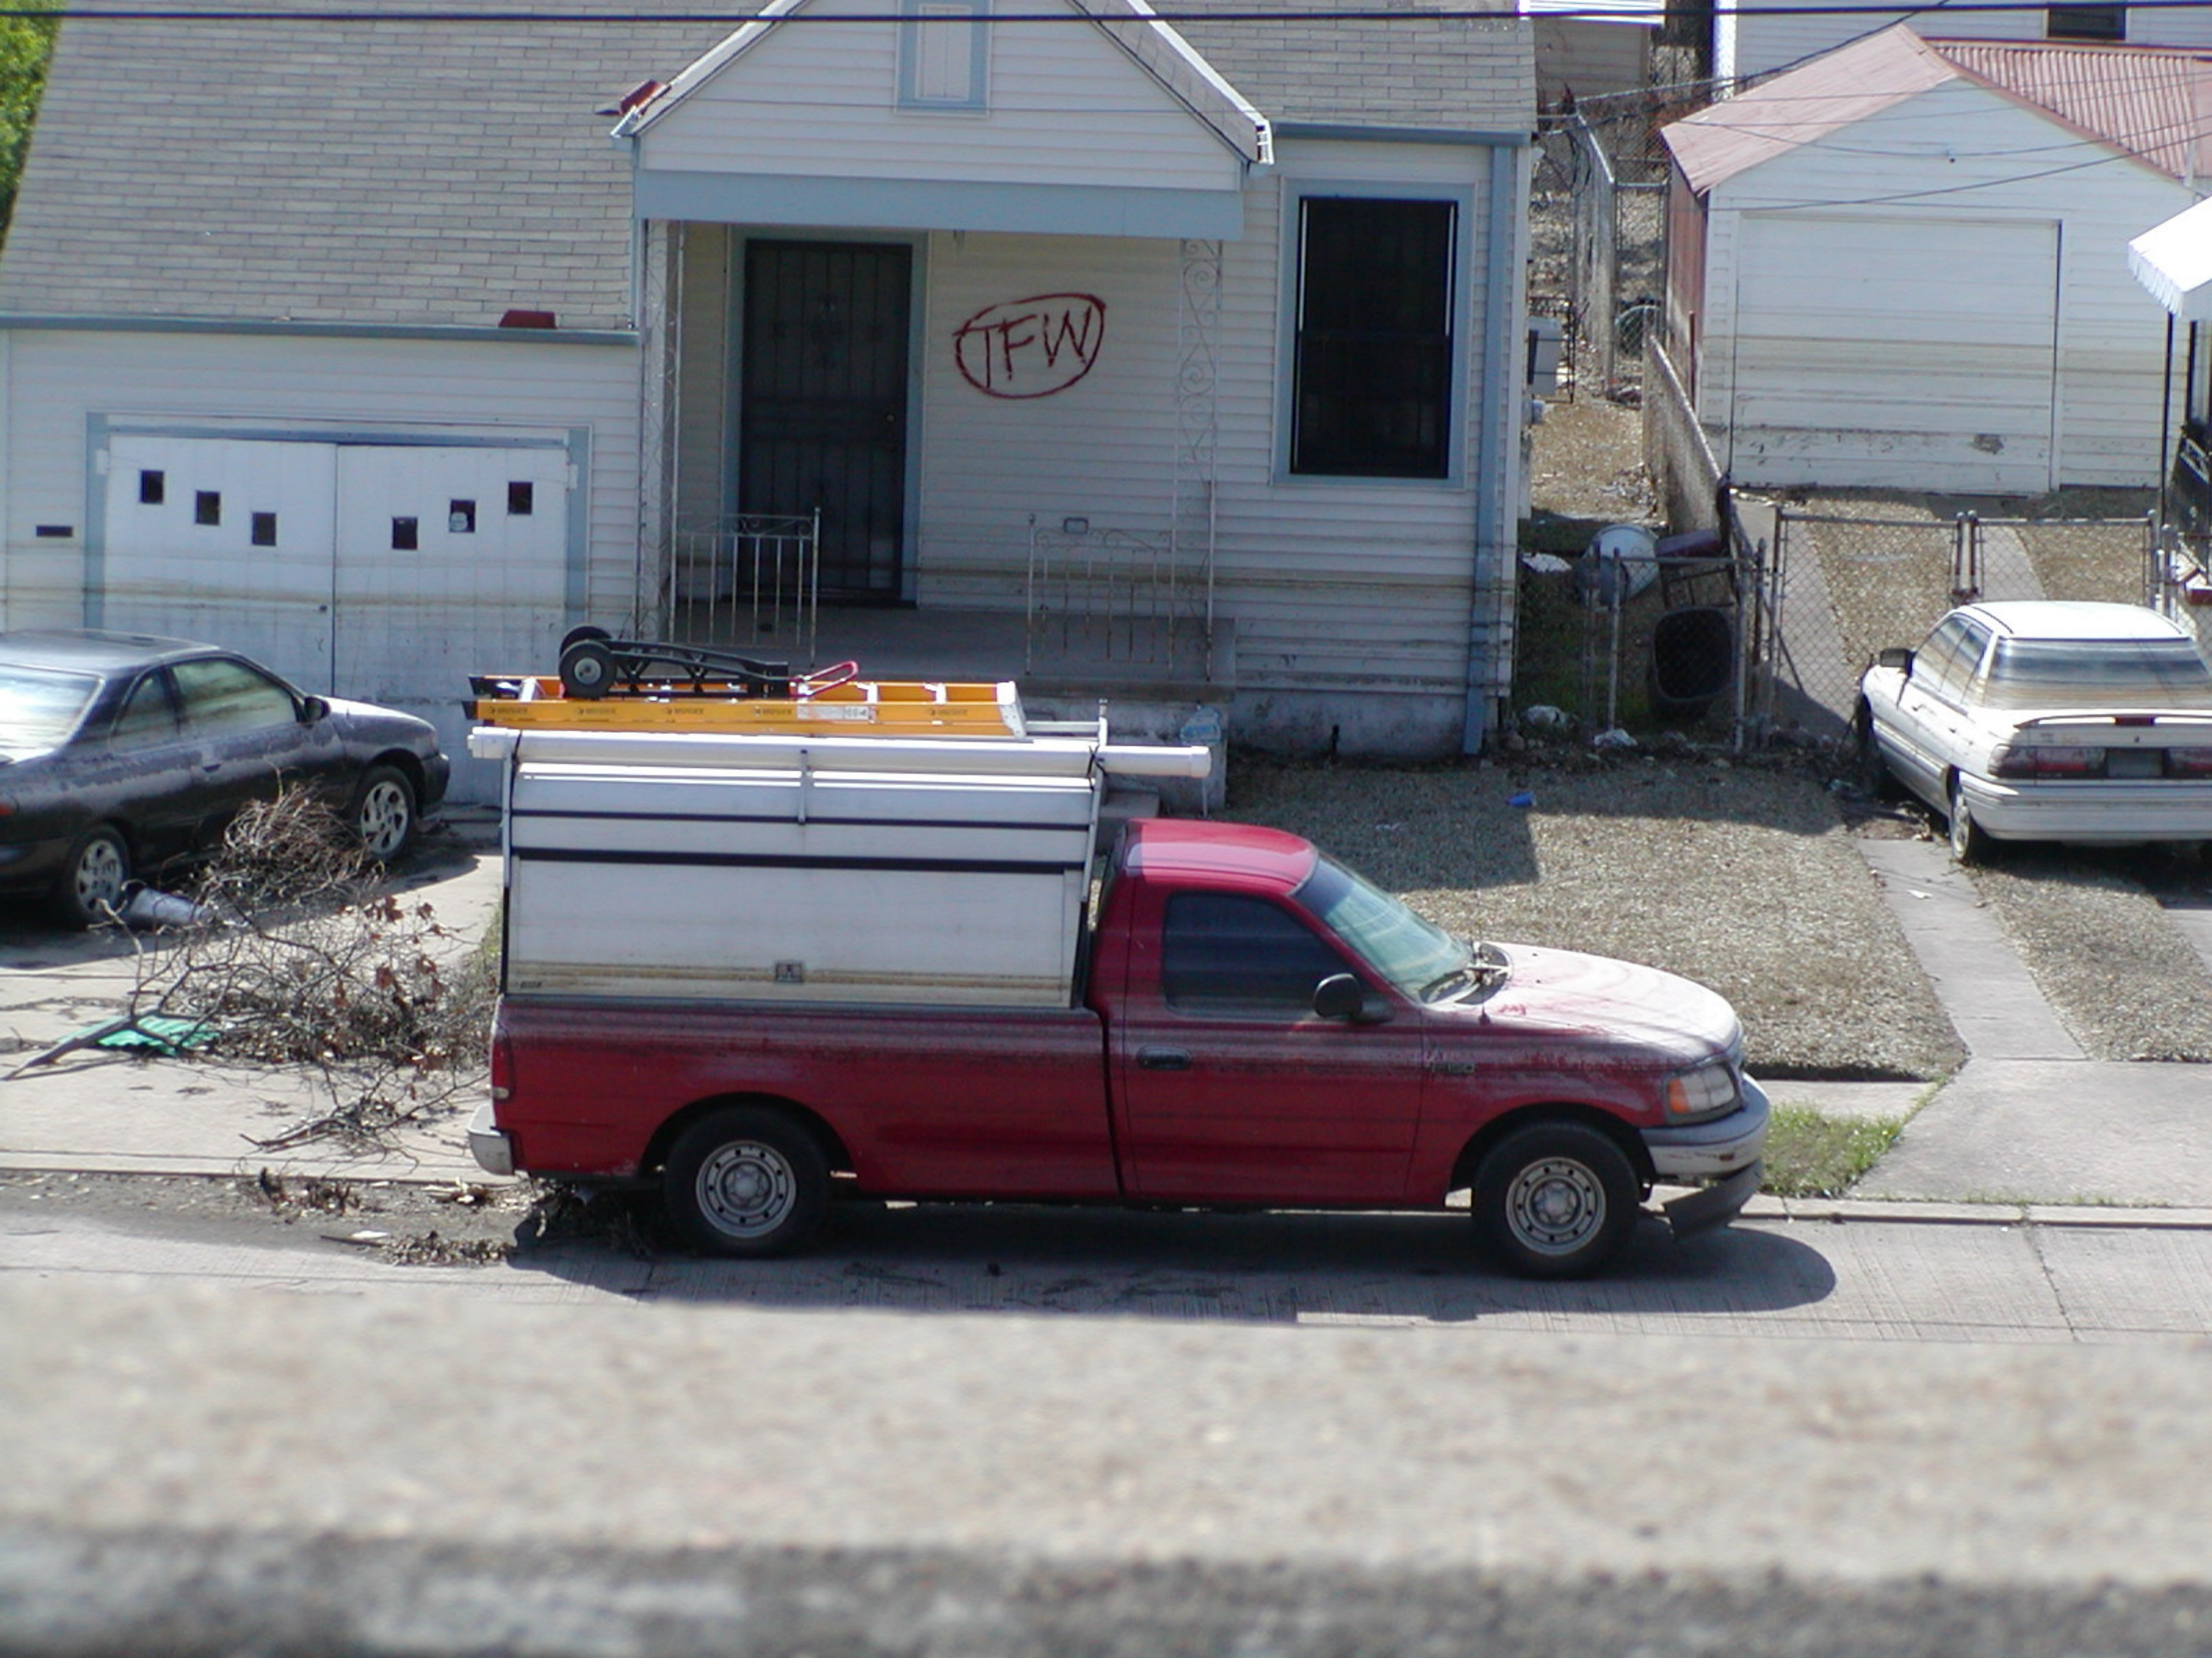
1. 9-27-05, all pictures taken by Stephen T. Maynard:
  - a. Picture 9270002- shows flooded cars, location unknown
  - b. Picture 9270003- South east breach on IHNC where barge went thru. Looking east from west side of IHNC on Claiborne Bridge.

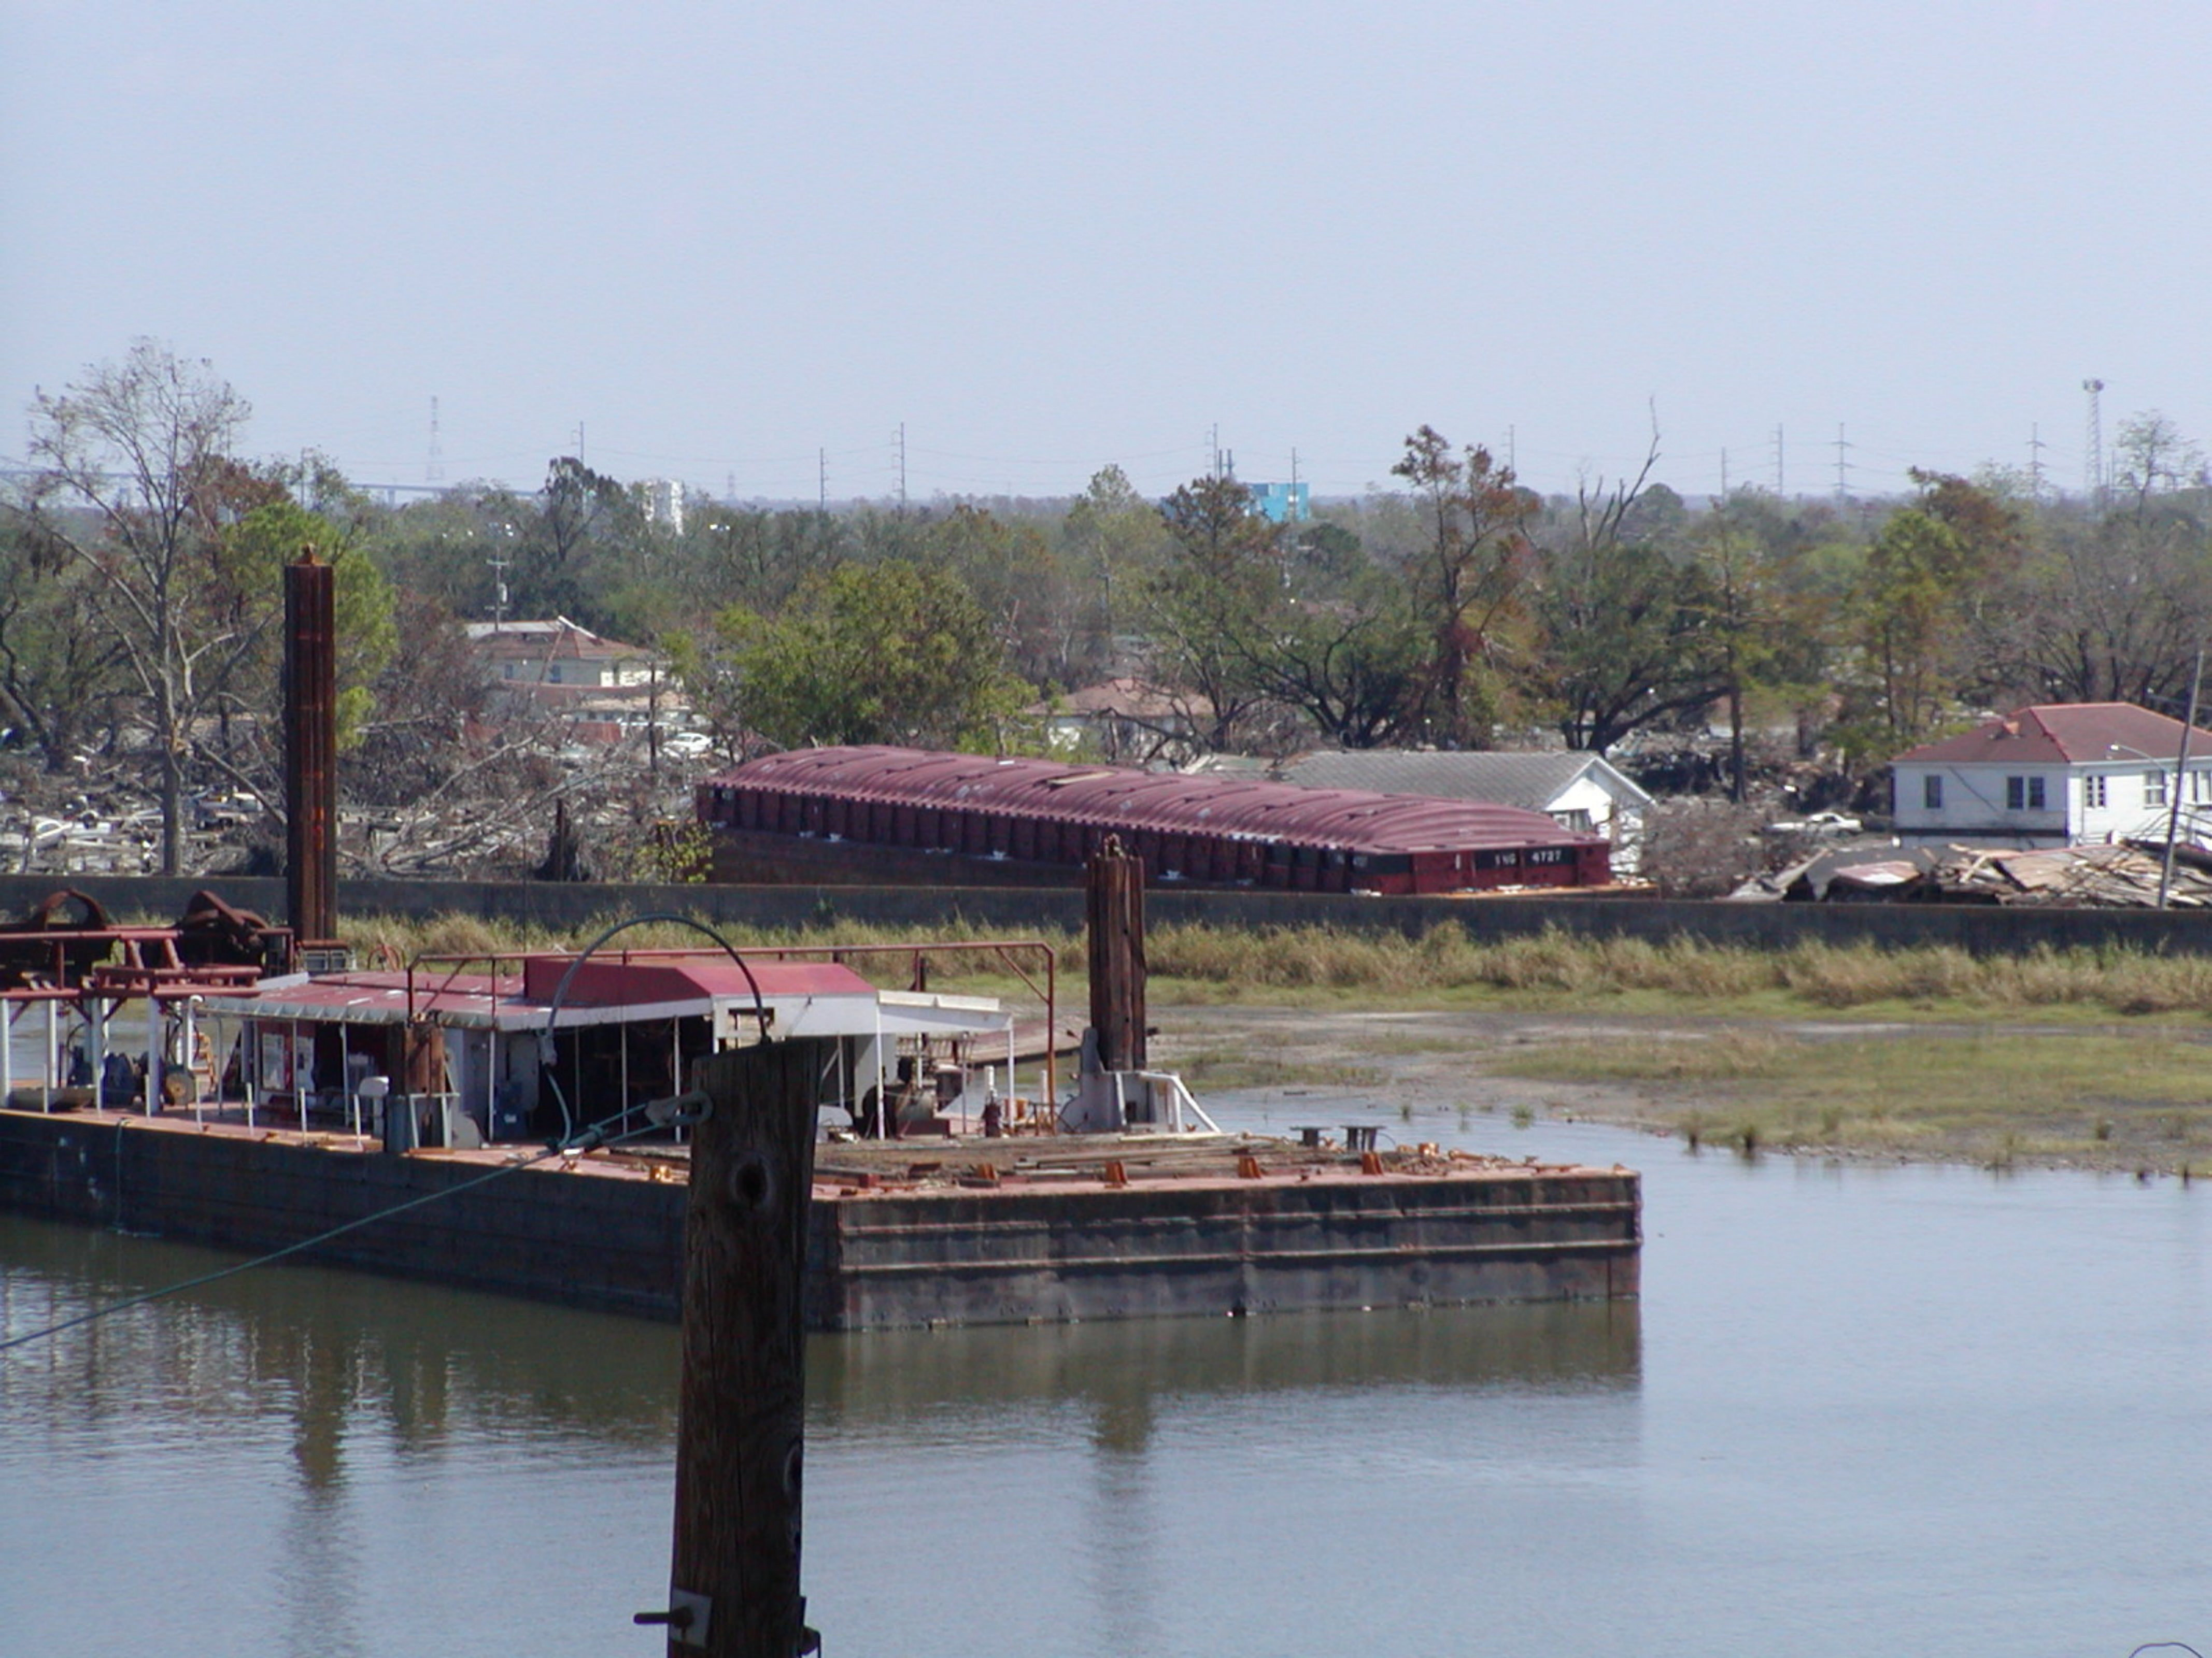
- c. Picture 9270004- Floodwall at south end of Southeast breach on IHNC showing barge behind wall. Looking east from west side of IHNC on Claiborne Bridge.

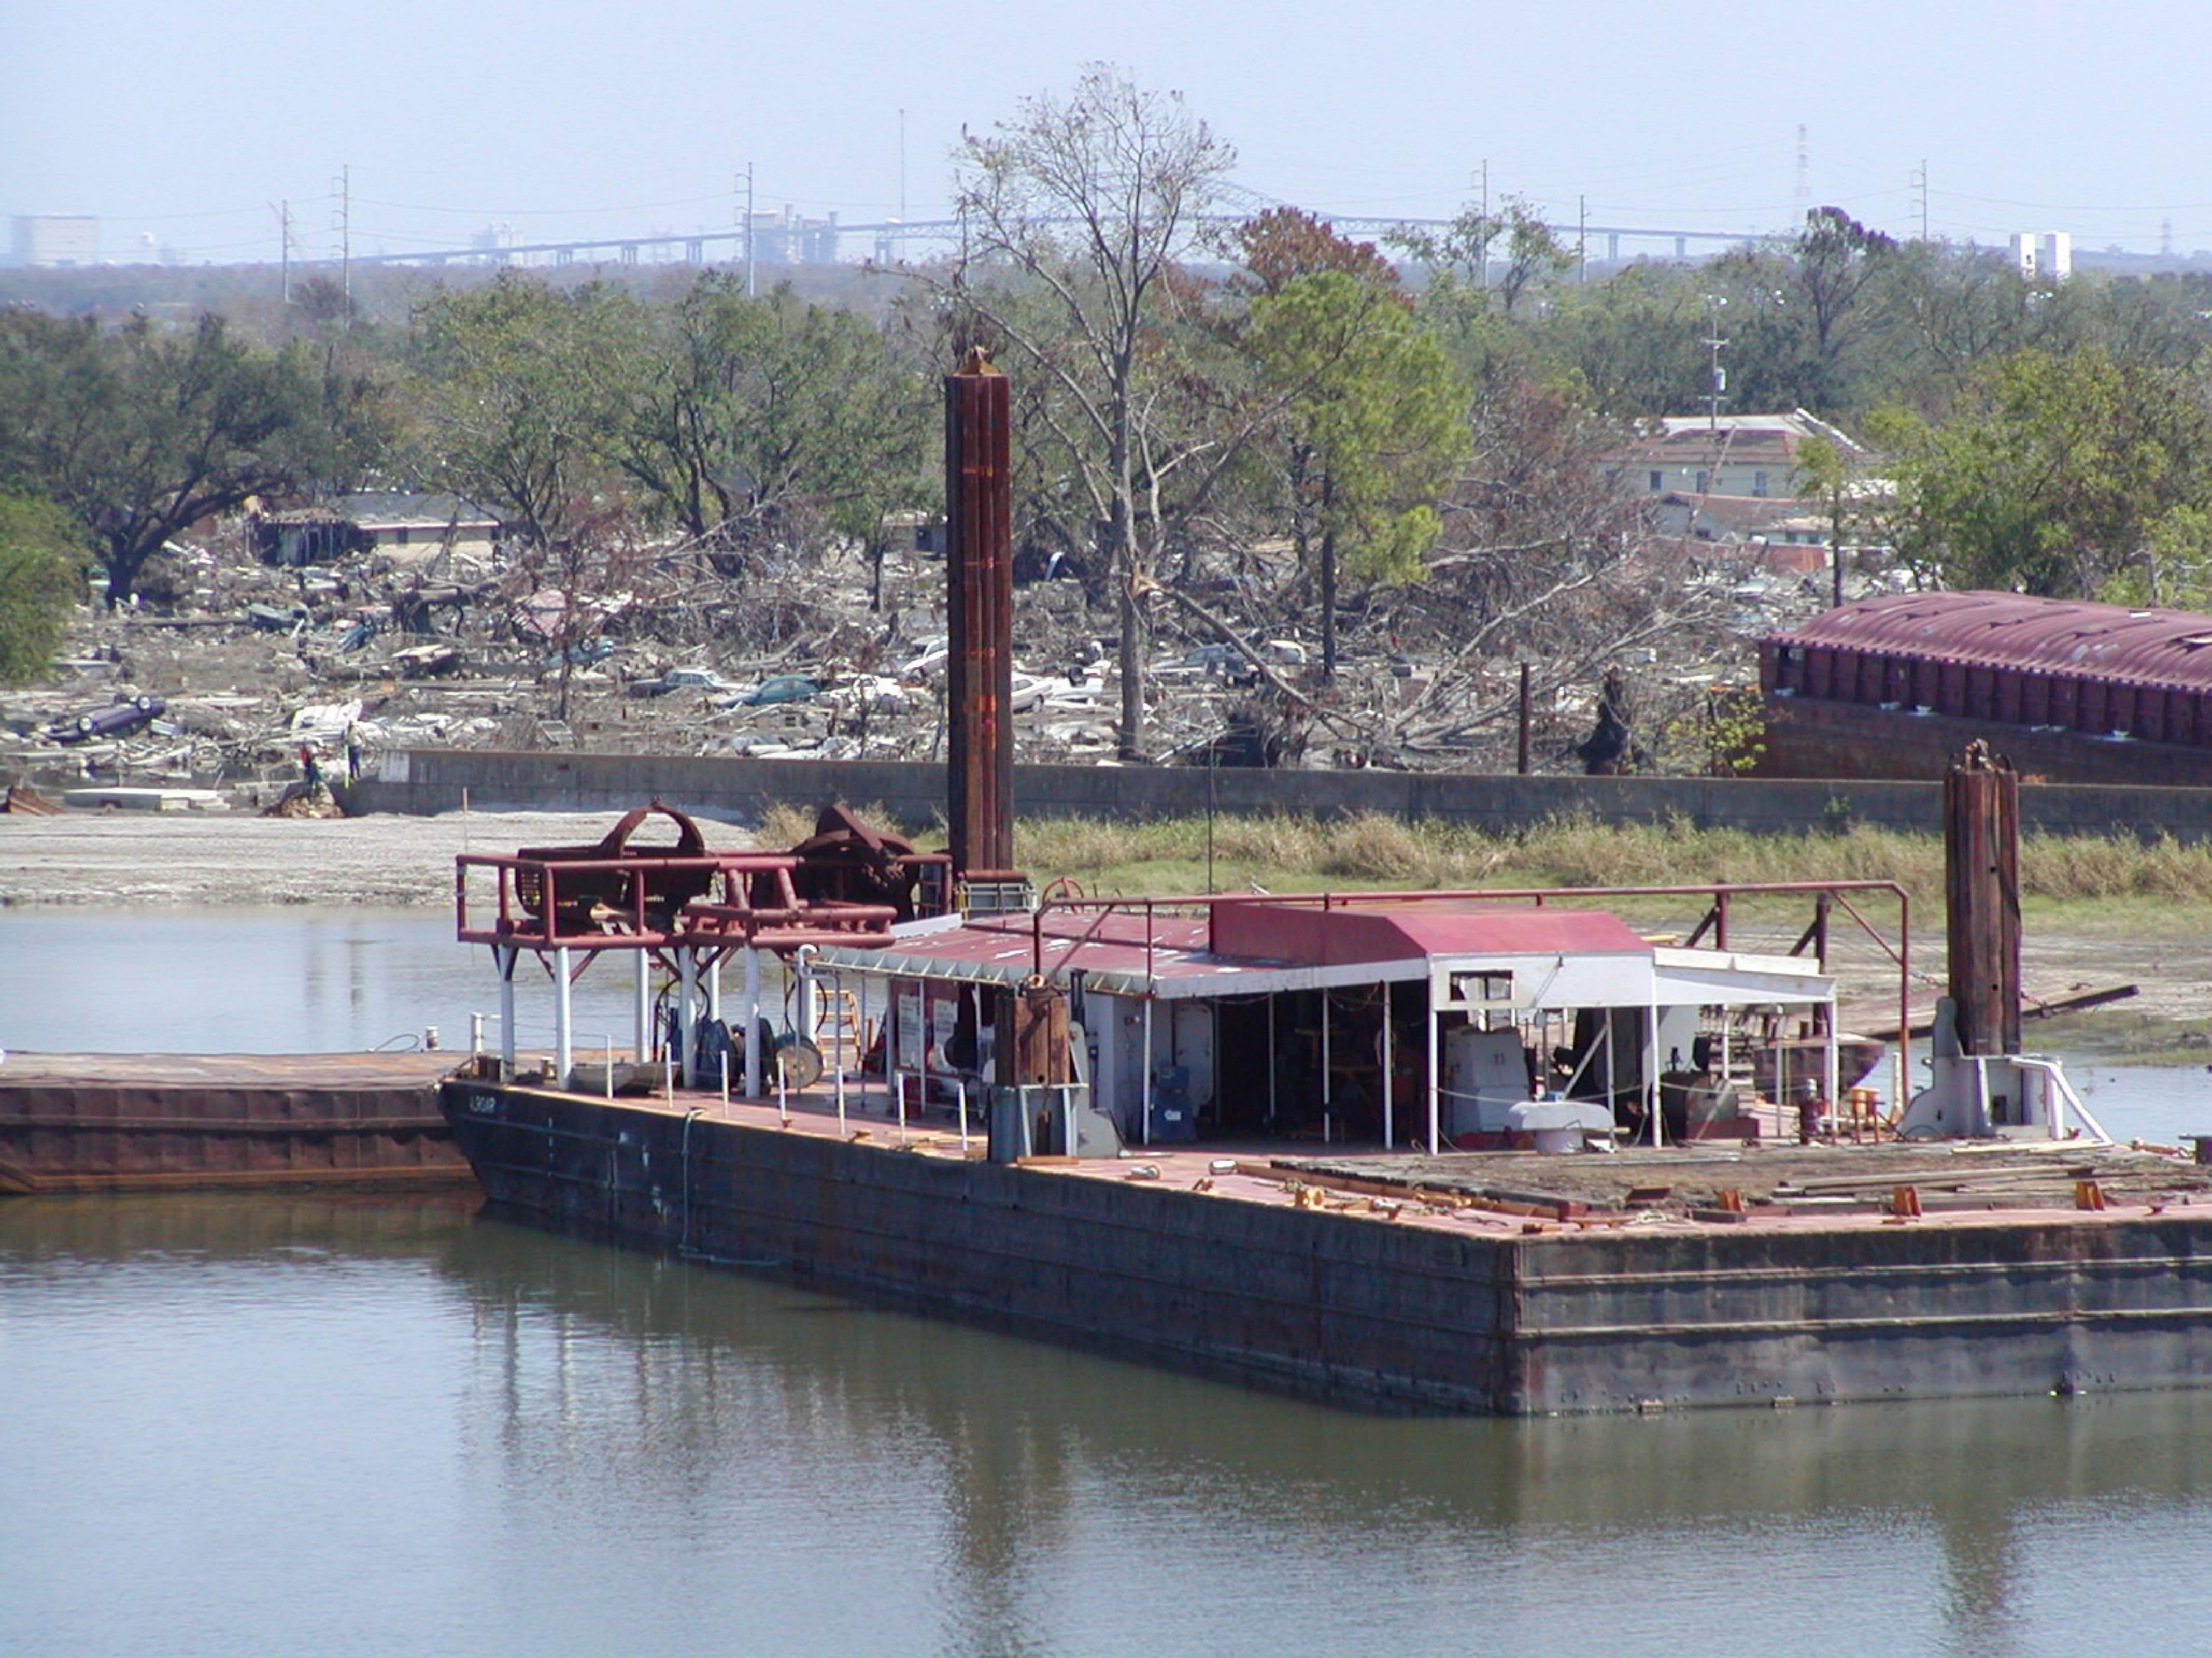
- d. Picture 9270005- South east breach on IHNC- south breach on east side with barge. South end of breach with rock barge in foreground. Looking east from west side of IHNC on Claiborne Bridge.

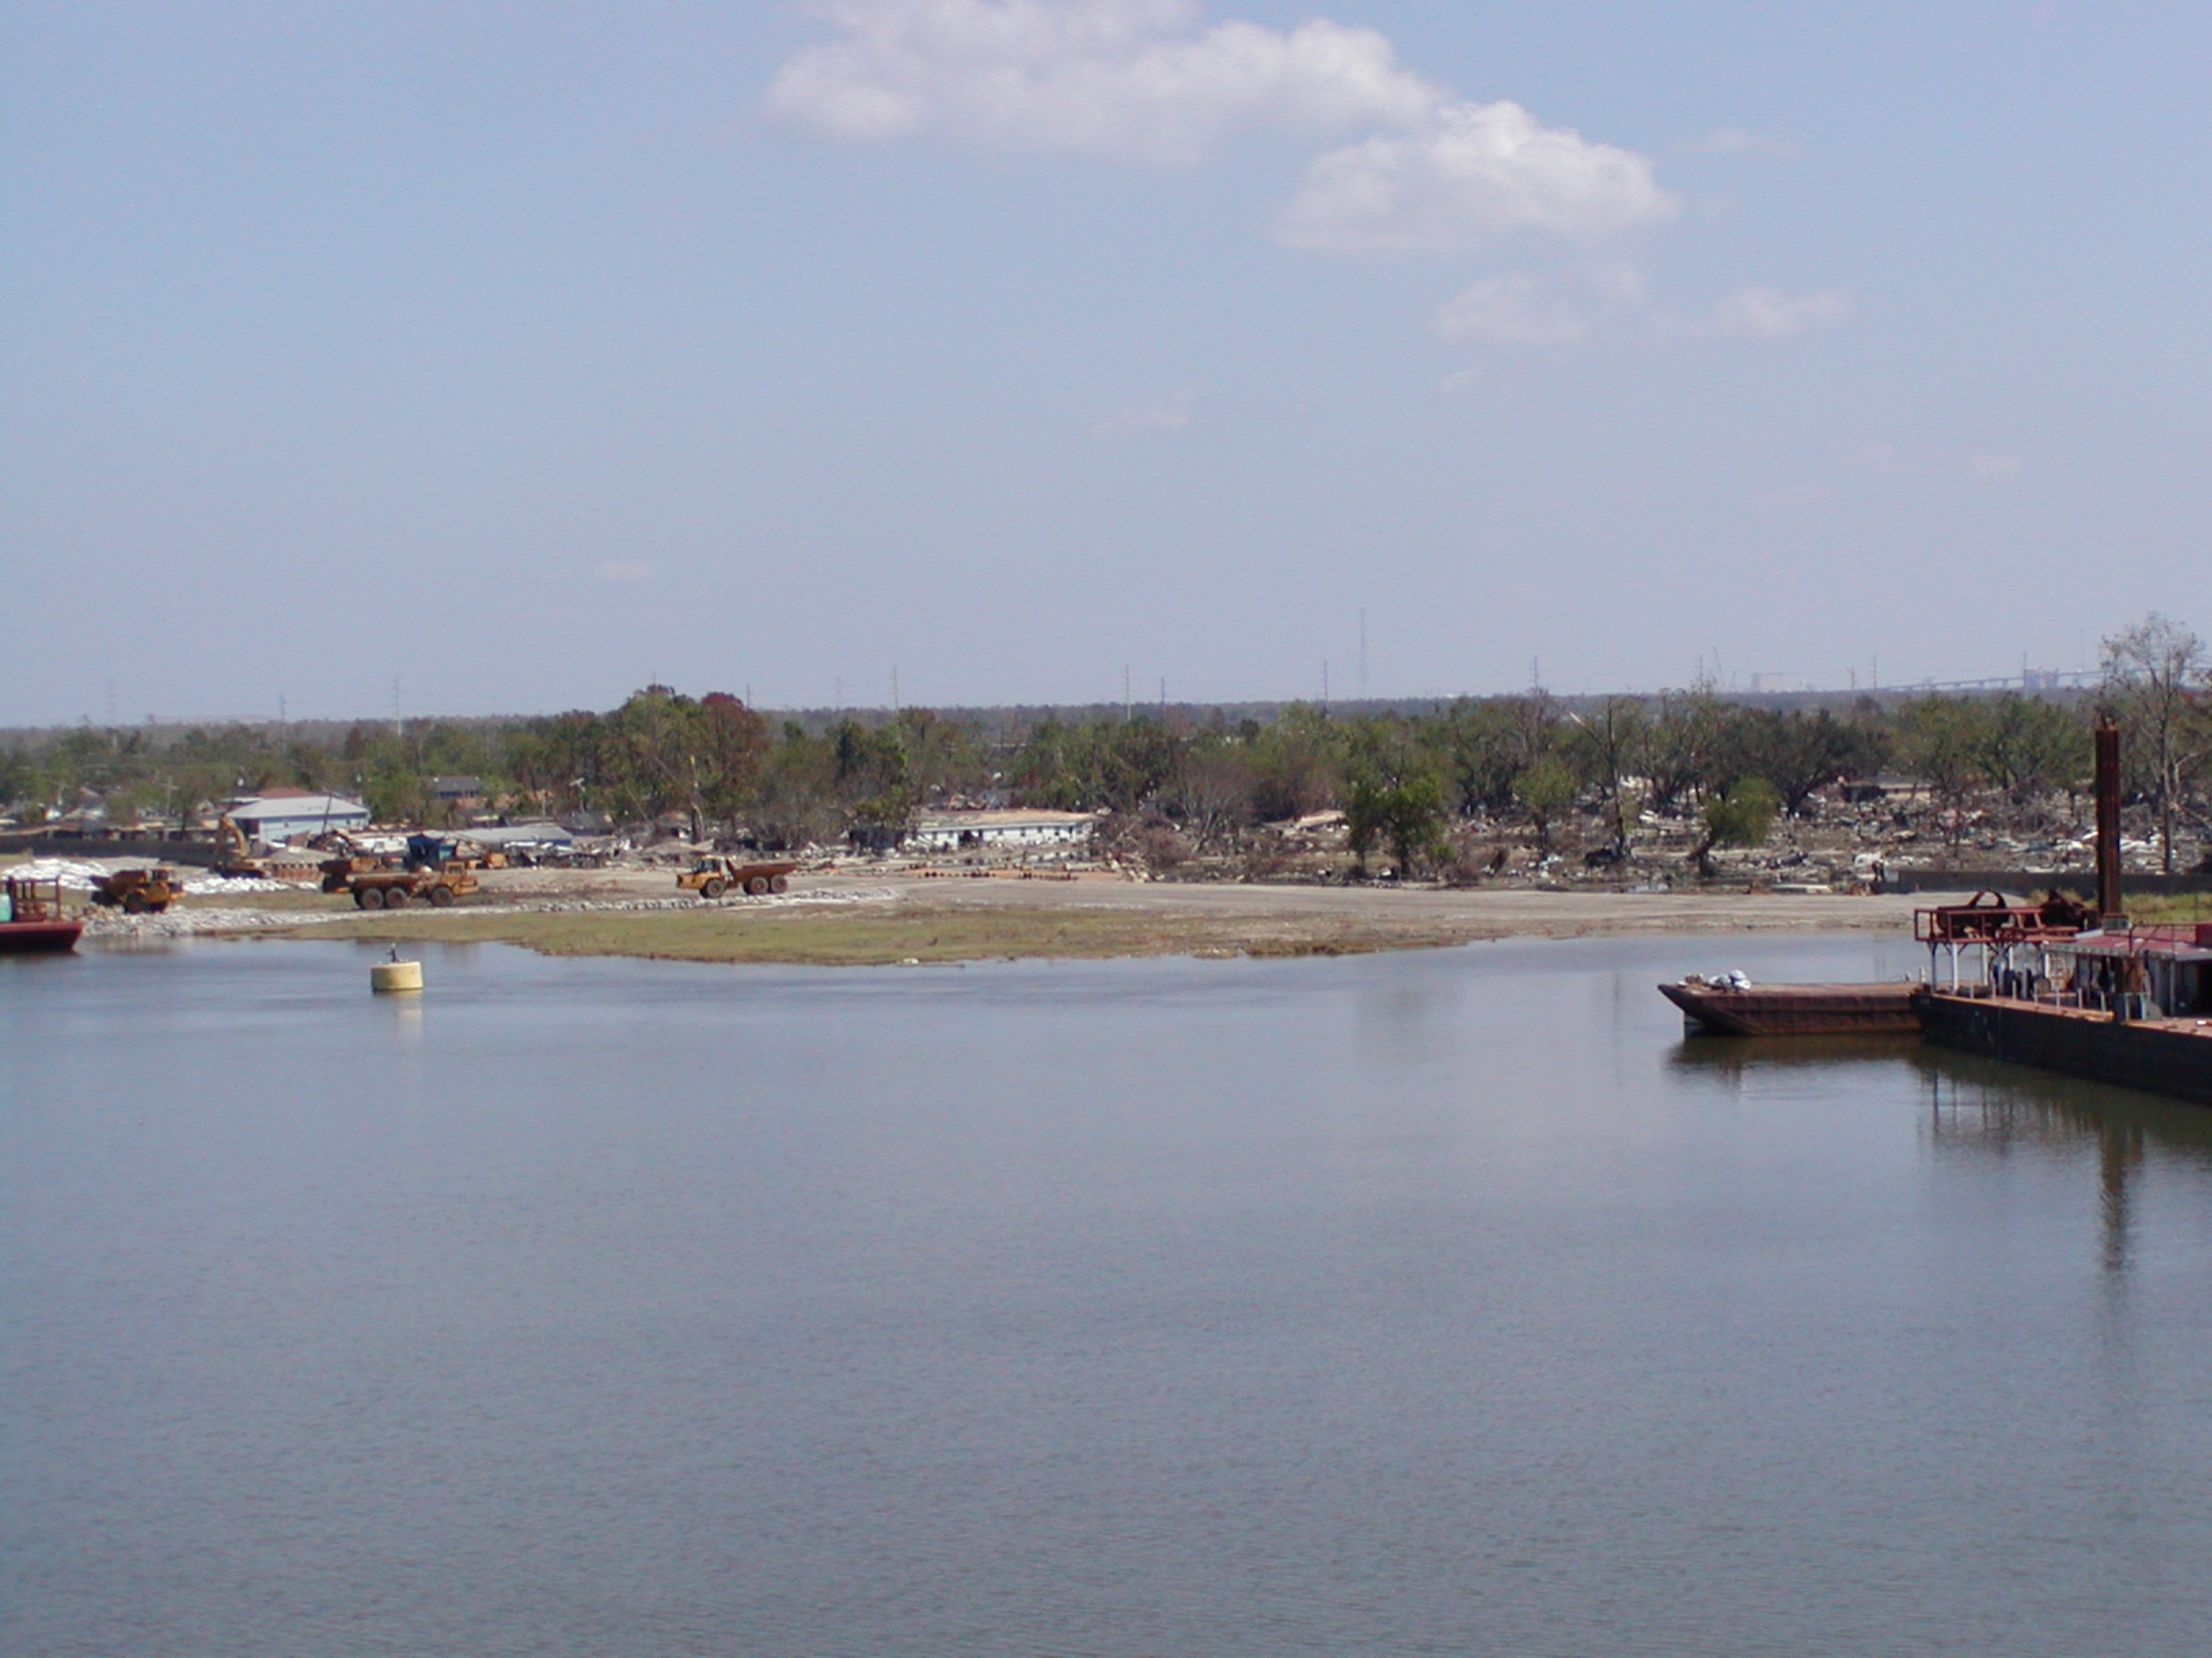
- e. Picture 9270006- South east breach on IHNC where barge went thru. Looking east from west side of IHNC on Claiborne Bridge.
  - f. Pictures 9270007 & 8- From west side of IHNC on Claiborne Bridge looking north at scour behind floodwall.

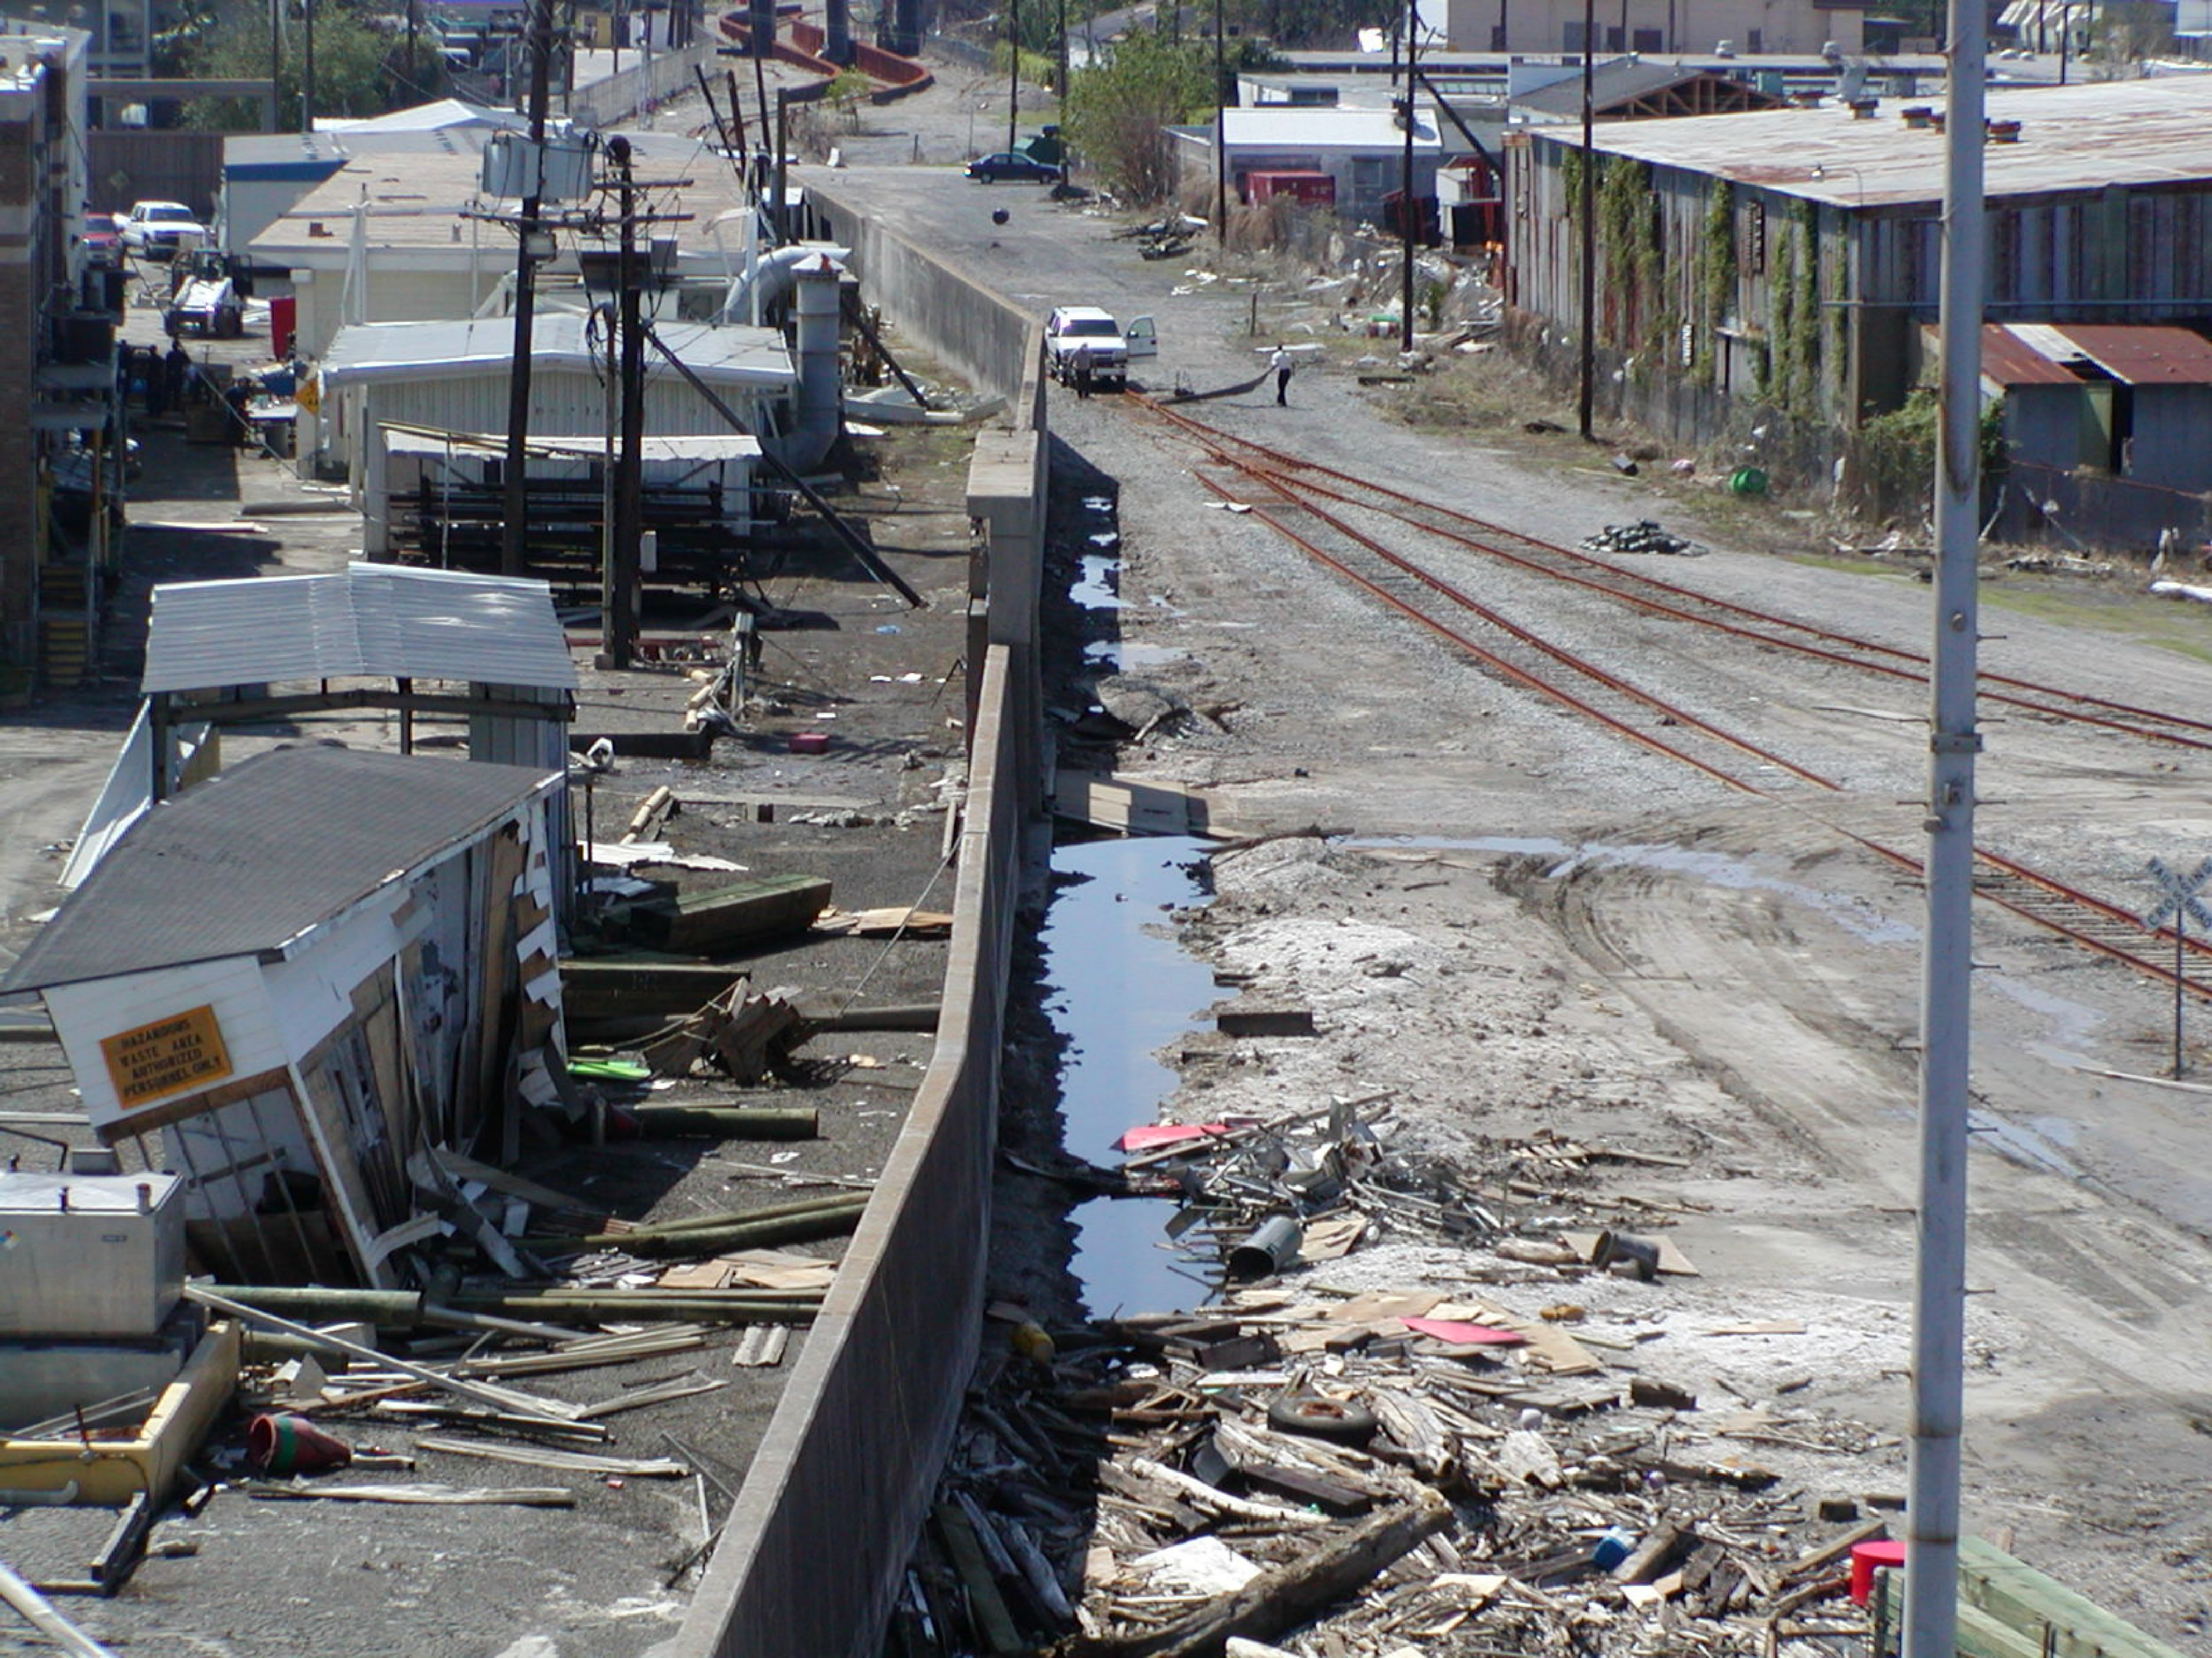
- g. Picture 9270009- From west side of IHNC on Claiborne Bridge looking south at scour behind floodwall. Left of floodwall is coast guard station.
  - h. Picture 9270010- Looking down from south side of Claiborne Street Bridge at debris on top of floodwall. On west side of IHNC.

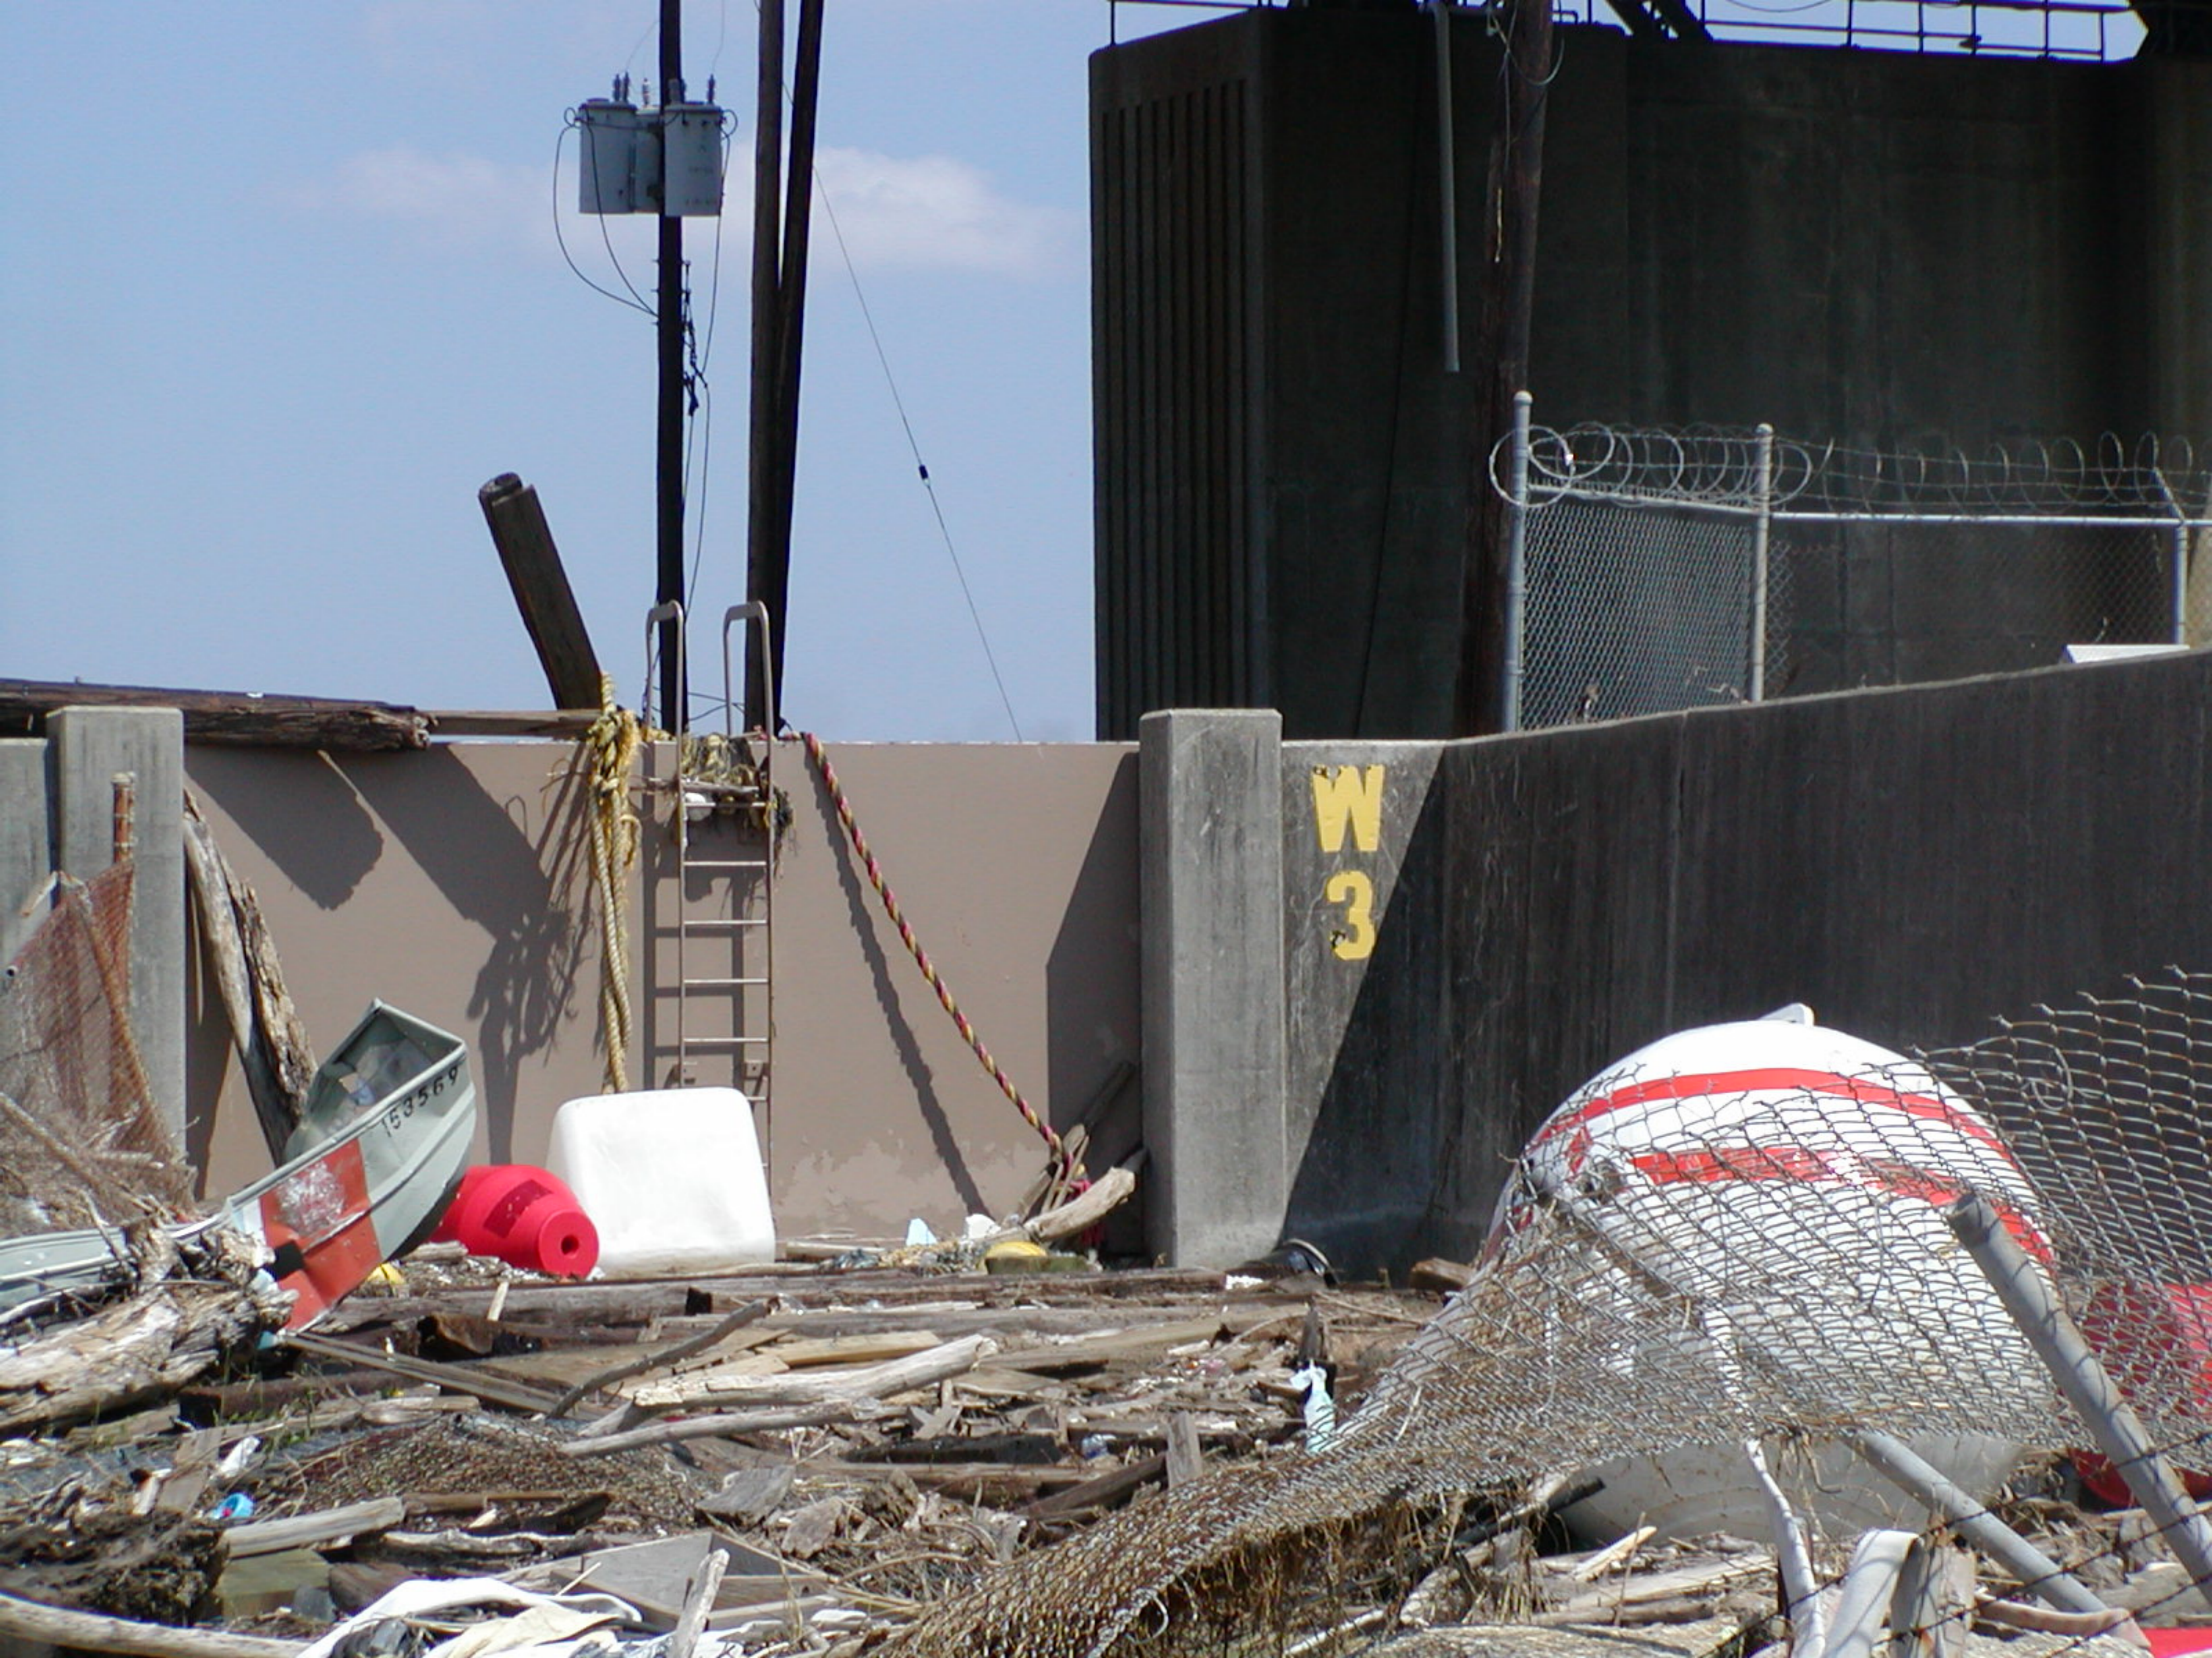
- i. Picture 9270011- Looking at debris on top of floodwall from ground level, protected side of floodwall just south of Claiborne street bridge, looking NNE.
